**ELLERBE CREEK STREAM RESTORATION – Project #127
Fifth Annual Monitoring Report - 2009 - FINAL**

Submitted on January 11, 2010 to:

North Carolina Department of
Environment and Natural Resources
Ecosystem Enhancement Program
1652 Mail Service Center
Raleigh, NC 27699-1652

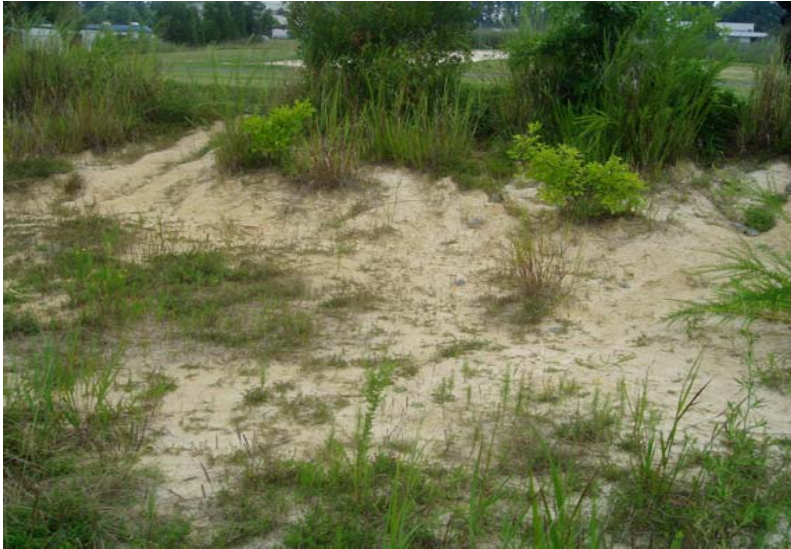
Feature/Issue	Station	Suspected Cause	Photo #
Rill and gully	1370	Insufficient growth medium	SP1
Beaverdam	1719	Beaver activity	SP8
Bank scour	1790	Scour in stormwater drainageway	SP2
Rill and gully	1860	Insufficient growth medium	SP1
Beaverdam	2060	Beaver activity	
Bank slump/scour	2060-2080	Insufficient rootwad/armoring	SP3
Beaverdam	2130	Beaver activity	SP8
Beaverdam	2219	Beaver activity	SP8
Aggradation (bar)	2220	Sedimentation due to downstream beaver dam	SP7
Bank erosion/scour	2300-2320	Under bridge, poor armoring of constricted flow passage	SP4
Aggradation (bar)	1000*	Sedimentation at culvert from upstream sources	SP7
Aggradation (bar)	1125*	Sedimentation from level spreader	SP7
Beaverdam	2415	Beaver activity	SP8
Beaverdam	2599	Beaver activity	SP8
Beaverdam	2975	Beaver activity	SP8
Beaverdam	3452	Beaver activity	SP8
Beaverdam	3992	Beaver activity	SP8
Beaverdam	4770	Beaver activity	SP8
Bank slump/scour	4955-5005	Insufficient rootwad/armoring	SP6

Rill and gully	5550	Insufficient growth medium	SP1
Mid-channel bar	6110	Sediment from stormwater/scour areas	SP7
Bank slump/scour	6220-6270	Insufficient rootwad/armoring	SP6
Rill and gully	6350	Insufficient growth medium	SP1
Bank undercut/scour	6340-6360	Insufficient rootwad/armoring	SP6
Aggradation (bar)	6390	Sediment from stormwater/scour areas	SP7
Rill and gully	6340	Insufficient growth medium	SP1
Rill and gully	6425	Insufficient growth medium	SP1

SP1. Rill and gully (7/16/09)

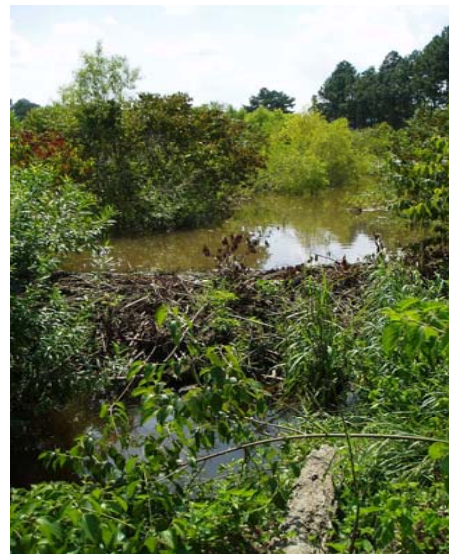
As of 16 July, a total of eight active beaverdams were observed throughout the restoration project, seven of which are located in the Hillsborough and Hillandale reaches. Those eight, along with two additional abandoned dams and one incomplete dam, are impounding water and sediment in these reaches. At station 1719, the dam extends across the entire floodplain and is impounding water above bankfull elevation. All dams are identified in the longitudinal profile (Appendix B).

SP8. Beaverdams (7/1/09)
