**ELLINGTON BRANCH STREAM RESTORATION SITE
FULL DELIVERY PROJECT
WARREN COUNTY, NORTH CAROLINA**

EEP Project No. 16-D06045

Final Monitoring Report Year #2 (2009)

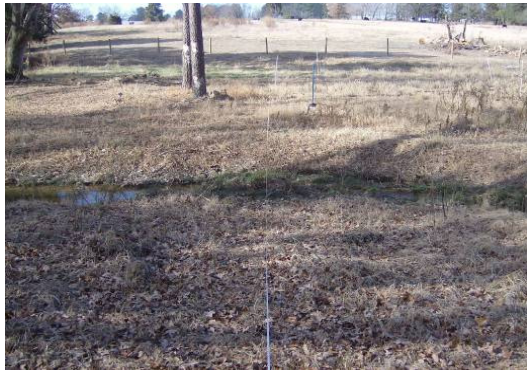
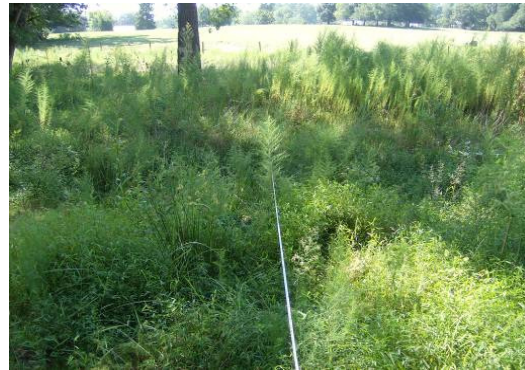
Photo #21
Facing north
(downstream) at
Cross Section #11
along Ellington
Branch

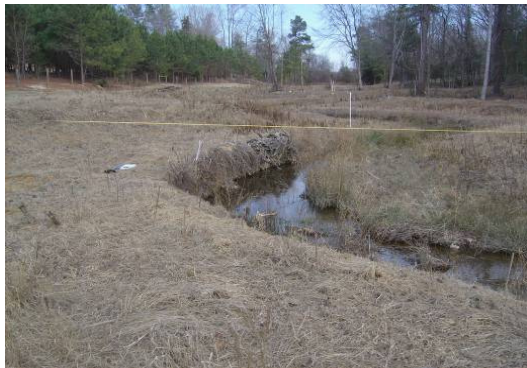
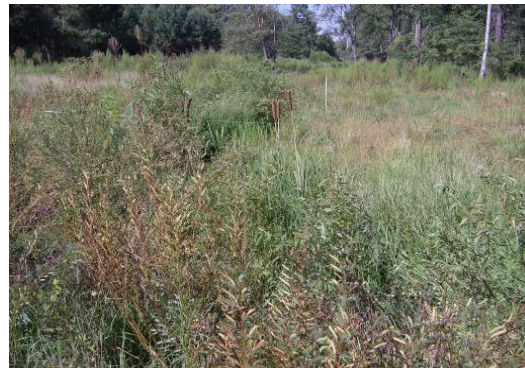
Photo #22
Facing west across
Cross Section #11
along Ellington
Branch

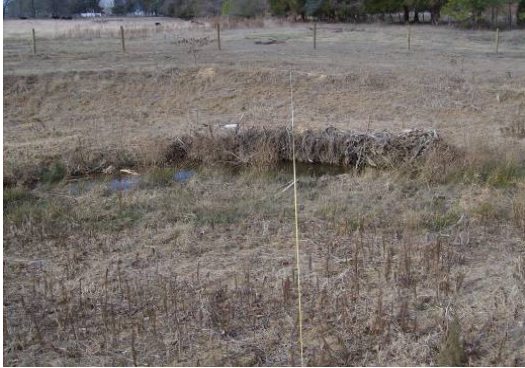
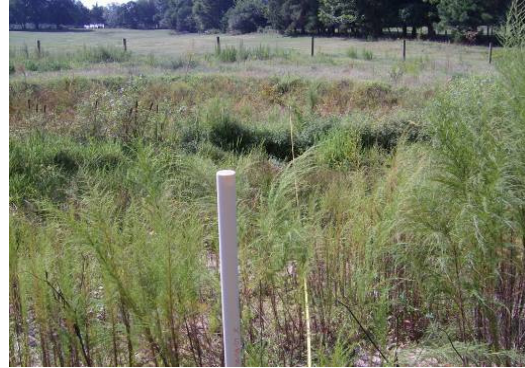
Photo #23
Facing north
(downstream) at
Cross Section #12
along Ellington
Branch

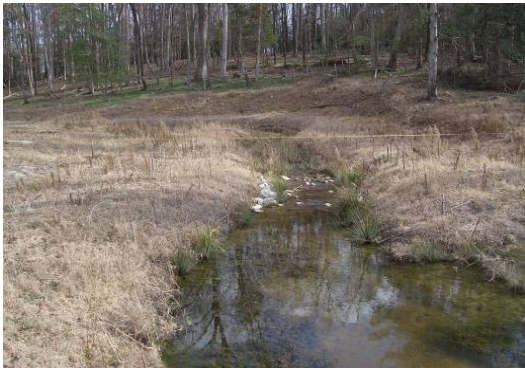
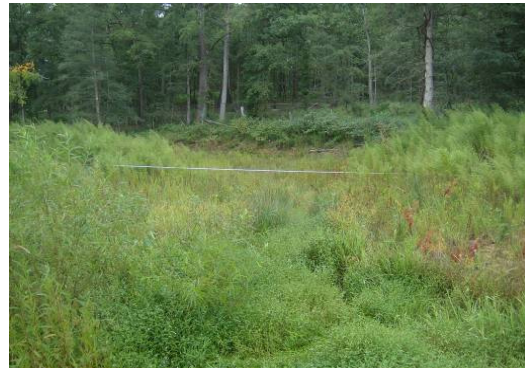
Photo #24
Facing west across
Cross Section #12
along Ellington
Branch

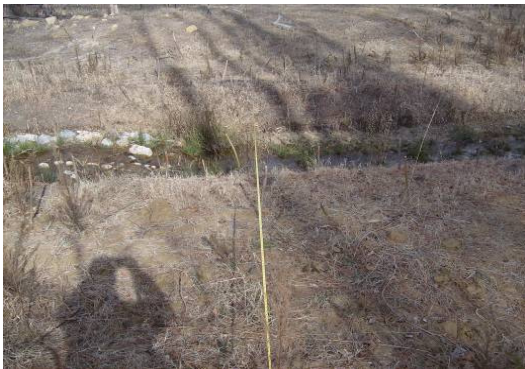
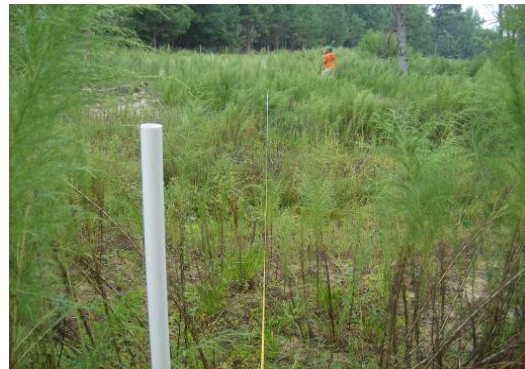
Photo #25
Facing north
(downstream) at
Cross Section #13
along Ellington
Branch

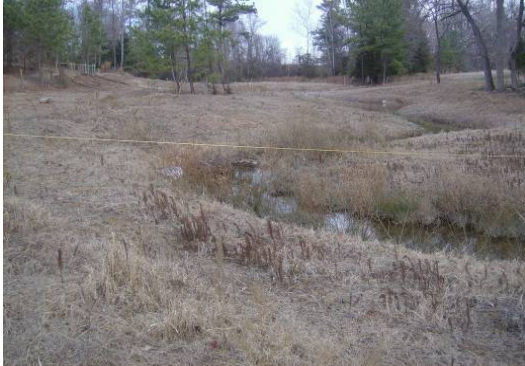
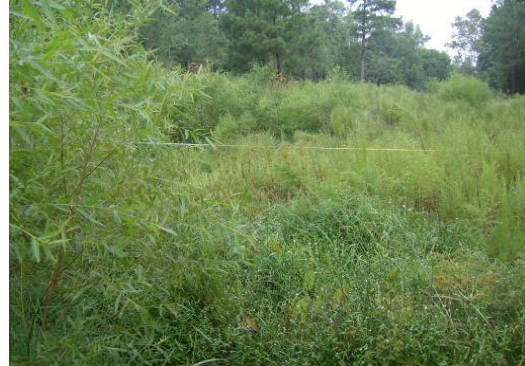
Photo #26
Facing west across
Cross Section #13
along Ellington
Branch

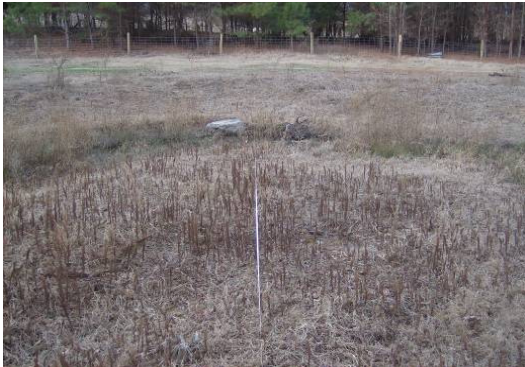
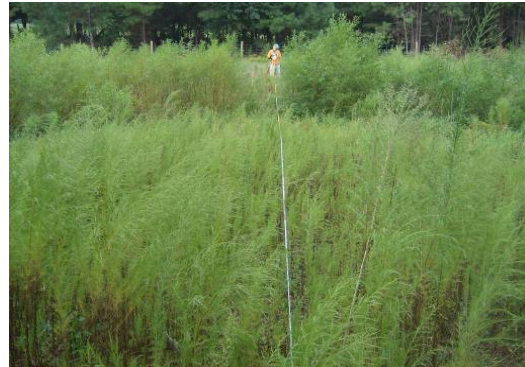
Photo #27
Facing north
(downstream) at
Cross Section #14
along Ellington
Branch

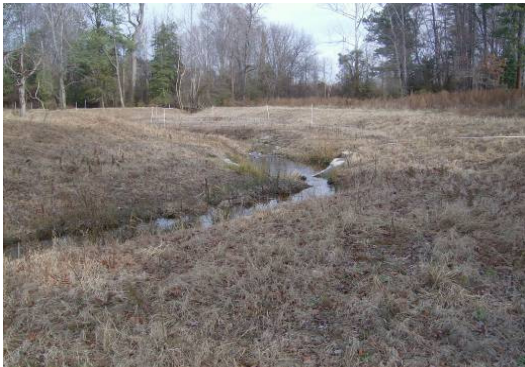
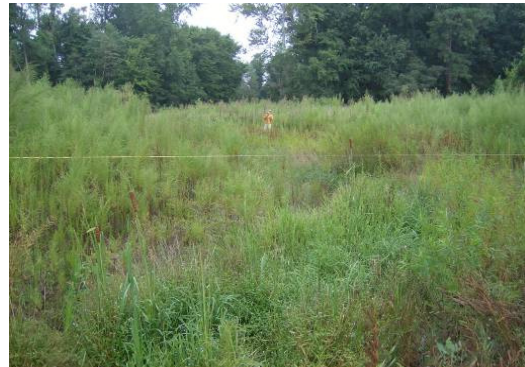
Photo #28
Facing west across
Cross Section #14
along Ellington
Branch

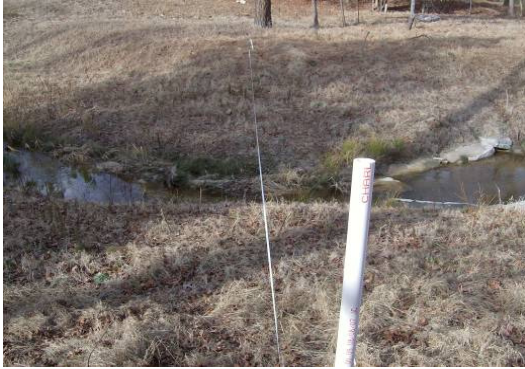
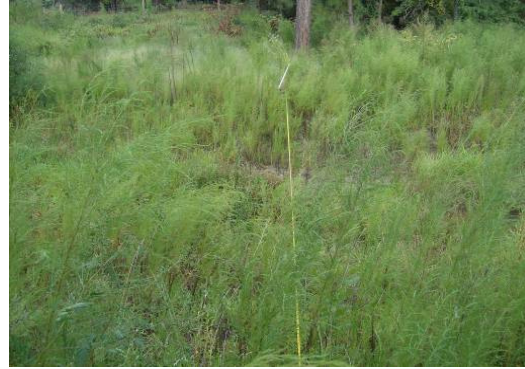
Photo #29
Facing north
(downstream) at
Cross Section #15
along Ellington
Branch

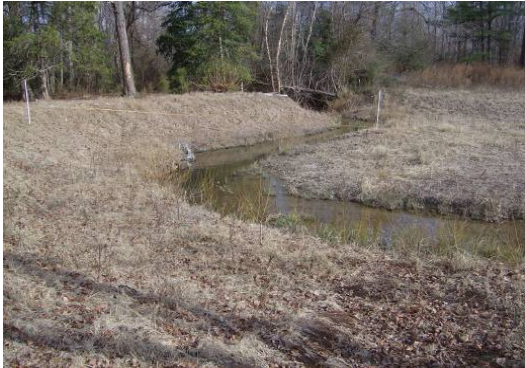
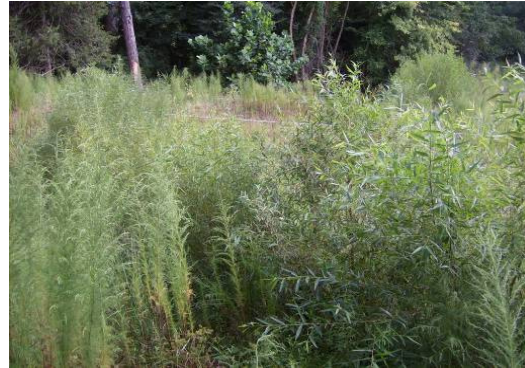
Photo #30
Facing west across
Cross Section #15
along Ellington
Branch

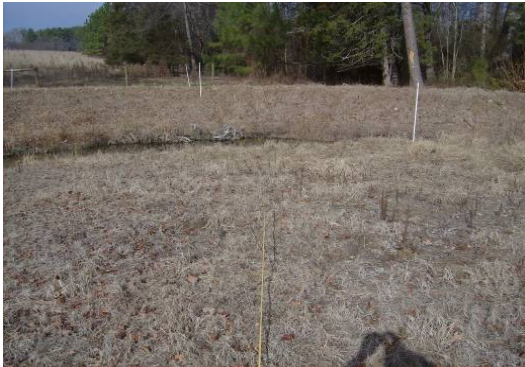
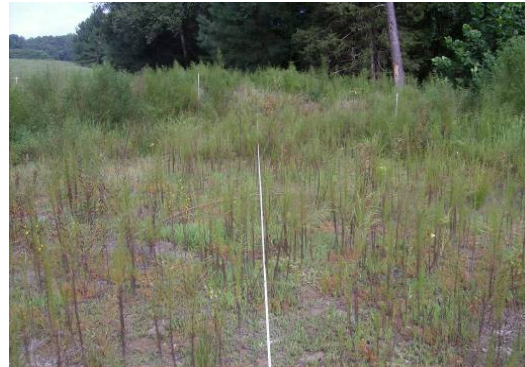
Photo #31
Facing east
(downstream) at
Cross Section #16
along the Unnamed
Tributary

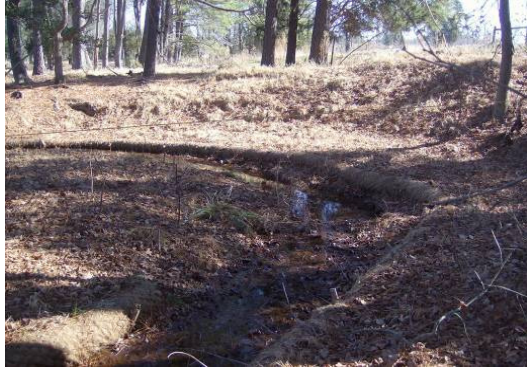
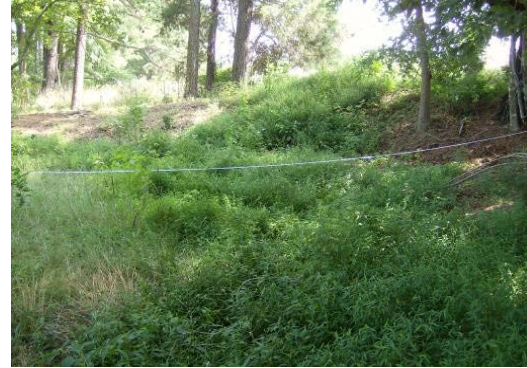
Photo #32
Facing north across
Cross Section #16
along the Unnamed
Tributary

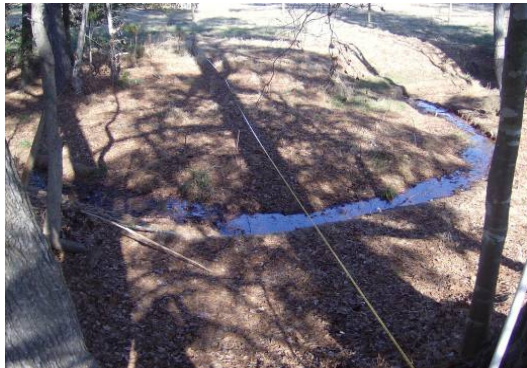
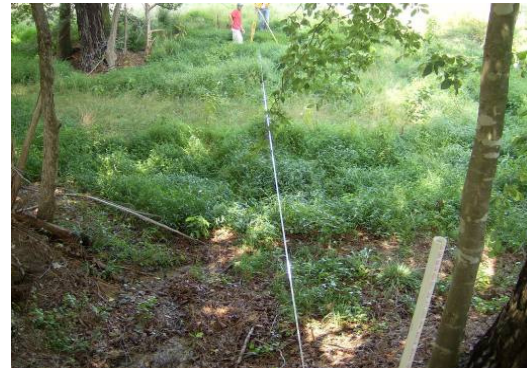
Photo #33
Facing east
(downstream) at
Cross Section #17
along the Unnamed
Tributary

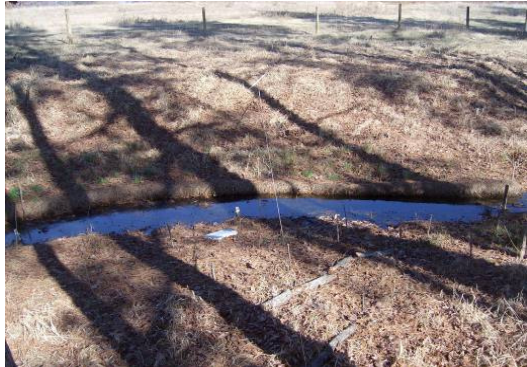
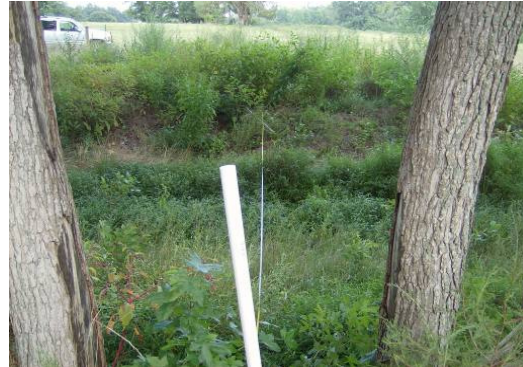
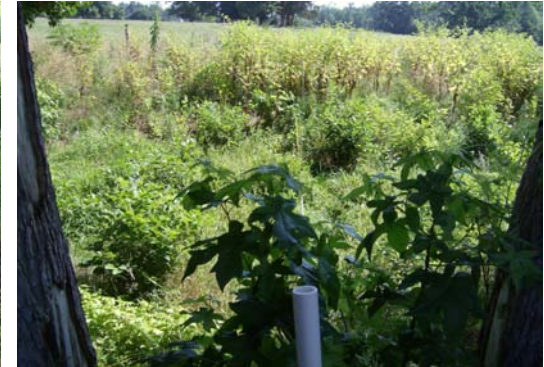
Photo #34
Facing north across
Cross Section #17
along the Unnamed
Tributary

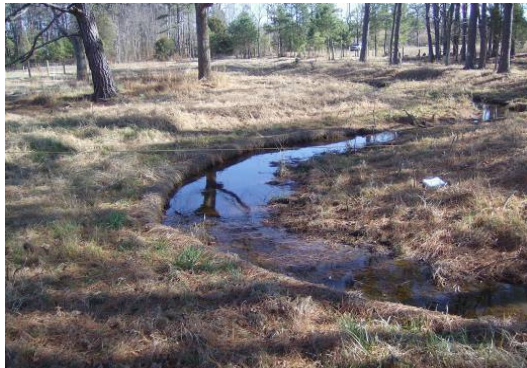
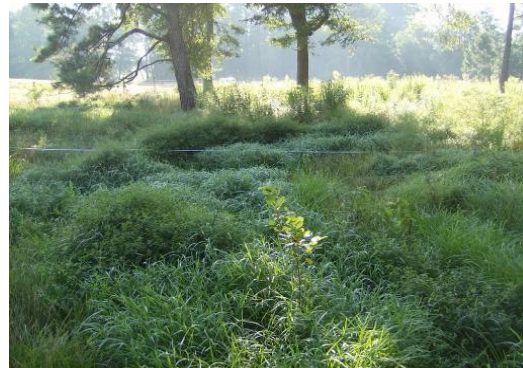
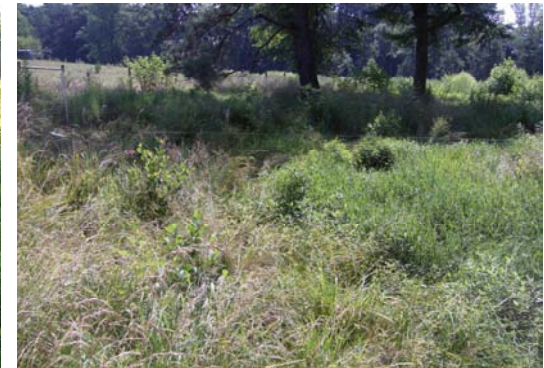
Photo #35
Facing east
(downstream) at
Cross Section #18
along the Unnamed
Tributary

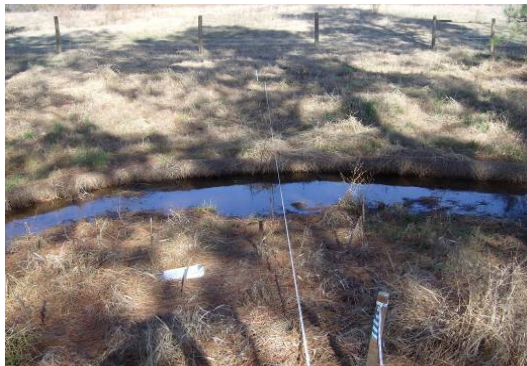
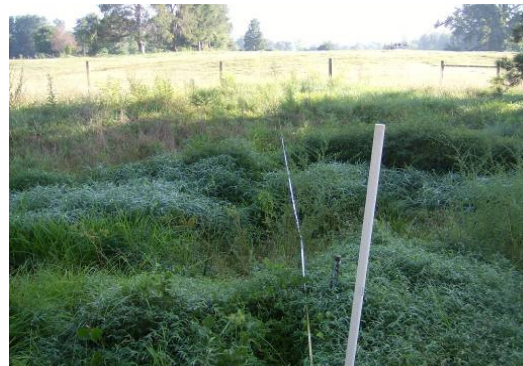
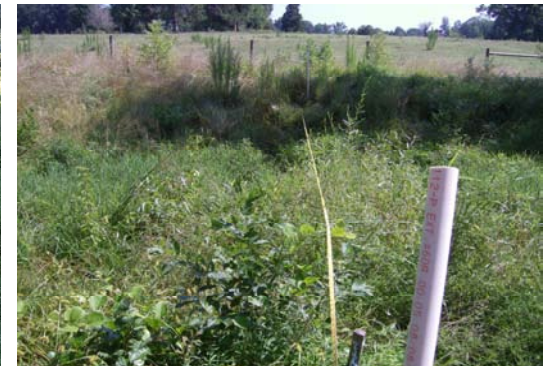
Photo #36
Facing north across
Cross Section #18
along the Unnamed
Tributary

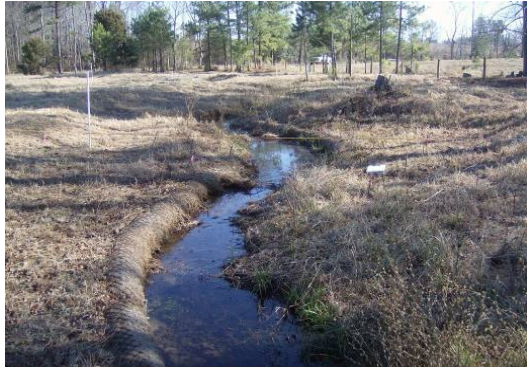
Photo #37
Facing east
(downstream) at
Cross Section #19
along the Unnamed
Tributary

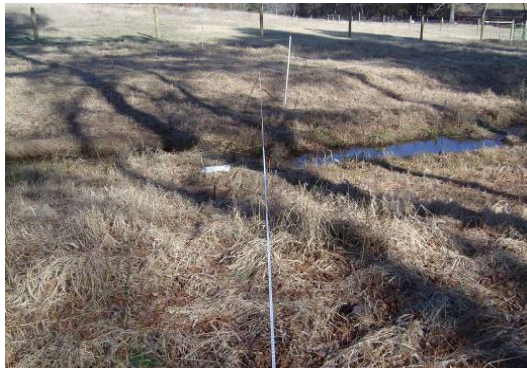
Photo #38
Facing north across
Cross Section #19
along the Unnamed
Tributary

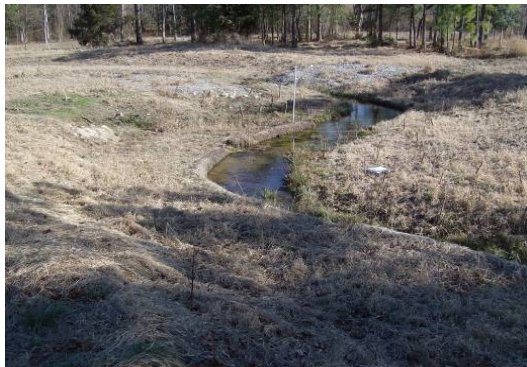
Photo #39
Facing east
(downstream) at
Cross Section #20
along the Unnamed
Tributary
