**ELLINGTON BRANCH STREAM RESTORATION SITE
FULL DELIVERY PROJECT
WARREN COUNTY, NORTH CAROLINA**

EEP Project No. 16-D06045

FINAL Monitoring Report #3 (Year 2010)

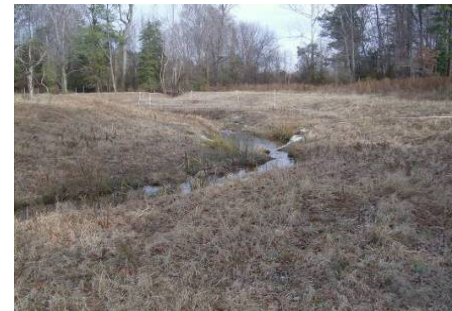
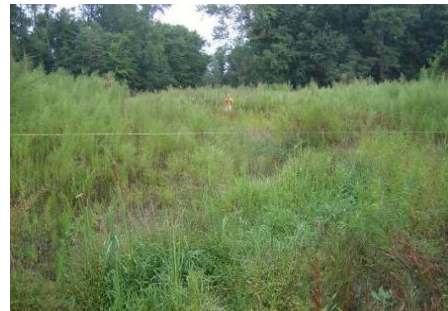
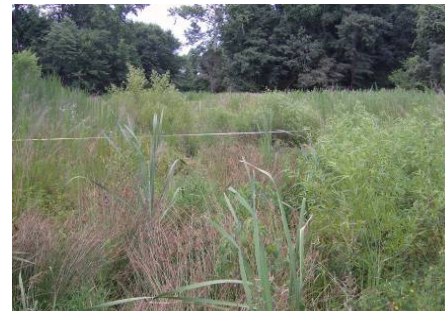
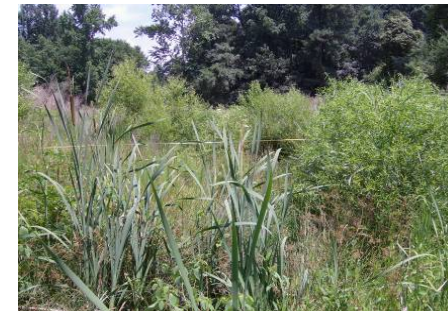
Photo #27
Facing north
(downstream)
at Cross Section
#14 along
Ellington Branch

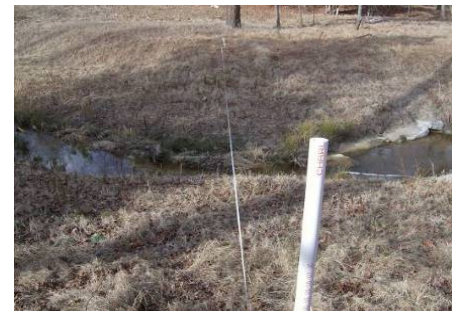
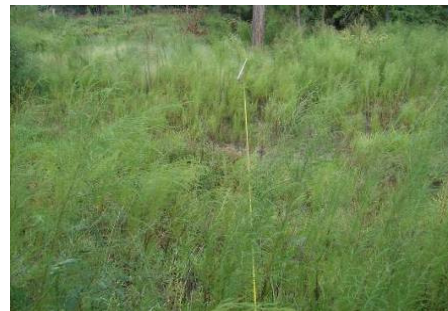
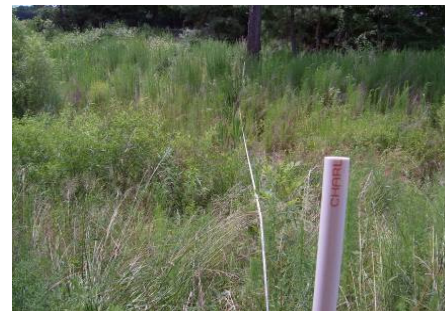
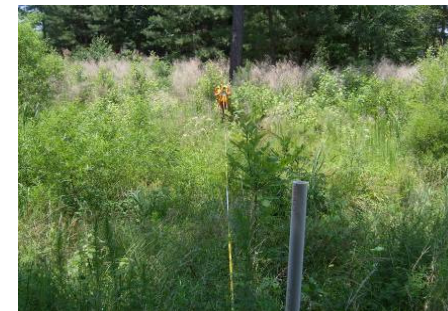
Photo #28
Facing west
across Cross
Section #14
along Ellington
Branch

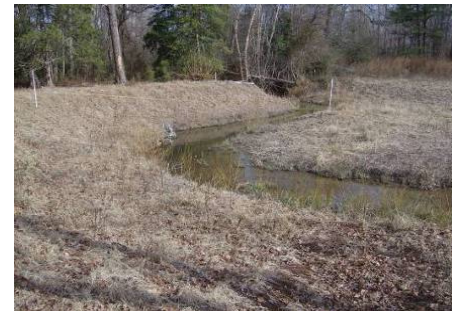
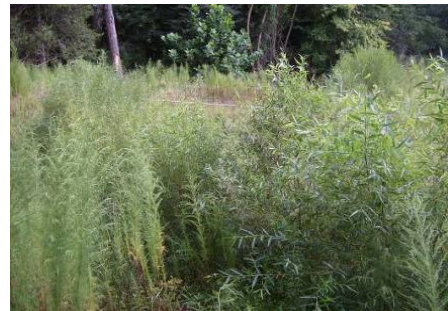
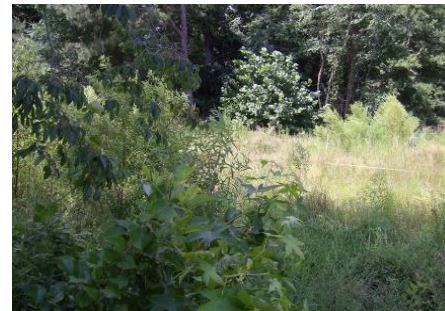
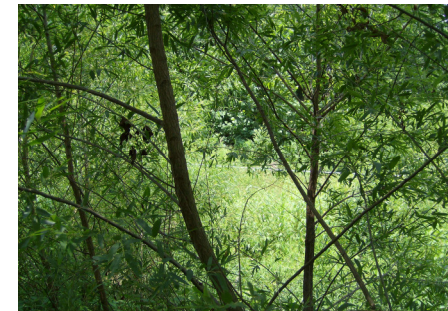
Photo #29
Facing north
(downstream)
at Cross Section
#15 along
Ellington Branch

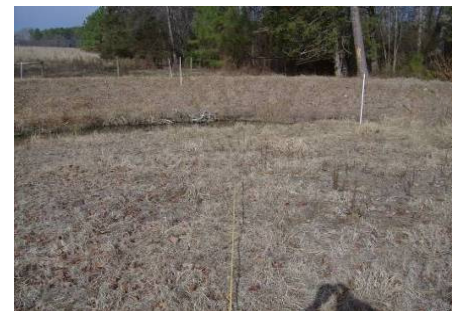
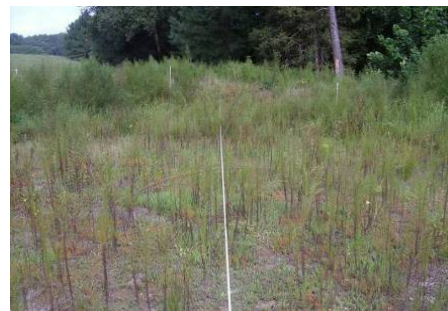
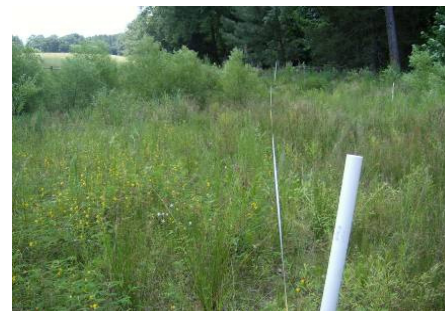
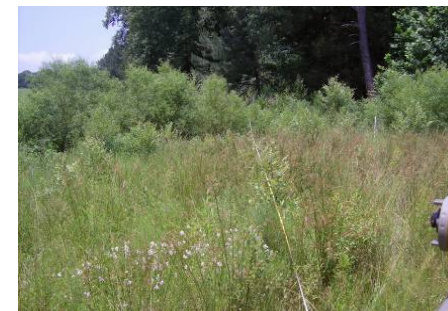
Photo #30
Facing west
across Cross
Section #15
along Ellington
Branch

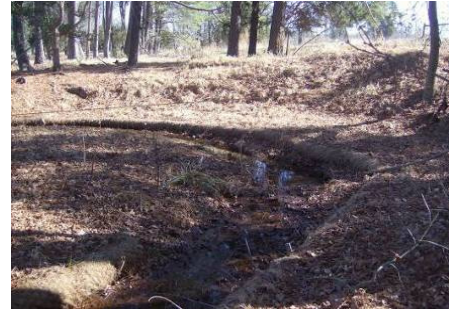
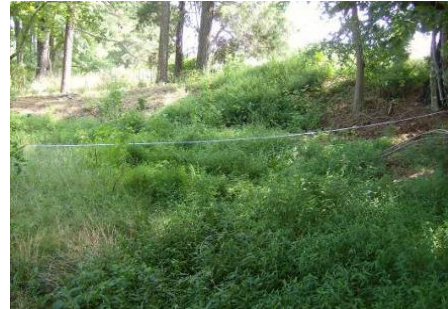
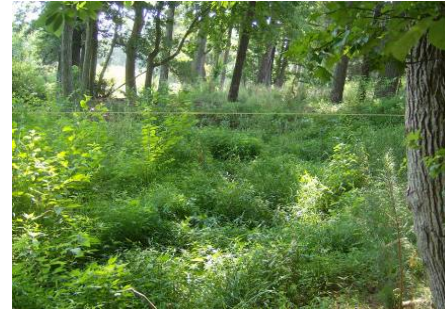
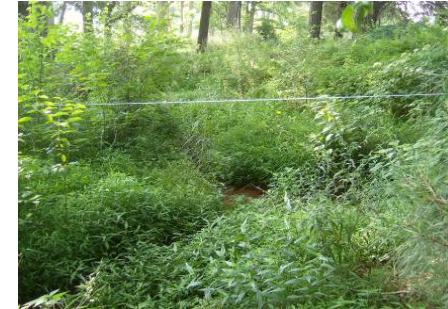
Photo #31
Facing east
(downstream) at
Cross Section
#16 along the
Unnamed
Tributary

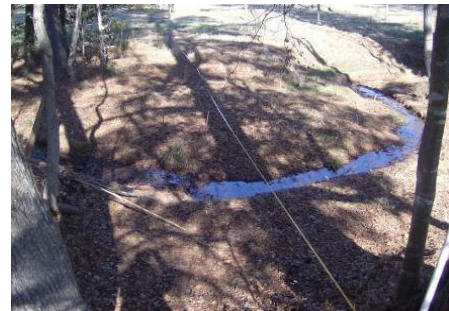
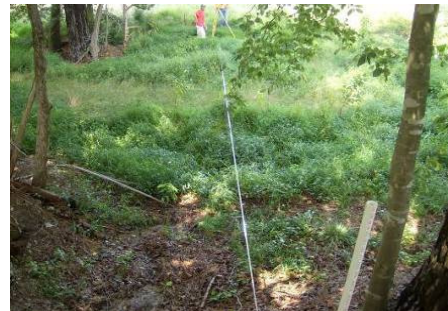
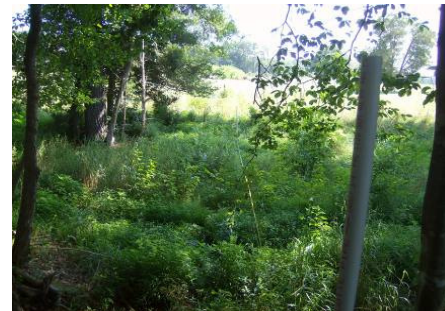
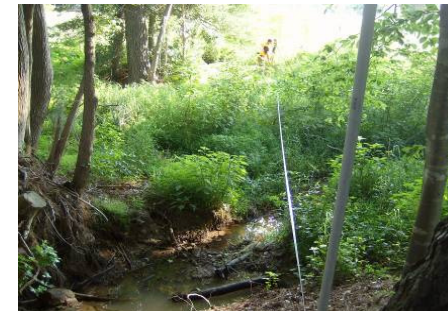
Photo #32
Facing north
across Cross
Section #16
along the
Unnamed
Tributary

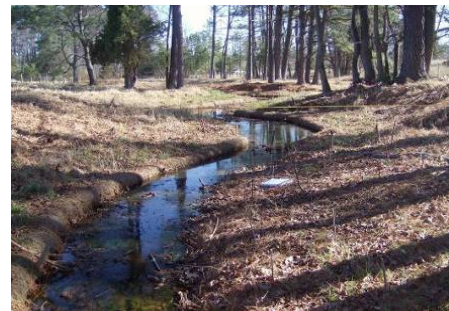
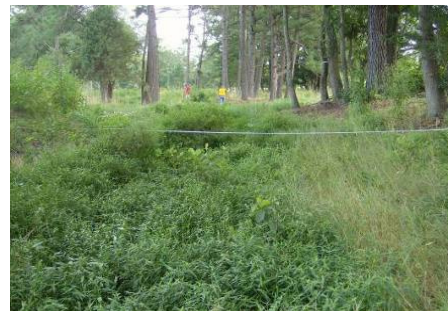
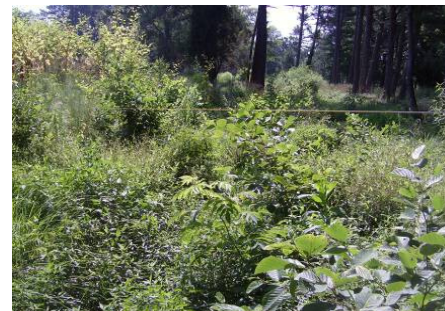
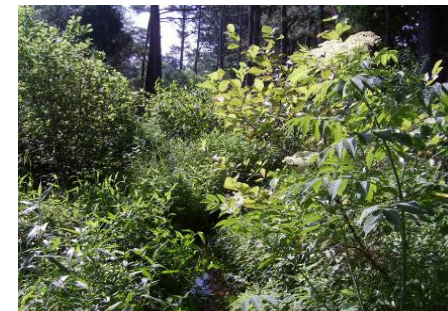
Photo #33
Facing east
(downstream) at
Cross Section
#17 along the
Unnamed
Tributary

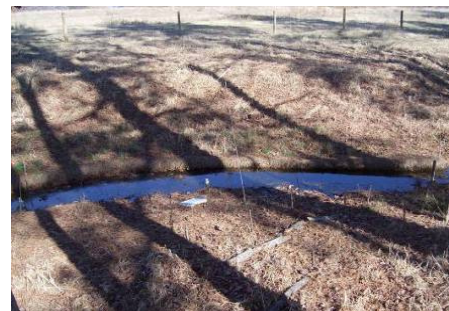
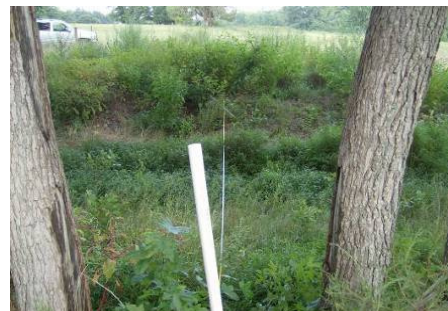
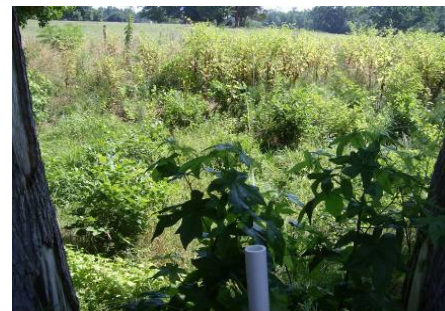
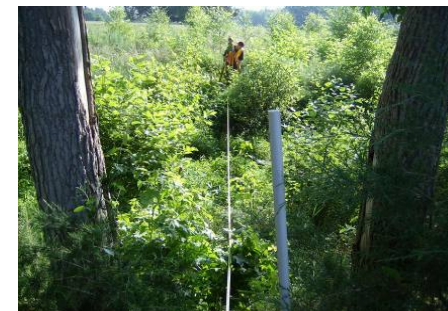
Photo #34
Facing north
across Cross
Section #17
along the
Unnamed
Tributary

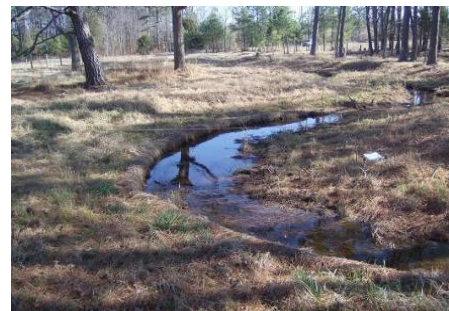
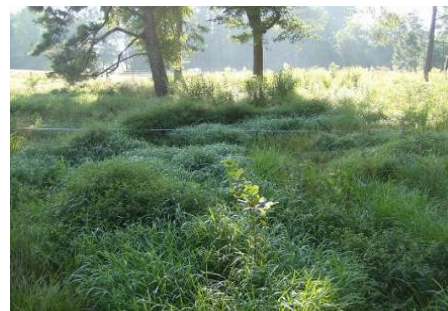
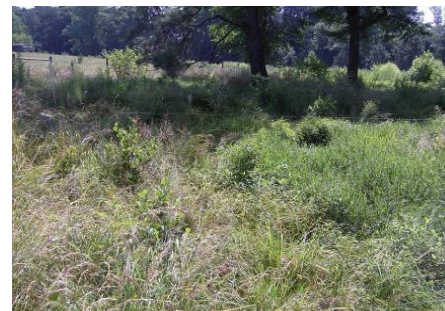
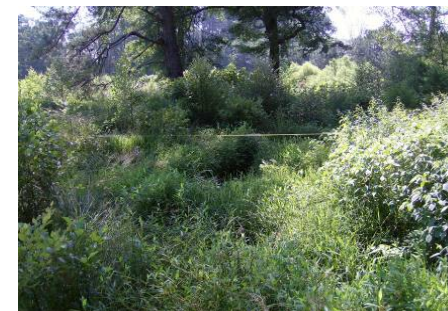
Photo #35
Facing east
(downstream) at
Cross Section
#18 along the
Unnamed
Tributary

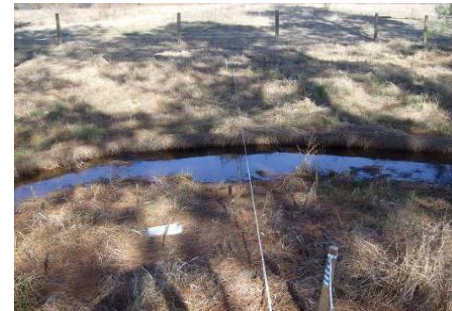
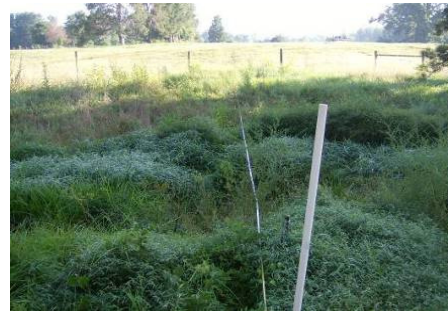
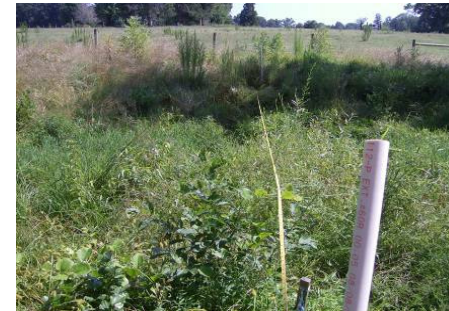
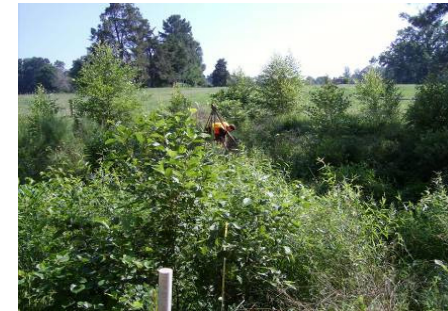
Photo #36
Facing north
across Cross
Section #18
along the
Unnamed
Tributary
