**ELLINGTON BRANCH STREAM RESTORATION SITE
FULL DELIVERY PROJECT
WARREN COUNTY, NORTH CAROLINA**

EEP Project No. 16-D06045

Final Monitoring Report MY5 (Year 2012)

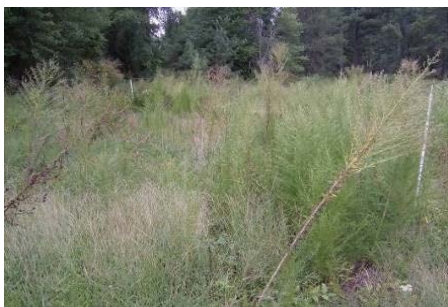
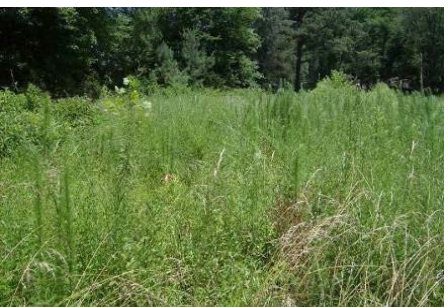
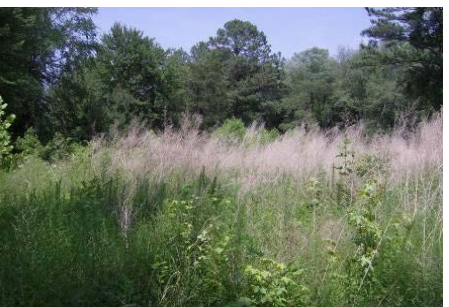
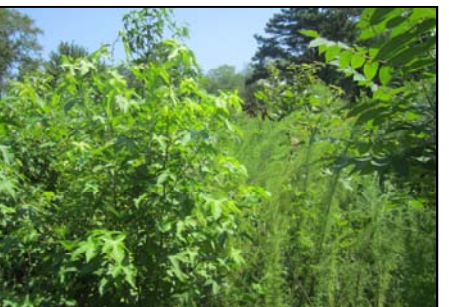
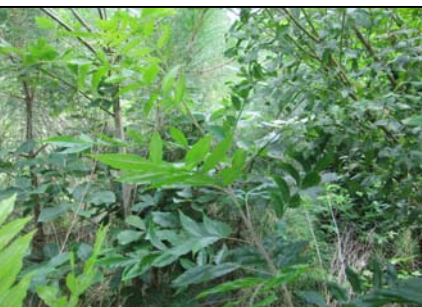
Photo # VP-5 Facing north at Vegetation Plot #5

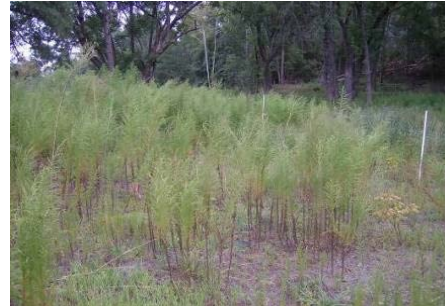
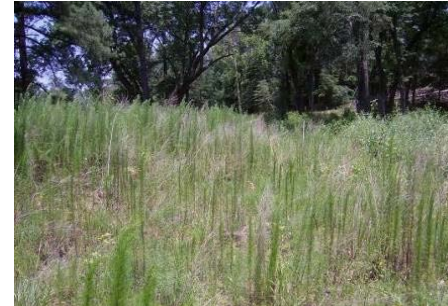
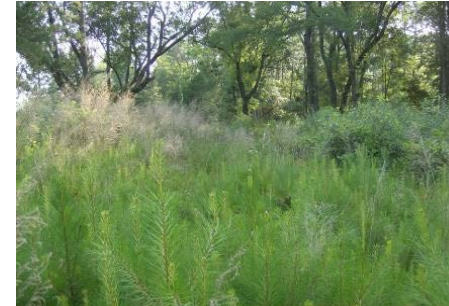
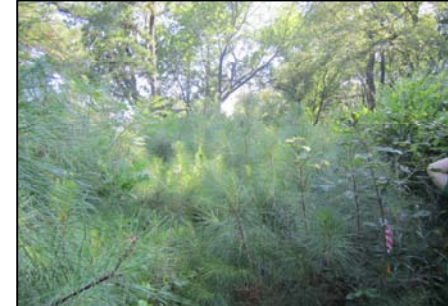
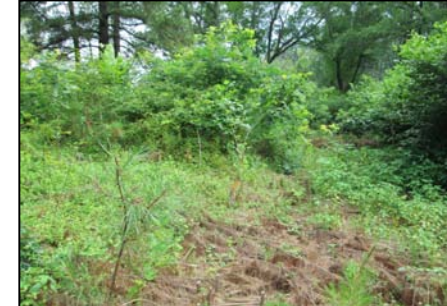
Photo # VP-6
Facing north at
Vegetation Plot #6

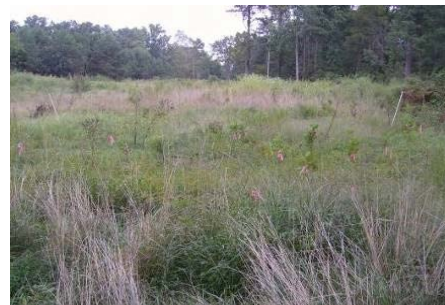
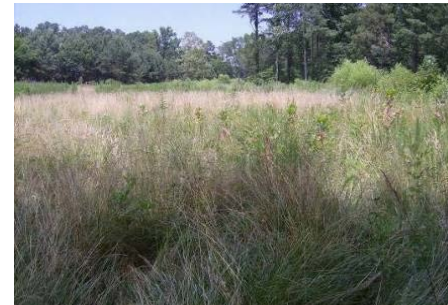
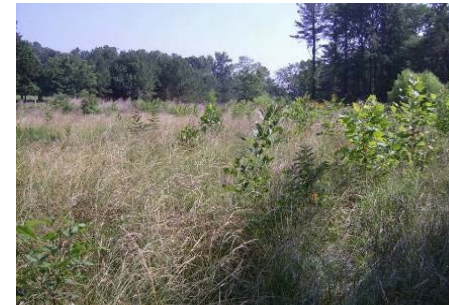
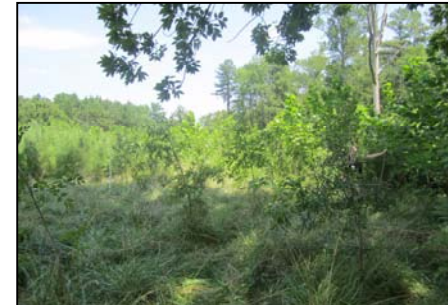
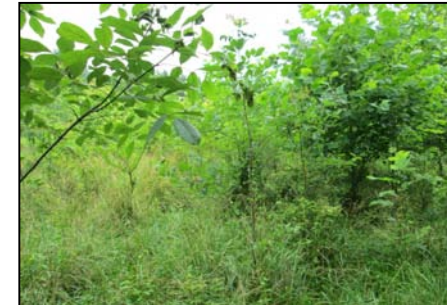
Photo # VP-7
Facing north at
Vegetation Plot #7

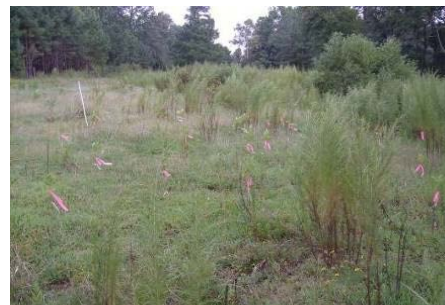
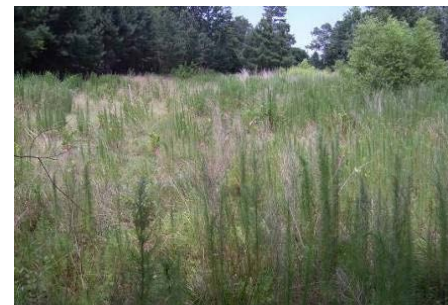
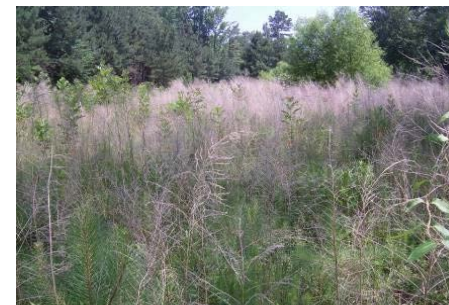
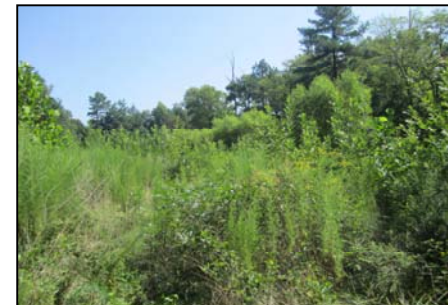
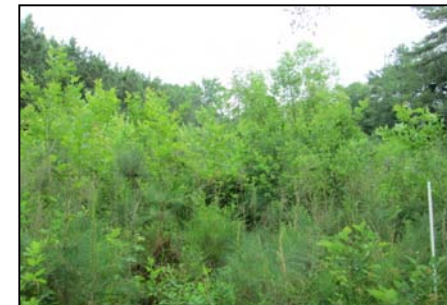
Photo # VP-8
Facing north at
Vegetation Plot #8

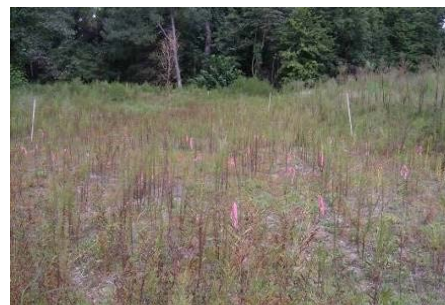
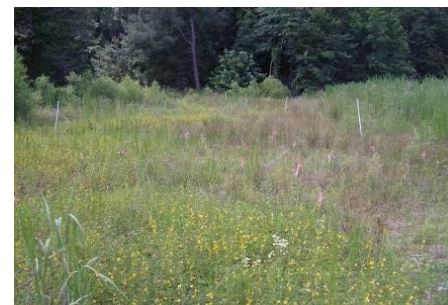
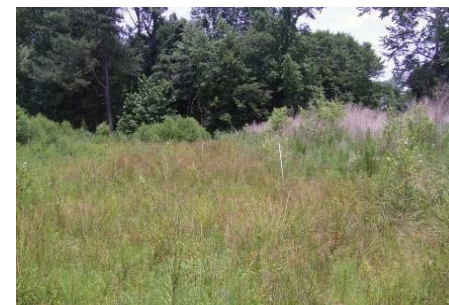
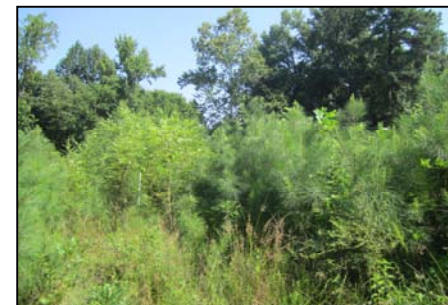
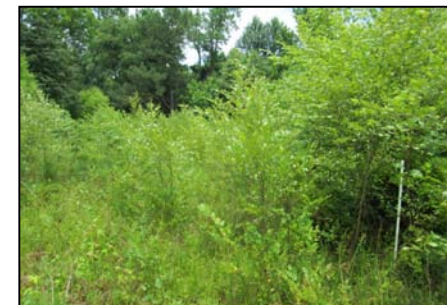
Photo # VP-9
Facing north at
Vegetation Plot #9

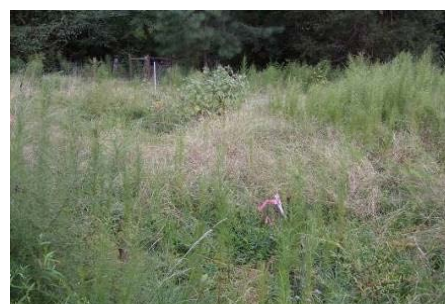
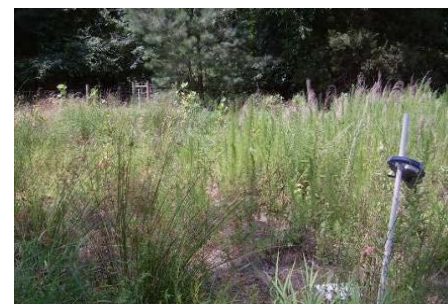
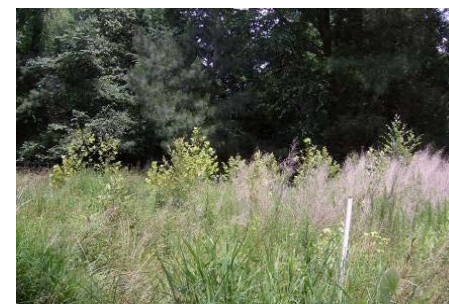
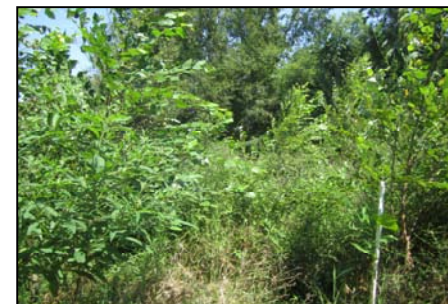
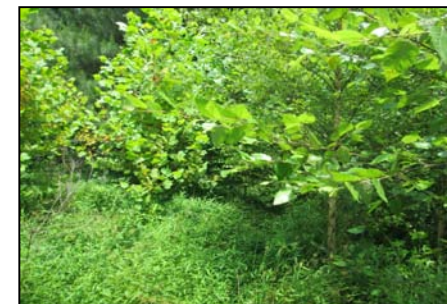
Photo # VP-10
Facing north at
Vegetation Plot #10

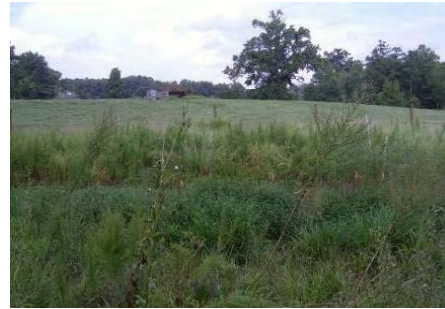
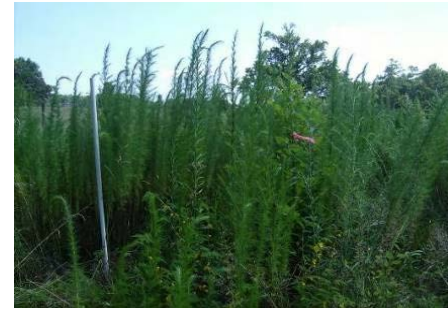
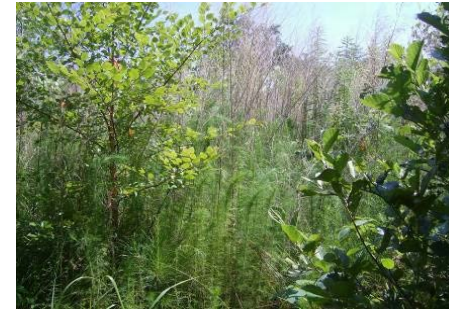
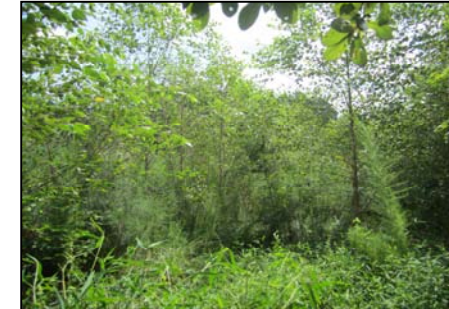
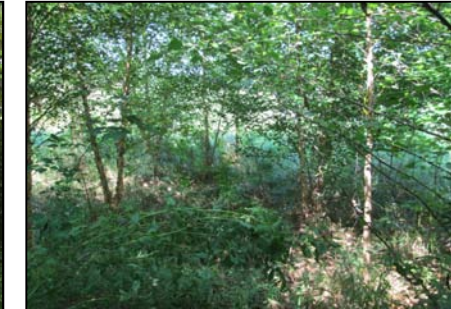
Photo # VP-11
Facing north at
Vegetation Plot #11

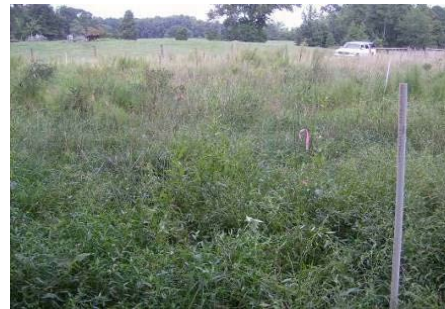
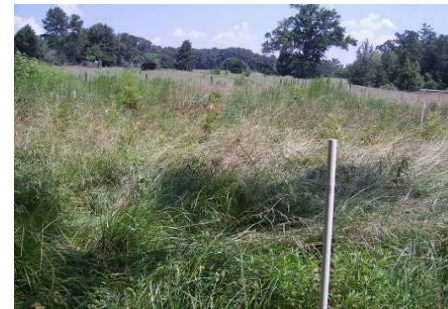
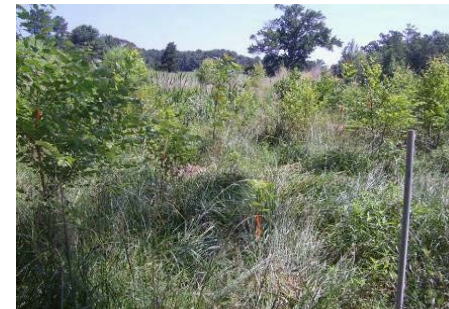
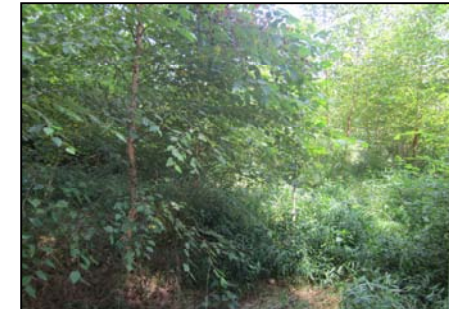
Photo # VP-12
Facing north at
Vegetation Plot #12

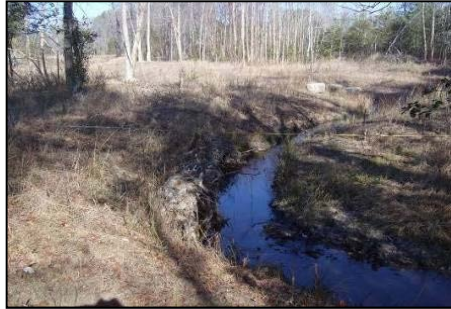
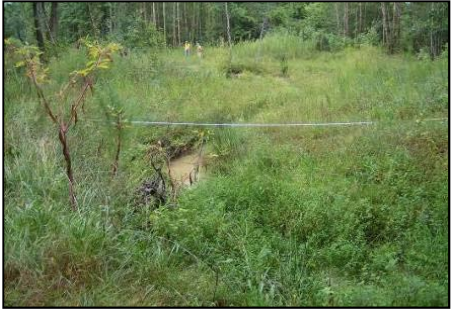
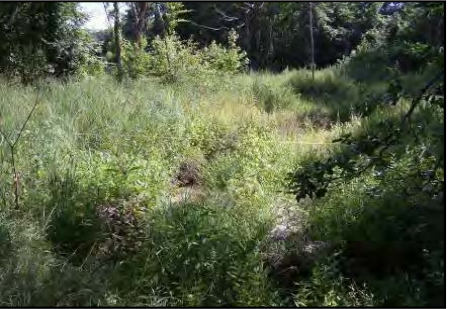
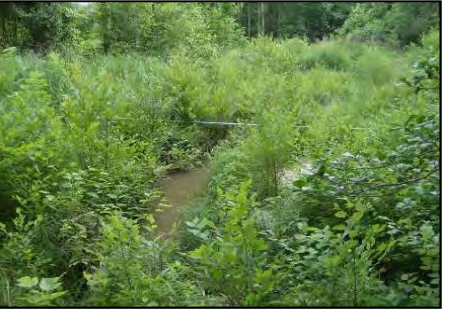
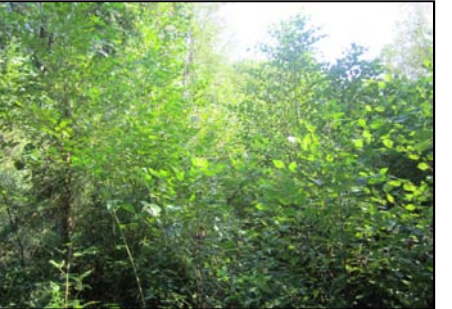
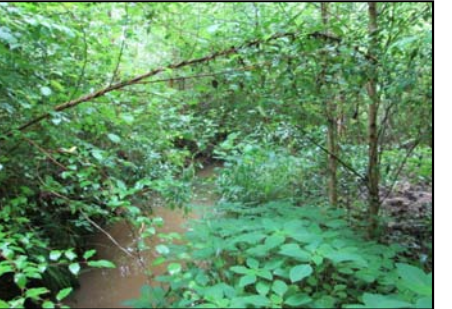
Photo Number and Location	As-Built Photographs taken January 2008	Year 2008 Monitoring Photographs taken September 2008	Year 2009 Monitoring Photographs taken July 2009	Year 2010 Monitoring Photographs taken June 2010	Year 2011 Monitoring Photographs taken August 2011	Year 2012 Monitoring Photographs taken July 2012
Photo #1 Facing north (downstream) at Cross Section #1 along Ellington Branch

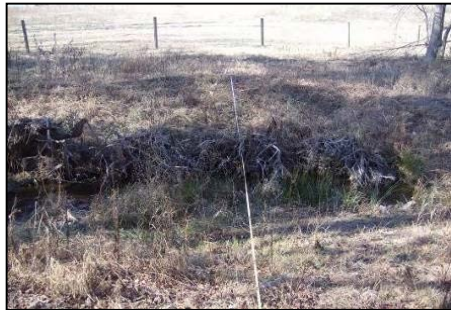
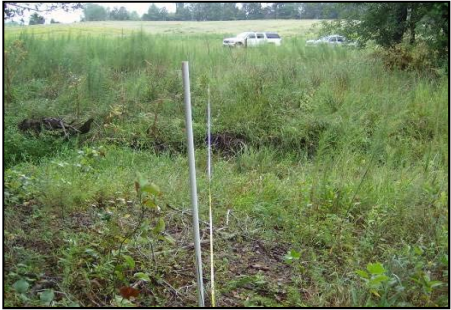
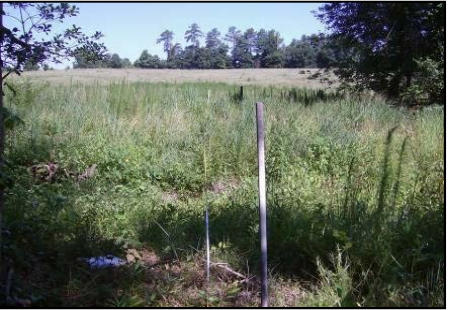
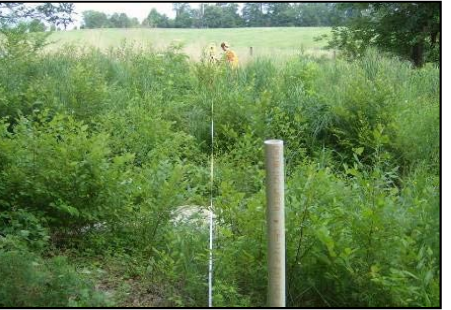
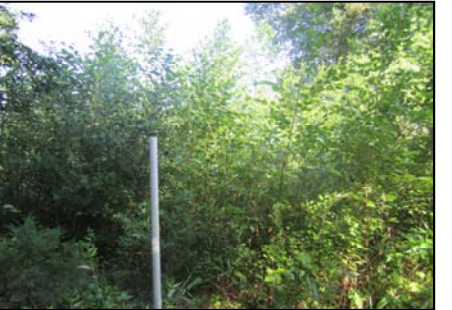
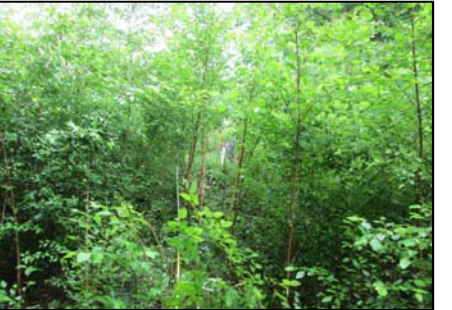
Photo #2 Facing west across Cross Section #1 along Ellington Branch

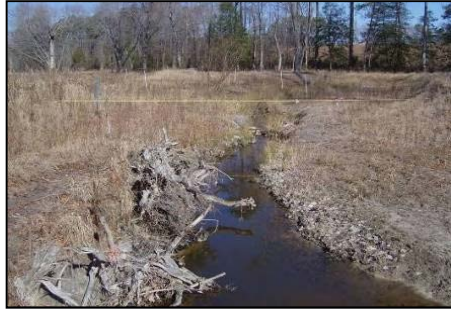
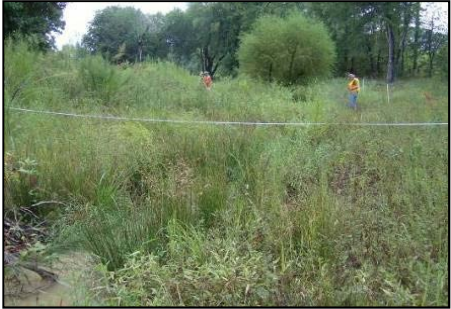
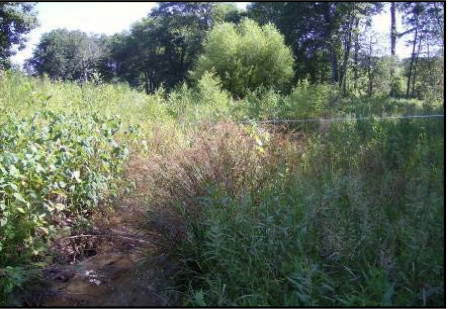
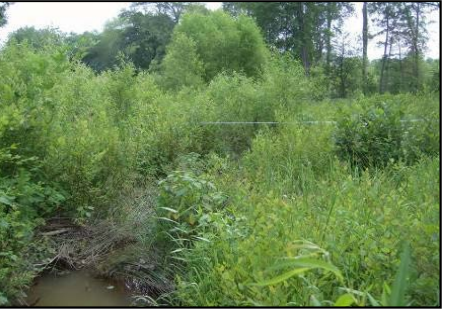
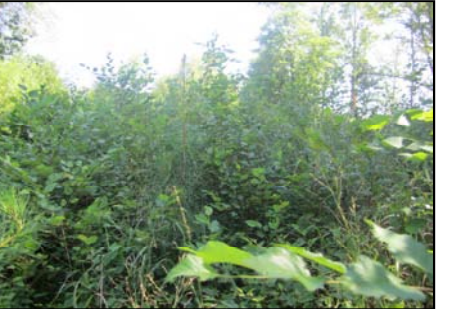
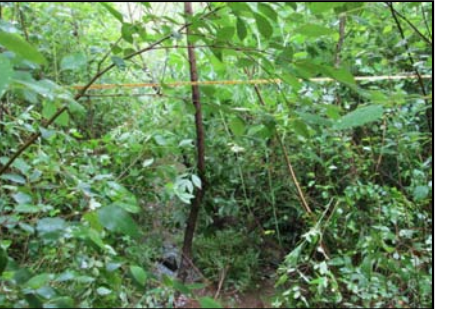
Photo #3 Facing north (downstream) at Cross Section #2 along Ellington Branch

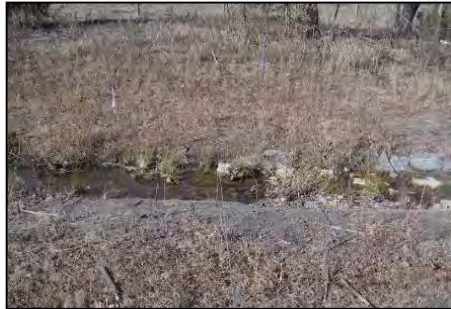
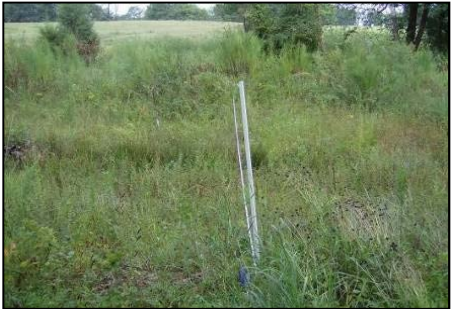
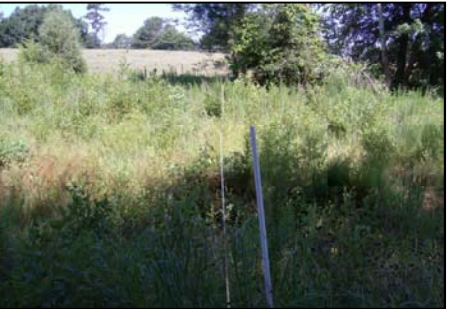
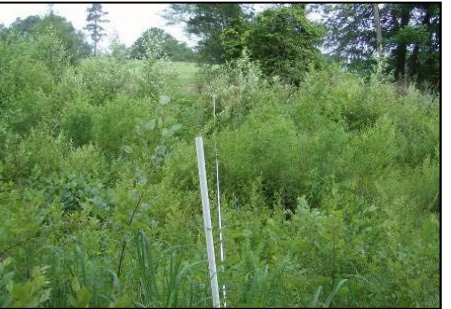
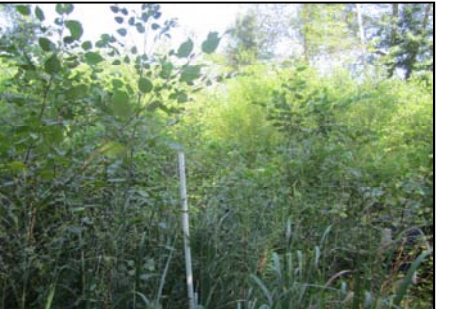
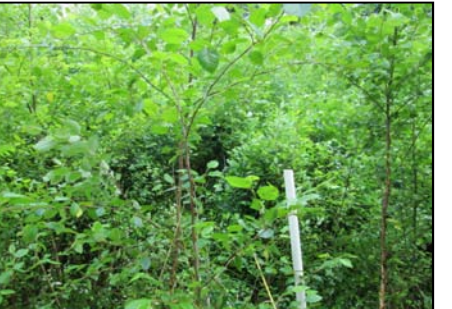
Photo #4 Facing west across Cross Section #2 along Ellington Branch

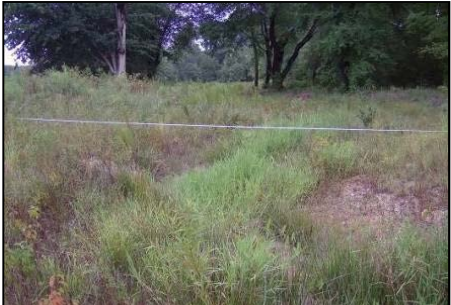
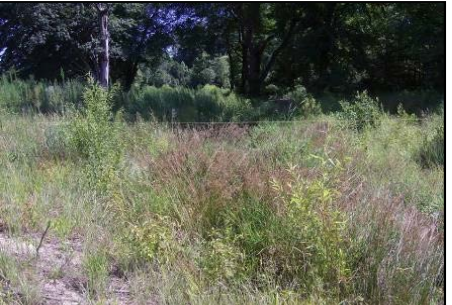
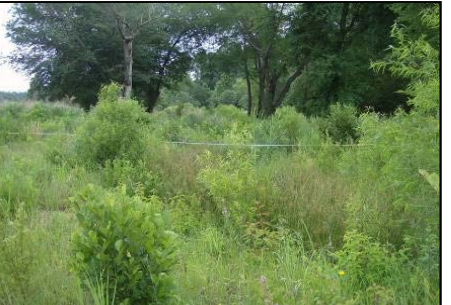
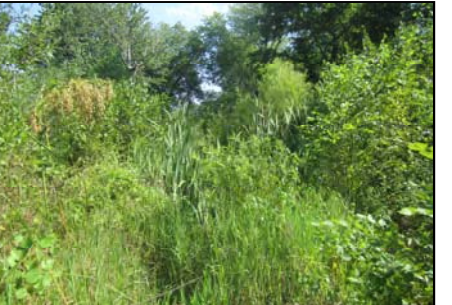
Photo #5 Facing north (downstream) at Cross Section #3 along Ellington Branch	<i>No photograph available</i>

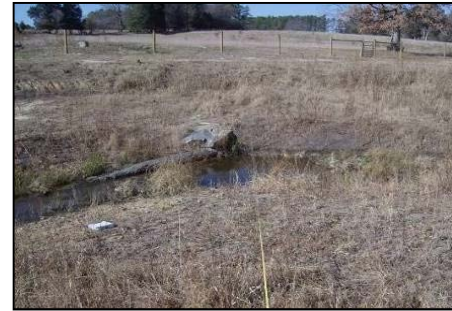
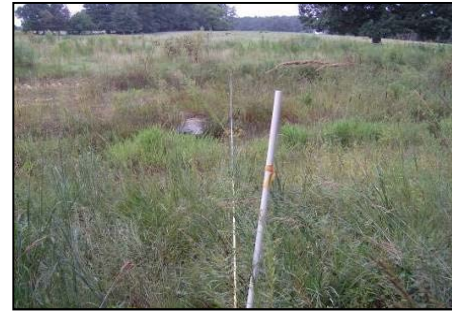
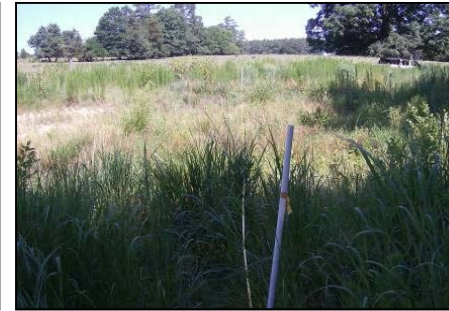
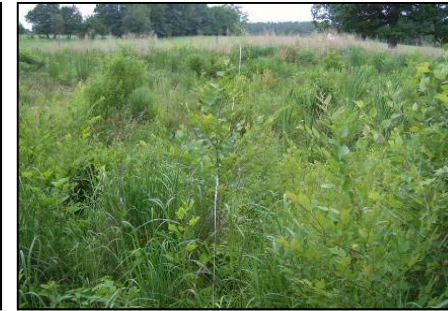
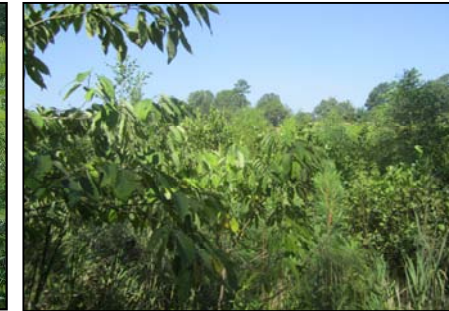
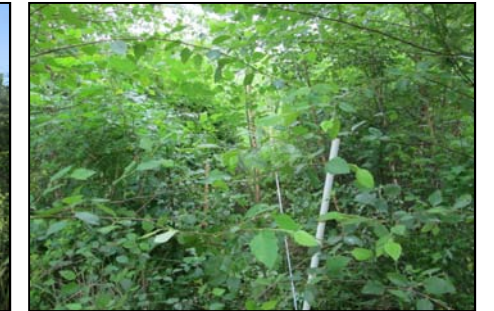
Photo #6
Facing west
across Cross
Section #3 along
Ellington Branch

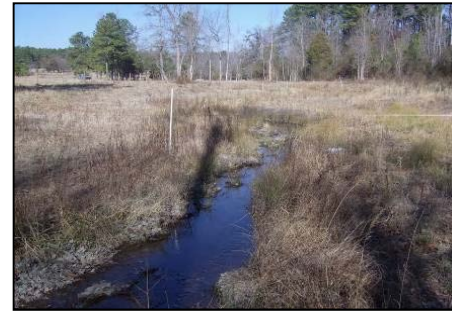
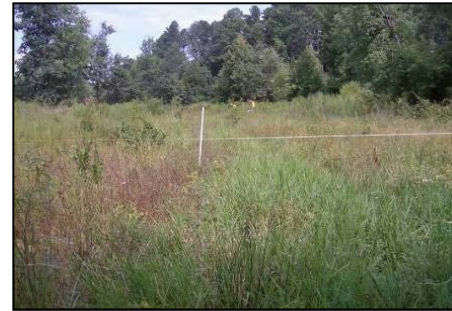
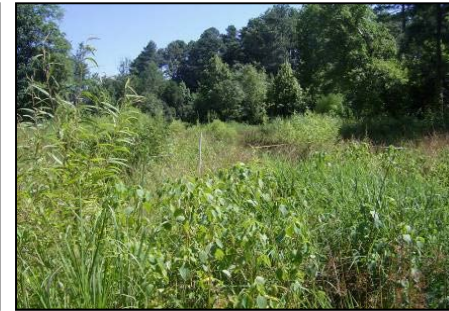
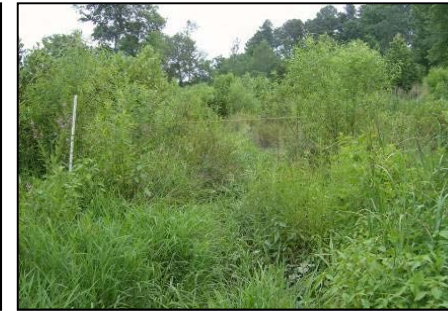
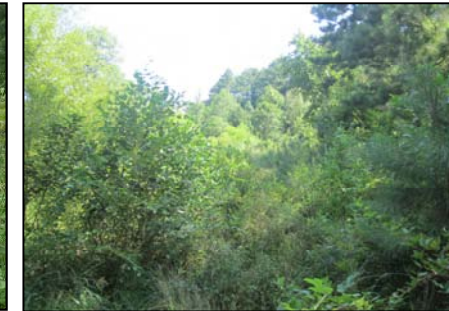
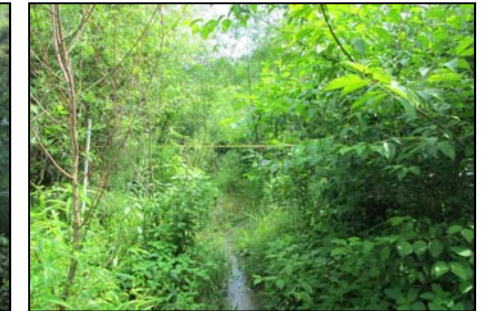
Photo #7
Facing north
(downstream) at
Cross Section #4
along Ellington
Branch

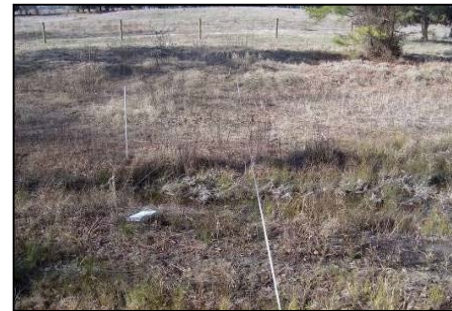
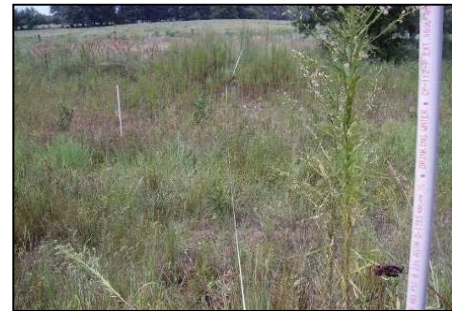
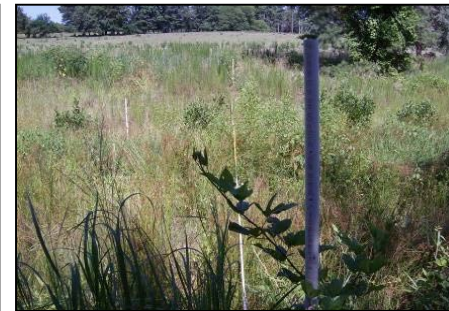
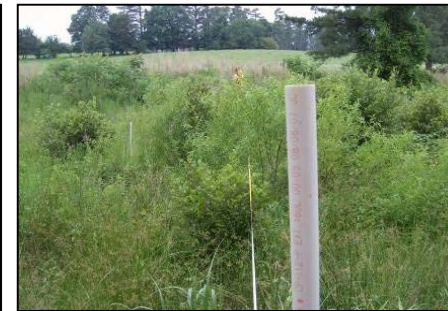
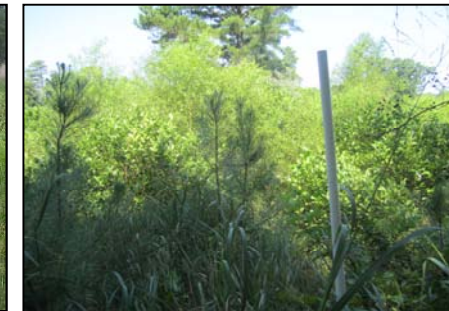
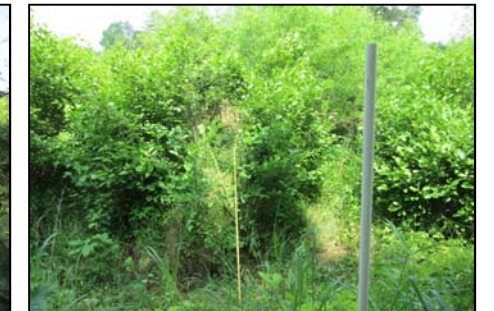
Photo #8
Facing west
across Cross
Section #4 along
Ellington Branch

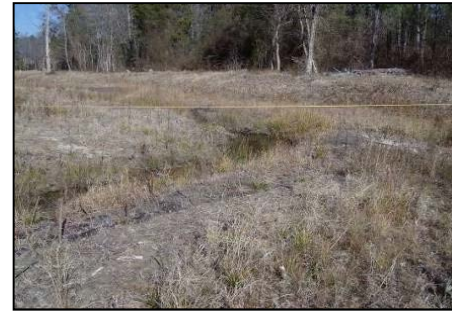
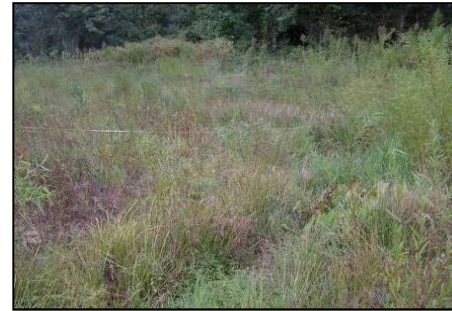
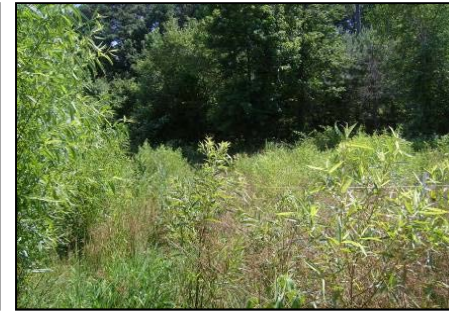
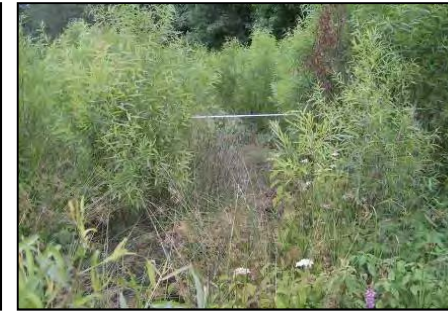
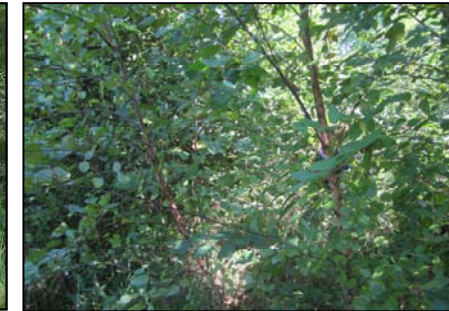
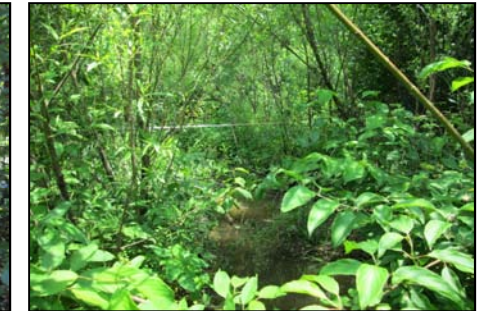
Photo #9
Facing north
(downstream) at
Cross Section #5
along Ellington
Branch

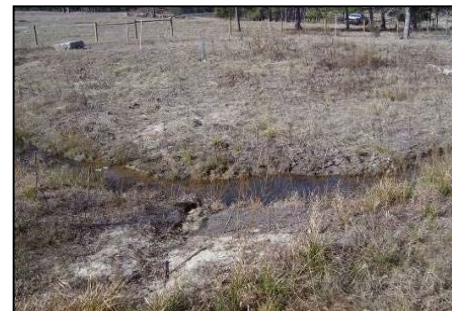
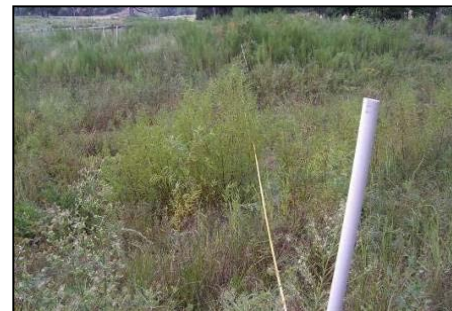
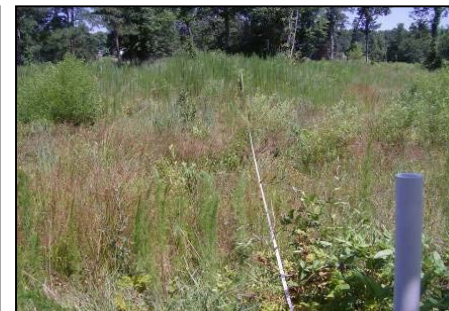
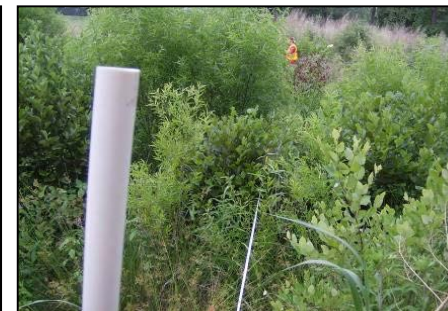
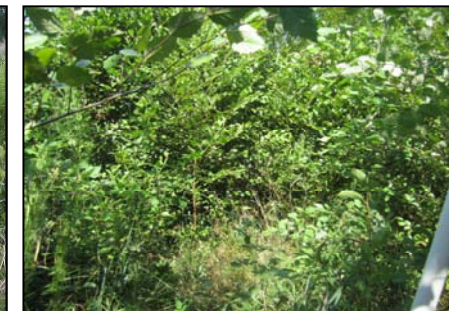
Photo #10
Facing west
across Cross
Section #5 along
Ellington Branch

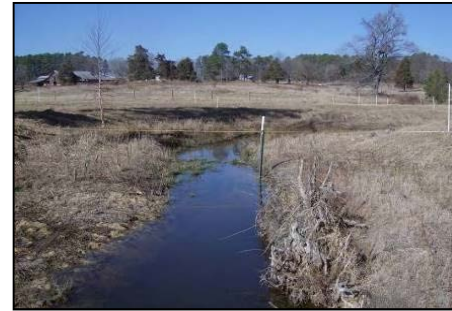
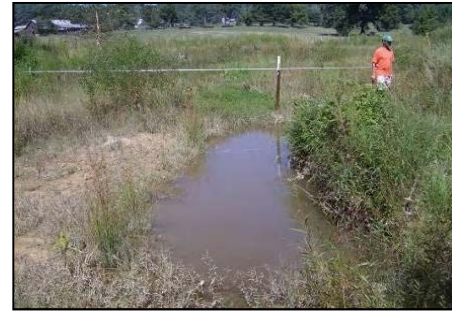
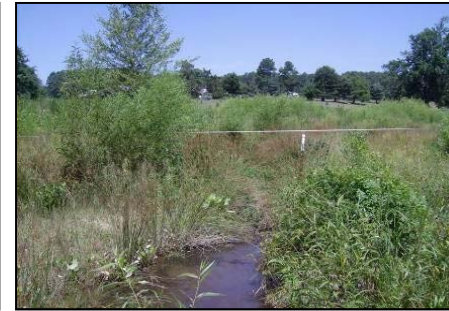
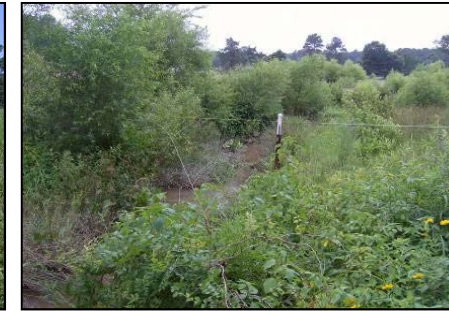
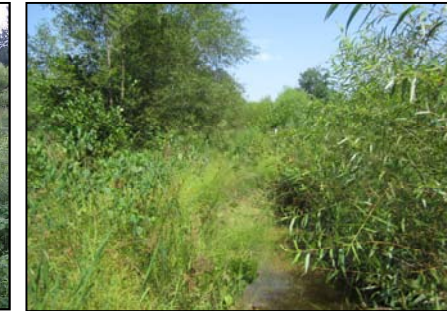
Photo #11
Facing north
(downstream) at
Cross Section #6
along Ellington
Branch

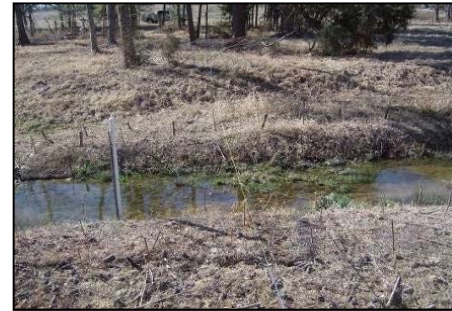
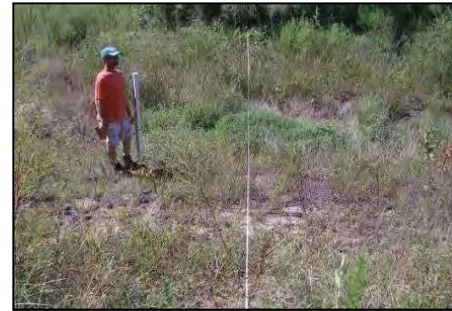
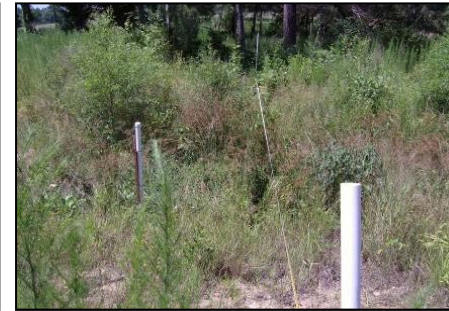
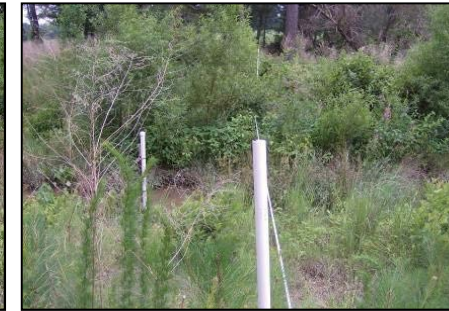
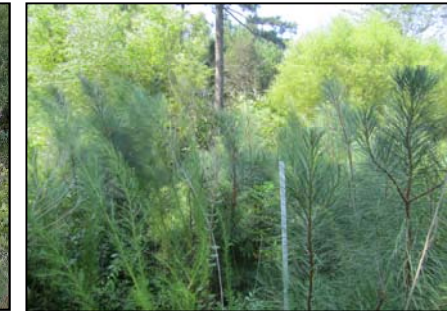
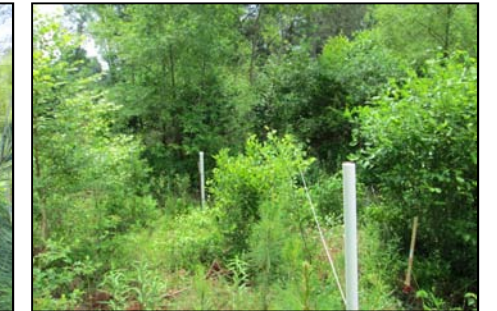
Photo #12
Facing west
across Cross
Section #6 along
Ellington Branch

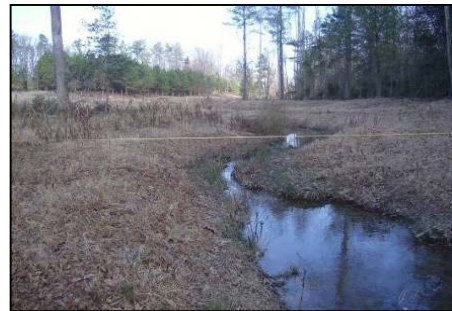
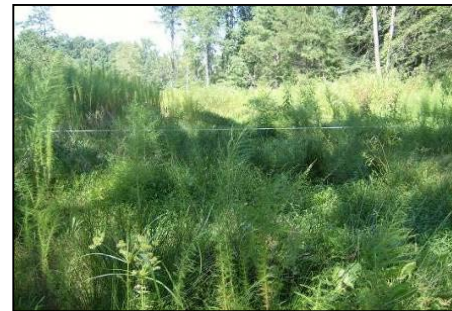
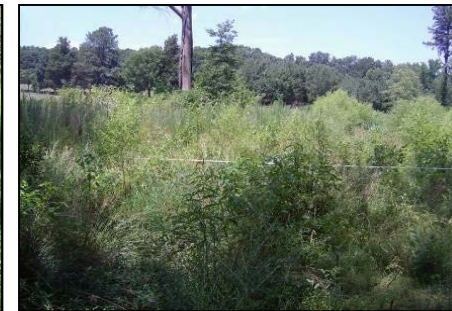
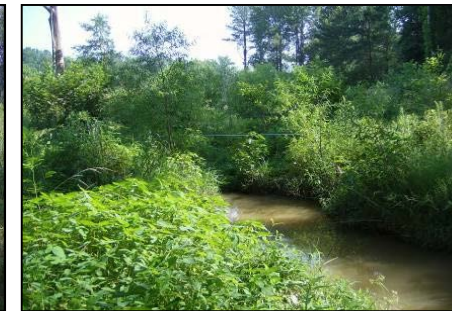
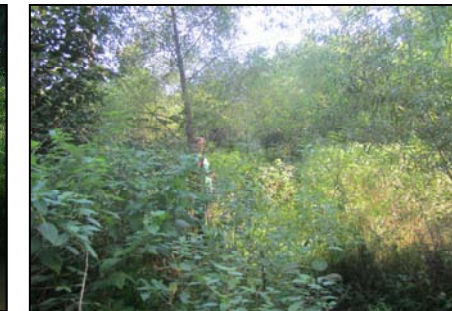
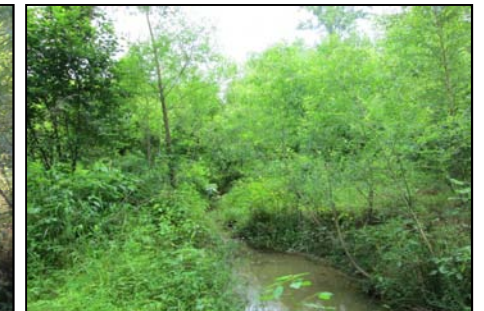
Photo #19
Facing north
(downstream) at
Cross Section
#10 along
Ellington Branch

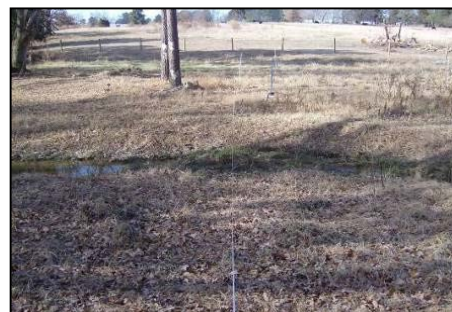
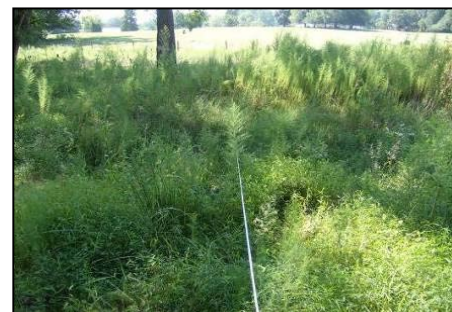
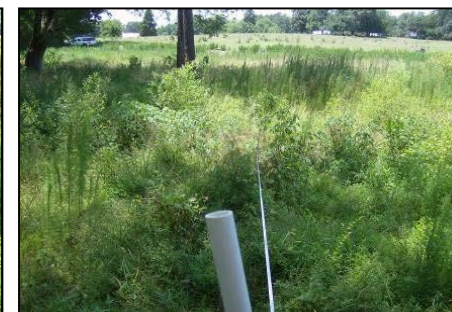
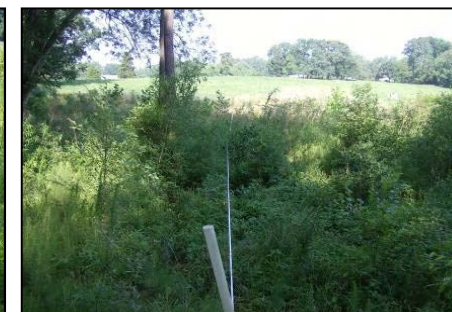
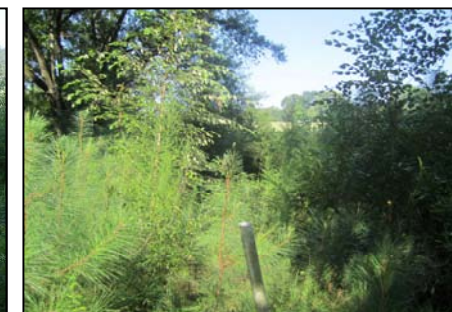
Photo #20
Facing west
across Cross
Section #10
along Ellington
Branch

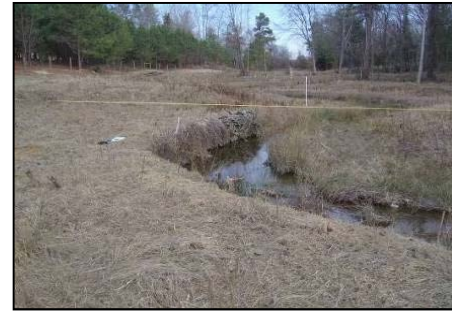
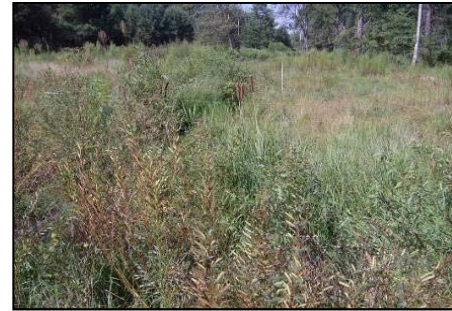
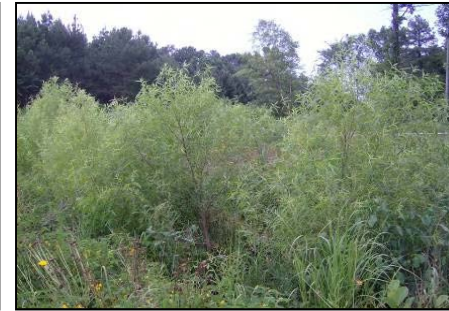
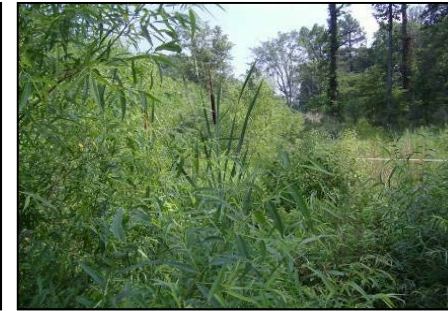
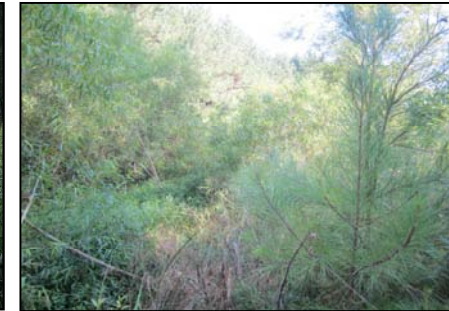
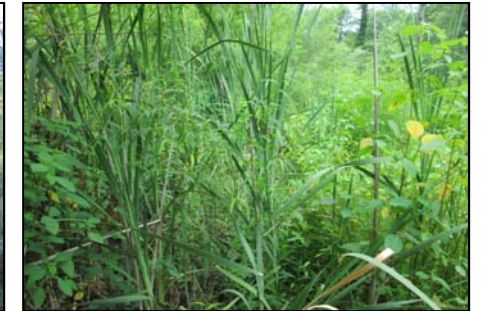
Photo #21
Facing north
(downstream) at
Cross Section
#11 along
Ellington Branch

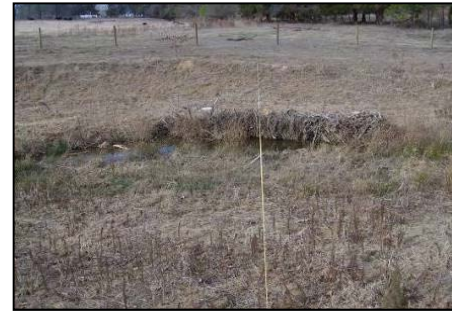
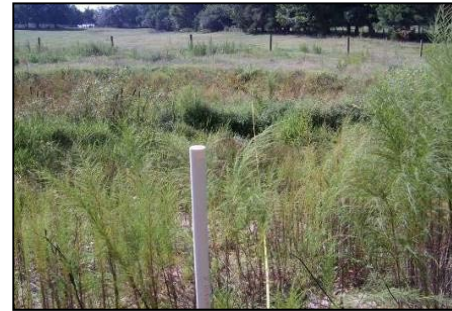
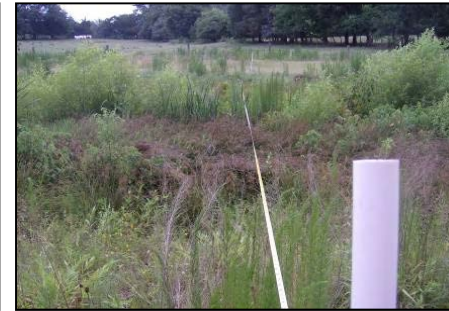
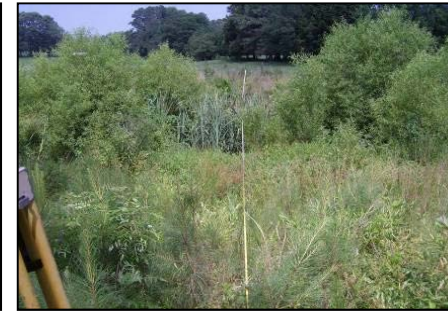
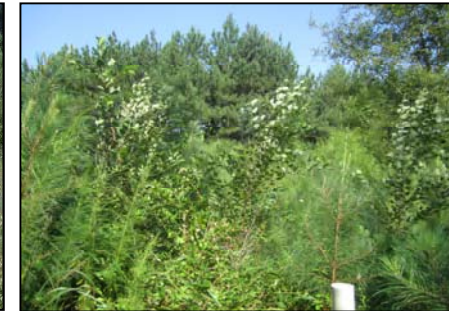
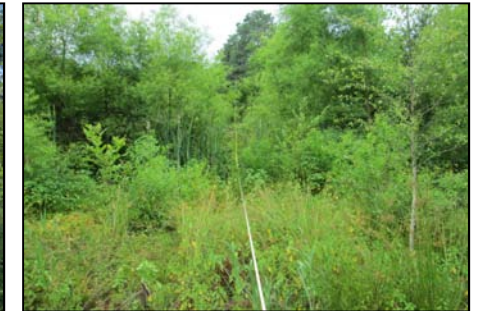
Photo #22
Facing west
across Cross
Section #11
along Ellington
Branch

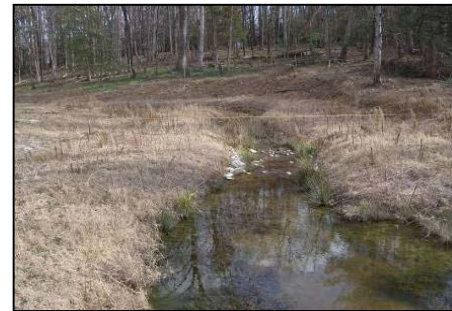
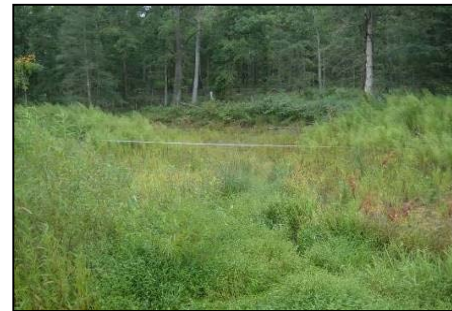
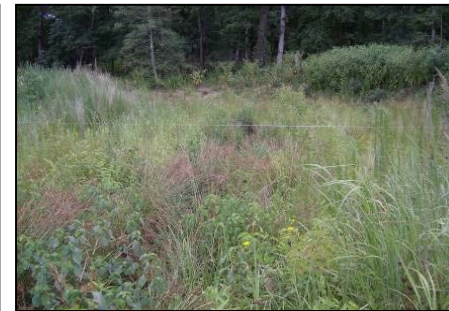
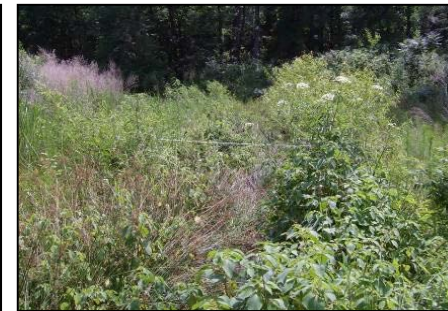
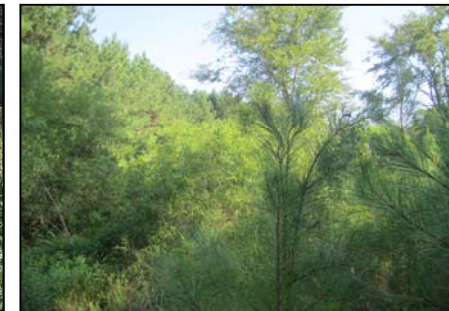
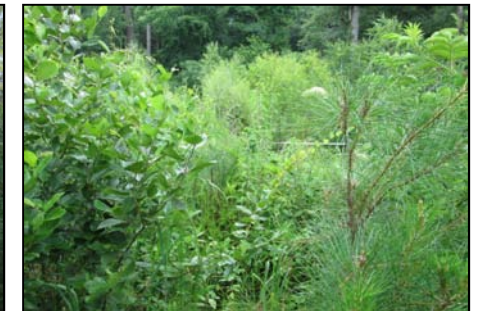
Photo #23
Facing east
(downstream) at
Cross Section
#12 along
Ellington Branch

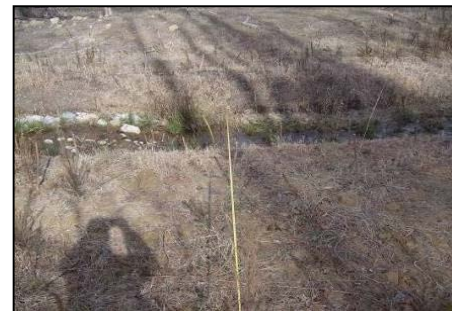
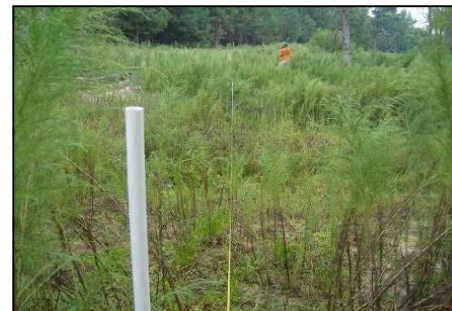
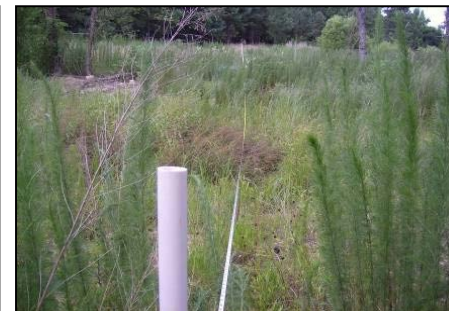
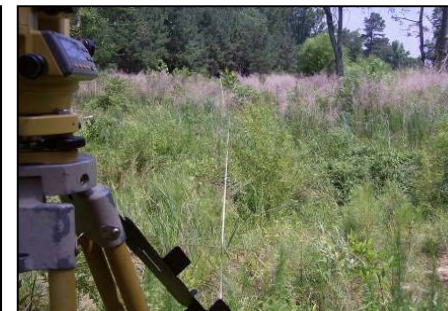
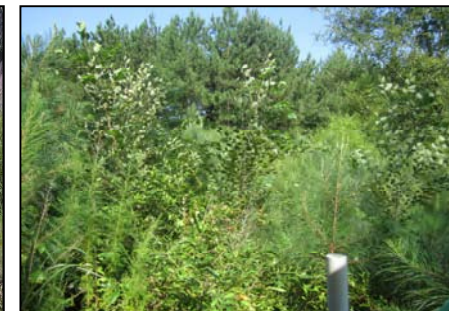
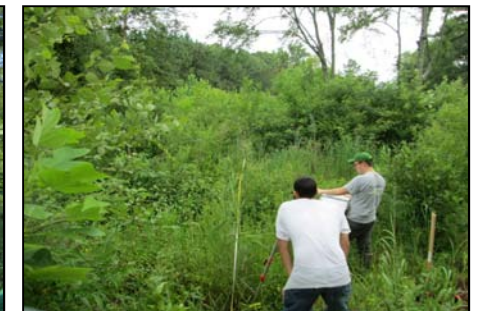
Photo #24
Facing north
across Cross
Section #12
along Ellington
Branch

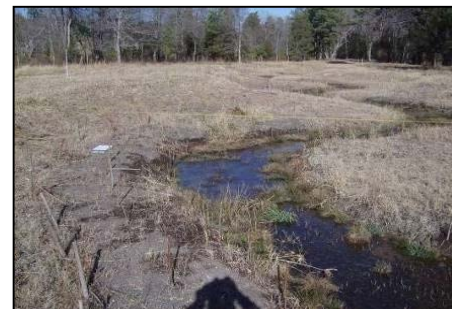
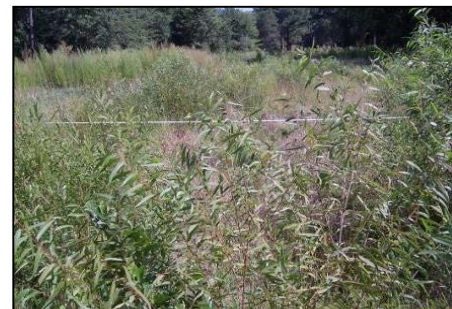
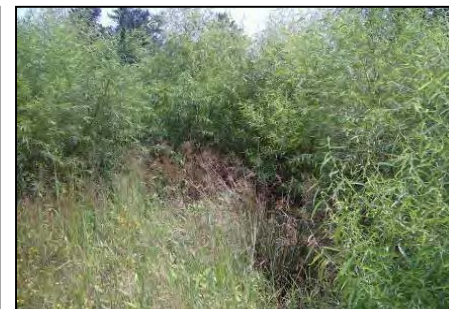
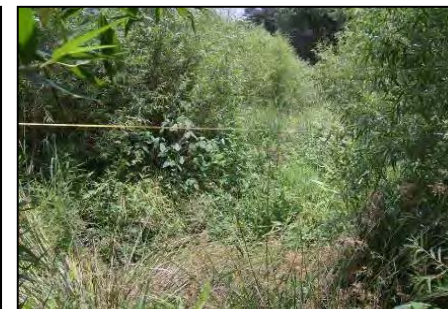
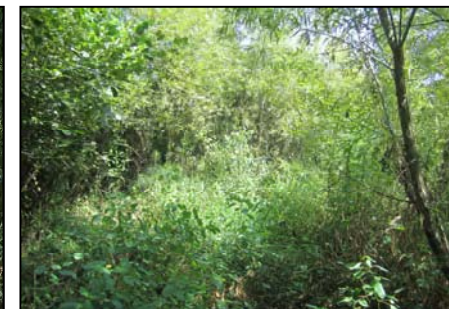
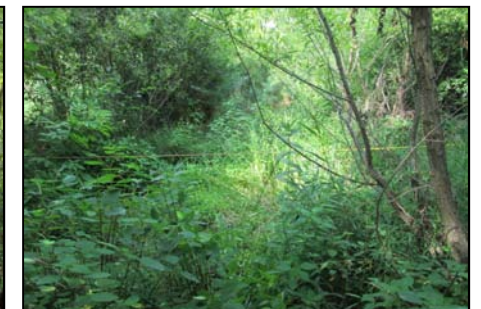
Photo #43
Facing north
(downstream) at
Cross Section
#22 along the
Unnamed
Tributary

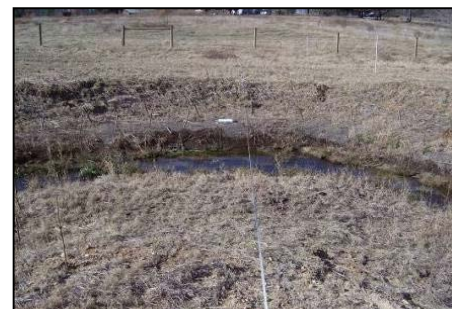
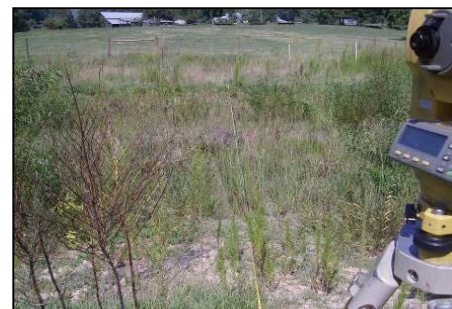
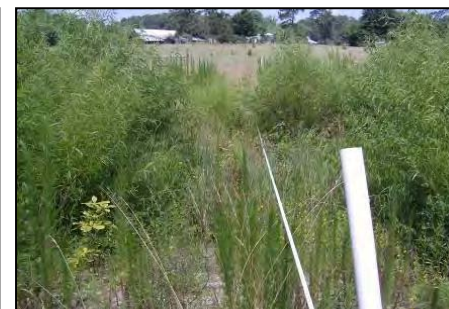
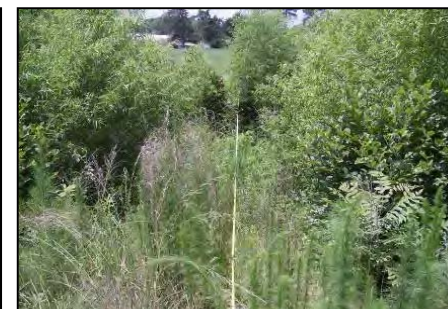
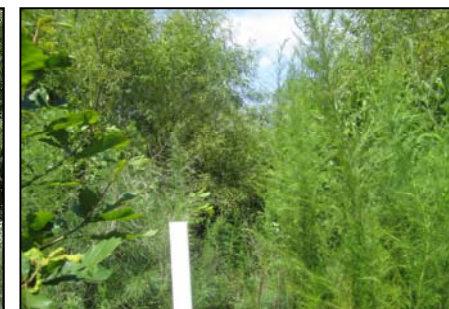
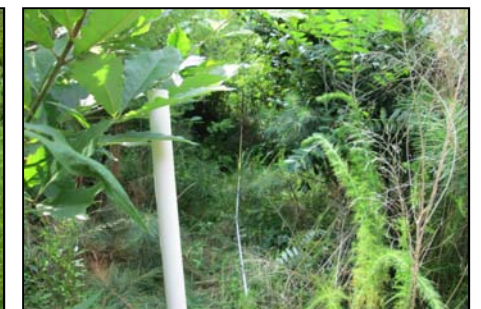
Photo #44
Facing west
across Cross
Section #22
along the
Unnamed
Tributary

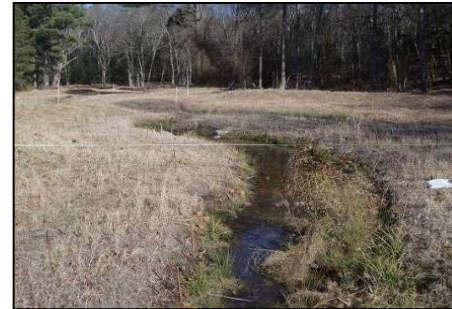
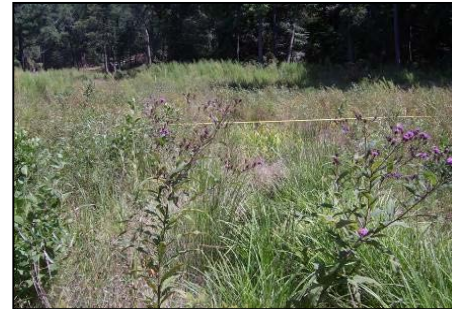
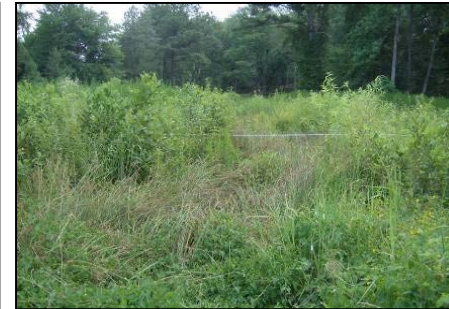
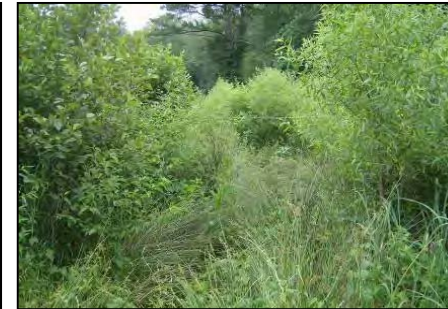
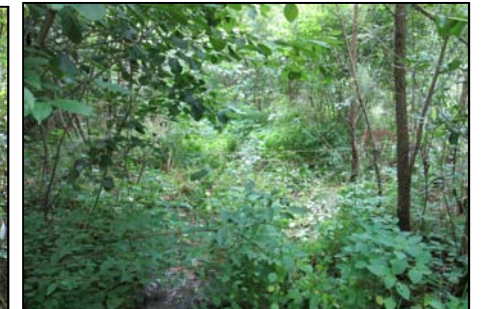
Photo #45
Facing north
(downstream) at
Cross Section
#23 along the
Unnamed
Tributary
