**ELLINGTON BRANCH STREAM RESTORATION SITE
FULL DELIVERY PROJECT
WARREN COUNTY, NORTH CAROLINA**

EEP Project No. 16-D06045

Final Monitoring Report MY5 (Year 2012)

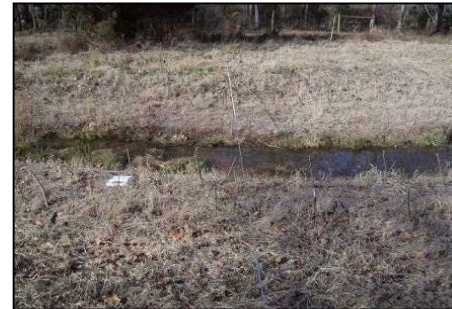
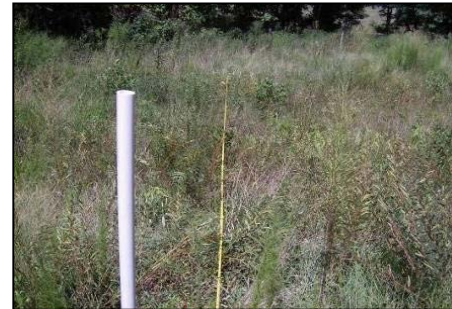
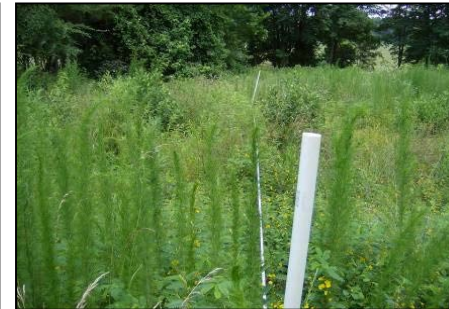
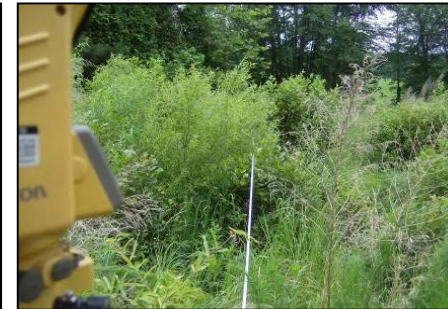
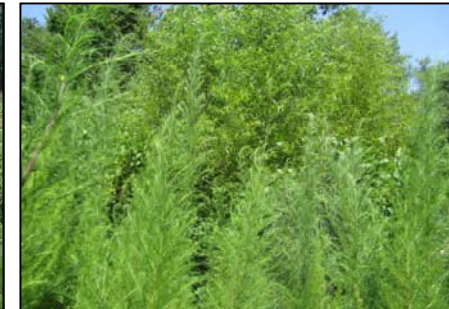
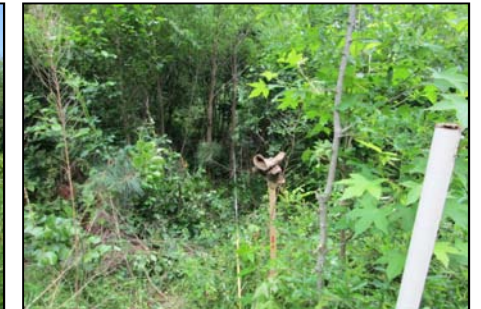
Photo #46
Facing west
across Cross
Section #23
along the
Unnamed
Tributary

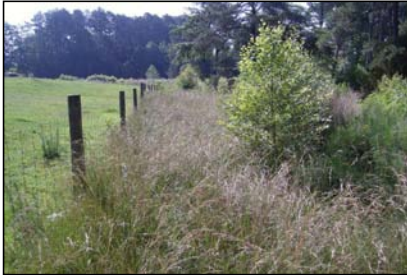
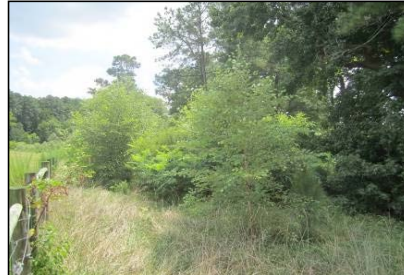
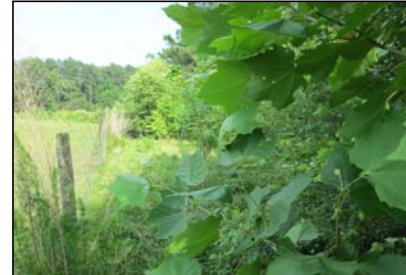
Photo #47. Facing east (downstream) along the northern edge of the Unnamed Tributary at fescue from the adjacent pasture.

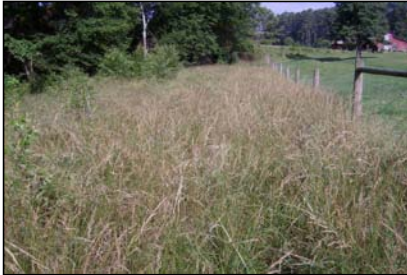
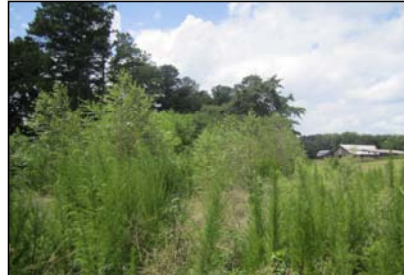
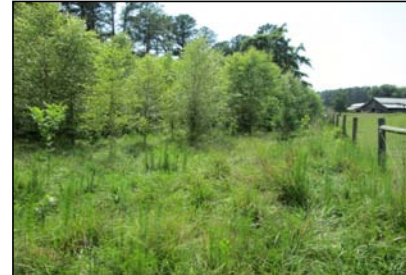
Photo #48. Facing west (upstream) along the Unnamed Tributary at fescue from the adjacent pasture.

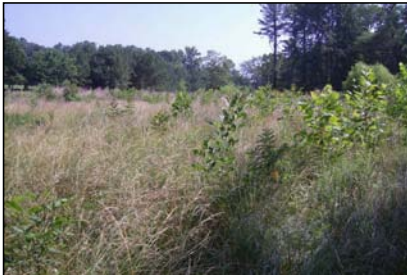
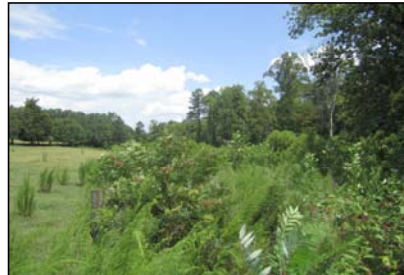
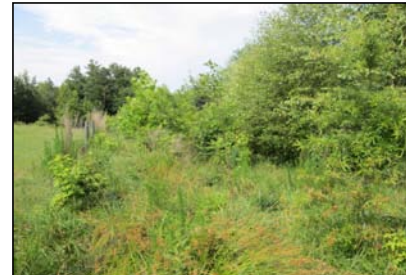
Photo #49. Facing north at fescue within and adjacent to Vegetation Plot #7.

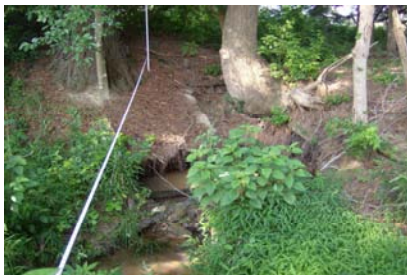
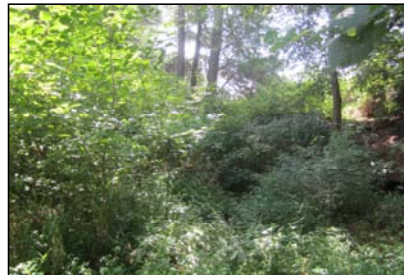
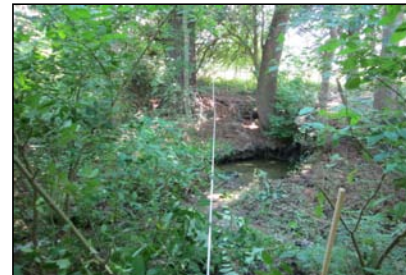
In addition, during the winter months of 2009, the standpipe associated with the irrigation pond immediately upstream of the easement area associated with the UT became clogged. As a result, excess water draining from the pond utilized the auxiliary or emergency spillway situated along the southeastern corner of the dam. In November 2009, the site received between four and five inches of rain during one storm event. The resulting flows were forced into and outside of the auxiliary spillway. The majority of these flows were scattered along and through the adjacent pasture, immediately south of the easement area. A portion of the flows however, did enter the easement area in the vicinity of Cross Section #16. While the side slopes remained stable, a scour hole was created adjacent to the channel in the vicinity of a natural spring. The result was an expanded hole approximately two feet deep. The property owner installed a new pipe into the existing dam during the month of April 2010. This pipe currently facilitates proper drainage from the pond. The expanded scour hole has been closely inspected during the past three monitoring assessments. It is stable as well as its surrounding side slopes. No concerns regarding this area exist at the current time. Photograph #50 in Appendix C-2 identifies this area.

Photo #50. Facing south across Cross Section #16 along the Unnamed Tributary at the springhead and enlarged scour area.

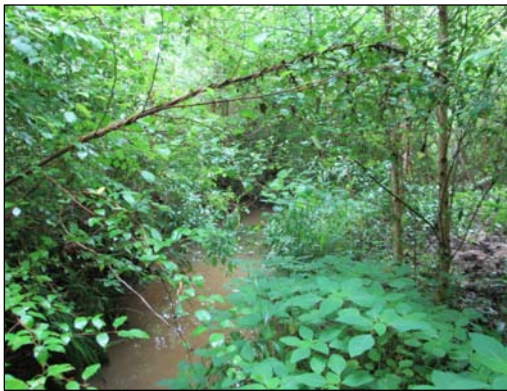
Facing north (downstream) at Cross Section #1 (2012)

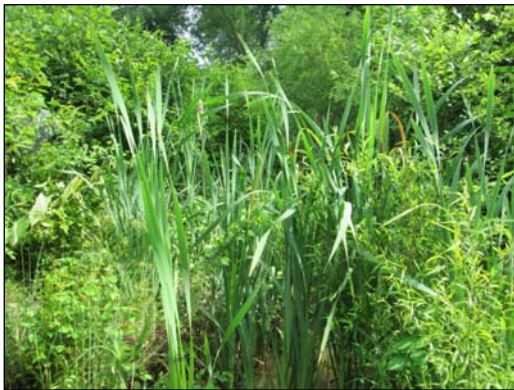
Facing north (downstream) at Cross Section #3 (2012)

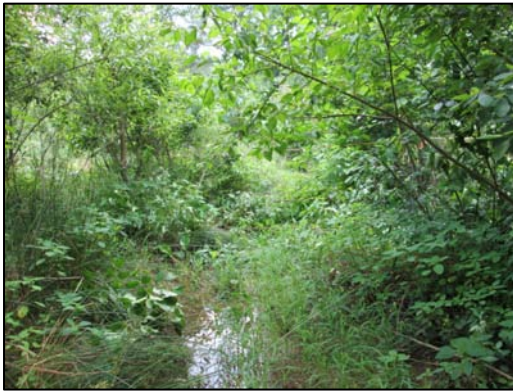
Facing north (downstream) at Cross Section #7 (2012)

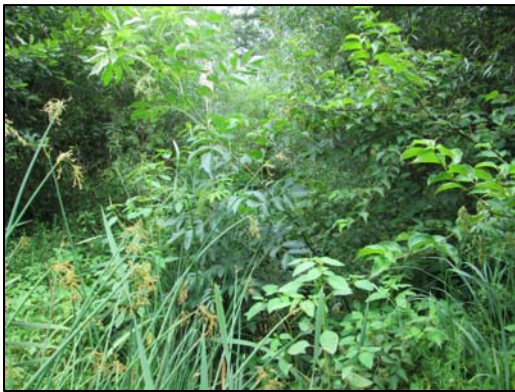
Facing north (downstream) at Cross Section #9 (2012)

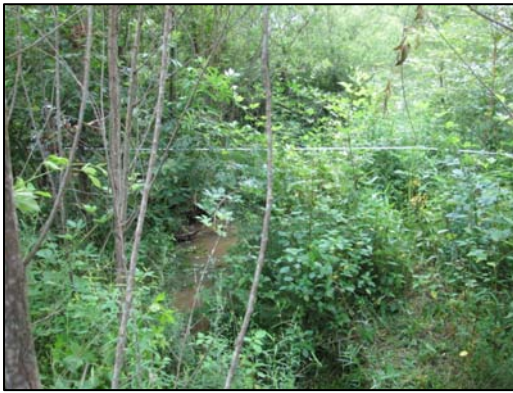
Facing north (downstream) at Cross Section #13 (2012)

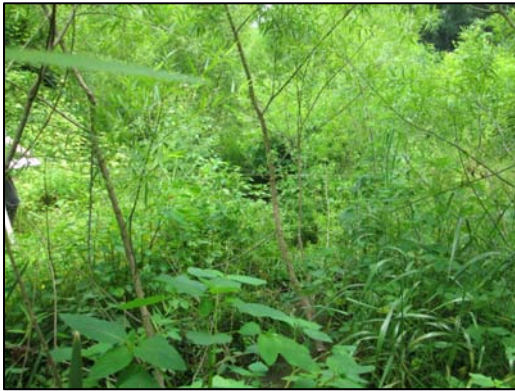
Facing north (downstream) at Cross Section #14 (2012)

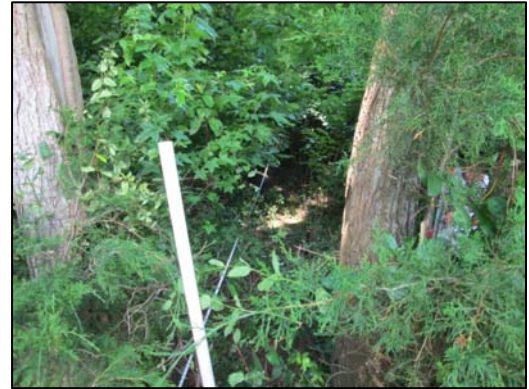
Facing north along Cross Section #17 (2012)

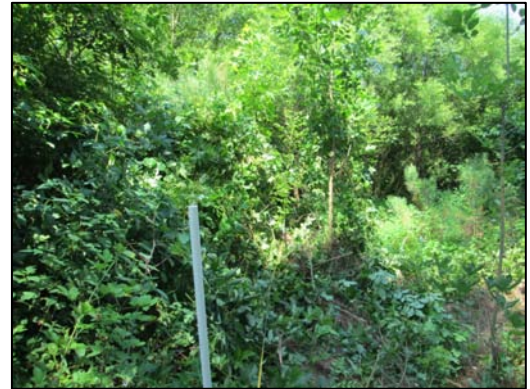
Facing north along Cross Section #19 (2012)

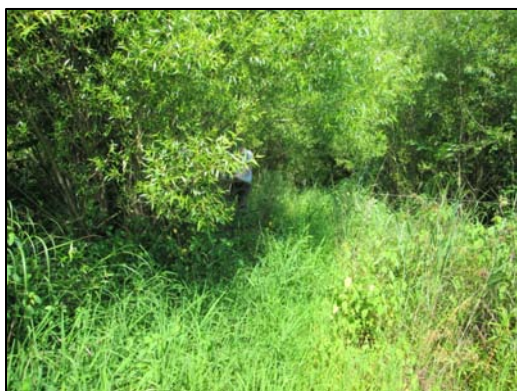
Facing north (downstream) at Cross Section #21 (2012)

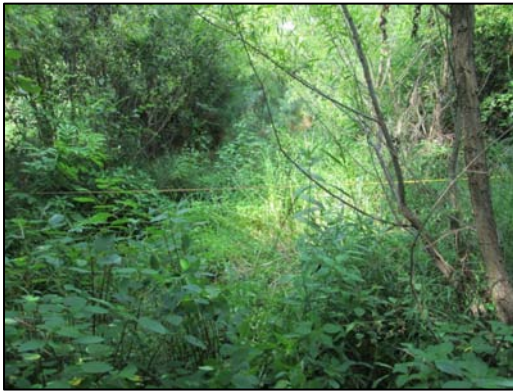
Facing north (downstream) at Cross Section #22 (2012)

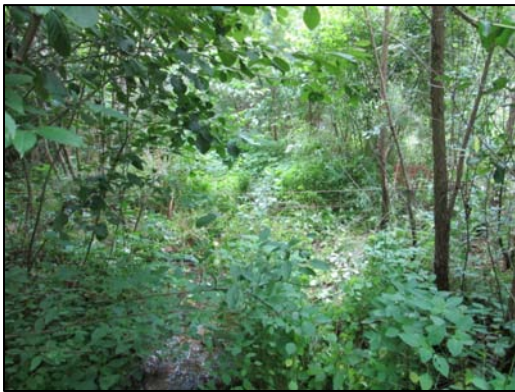
Facing north (downstream) at Cross Section #23 (2012)
