## **Year 2 of 5 Monitoring Report**

**Five-Mile Branch Stream and Wetland  
Restoration, Iredell County**

**NCEEP IMS ID# 92185**

March 2015

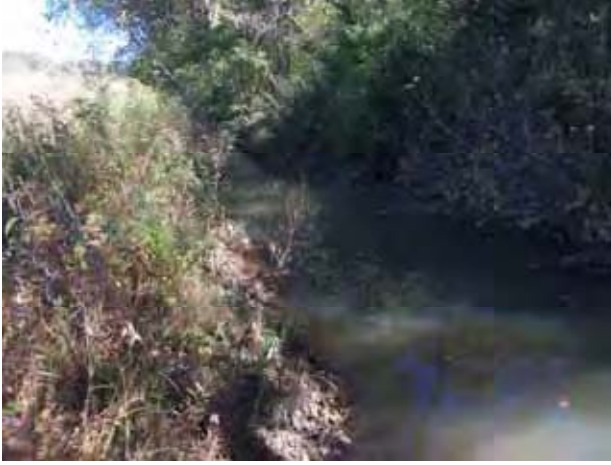
Photo Point 9. Beaver dam at Cross Vane 10/17/14

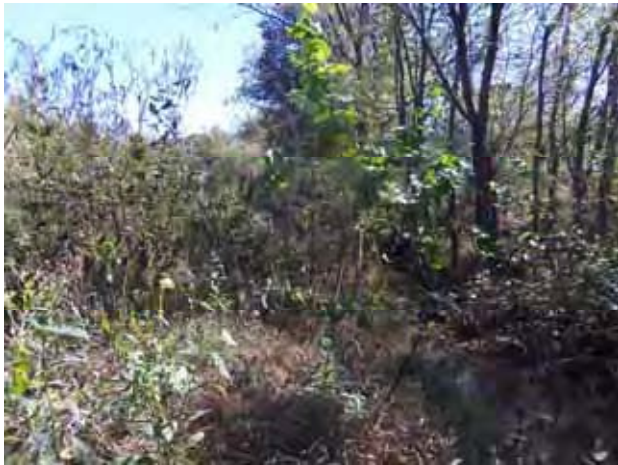
Photo Point 23. Fallen tree 10/17/14

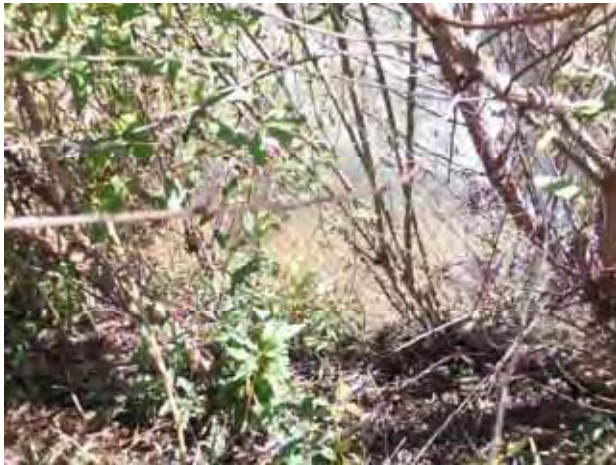
Photo Point 25. Cross Vane. Left arm scour. 10/17/14
