## **Year 3 of 5 Monitoring Report**

**Five-Mile Branch Stream and Wetland  
Restoration, Iredell County**

**NCDMS IMS ID# 92185  
DEQ Contract # 6036**

ARCADIS G&M of North Carolina, Inc.

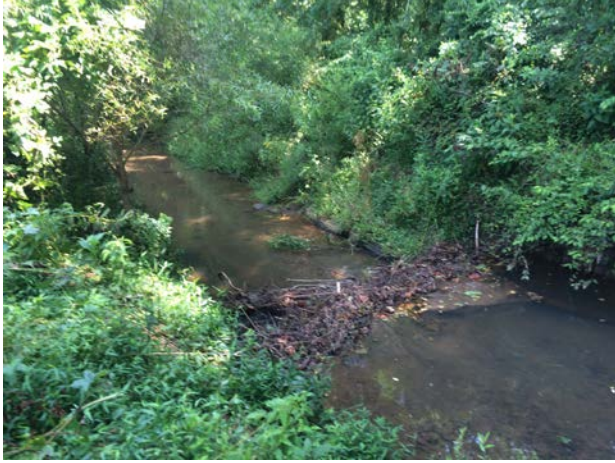
Photo Point 9. Beaver dam at Cross Vane 08/13/15

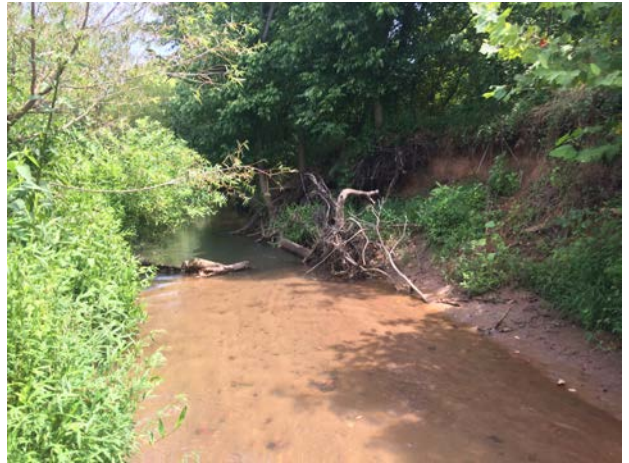
Photo Point 23. Fallen tree location 08/13/15

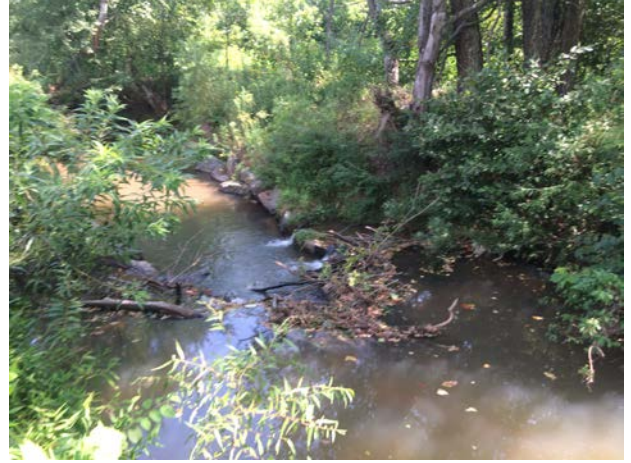
Photo Point 30. Cross Vane with beaver dam 08/13/15
