YEAR 4 OF 5 MONITORING REPORT - FINAL

**Five-Mile Branch Stream and Wetland Restoration, Iredell County
NCDMS IMS ID# 92185**

**North Carolina Department of Environmental Quality,
Division of Mitigation Services Raleigh North Carolina**

April 25, 2017

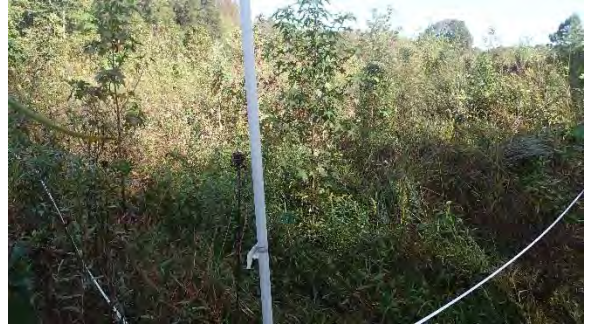
Vegetation Monitoring Plot #5 10/24/2016

Planted woody stem densities are low in Plots 2, 3, 5, 7, 8, 10, 12-16, and 18-23. River birch, silky dogwood (*Cornus amomum*), willow oak and cherrybark oak (*Quercus pagoda*) are the most successful and commonly occurring planted stems. Other planted species include possumhaw (*Ilex decidua*), black walnut (*Juglans nigra*), black gum (*Nyssa sylvatica*), sycamore and swamp chestnut oak (*Q. michauxii*). Natural stems observed in the floodplain of the conservation easement include red maple (*Acer rubrum*), ironwood (*Carpinus caroliniana*), tulip poplar (*Liriodendron tulipifera*), sycamore, sweetgum (*Liquidambar styraciflua*), silky dogwood, cottonwood (*Populus deltoides*), box elder (*Acer negundo*), green ash (*Fraxinus pennsylvanica*), river birch, and red elm (*Ulmus rubra*). Beyond the wetland boundaries in the conservation easement, natural stems such as black walnut (*Juglans nigra*), sweetgum, loblolly pine (*Pinus taeda*), American hazelnut (*Corylus americana*), and Eastern red cedar (*Juniperus virginiana*) were commonly observed.

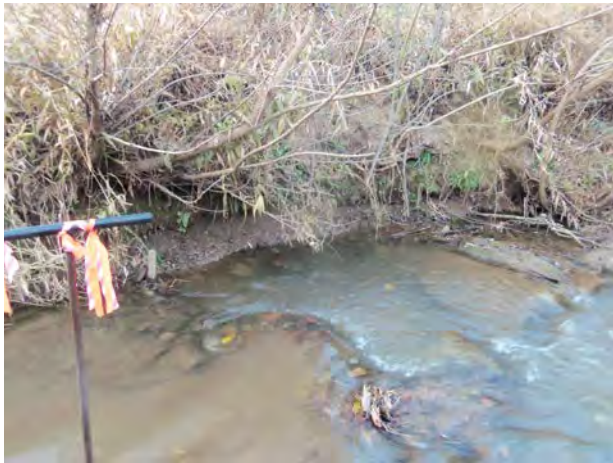
Photo Point 25. Cross Vane. Left arm scour. 11/16/2016

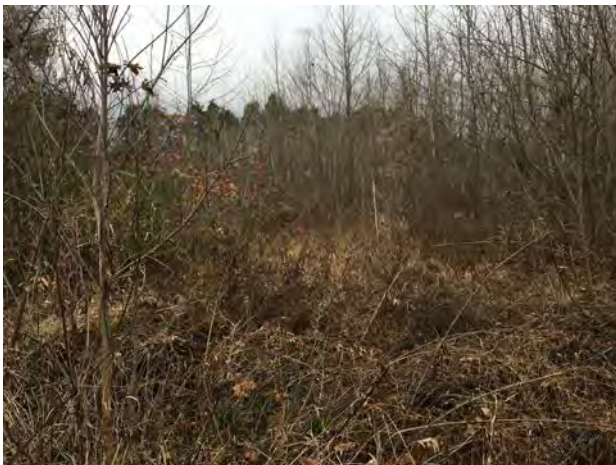
Photo Point 37. Floodplain pool looking north 12/08/2016

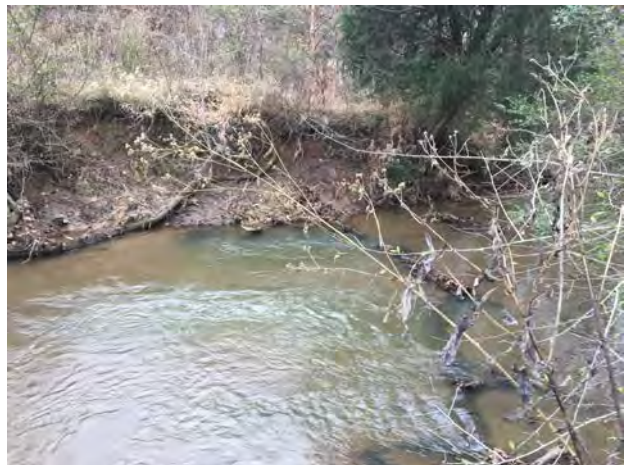
Photo Point 38. Looking south 12/08/2016

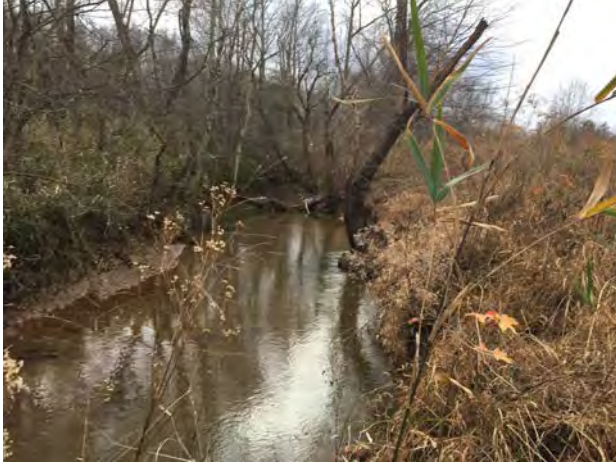
Photo Point 39. Looking upstream 12/08/2016

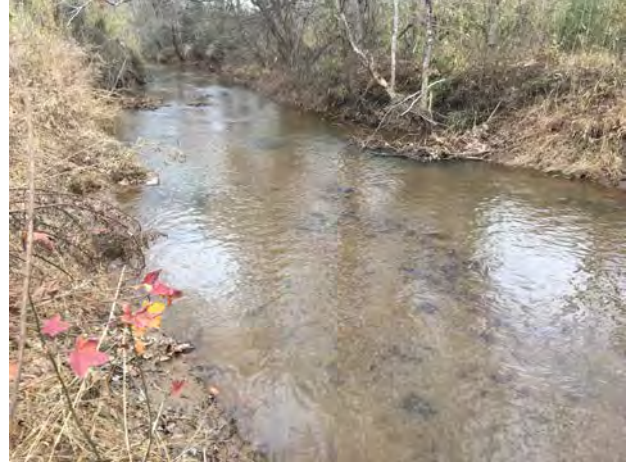
Photo Point 40 Cross Vane 12/08/2016

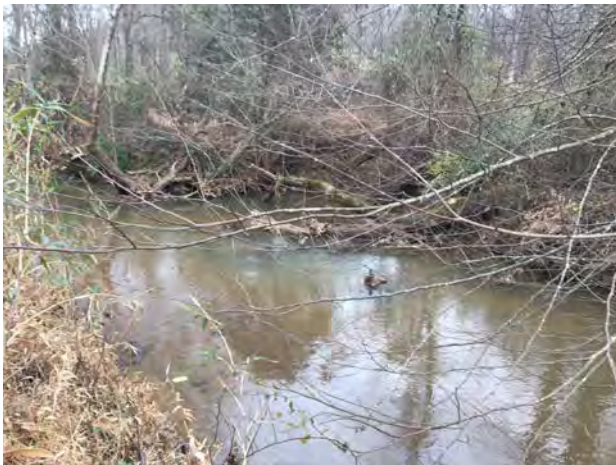
Photo Point 39. Looking downstream 12/08/2016

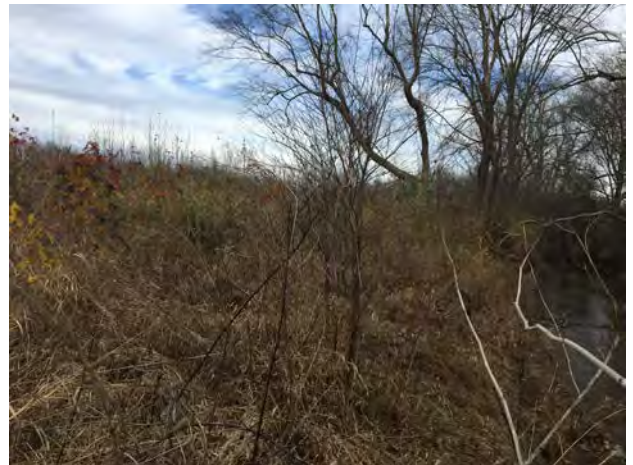
Photo Point 40. Looking downstream 12/08/2016

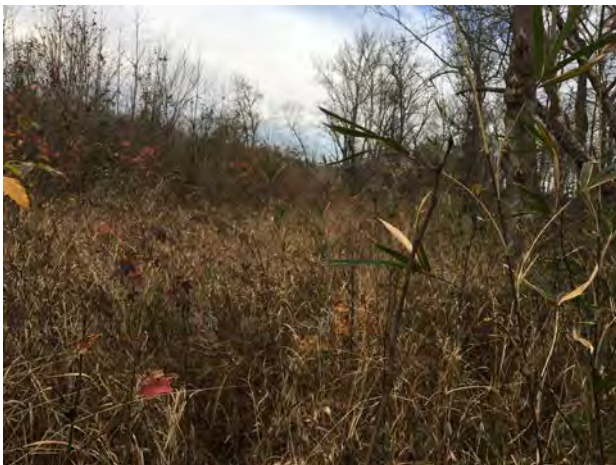
Photo Point 39. Floodplain looking east 12/08/2016

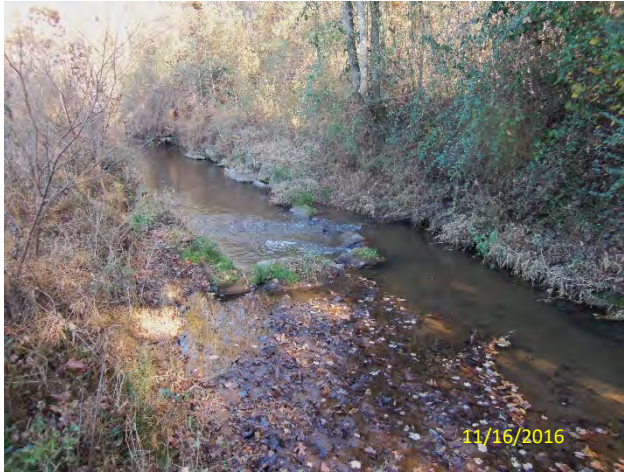
Cross Vane 25+25 BVR

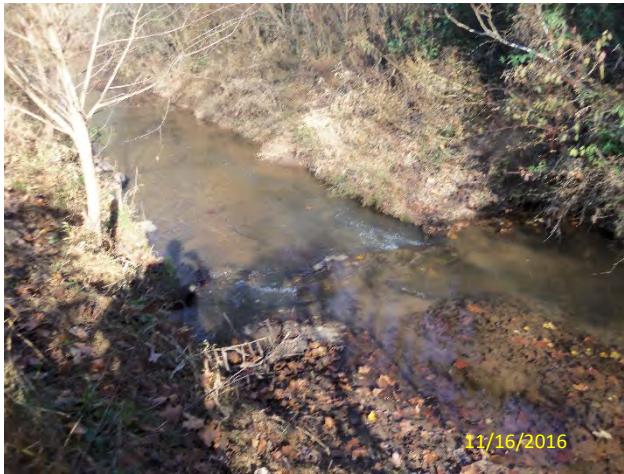
Cross Vane 32+50 BVR

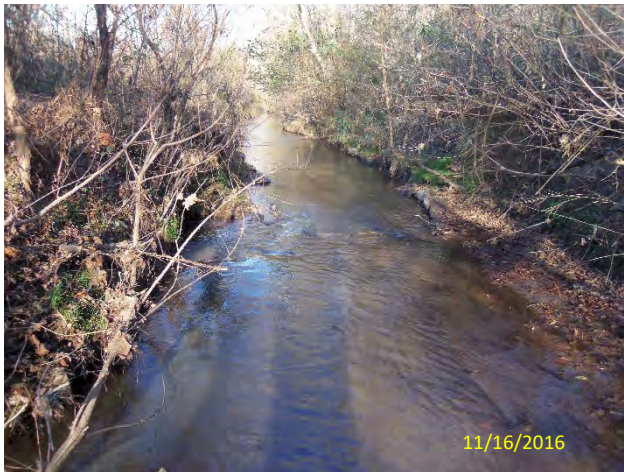
Cross Vane 60+75 BVR

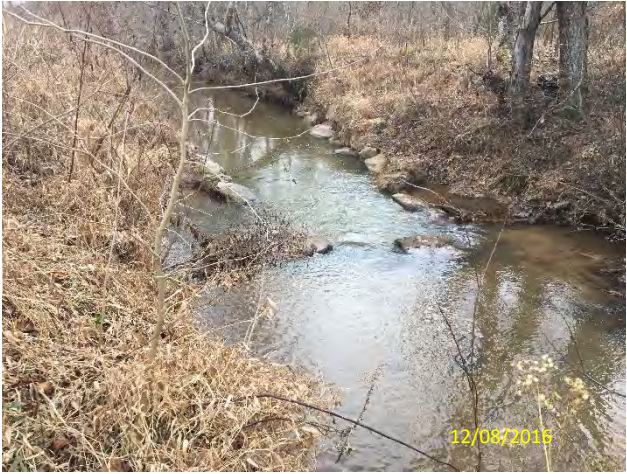
Bank Erosion	67+00 FTH		99
Bank Erosion	73+25 FTH		94
Structure boulder settled/fell	32+50 FTH		84

Cross Vane 32+50 FTH
