Fletcher Stream and Wetland Mitigation Site

Annual Monitoring Report

Monitoring Year 3 of 7

Henderson County, North Carolina

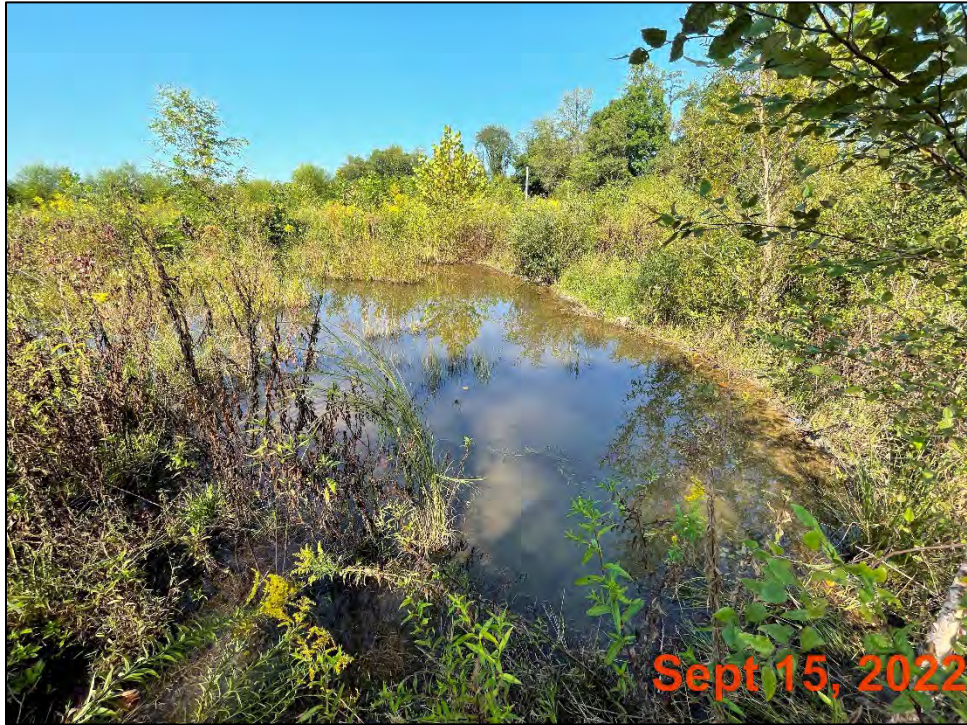
Beaver Dam Weston Reach 1B, Station 424+50
