# **Fletcher Stream and Wetland Mitigation Site**

## **Annual Monitoring Report**

Monitoring Year 4 of 7

Fletcher Stream and Wetland Mitigation Site

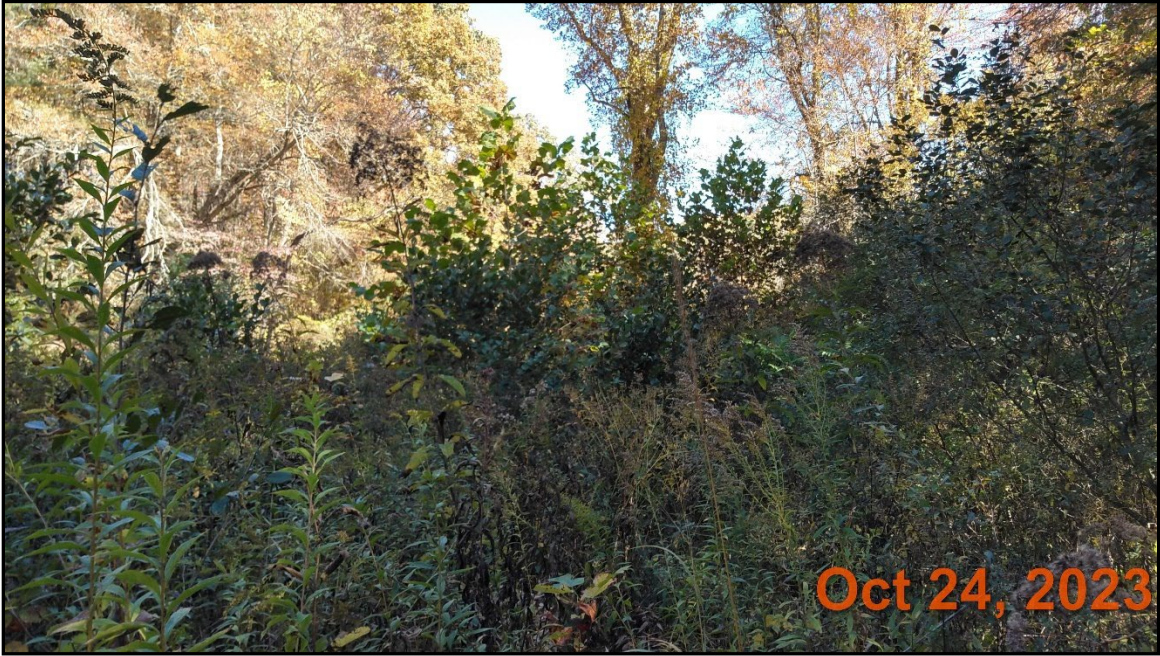
Fletcher Creek 1A – Permanent Photo Station 1  
Looking Upstream

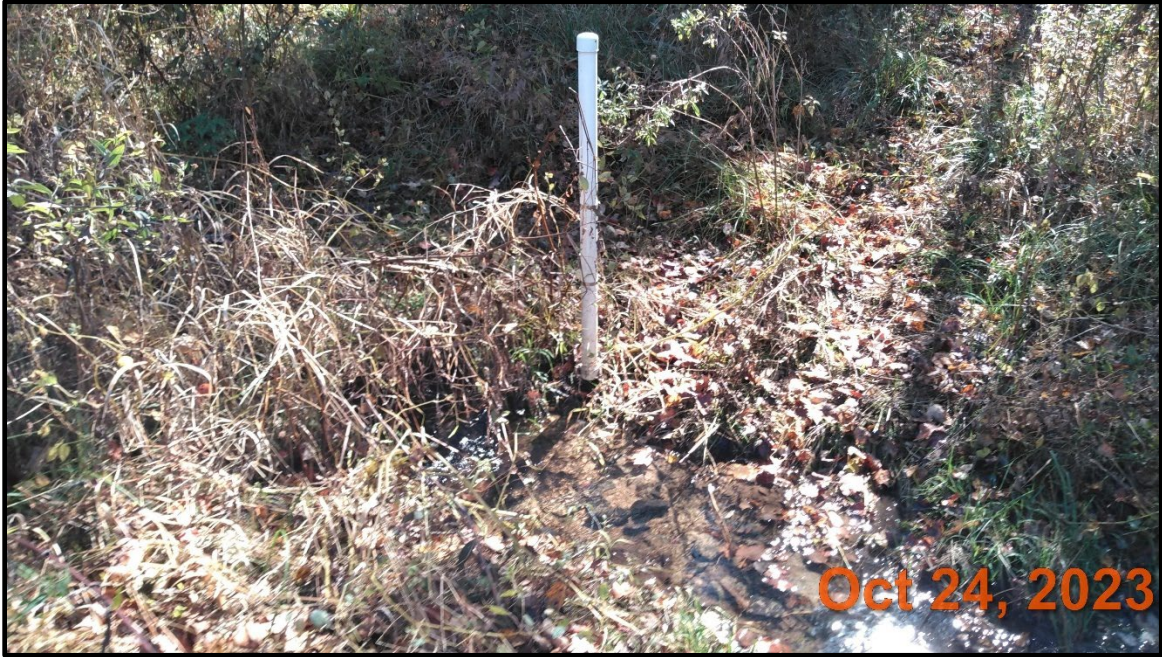
Fletcher 1B, Cross section 1 Crest Gauge.

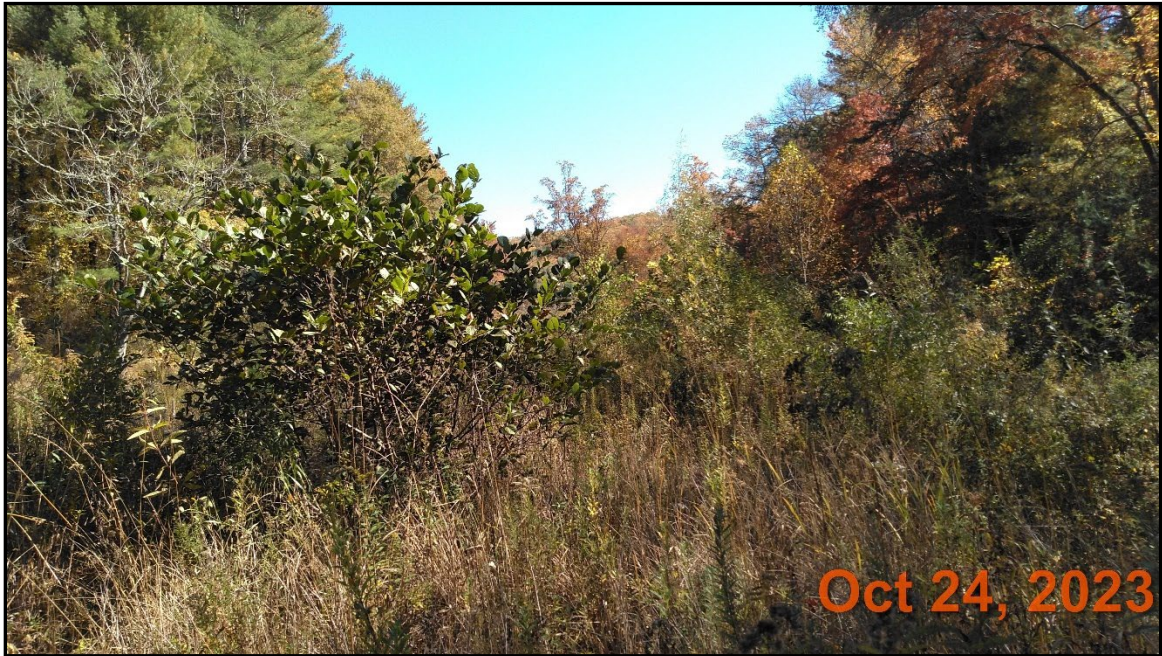
Fletcher Creek 1B – Permanent Photo Station 2  
Looking Upstream

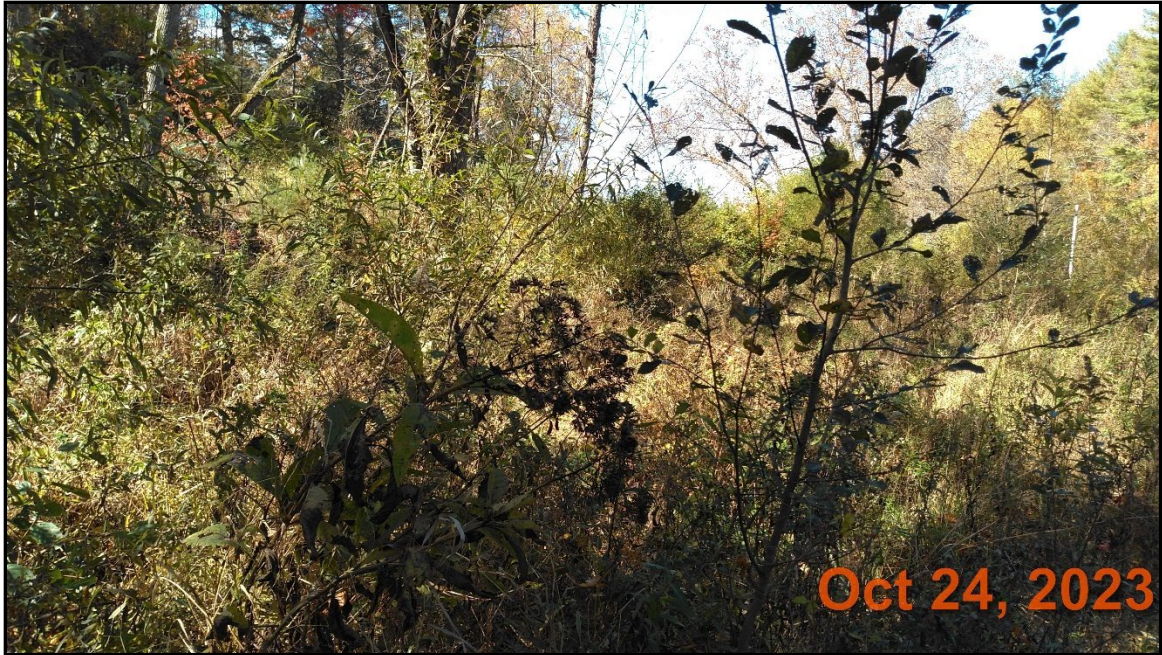
Fletcher Creek 1B – Permanent Photo Station 2  
Looking Downstream

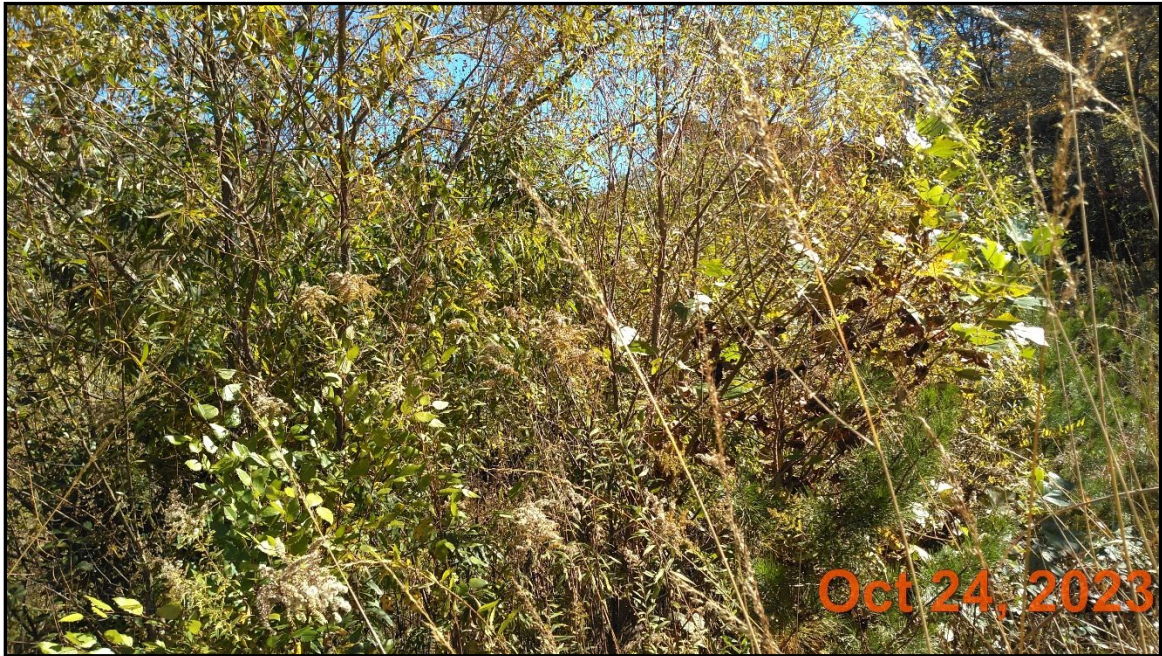
Fletcher Creek 1B – Permanent Photo Station 3  
Looking Upstream

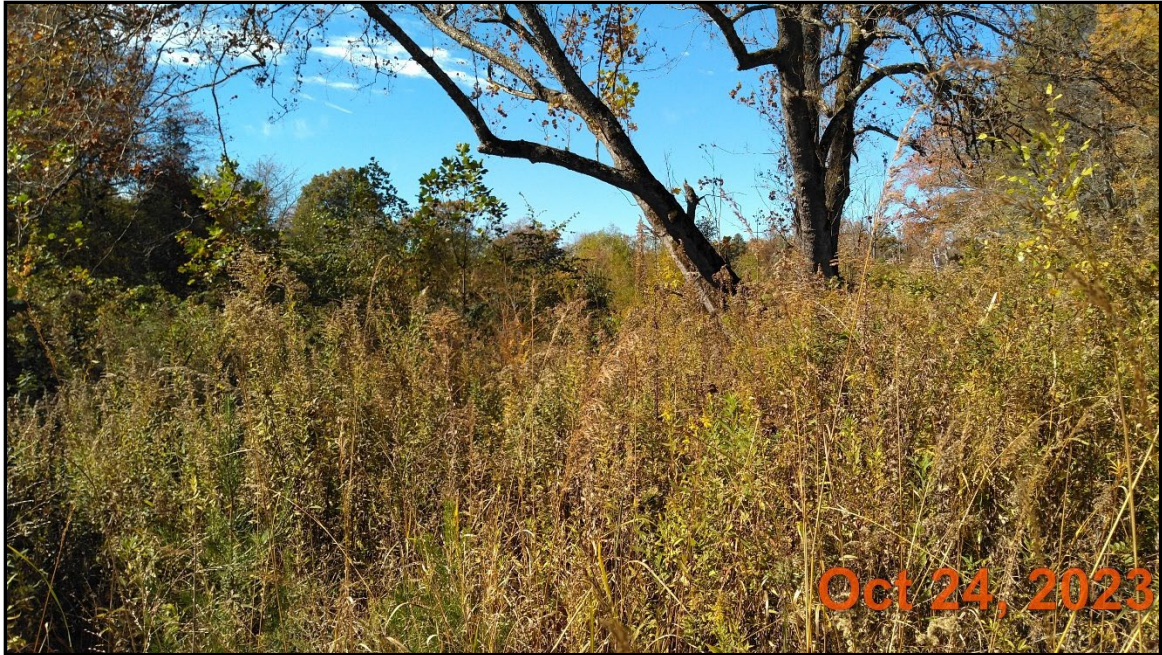
Fletcher Creek 1C – Permanent Photo Station 3  
Looking Downstream

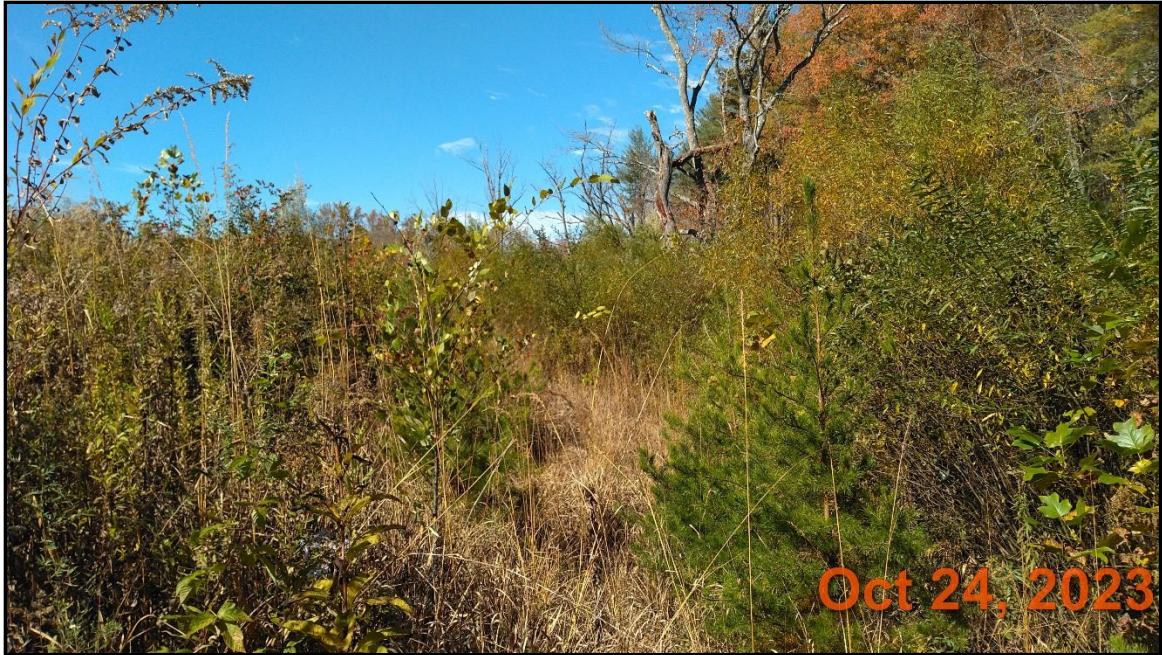
Fletcher Creek 1C – Permanent Photo Station 4  
Looking Downstream

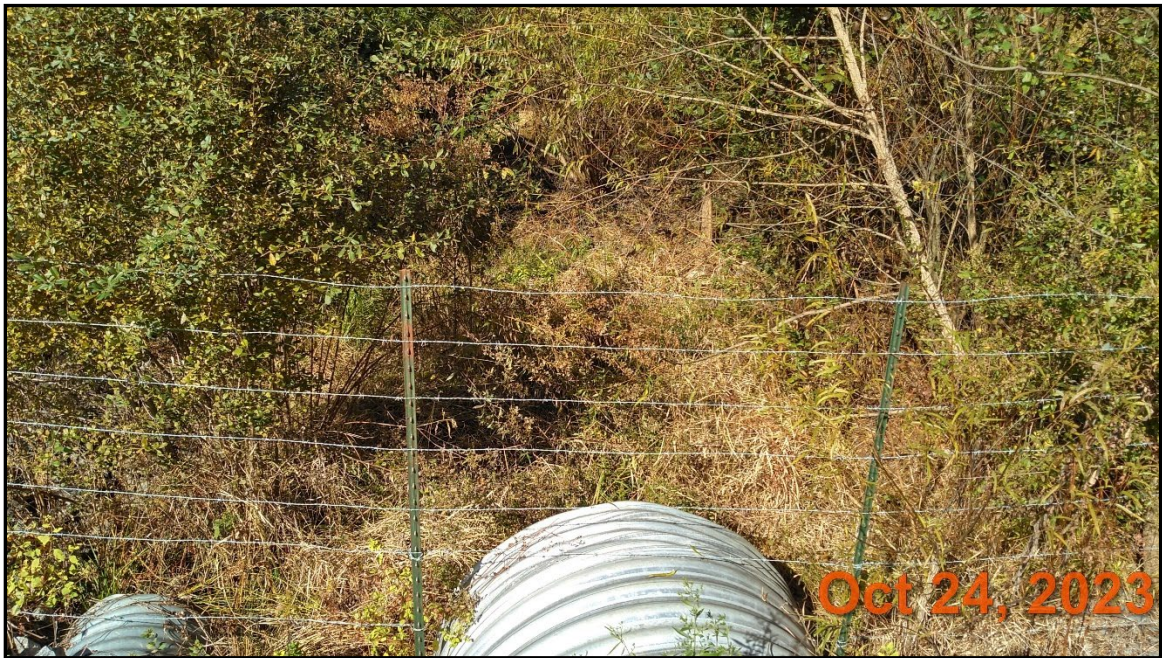
Fletcher Creek 1C – Permanent Photo Station 5  
Looking Downstream from Crossing

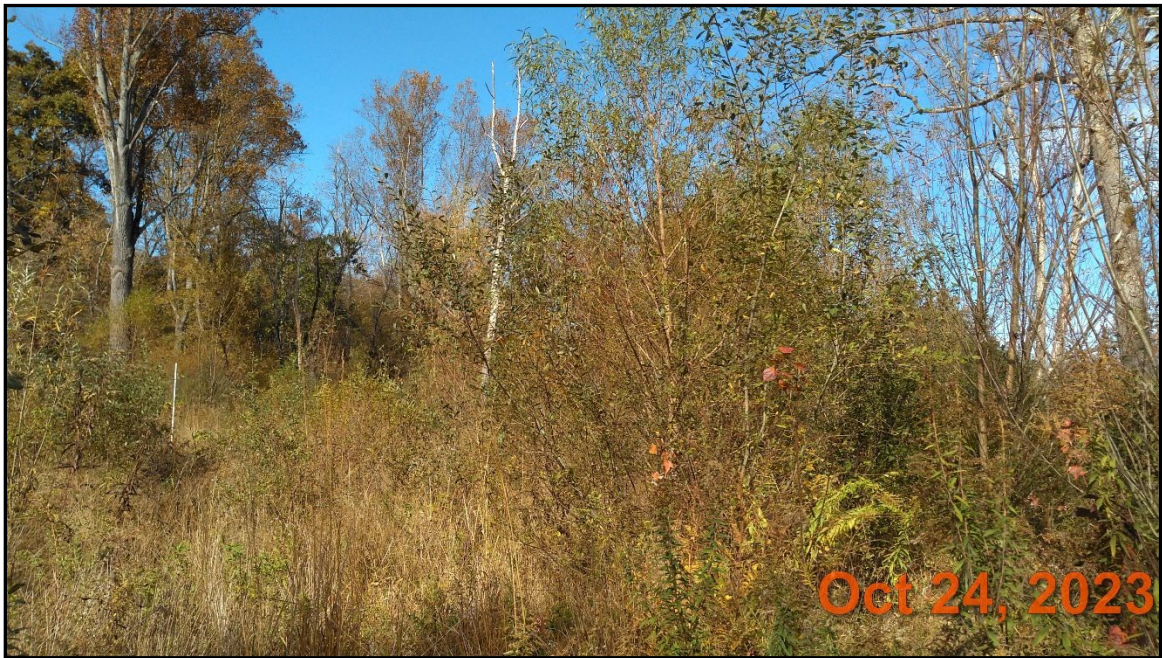
Fletcher Creek 1C – Permanent Photo Station 6  
Looking Downstream

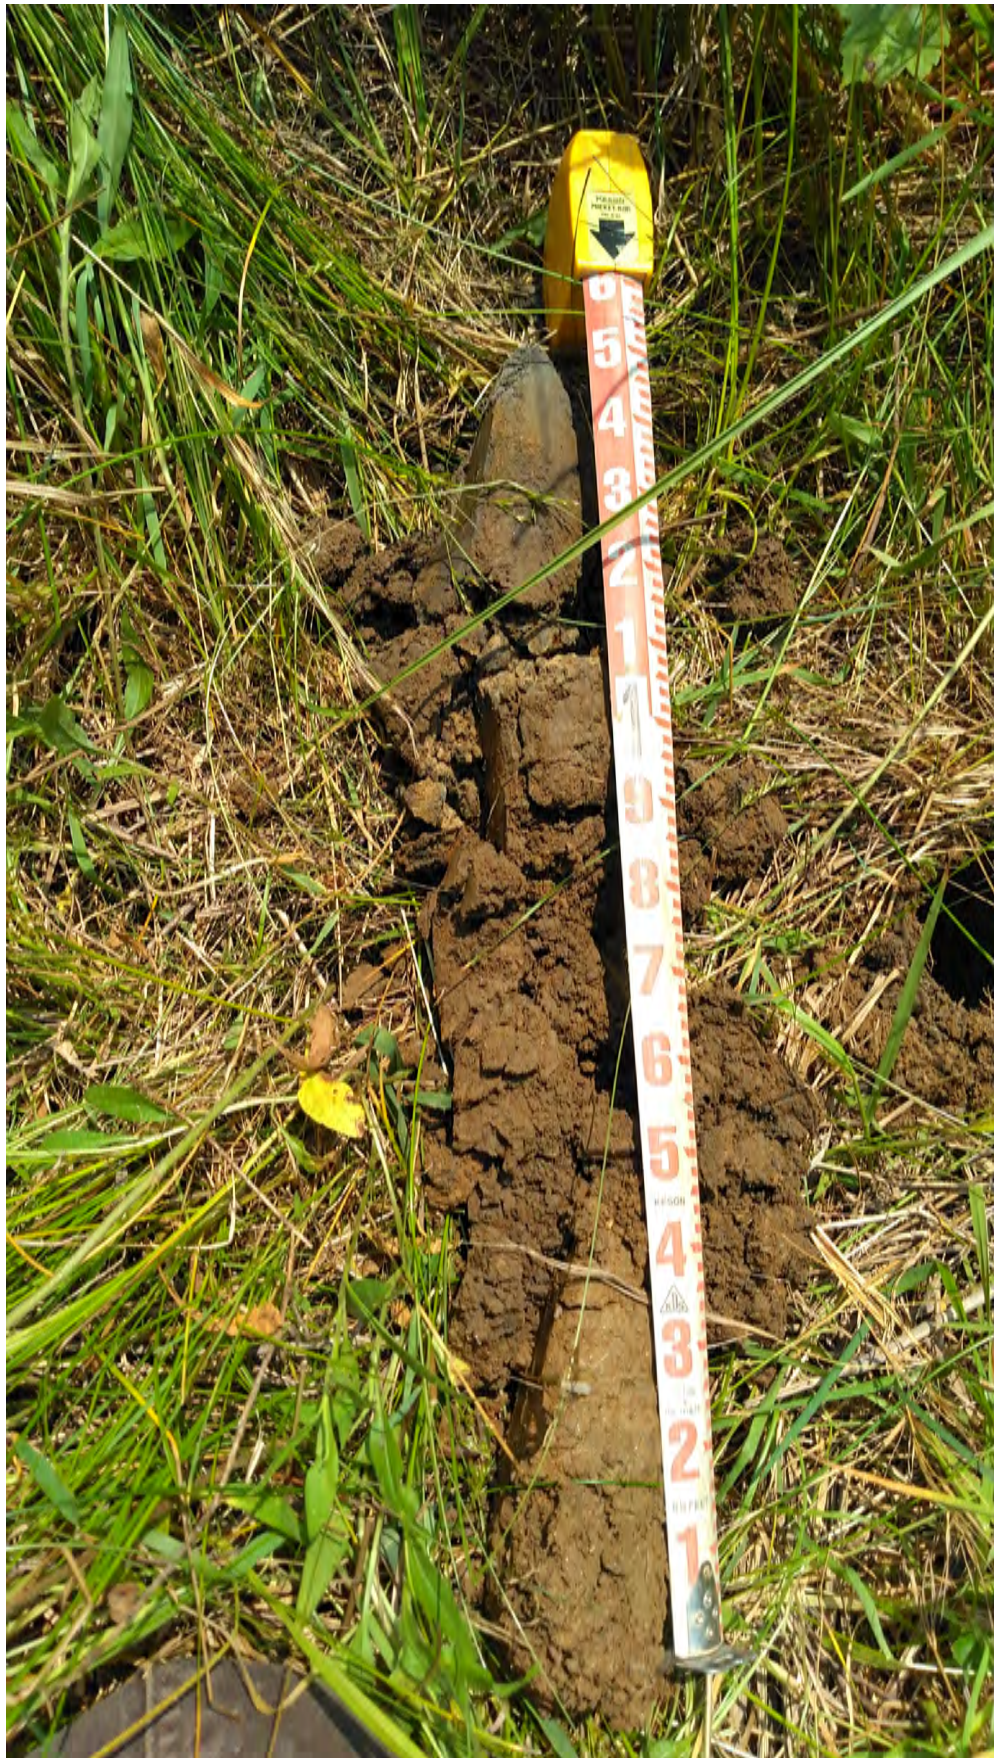
Sampling Point: FC1

Depth (Feet)	Matrix		Redox Features				Texture	Remarks
	Color (moist)	%	Color (moist)	%	Type <sup>1</sup>	Loc <sup>2</sup>		
0-0.7	10yr 4/3	80	10yr4/1	20	d	m	Loamy clay	
0.7-1.1	7.5yr 4/1	60	7.5yr 4/6	40	c	pl	Clay loam	Saturation below 1.0'
1.1-1.5	5yr 4/1	90	7.5yr 4/4	10	rm	pl	Loamy clay	
1.5+	5yr 4/1	100	-----				Sandy	Coarse sands/fine gravels

<b>Restrictive Layer (if observed):</b> None Type: Depth (inches):	<b>Hydric Soil Present?</b> Yes <input checked="" type="checkbox"/> No
--	--

Remarks:    Uppermost core in array

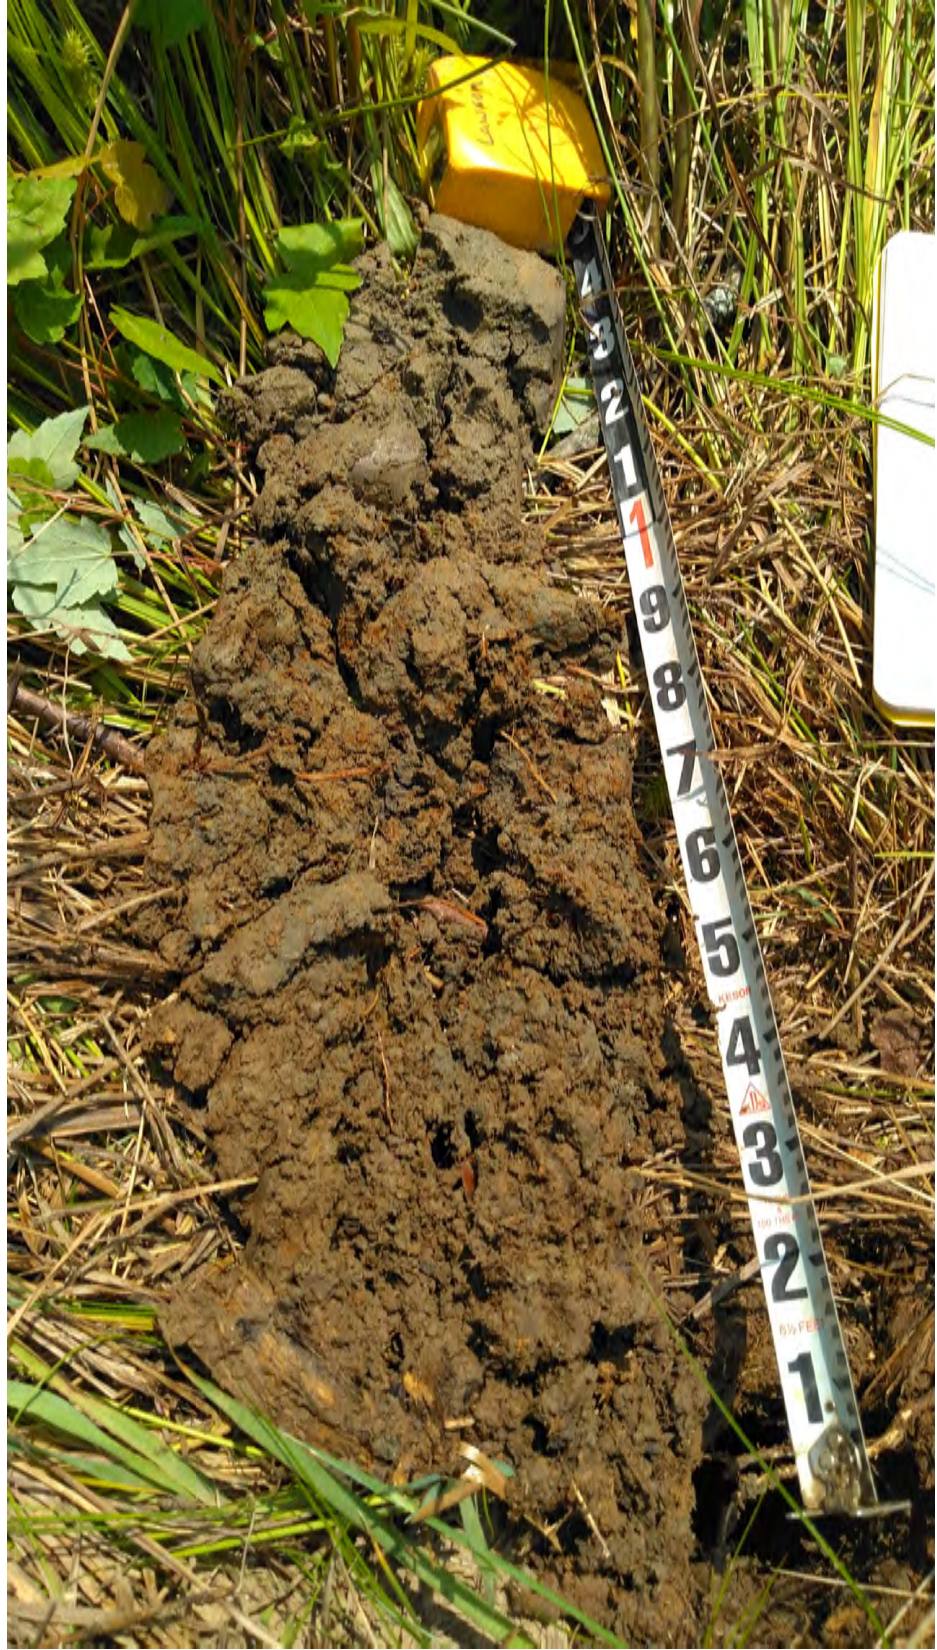
Sampling Point: FC2

Depth (Feet)	Matrix		Redox Features				Texture	Remarks
	Color (moist)	%	Color (moist)	%	Type <sup>1</sup>	Loc <sup>2</sup>		
0-1.1	2.5y 4/2	80	5yr 4/4	20	c	pl	Loam clay	Saturation to surface
1.1-1.3+	2.5y 5/2	99	5yr 4/6	1	rm	m	Sandy loam

<b>Restrictive Layer (if observed):</b> Type: None Depth (inches):	<b>Hydric Soil Present?</b> Yes <input checked="" type="checkbox"/> No
--	--

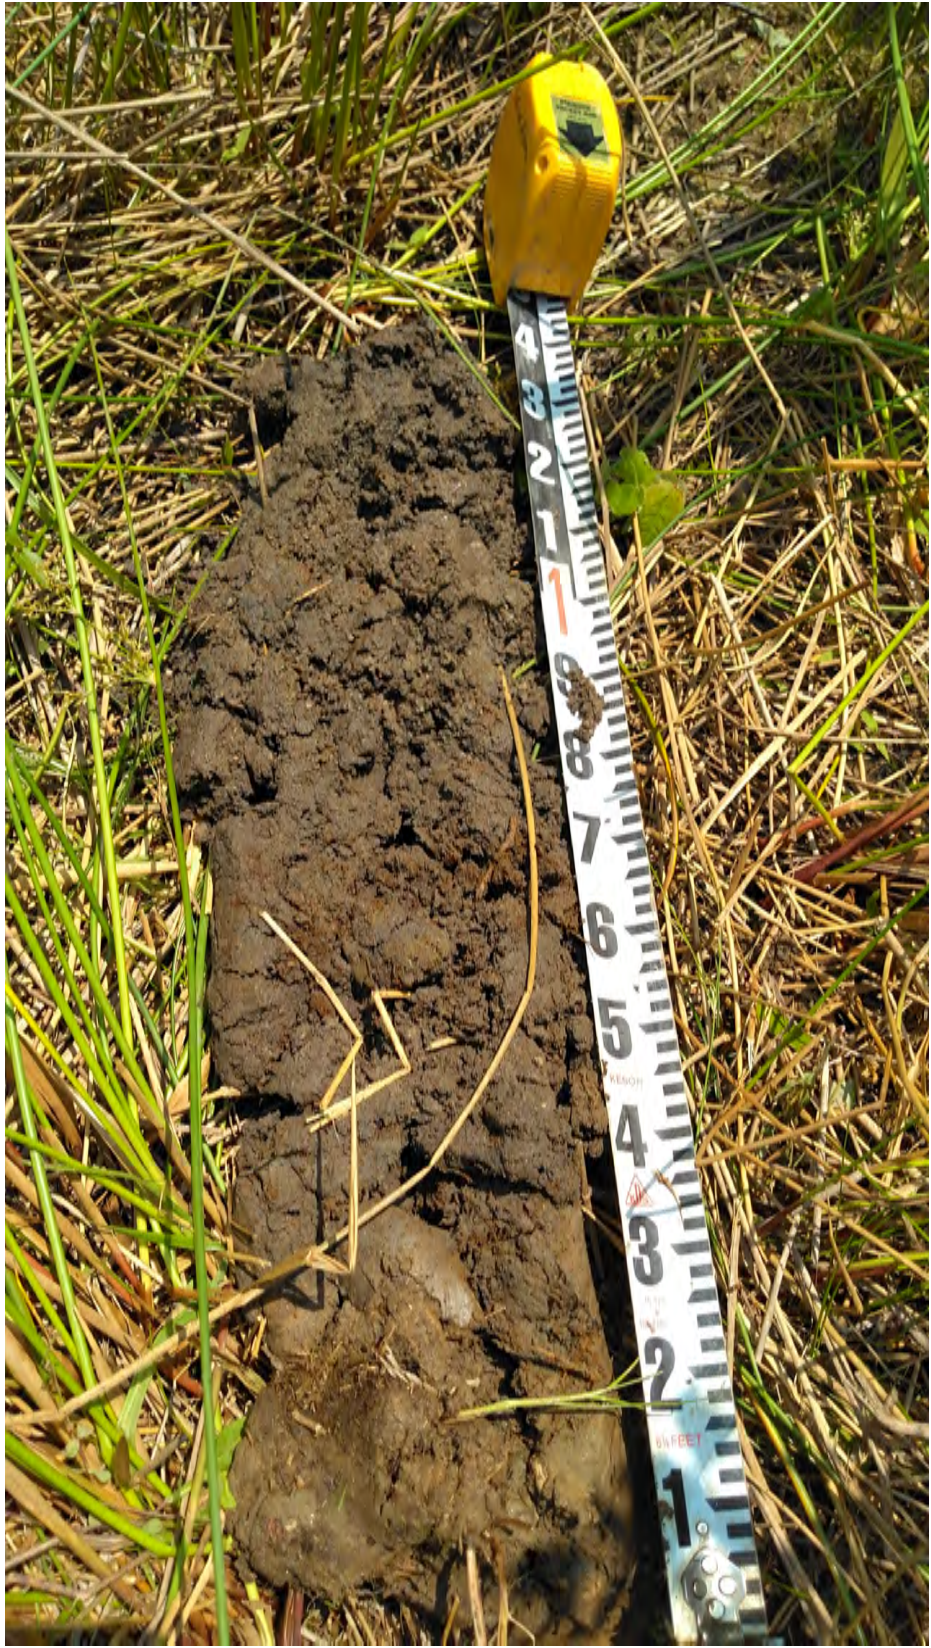
Sampling Point: FC3

Depth (Feet)	Matrix		Redox Features				Texture	Remarks
	Color (moist)	%	Color (moist)	%	Type <sup>1</sup>	Loc <sup>2</sup>		
0-0.2	O horizon							Saturation to surface
0.2-0.8	5yr 4/1	95	7.5yr 3/3	5	c	pl	Sandy loam	
0.8-1.4+	5y 4/1	99	5yr 3/4	1	c	pl	Loamy sand	WT 12" at time 0 & 10m

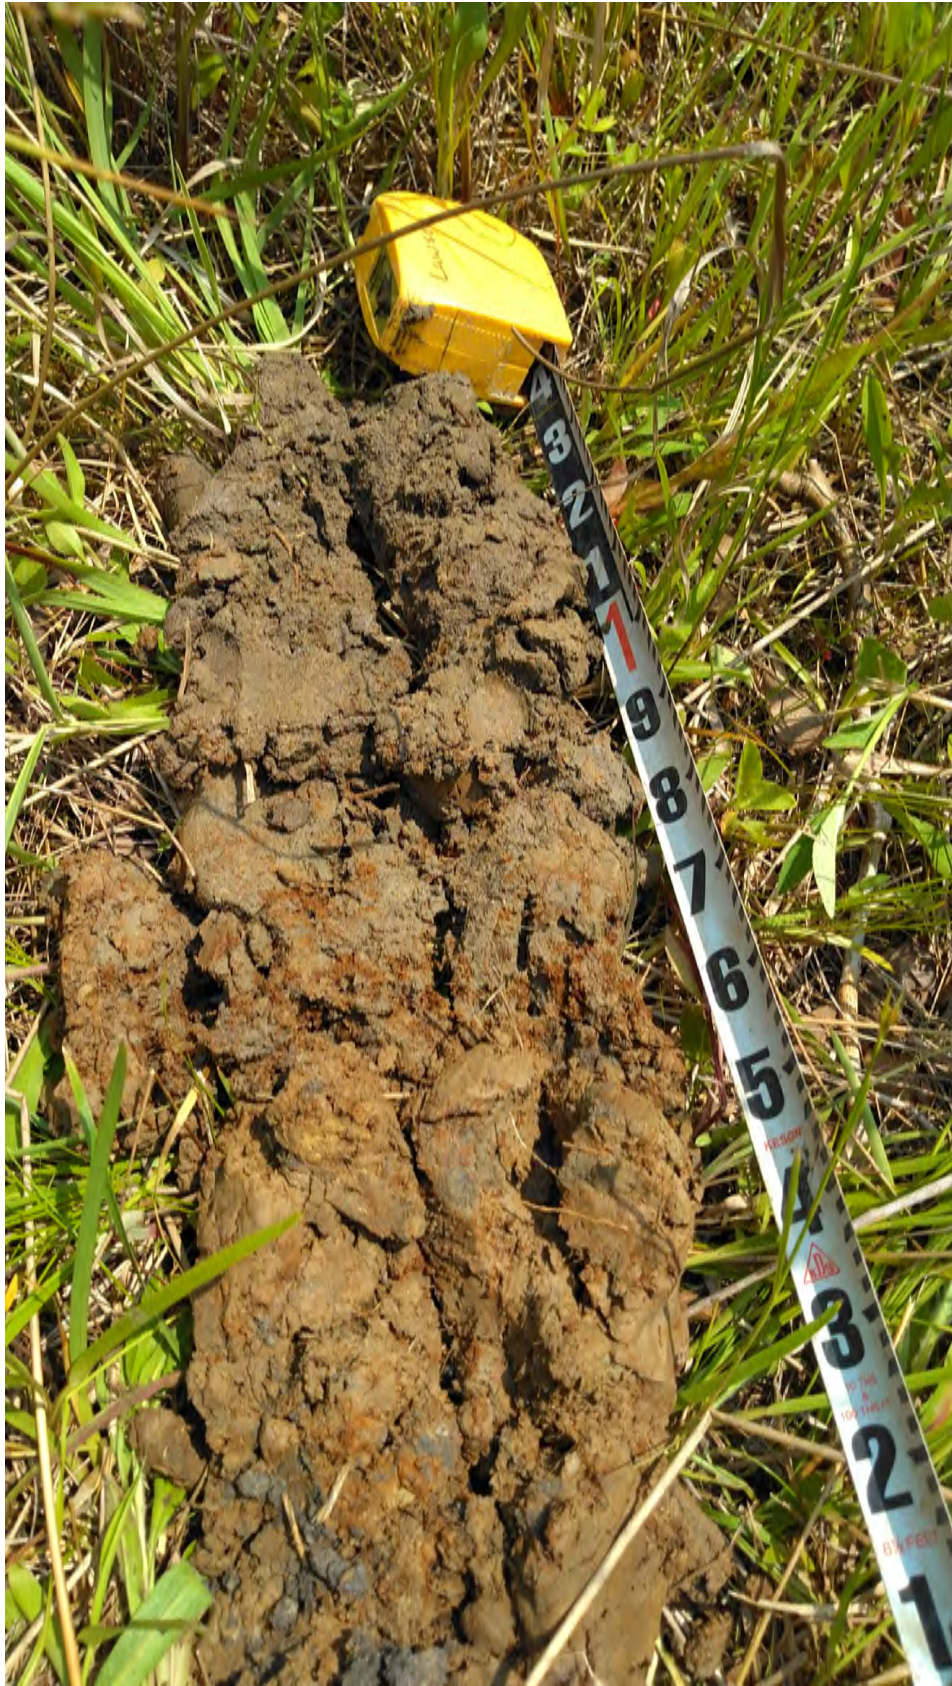
Sampling Point: FC4

Depth (Feet)	Matrix		Redox Features				Texture	Remarks
	Color (moist)	%	Color (moist)	%	Type <sup>1</sup>	Loc <sup>2</sup>		
0-0.5	2.5y 3/3	60	2.5yr 4/6	40	c	pl	Loamy clay	Saturation to surface
0.5-0.9	2.5y 4/1	90	2.5yr 3/6	10	c	pl	Sandy loam	
0.9-1.3+	2.5y 4/2	95	10y 3/6	5	c	pl	Sandy loam	WT 14" at time 0
