**Third Fork Creek Stream Restoration – NCEEP Project #139  
Durham, North Carolina**

**Third Annual Monitoring Report -- FINAL  
February 2008**

**THIRD FORK CREEK STREAM RESTORATION – NCEEP Project #139  
2007 MONITORING REPORT – YEAR 3**

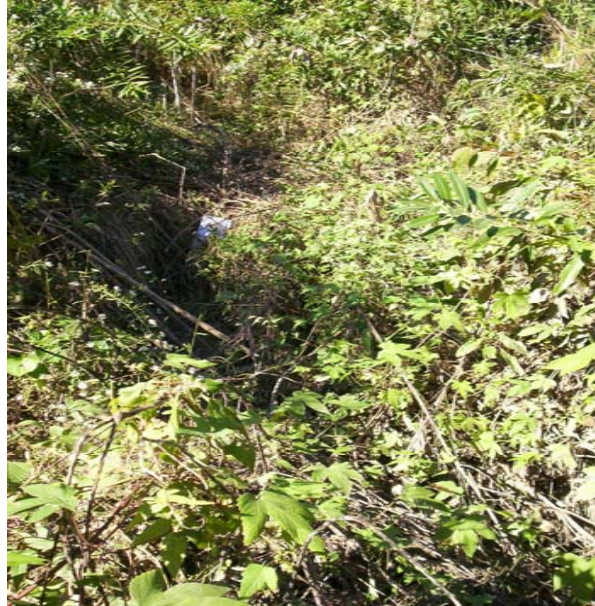
**SP5. Headcut**
