**THIRD FORK/FOREST HILLS CREEK STREAM RESTORATION – NCEEP
Project #139**

**2008 MONITORING REPORT – YEAR 4 - FINAL
January 2009**

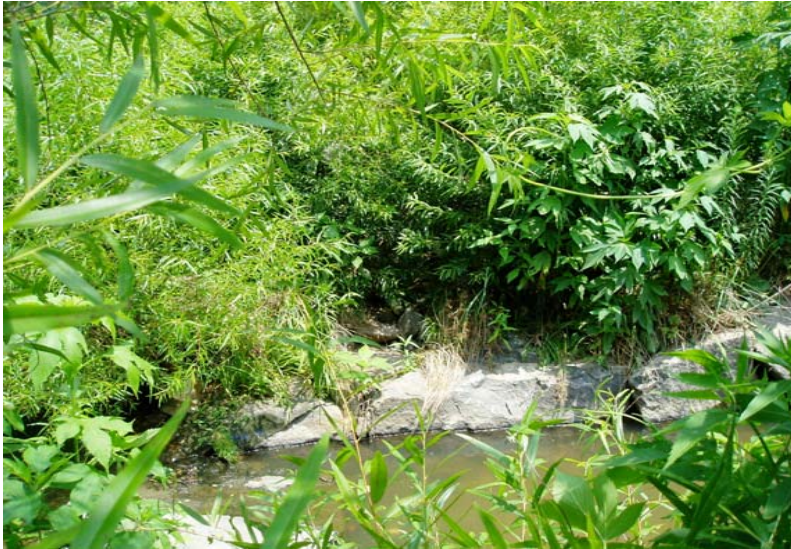
PP #5 – UT Entering Stream (07/16/07)

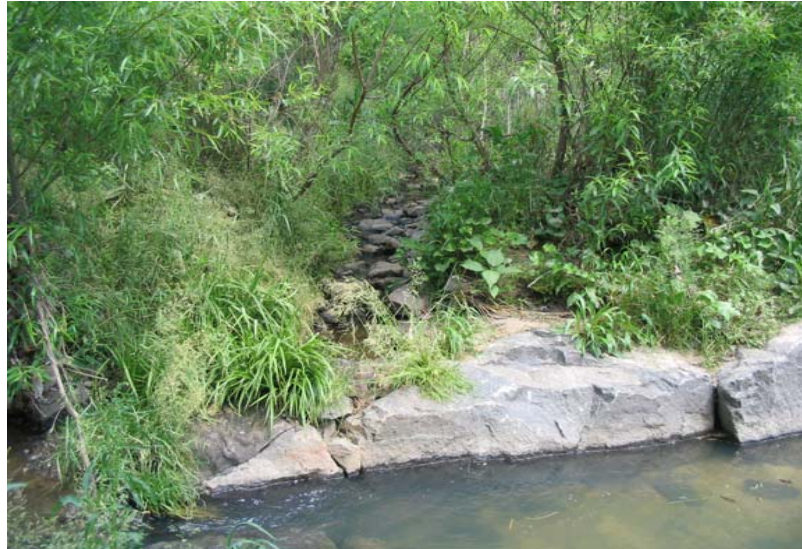
PP #5 – UT Entering Stream (05/06/08)

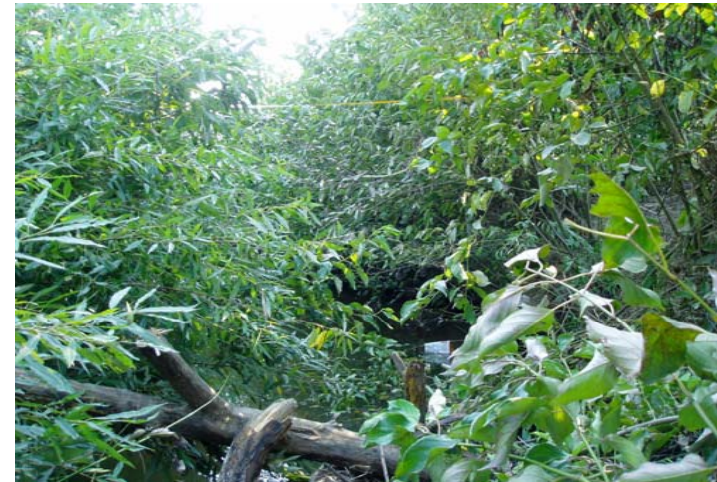
View of cross-section #3 looking downstream

Stream Type: C5

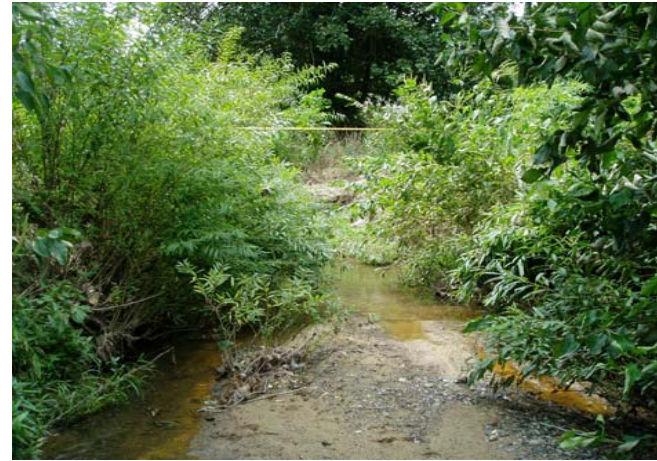
View of cross-section #3 looking downstream

Stream Type: E5
