THIRD FORK/FOREST HILLS CREEK STREAM RESTORATION–Project #139
Fifth Annual Monitoring Report – 2009 – FINAL

January 2010

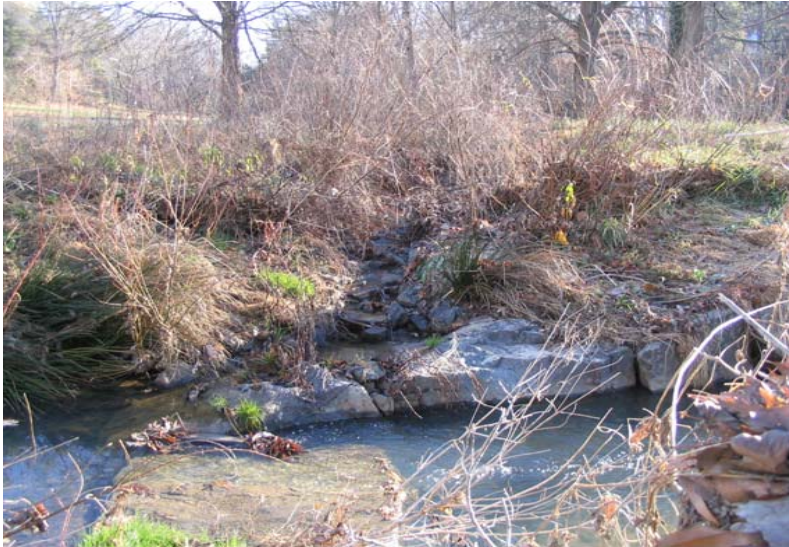
PP #5 – UT Entering Stream (11/20/06)

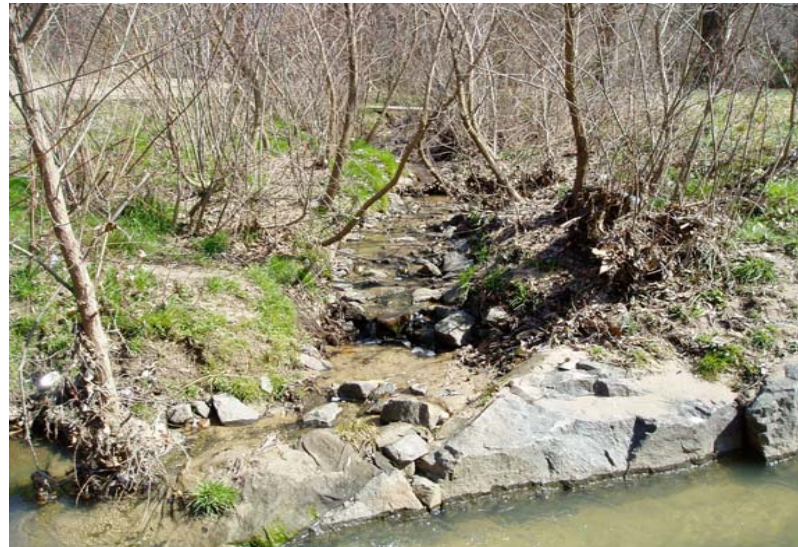
PP #5 – UT Entering Stream (03/06/09)

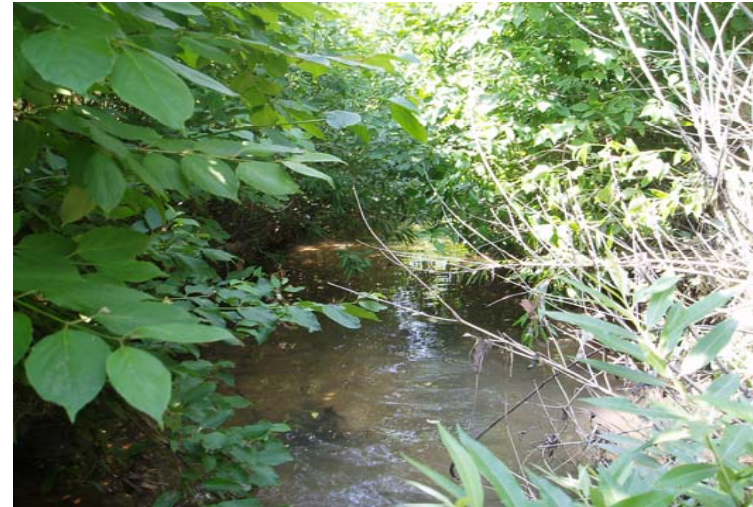
View of cross-section #1 looking downstream

Stream Type: C5

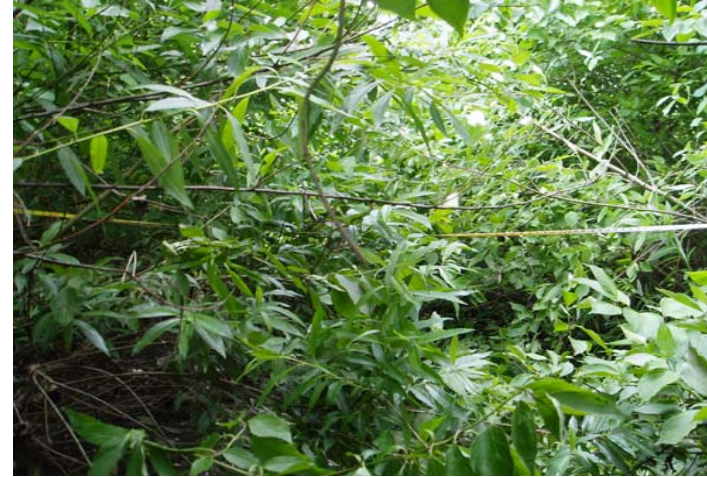
View of cross-section #2 looking downstream

Stream Type: C5c

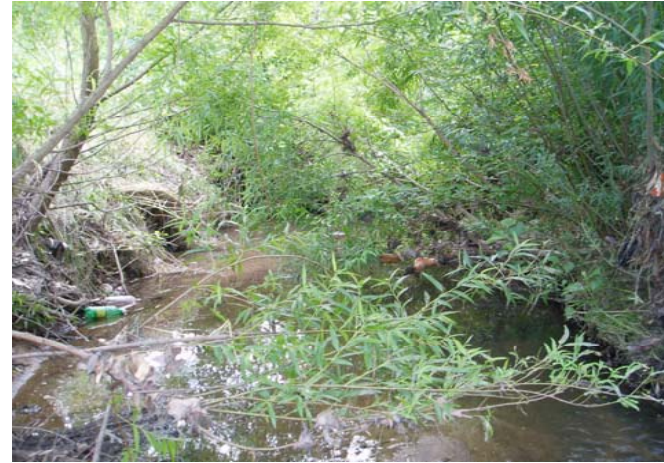
View of cross-section #3 looking downstream

Stream Type: E5

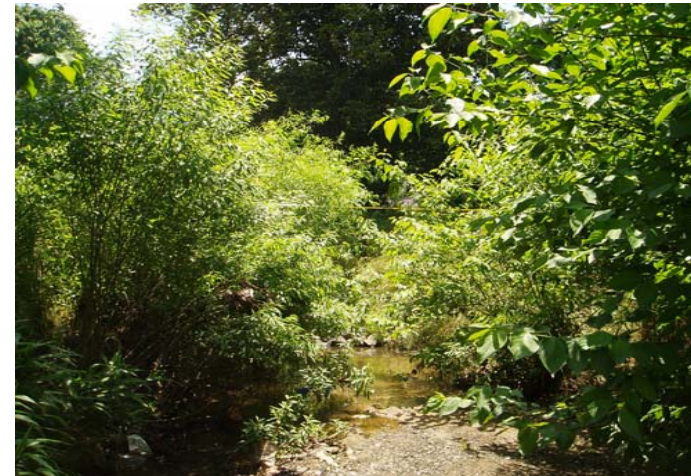
View of cross-section #4 looking downstream

Stream Type: E5
