Freedom Park (Little Sugar Creek) Final Monitoring Report Year 3 of 5 (2007)

Mecklenburg County, North Carolina

Project ID No. 141

February 2008

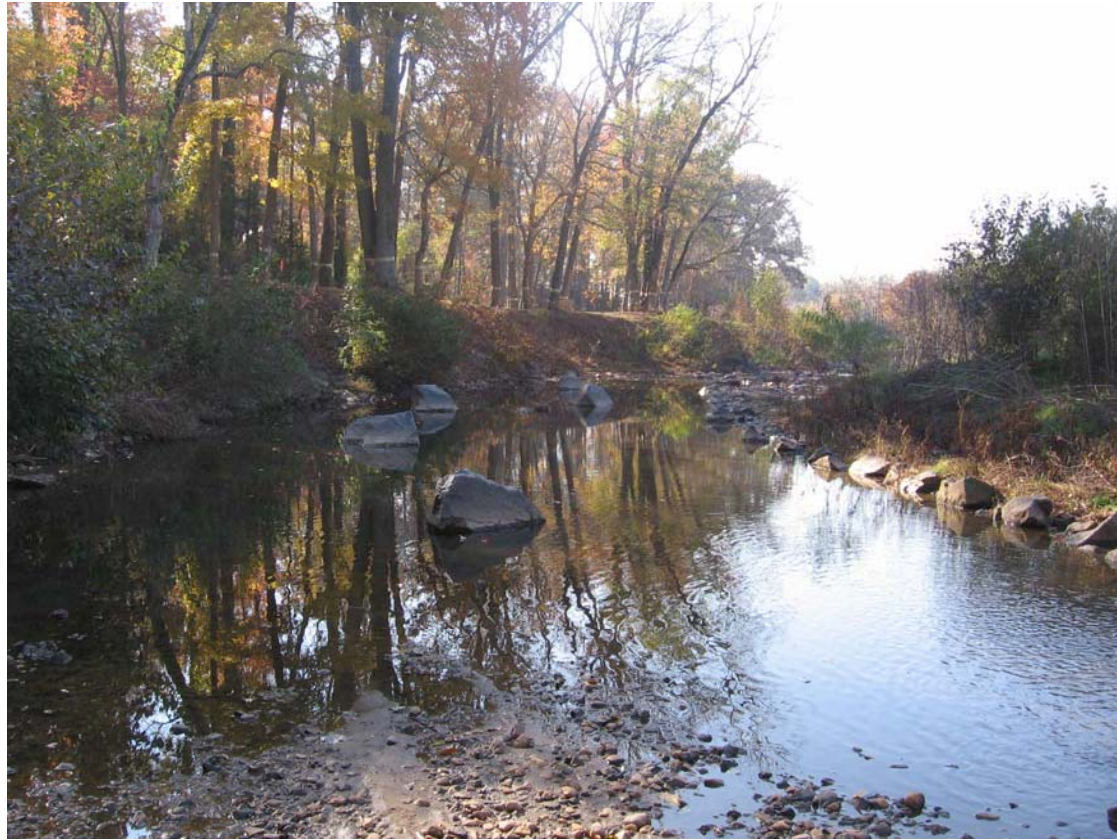
2,600 - 2,700 (Left Bank)	Excessive bank stresses during yearly flooding events or invasive treatment	
	3,010 - 3,070 (Left Bank)	Excessive bank stresses during yearly flooding events or invasive treatment	VP5
	3,120 - 3,190 (Right Bank)	Excessive bank stresses during yearly flooding events or invasive treatment	
Bare Bench	--	--	--
Bare Flood Plain	1,250 - 1,580 (Left Floodplain)	Cleared area exhibiting successional growth including invasives from local sources	VP6
	2,065 - 2,200 (Left Bank)	Excessive bank stresses during yearly flooding events or invasive treatment	VP7
Invasive/Exotic Populations	1,250 - 1,580 (Left Floodplain)	Cleared area exhibiting successional growth including invasives from local sources	VP6
2006			
Bare Bank	410 - 1,140 (Both Banks)	Excessive bank stresses during yearly flooding events	
	1,690 - 1,750 (Left Bank)		
	2,065 - 2,350 (Both Banks)		
Bare Bench	--	--	
Bare Flood Plain	1,250 - 1,580 (Left Floodplain)	Cleared area exhibiting successional growth including invasives from local sources

VP 5: Looking downstream at left bank, bare bank
