# Freedom Park (Little Sugar Creek) Monitoring Report Year 4 of 5 (2008)

Mecklenburg County, North Carolina

Project ID No. 141

May 2009

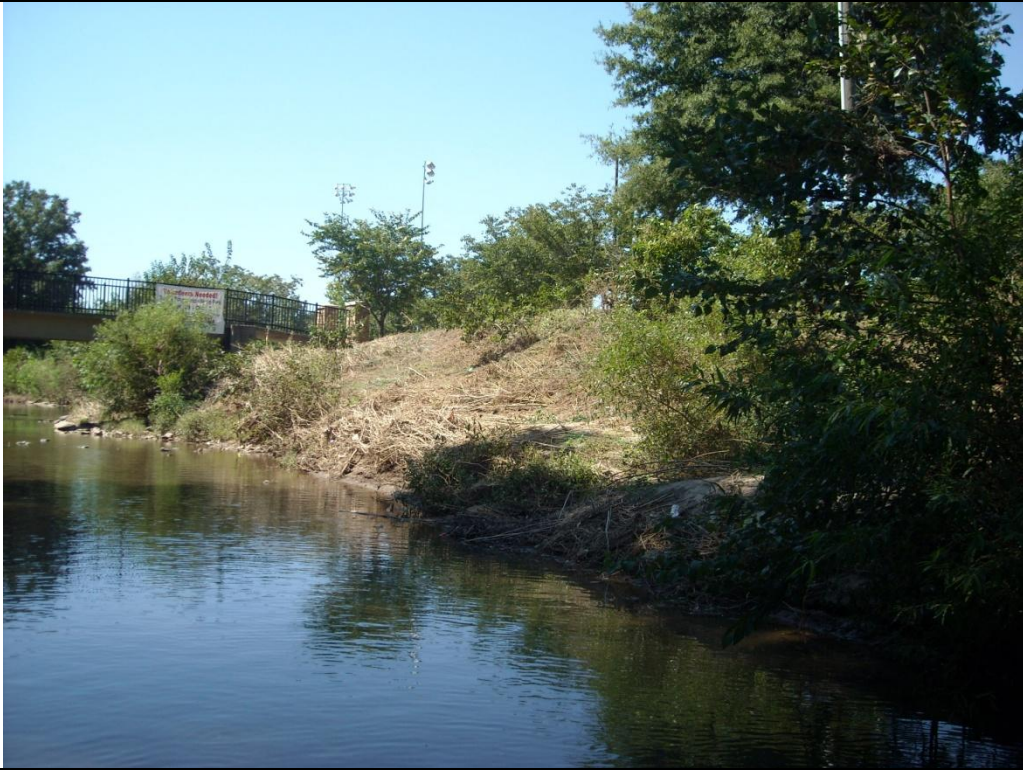
VP1: Bare bank  
Taken on 9/24/2008

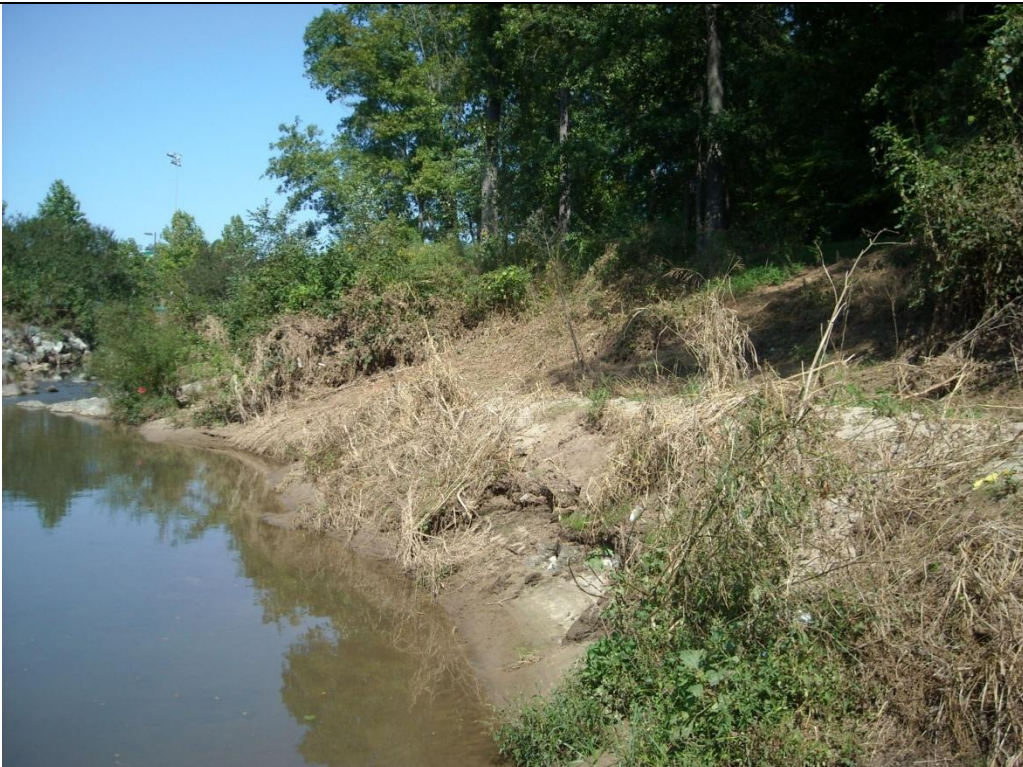
VP2: Bare Bank  
Taken on 9/24/2008

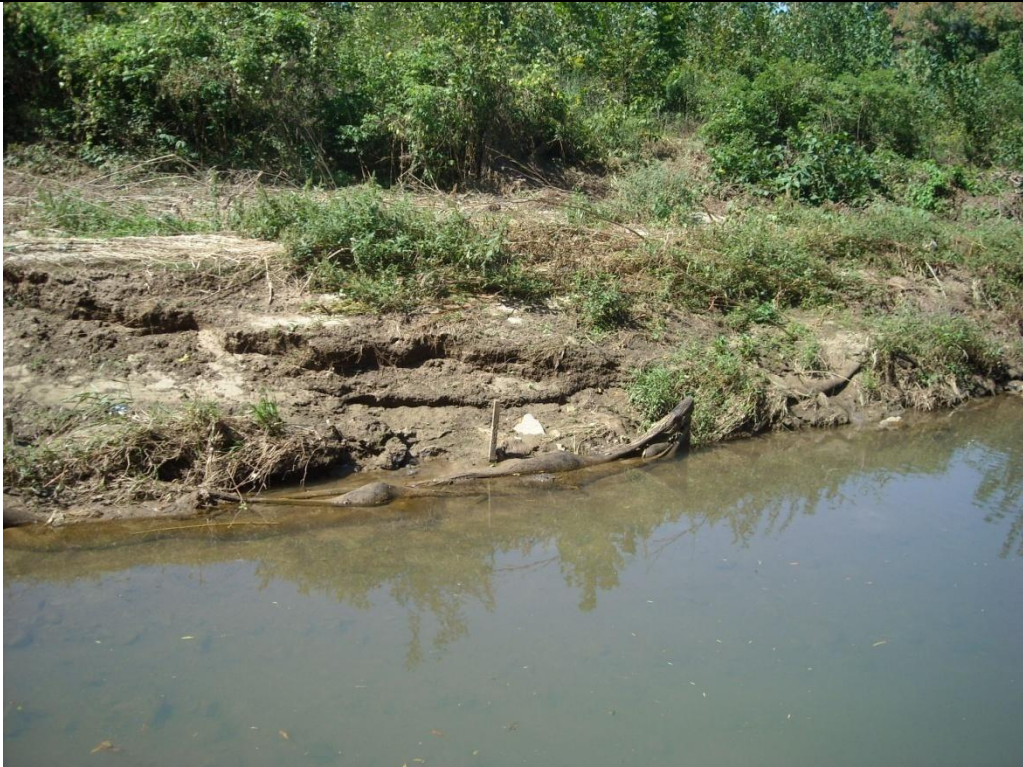
SP1: Bank erosion extending from point bar  
Taken 9/24/2008
