# Buffalo Creek Watershed Phase I Stream Mitigation Plan Greensboro, North Carolina

North Carolina Department of Environment and Natural Resources  
Ecosystem Enhancement Program

February 2005

Mitigation Plan Prepared By Buck Engineering PC

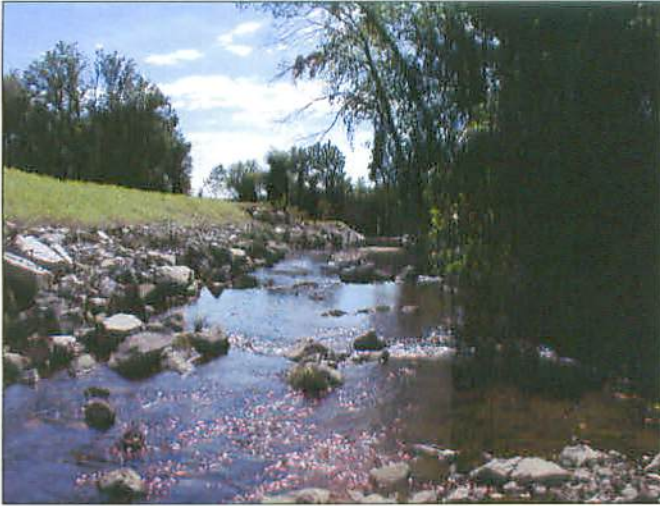
PP42 Reach 2 J-hook #5

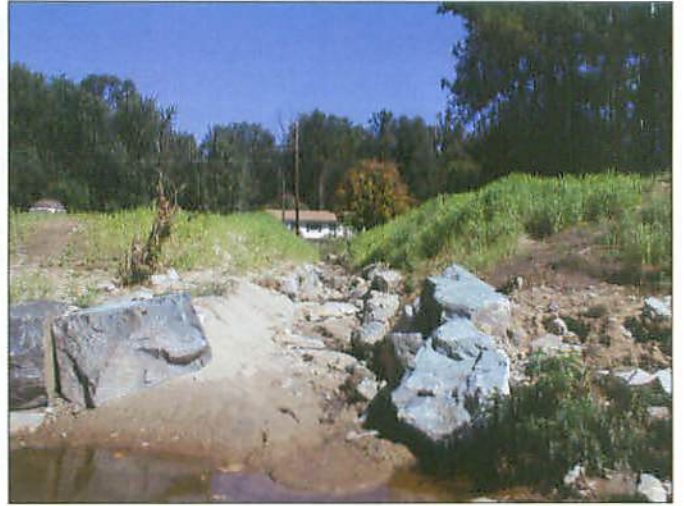
PP43A Reach 2 Riffle

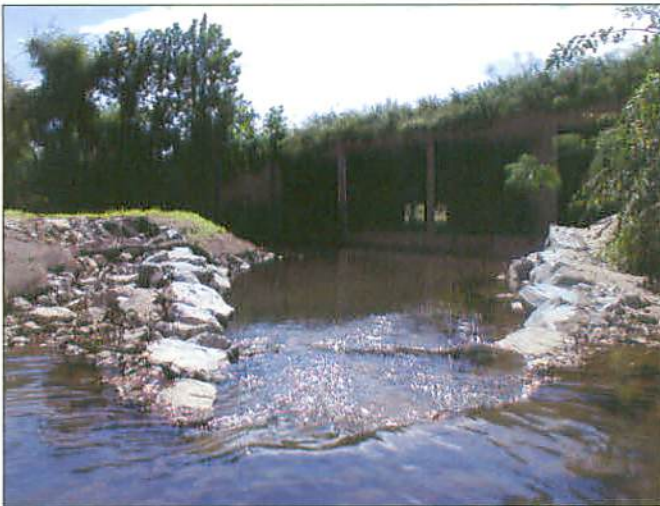
PP43B Reach 2 Step Pool #4

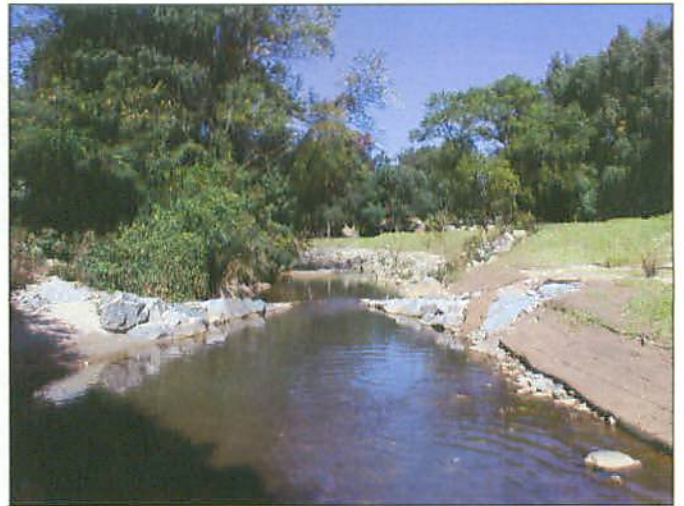
PP44 Reach 2 Cross Vane #4

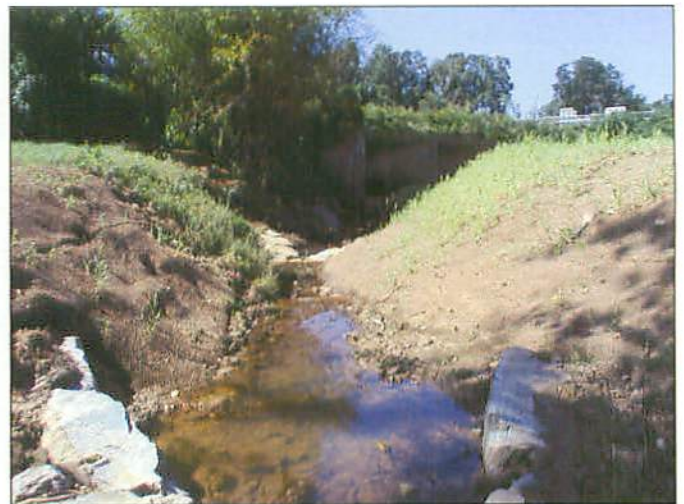
PP45B Reach 3 End (Upstream View)

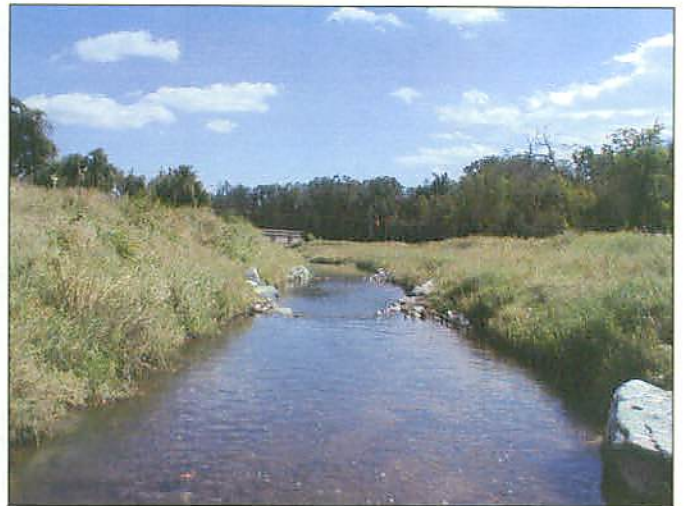
PP2 Reach 1A Cross Section 1

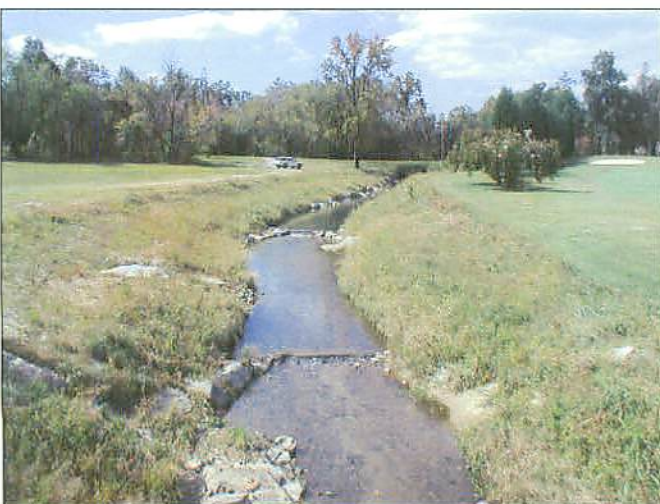
PP4A Reach 1A Looking Upstream

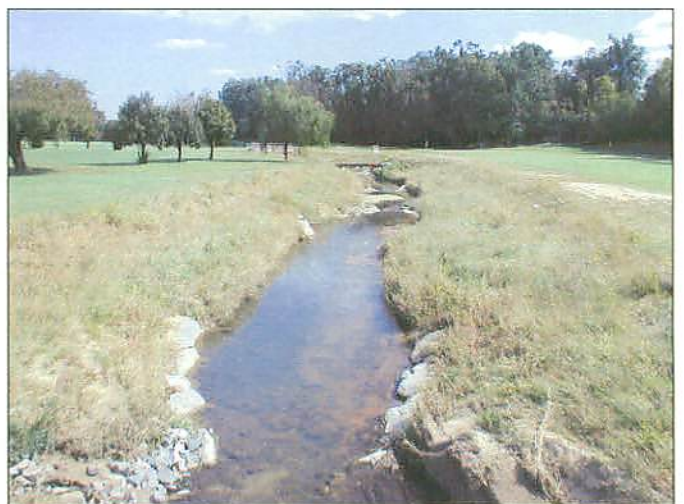
PP4B Reach 1B Start

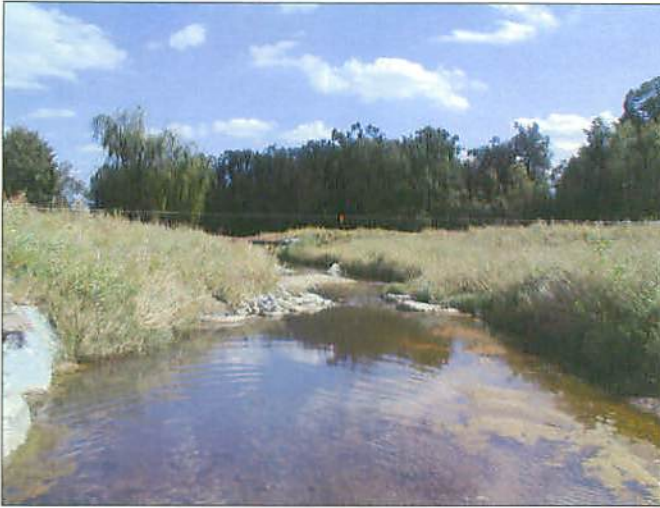
PP5 Reach 1B Cross Section 2

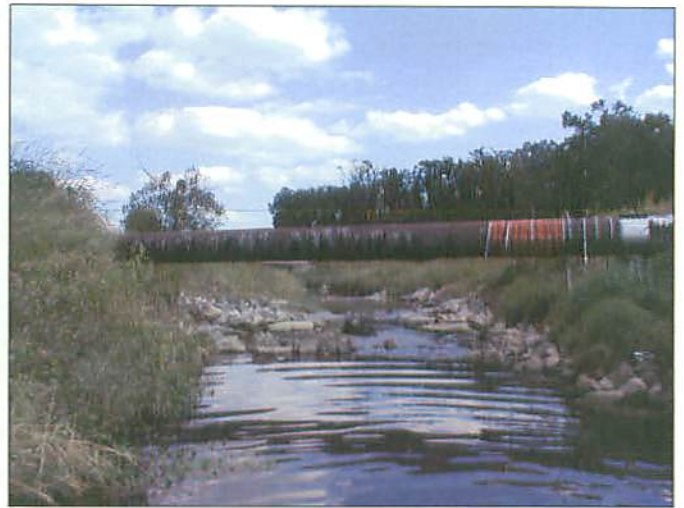
PP6 Reach 1B Cross Section 3

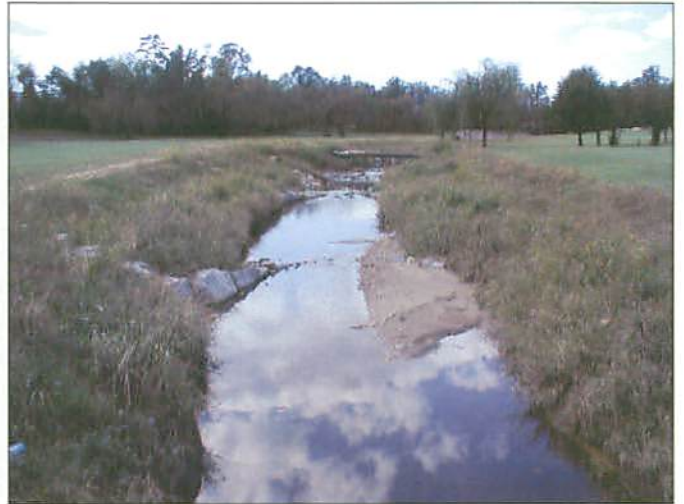
PP8A Reach 1B Looking Upstream

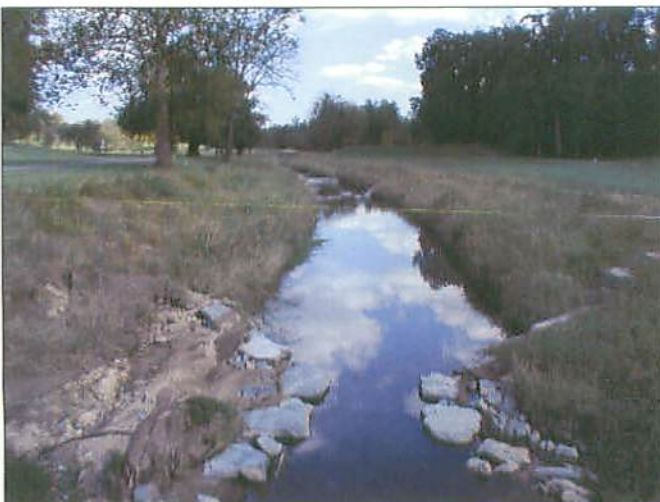
PP8B Reach 1C Start, Cross Section 4

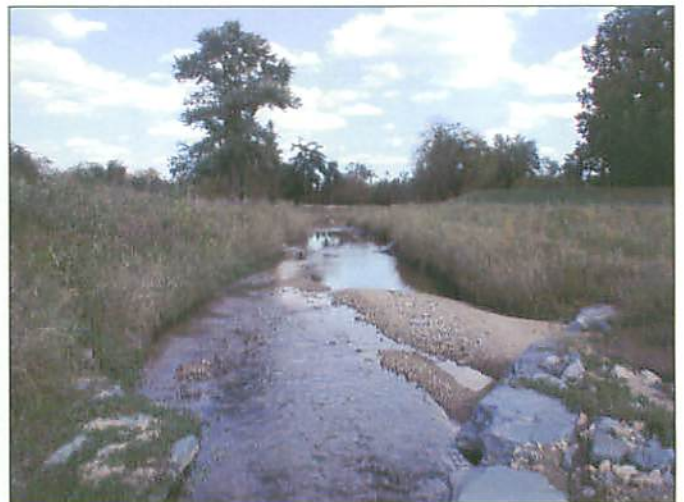
PP9A Reach 1C Cross Vane #2

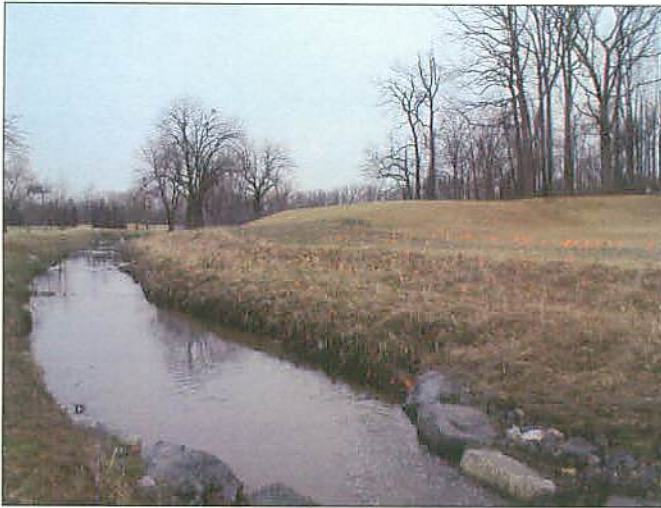
PP9B Managed Buffer  
Livestakes/Shrubs/Herbaceous Perennials  
Vegetation Plot Looking Downstream

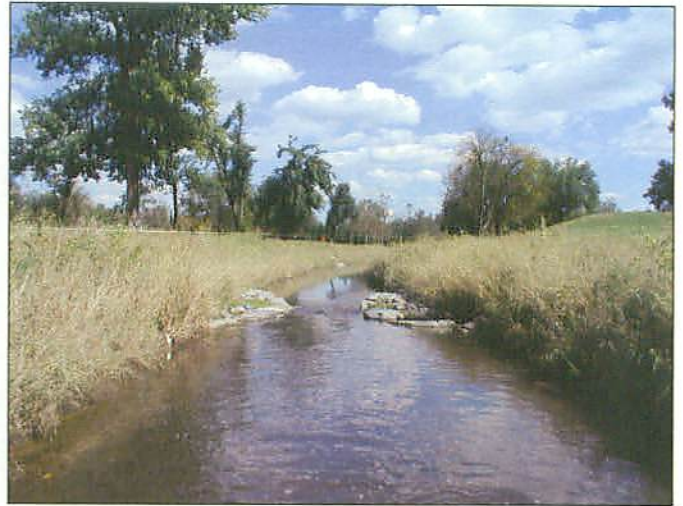
PP10 Reach 1C Cross Section 5

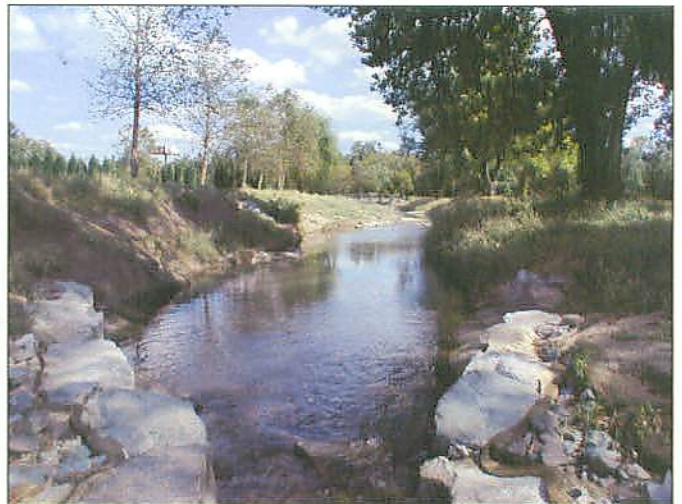
PP12 Reach 1D J-hook #1

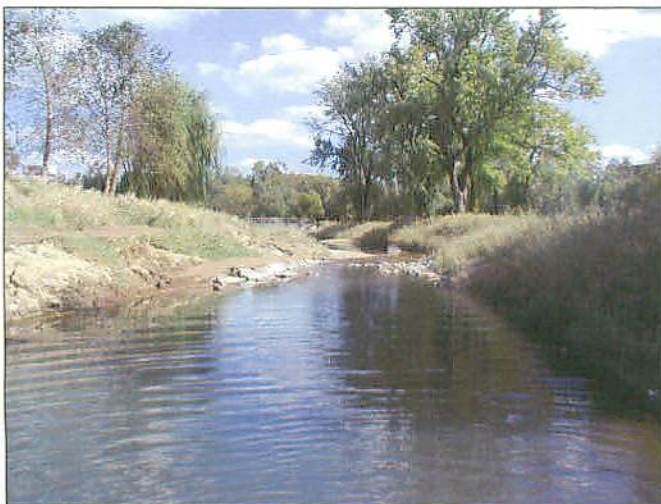
PP13 Reach 1D Constructed Riffle
