**Glen Raven Stream Restoration
Monitoring Report – MY01
Alamance County, NC
Basin 03030002 - Contract # D05011-1**

November 2007

**Project Manager: Joseph J. Pfeiffer, P.W.S.
Email: jpfeiffer@kci.com**

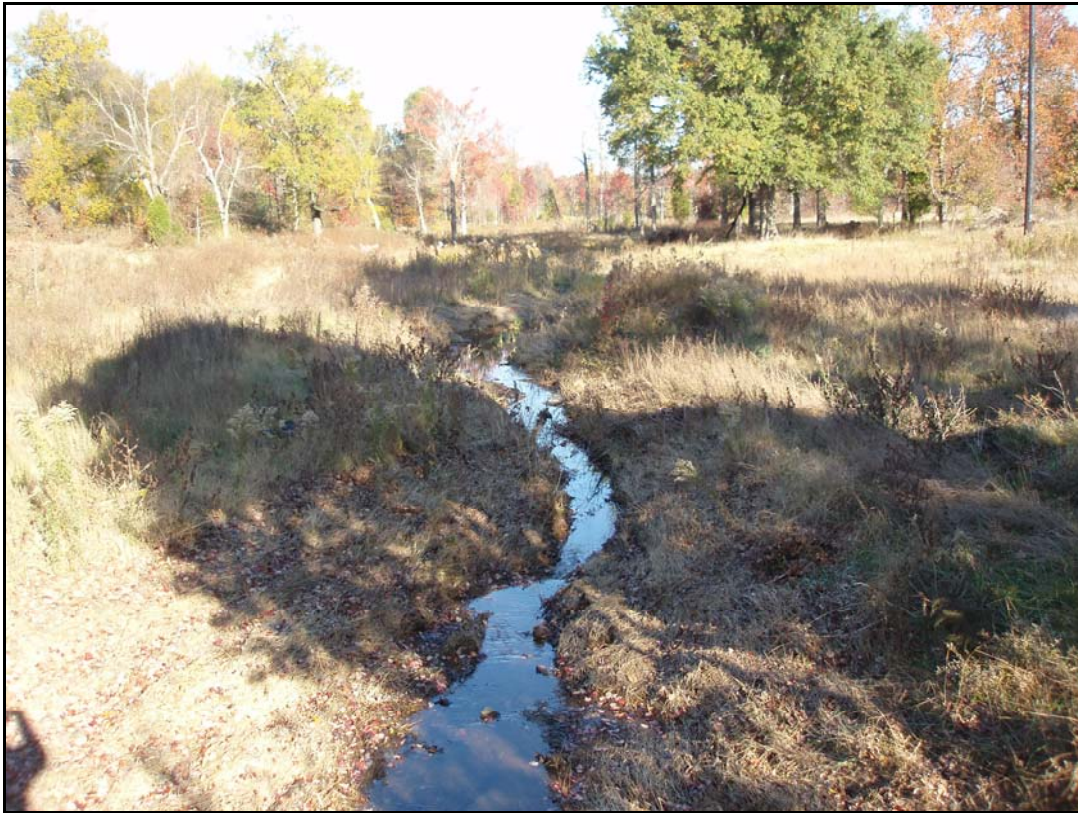
Photo Point 1: View looking north from Power Line Road. 11/16/07 – MY-01

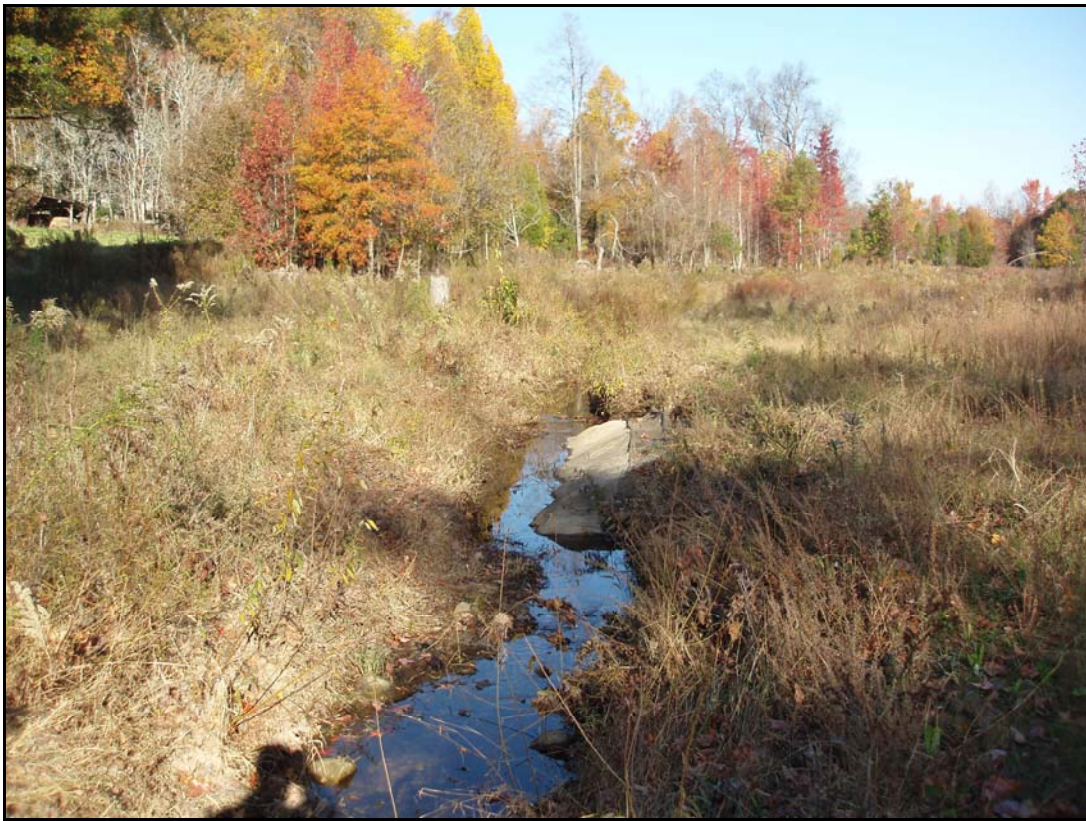
Photo Point 3b: View looking north toward vegetation plot #2. 11/16/07 – MY-01

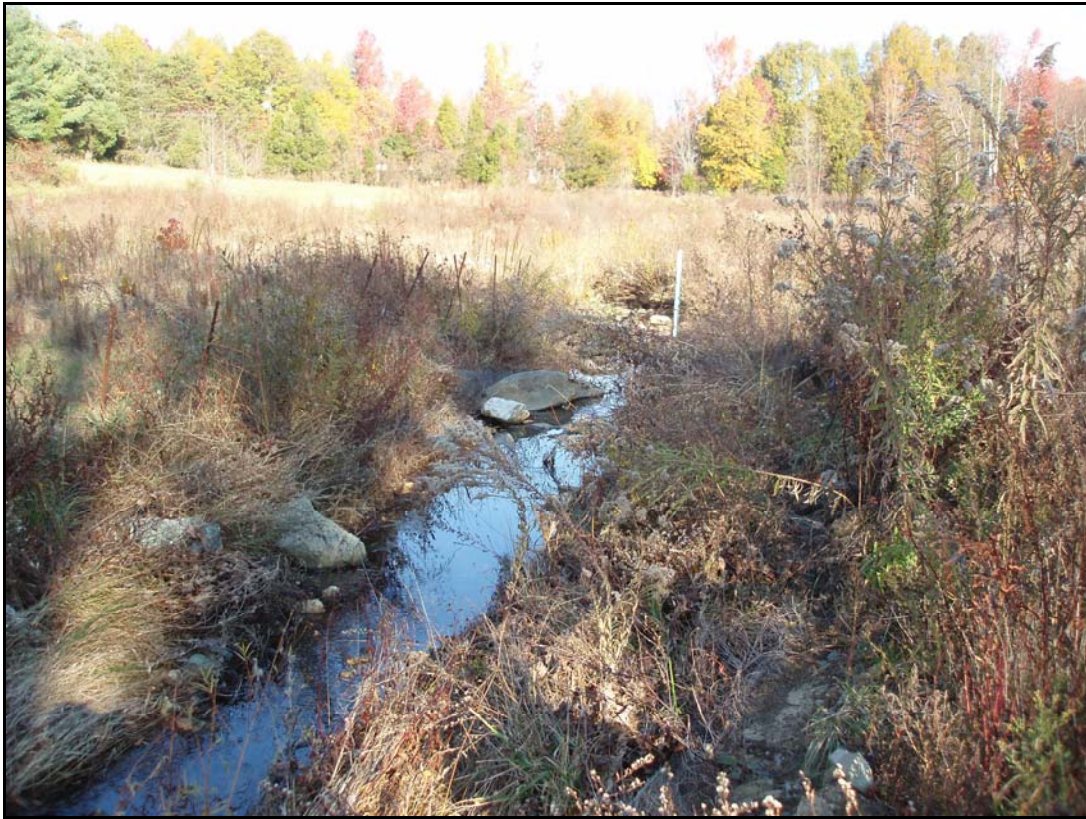
Photo Point 4b: View looking north toward vegetation plot #3. 11/16/07 – MY-01

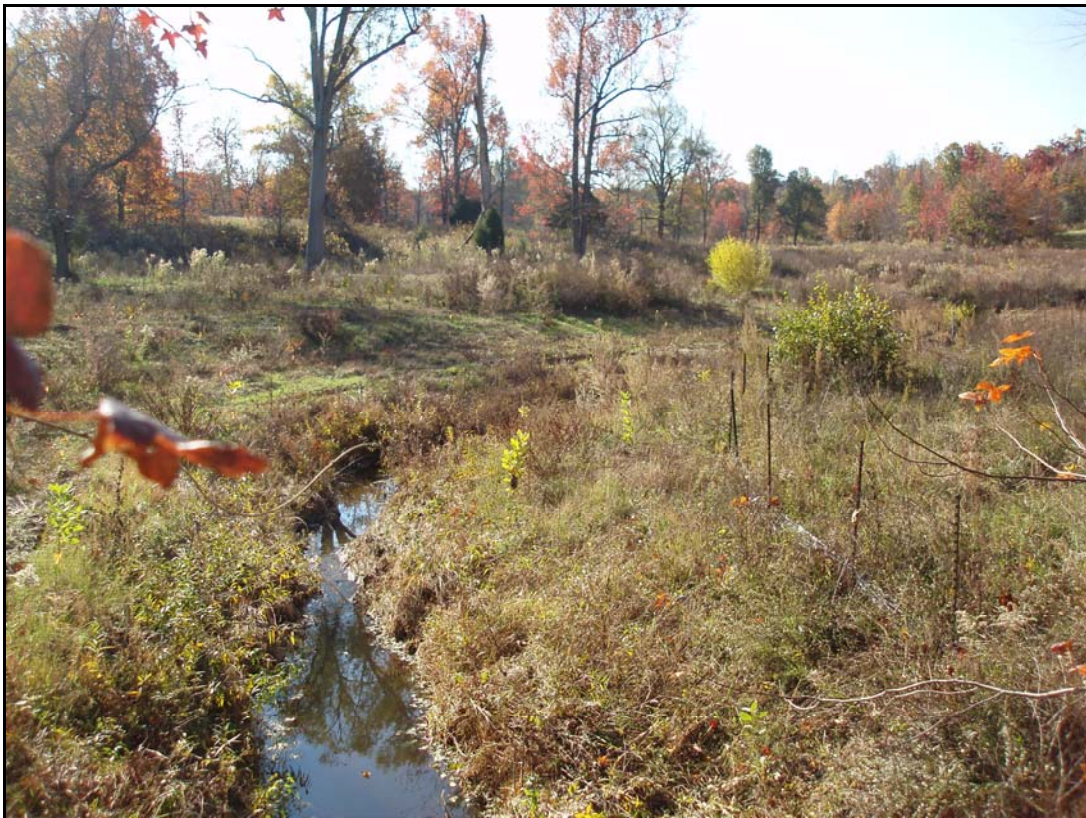
Photo Point 5: View looking south from Gerringer Road culvert. 11/16/07 – MY-01

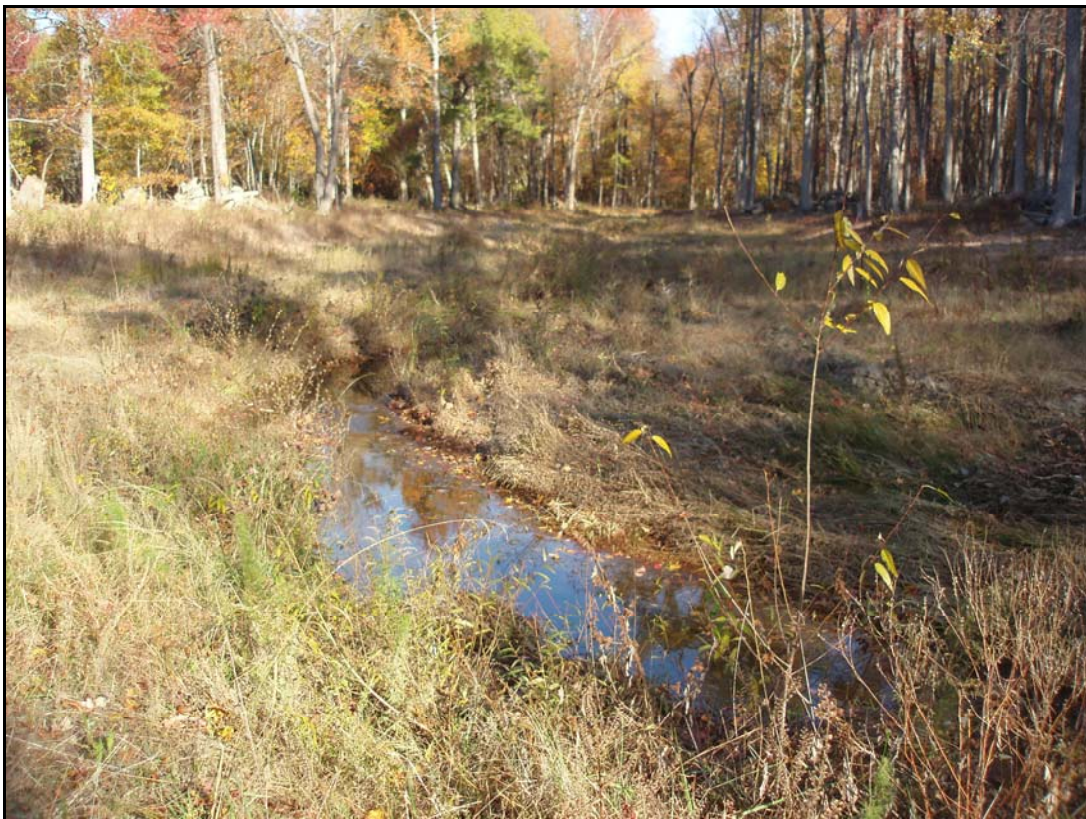
Photo Point 8: View looking south near vegetation plot #7. 11/16/07 – MY-01

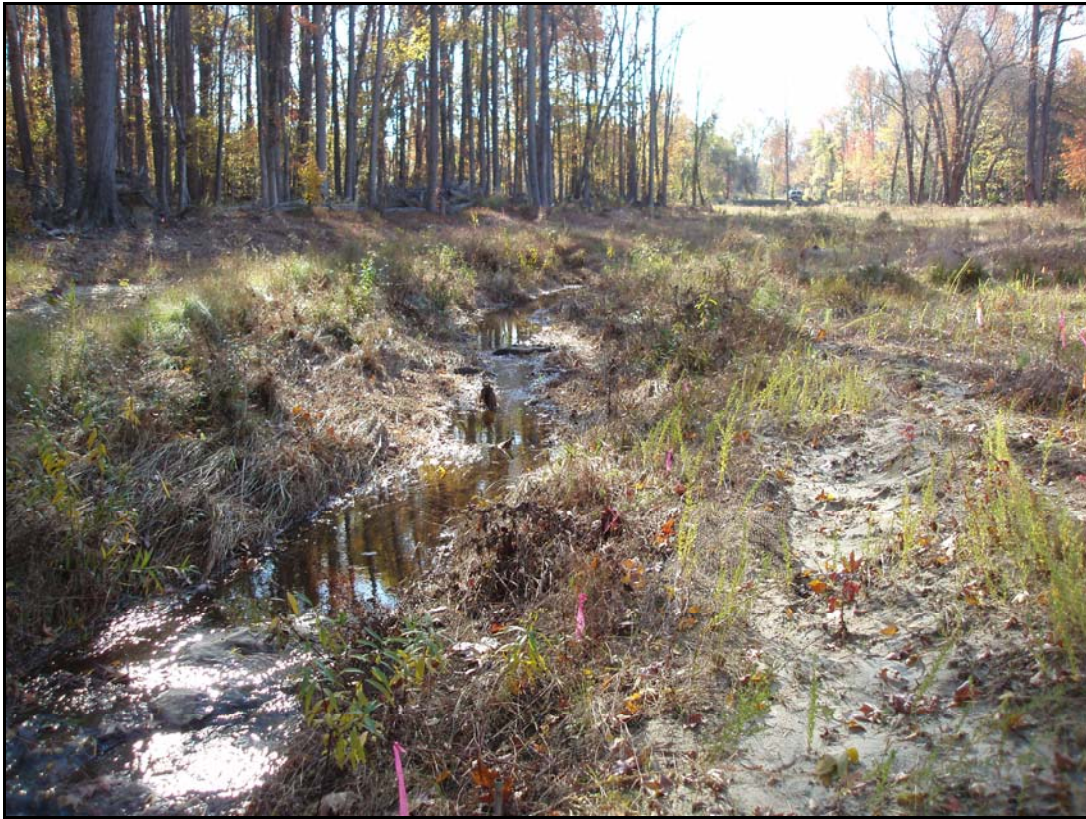
Photo Point 9a: View looking north toward vegetation plot #8. 11/16/07 – MY-01

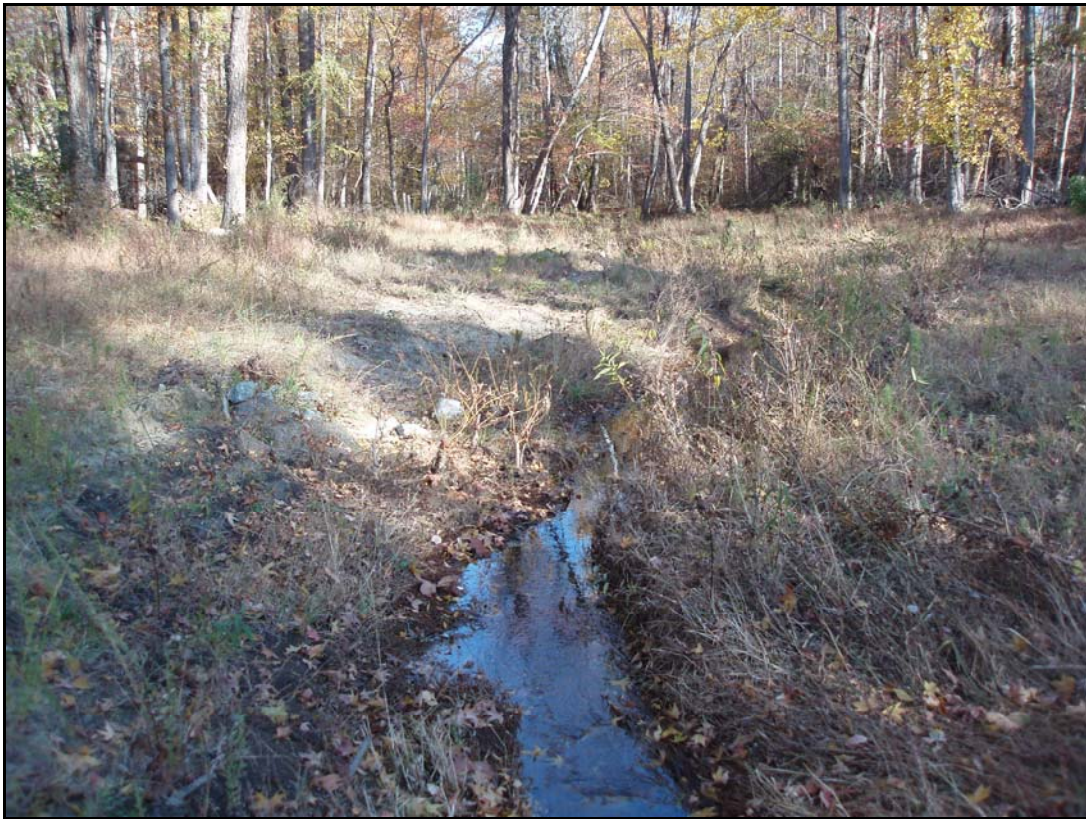
Photo Point 9b: View looking north toward end of project. 11/16/07 – MY-01

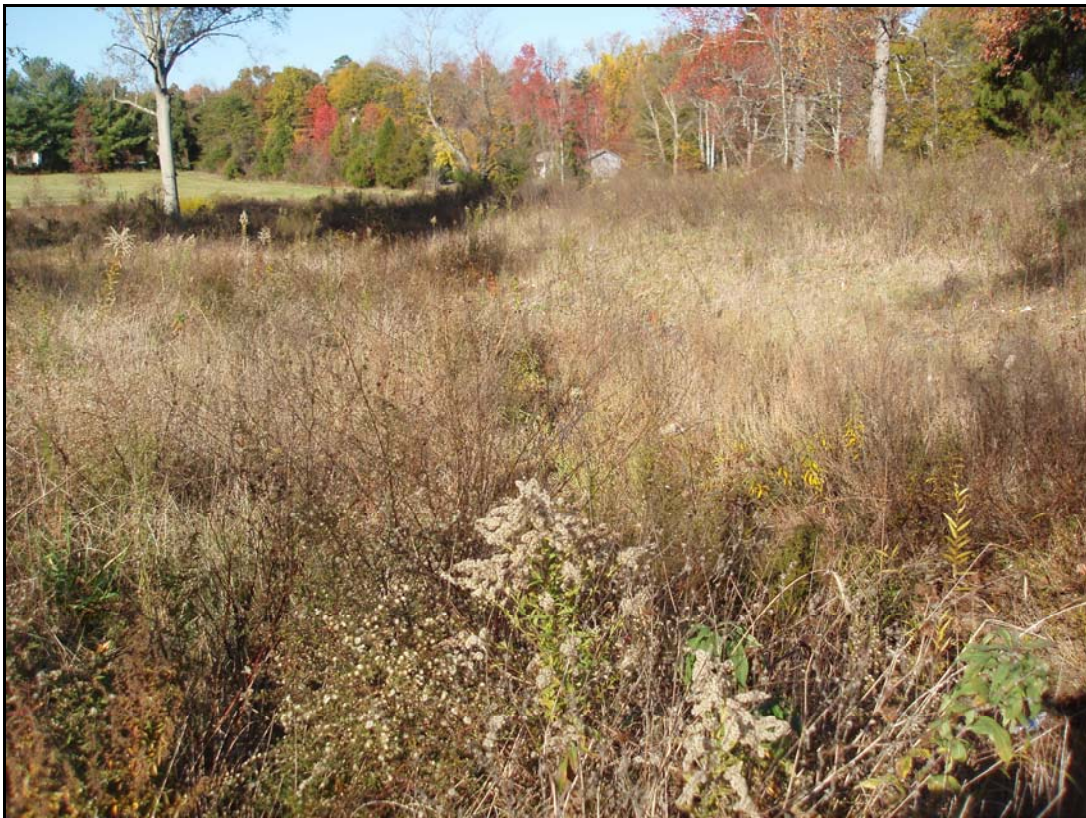
Photo Point 10b: View looking downstream on UT1 near Station 41+25. 11/16/07 – MY-01

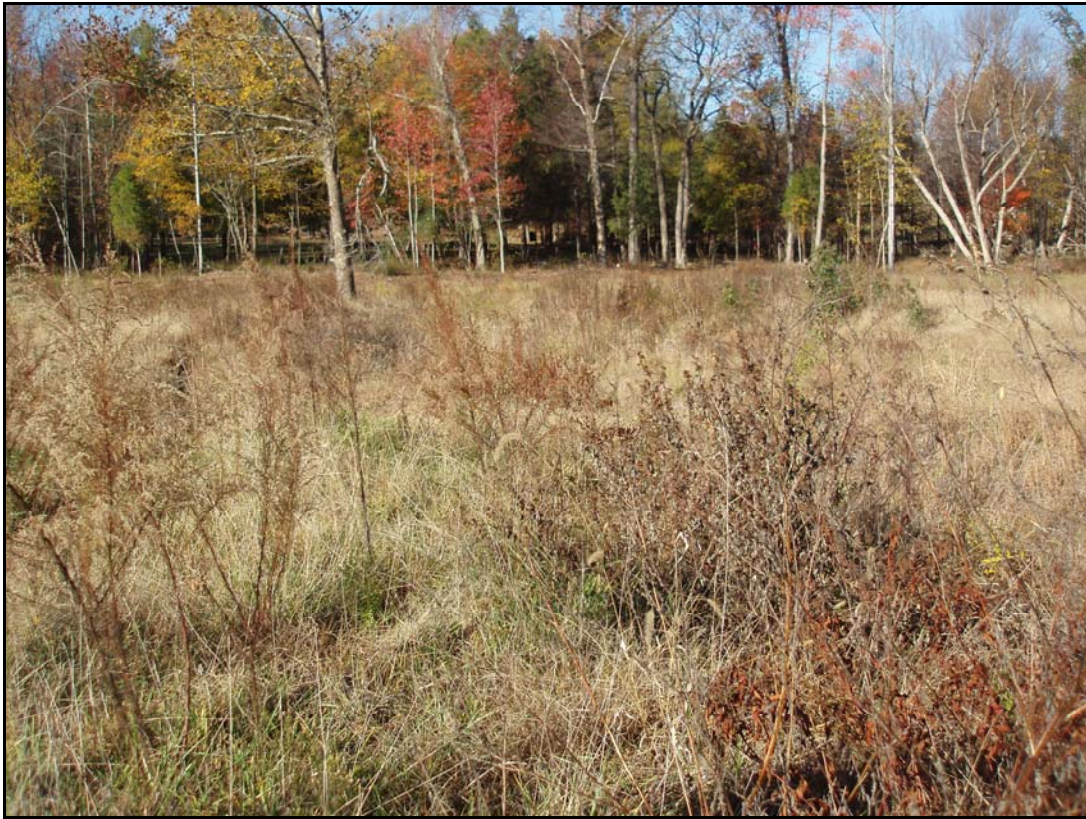
Photo Point 12a: View looking upstream on UT2. 11/16/07 – MY-01
