**Glen Raven Stream Restoration
Monitoring Report – MY02
Alamance County, NC
Basin 03030002 - Contract # D05011-1**

October 2008

**MONITORING
PLAN VIEW**

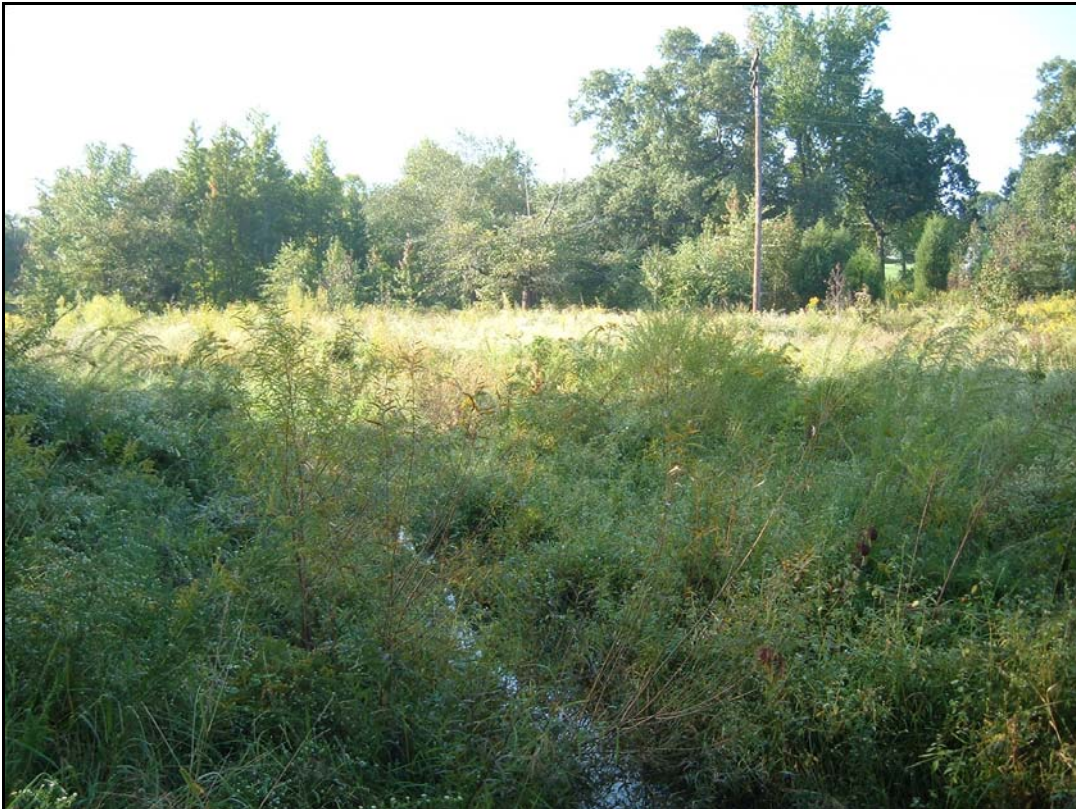
Photo Point 2a: View looking south near Station 13+25. 9/29/08 – MY-02
