**Glen Raven Stream Restoration
Monitoring Report – MY03
Alamance County, NC
Basin 03030002 - Contract # D05011-1**

December 2009

EXECUTIVE SUMMARY

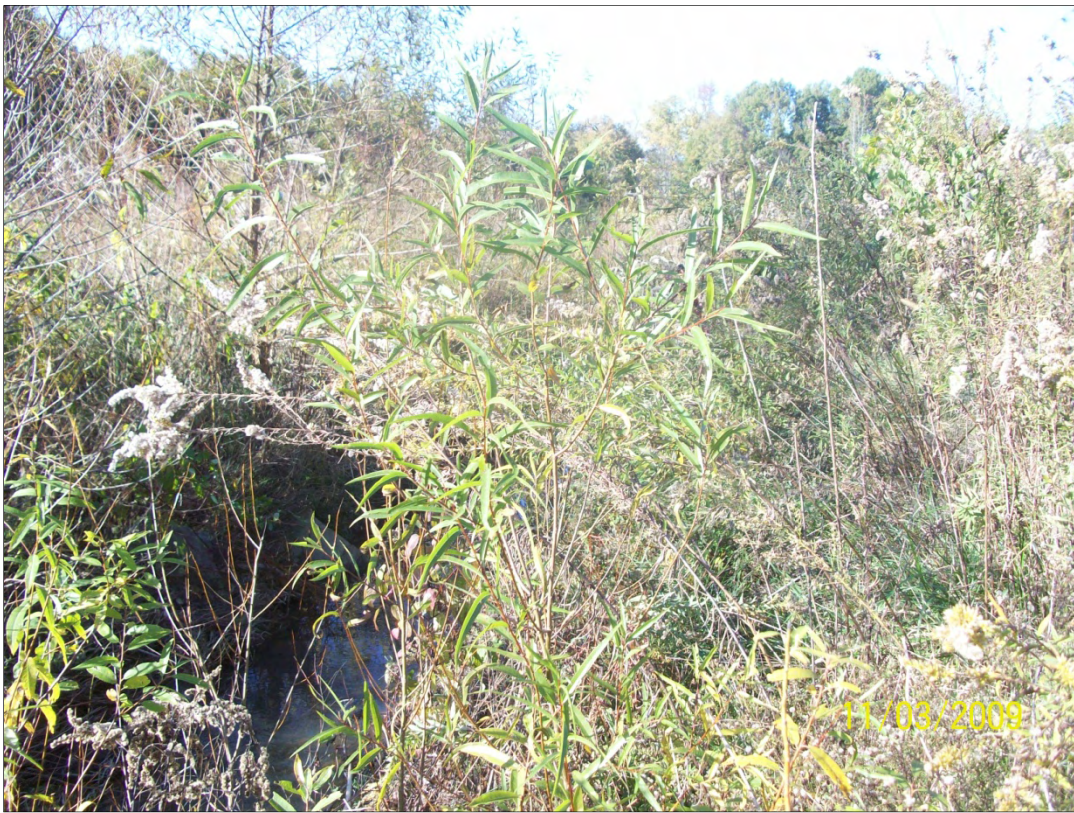
Photo Point 4b: View looking north toward Vegetation Plot #3. 11/3/09 – MY-03

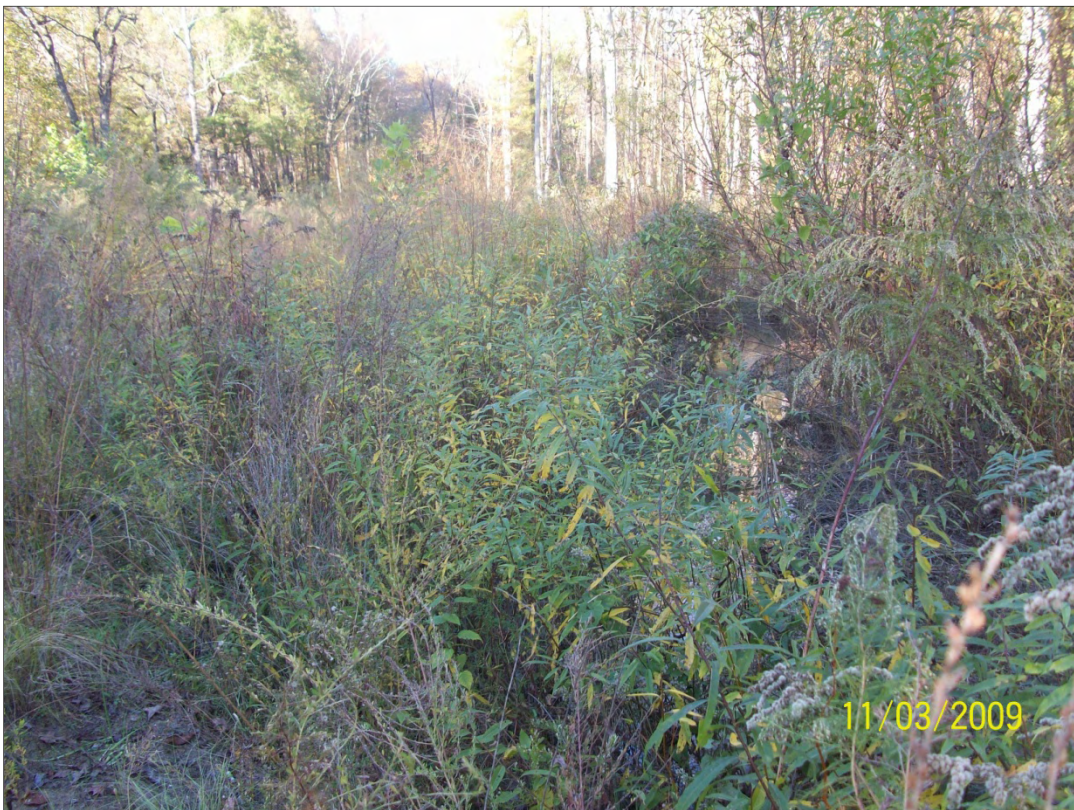
Photo Point 8: View looking north towards Vegetation Plot #6. 11/3/09 – MY-03

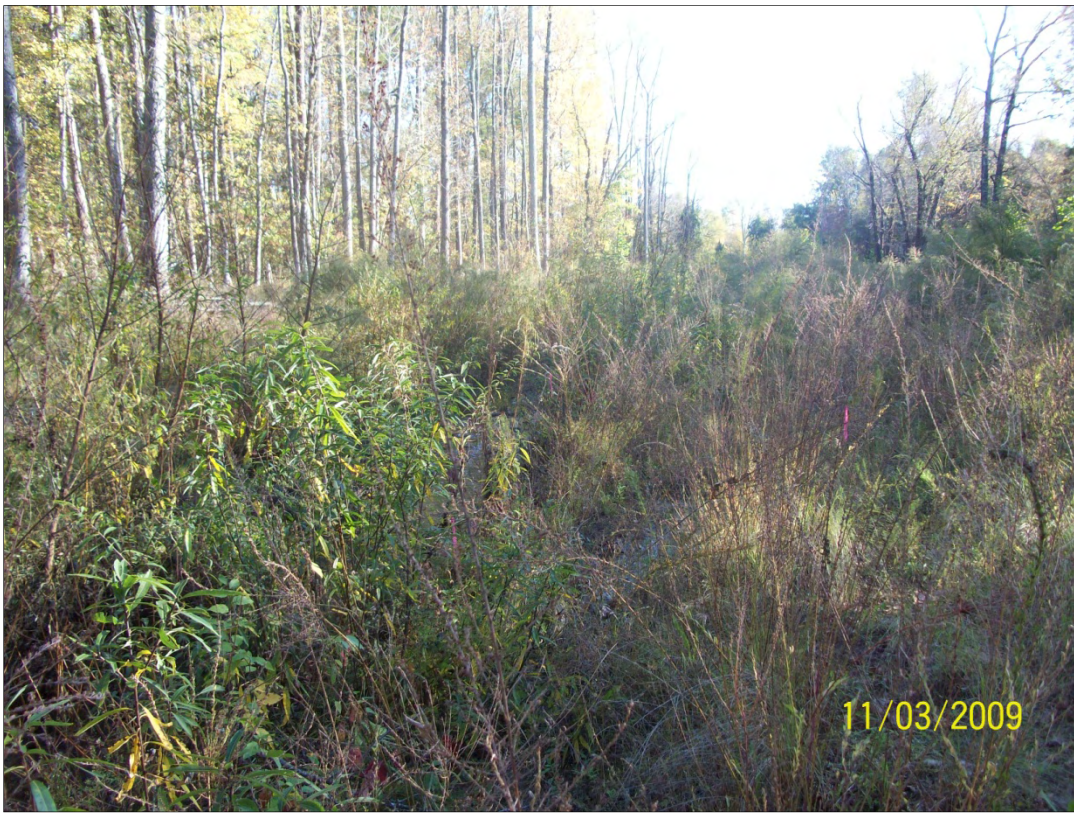
Photo Point 9a: View looking south toward Vegetation Plot #6. 11/3/09 – MY-03

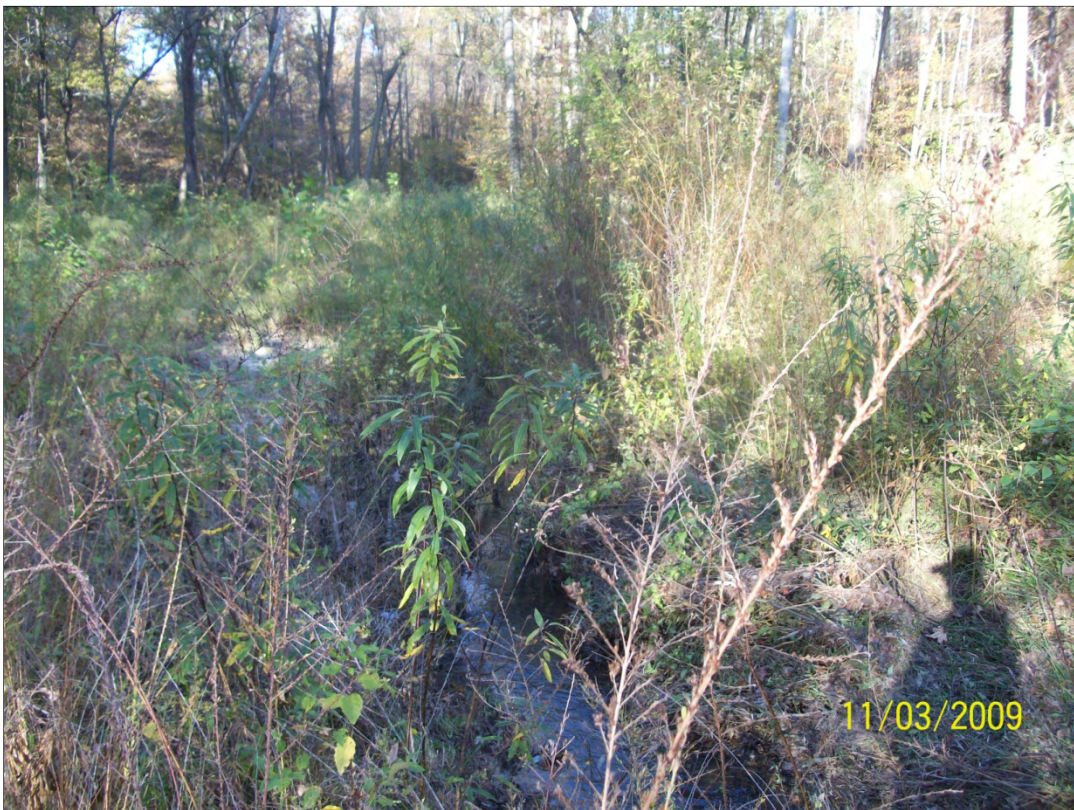
Photo Point 9b: View looking north toward end of project. 11/3/09 – MY-03

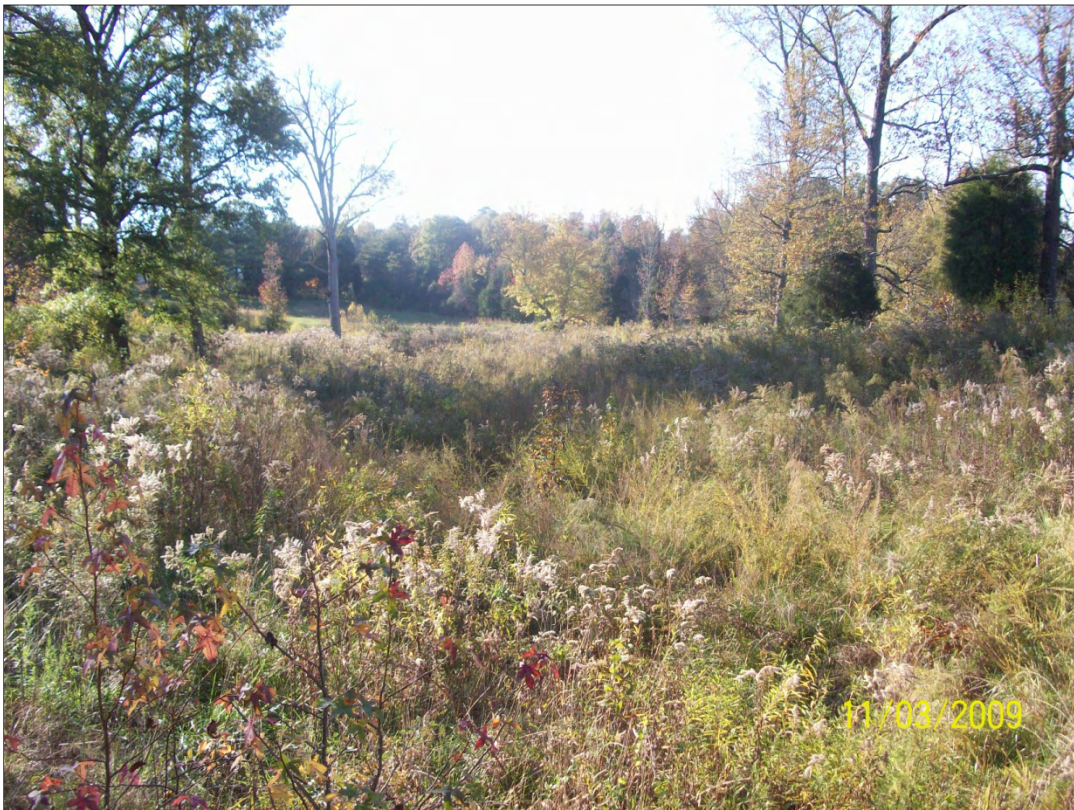
Photo Point 10b: View looking downstream on UT1 near Station 41+25. 11/3/09 – MY-03

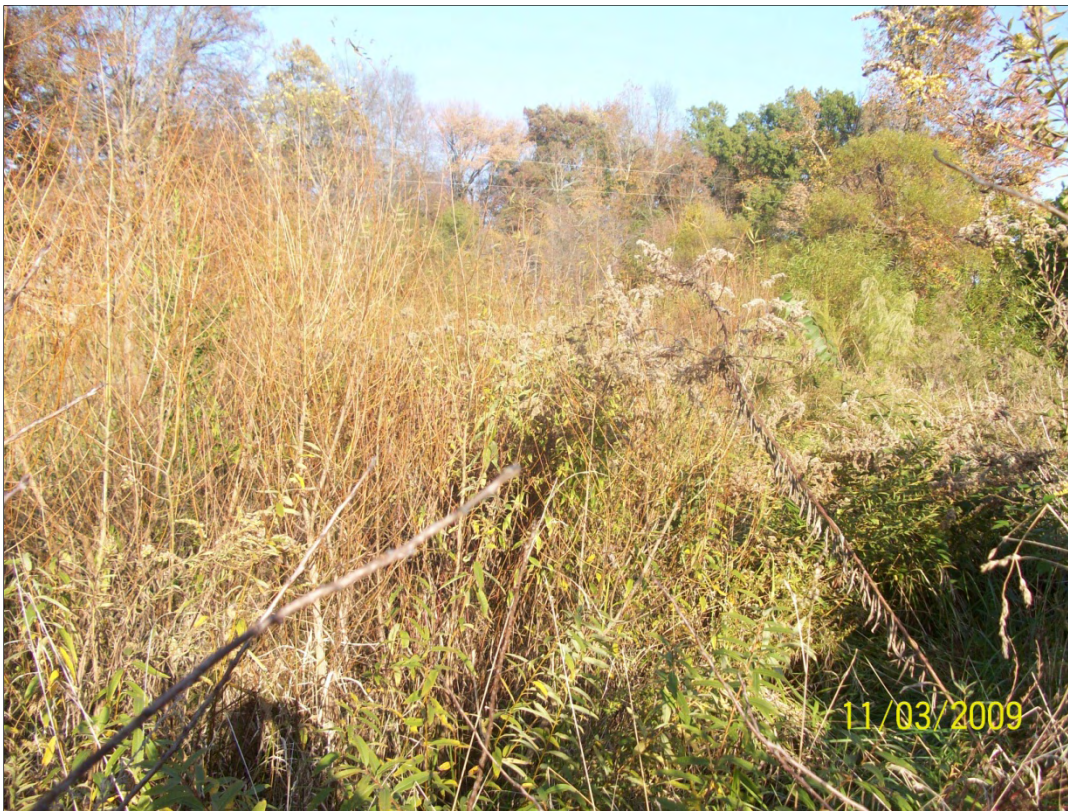
Photo Point 12a: View looking upstream on UT2. 11/3/09 – MY-03
