**UT Goose Creek (Greene Mitigation)
Stream Enhancement Project
EEP Project No. 92709
2011 Monitoring Report: Year 3**

**Construction Completed: February 2005
Submission Date: April 2012**

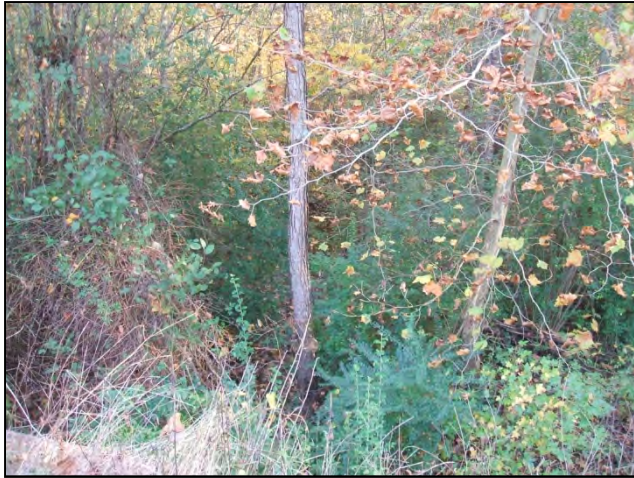
Photo Point 1: View Downstream Left Bank
(MY 1 - 11/2009)

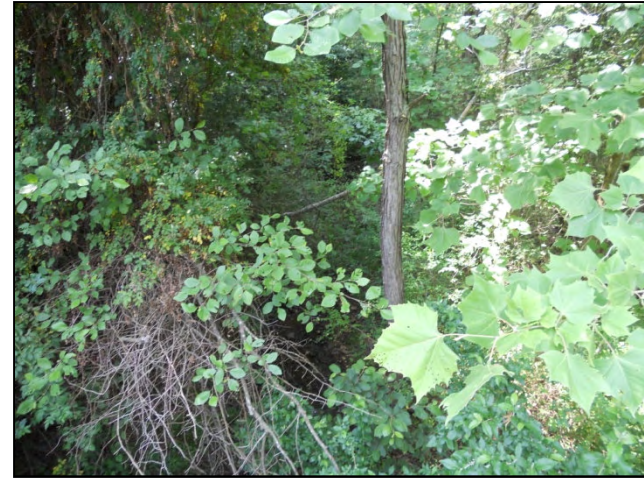
Photo Point 1: View Downstream Left Bank
(MY 3 - 6/2011)

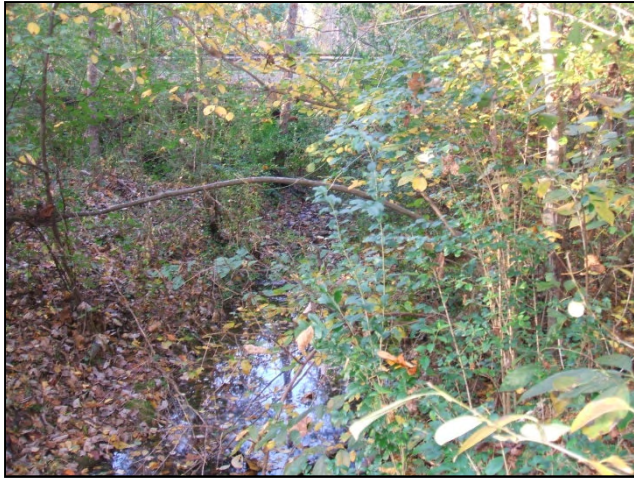
Photo Point 2: View Upstream
(MY 1 - 11/2009)

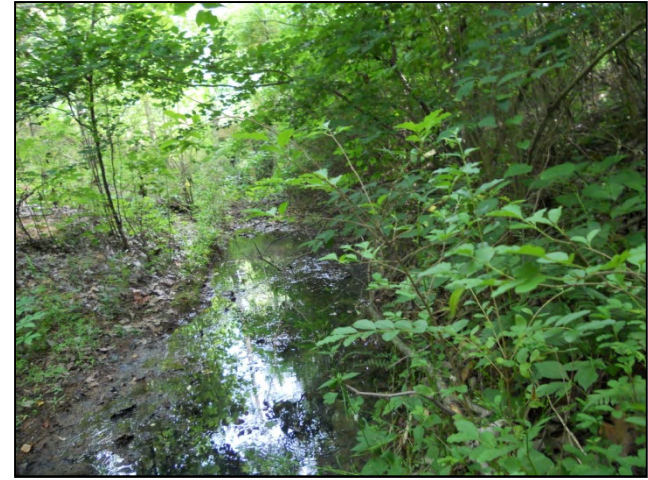
Photo Point 2: View Upstream
(MY 3 - 6/2011)

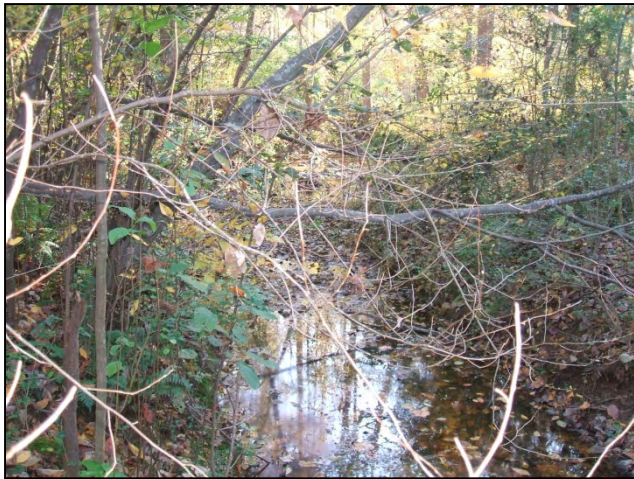
Photo Point 2: View Downstream
(MY 1 - 11/2009)

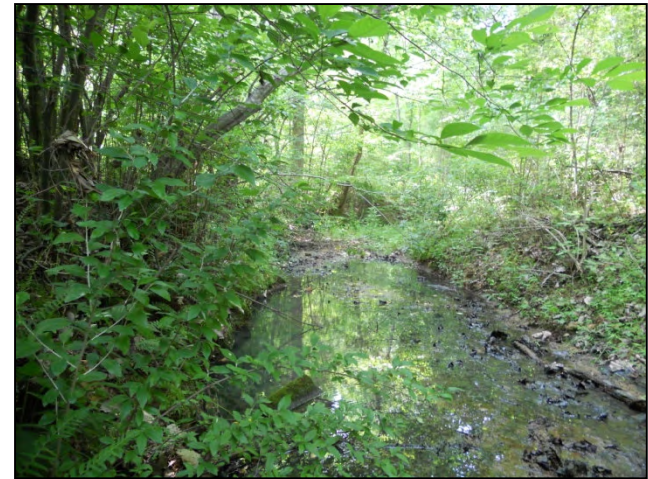
Photo Point 2: View Downstream
(MY 3 - 6/2011)

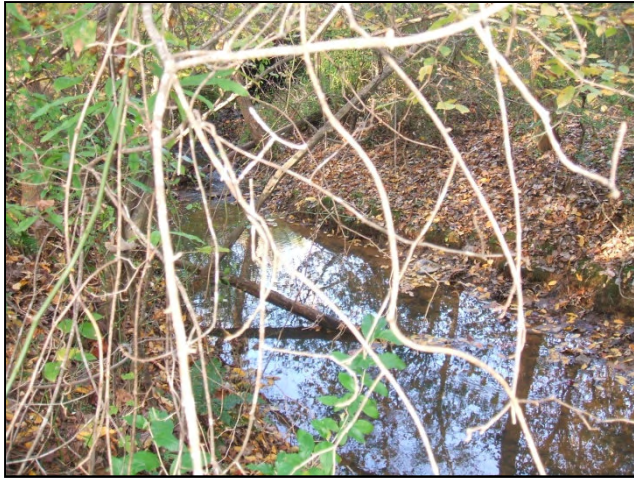
Photo Point 3: View Upstream
(MY 1 - 11/2009)

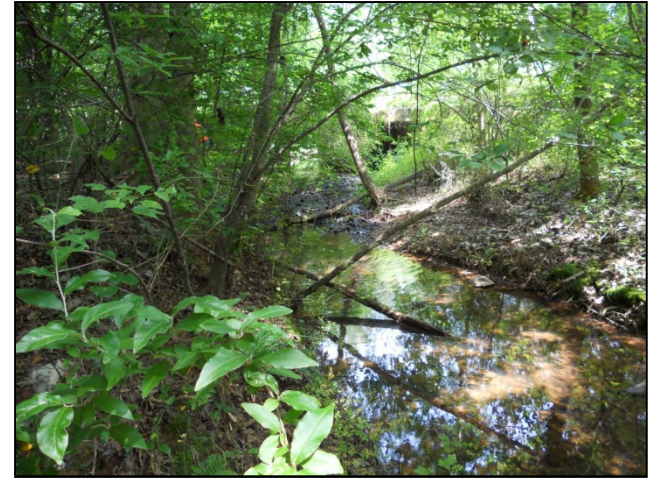
Photo Point 3: View Upstream
(MY 3 - 6/2011)

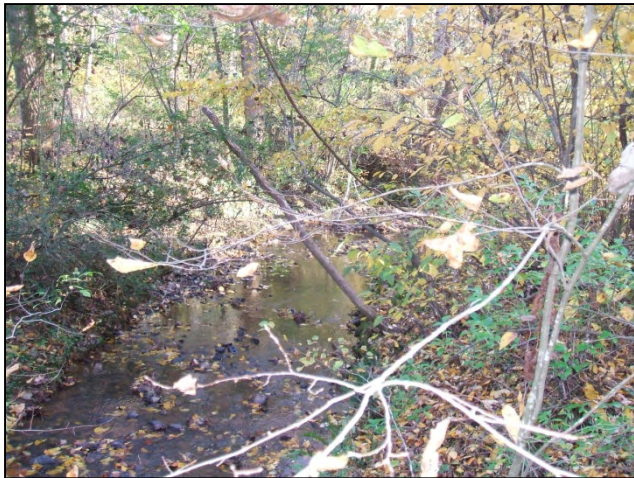
Photo Point 3: View Downstream
(MY 1 - 11/2009)

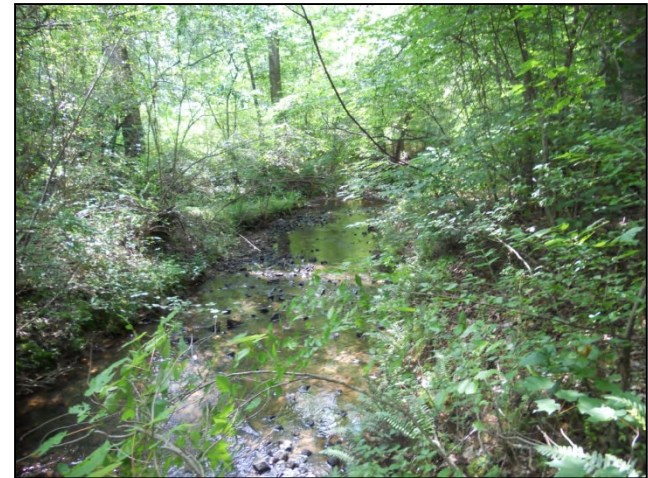
Photo Point 3: View Downstream
(MY 3 - 6/2011)

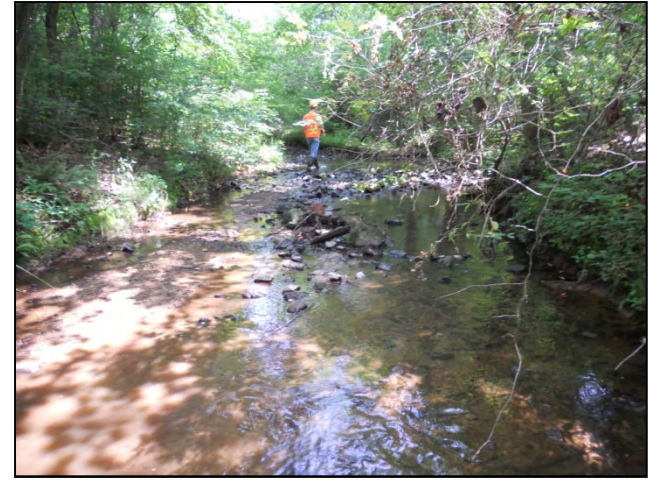
Photo Point 4: View Upstream
(MY 3 - 6/2011)

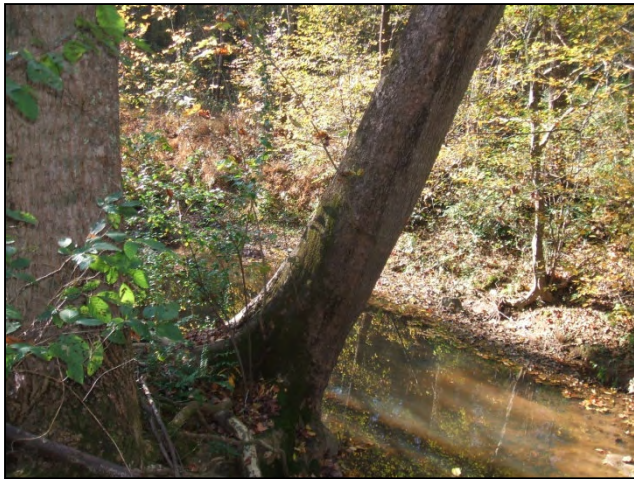
Photo Point 4: View Downstream
(MY 1 - 11/2009)

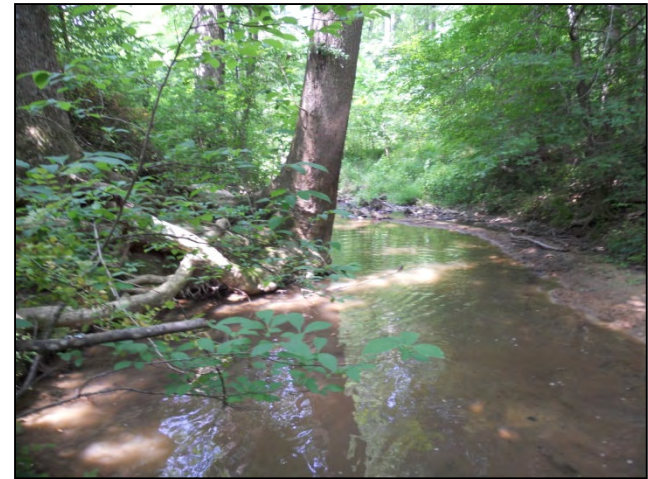
Photo Point 4: View Downstream
(MY 3 - 6/2011)

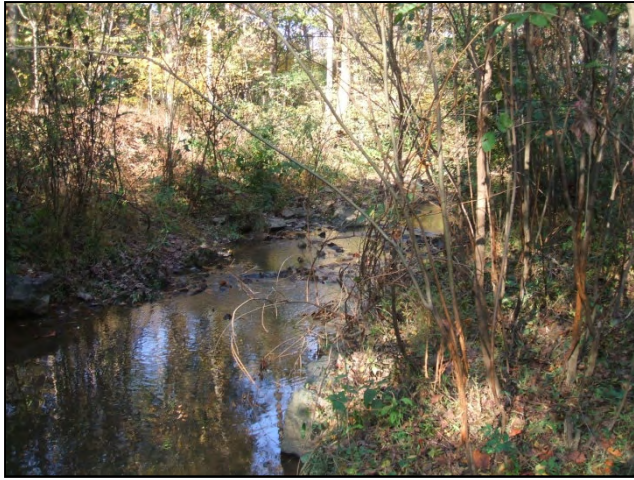
Photo Point 5: View Upstream
(MY 1 - 11/2009)

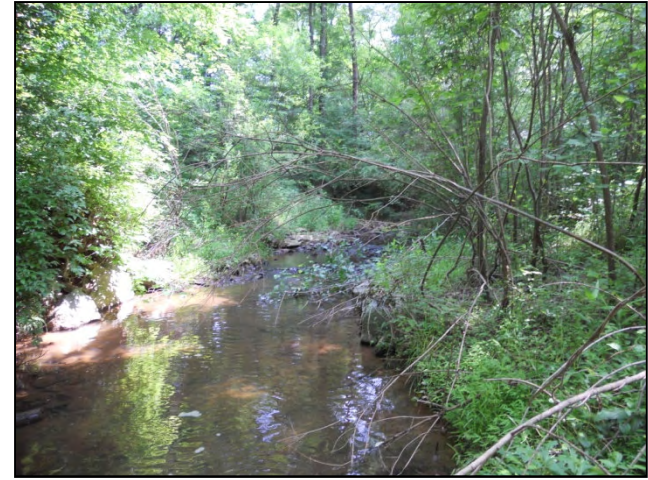
Photo Point 5: View Upstream
(MY 3 - 6/2011)

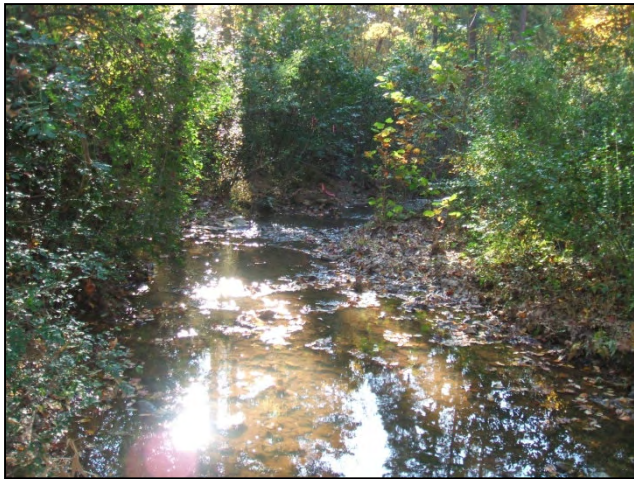
Photo Point 5: View Downstream
(MY 1 - 11/2009)

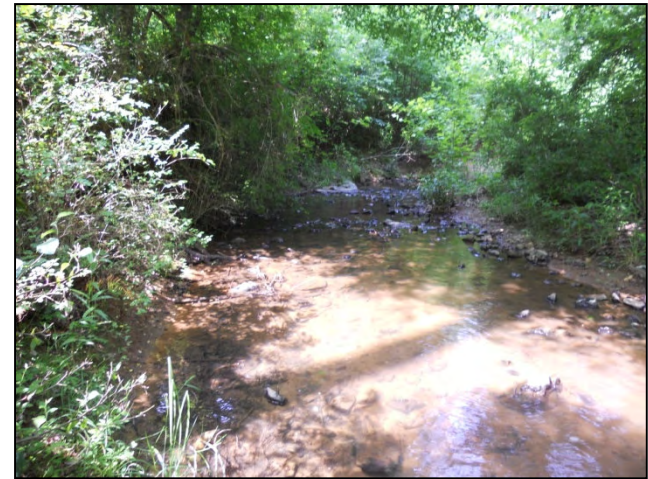
Photo Point 5: View Downstream
(MY 3 - 6/2011)

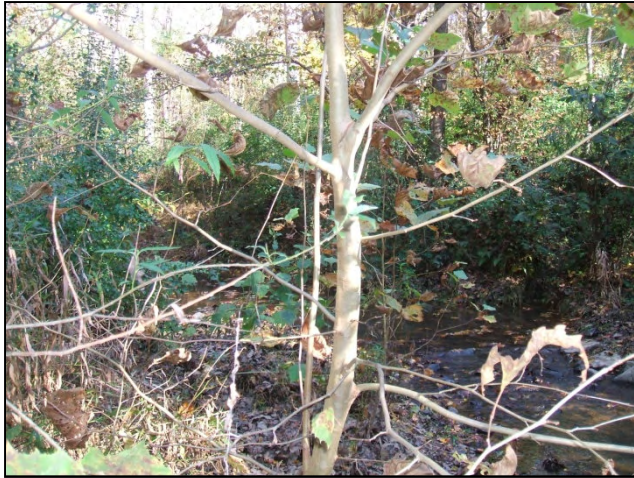
Photo Point 6: View Upstream
(MY 1 - 11/2009)

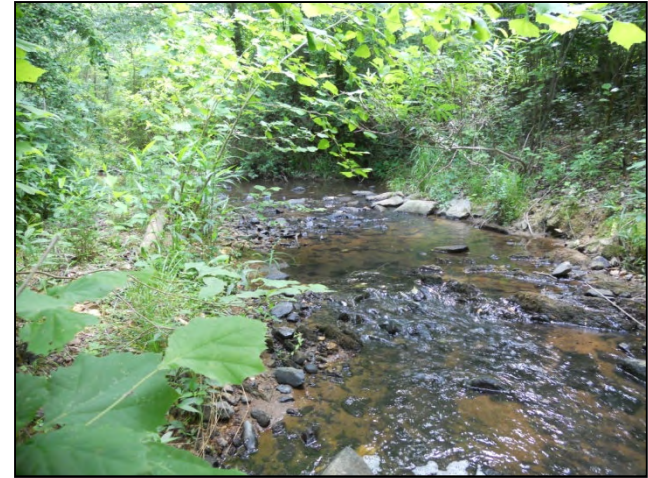
Photo Point 6: View Upstream
(MY 3 - 6/2011)

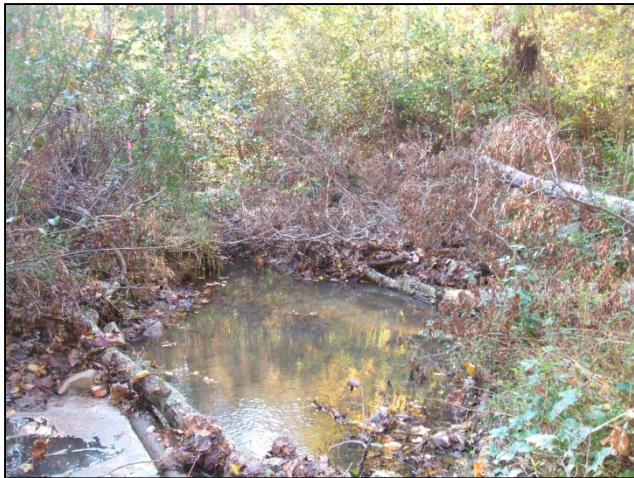
Photo Point 6: View Downstream
(MY 1 - 11/2009)

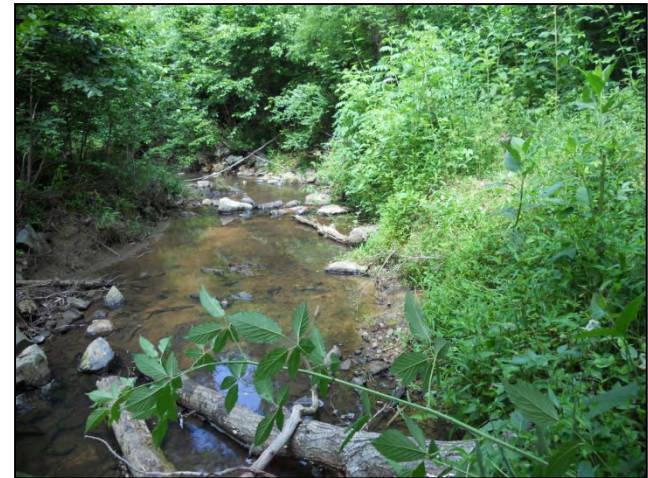
Photo Point 6: View Downstream
(MY 3 - 6/2011)

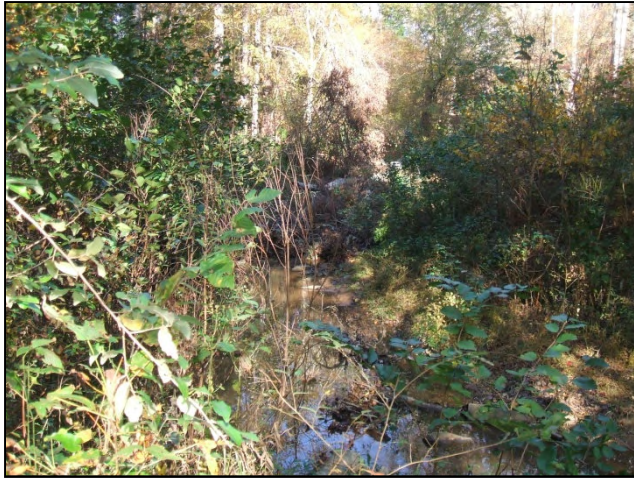
Photo Point 7: View Upstream
(MY 1 - 11/2009)

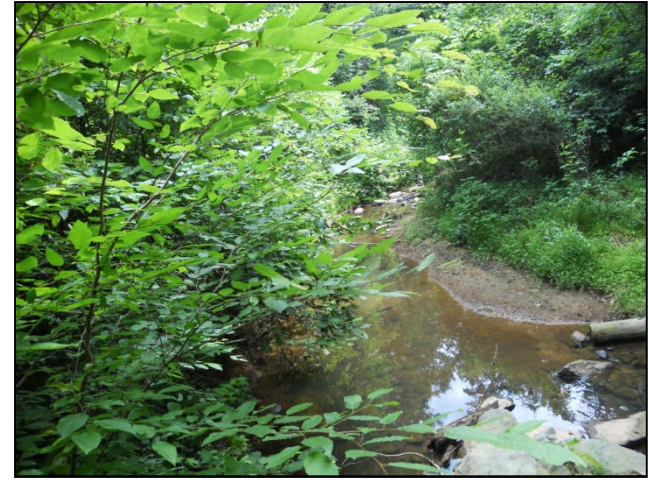
Photo Point 7: View Upstream
(MY 3 - 6/2011)

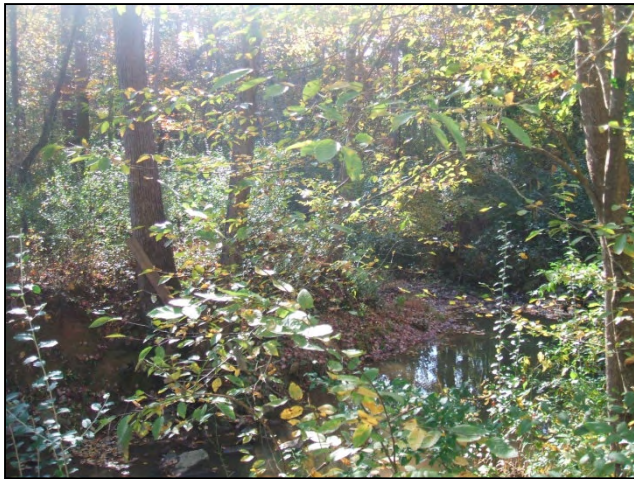
Photo Point 7: View Downstream
(MY 1 - 11/2009)

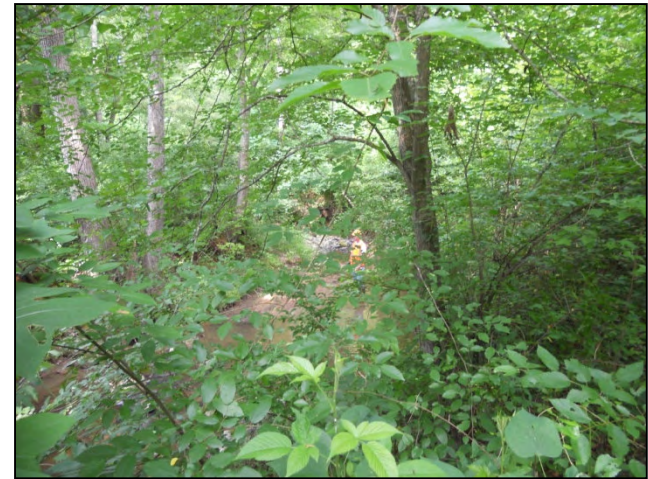
Photo Point 7: View Downstream
(MY 3 - 6/2011)

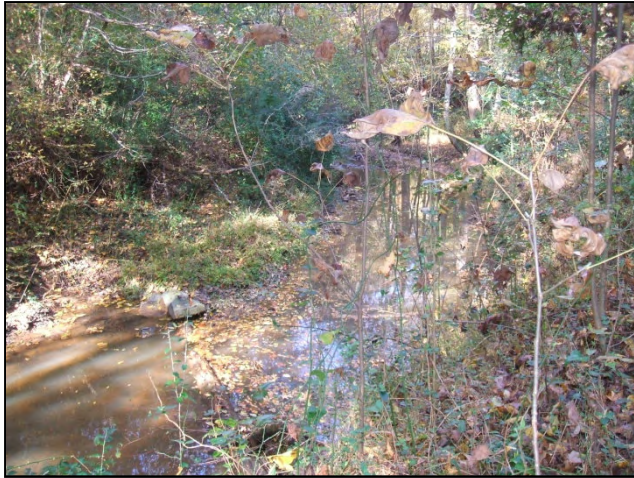
Photo Point 8: View Upstream
(MY 1 - 11/2009)

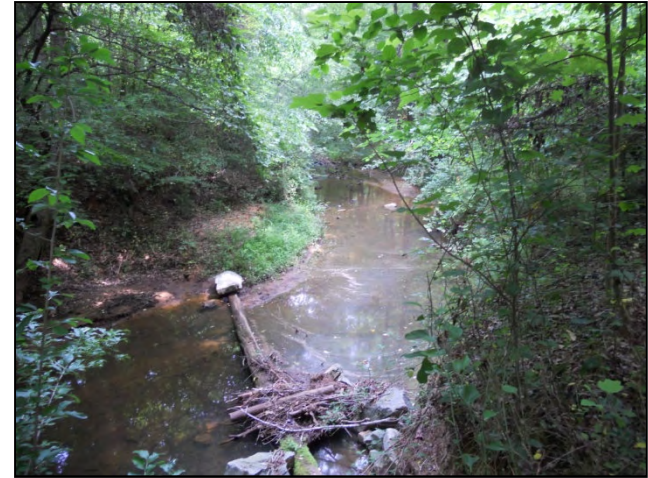
Photo Point 8: View Upstream
(MY 3 - 6/2011)

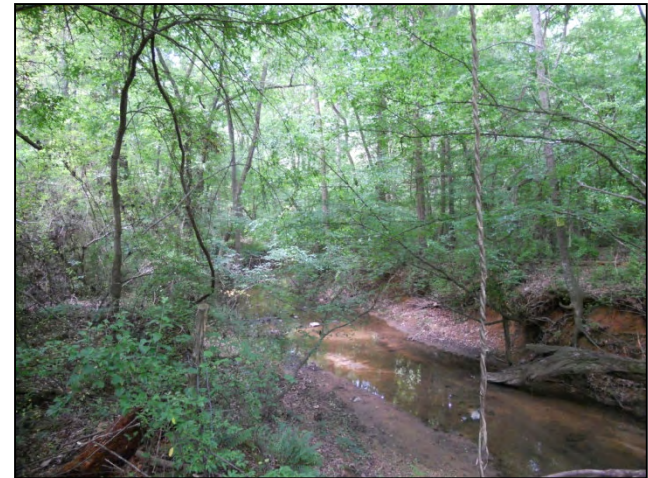
Photo Point 8: View Downstream
(MY 3 - 6/2011)

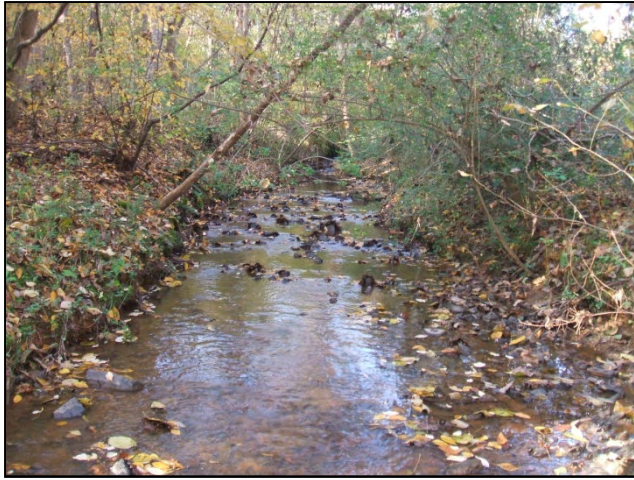
Cross Section 1: View Upstream
(MY 1 - 11/2009)

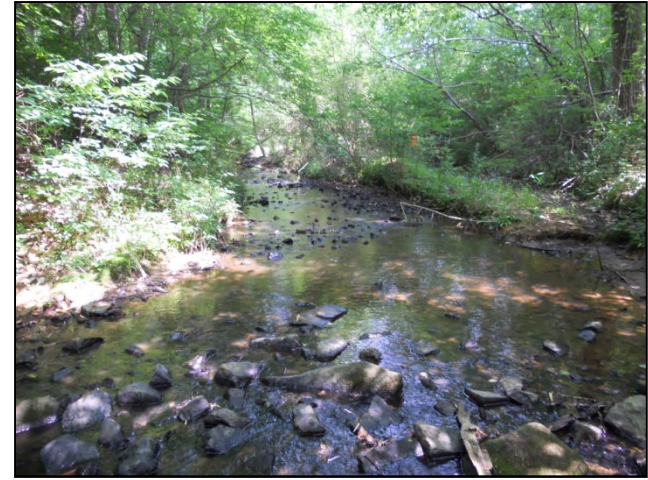
Cross Section 1: View Upstream
(MY 3 - 6/2011)

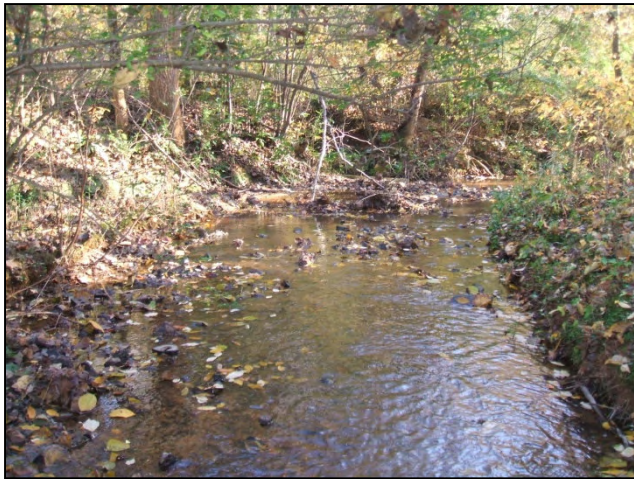
Cross Section 1: View Downstream
(MY 1 - 11/2009)

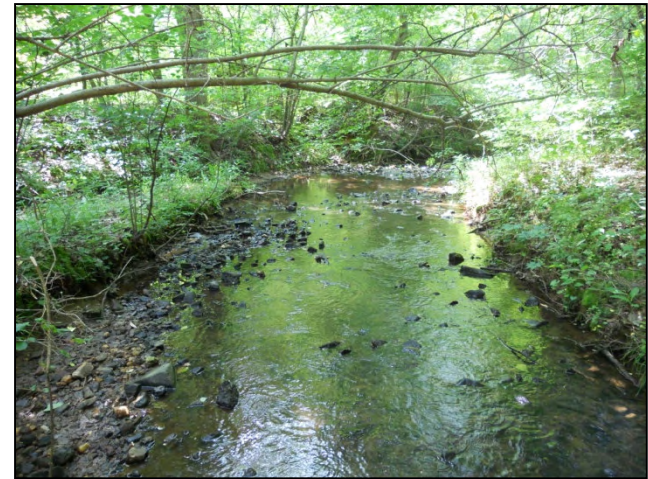
Cross Section 1: View Downstream
(MY 3 - 6/2011)

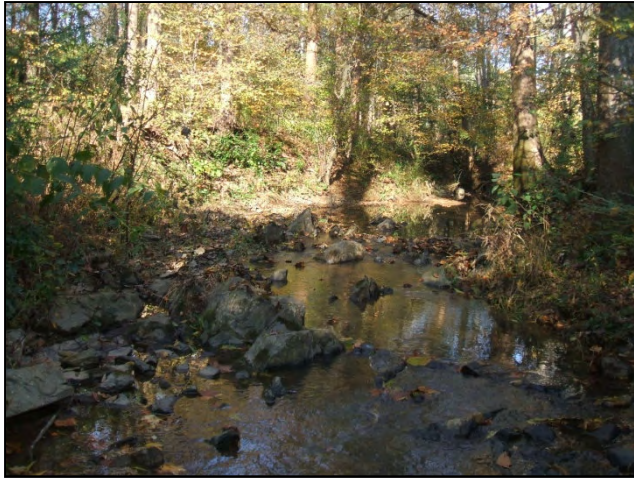
Cross Section 2: View Upstream
(MY 1 - 11/2009)

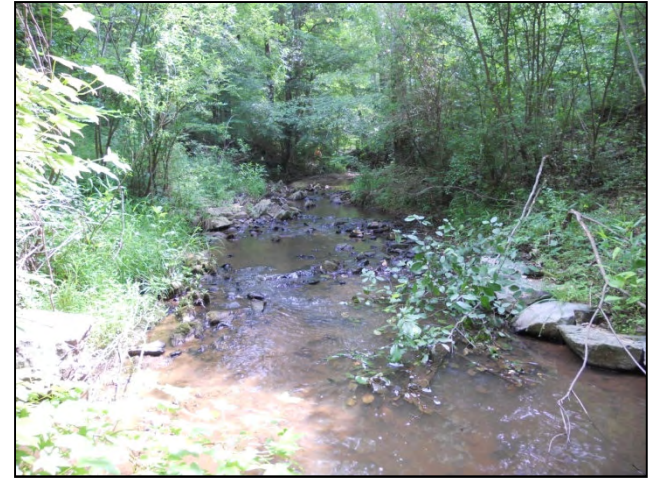
Cross Section 2: View Upstream
(MY 3 - 6/2011)

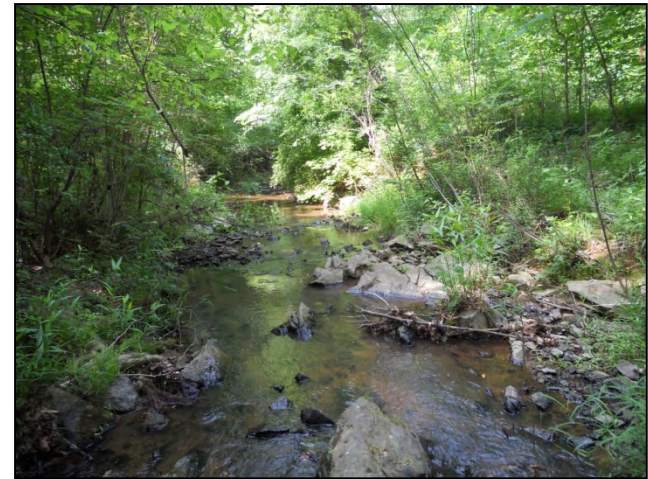
Cross Section 2: View Downstream
(MY 3 - 6/2011)

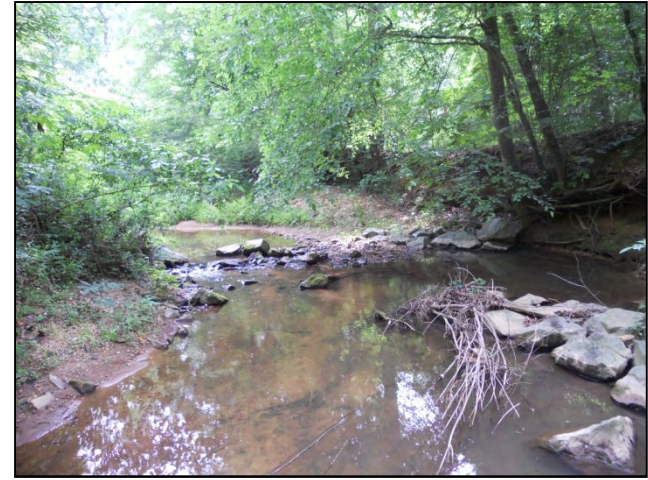
Cross Section 3: View Upstream
(MY 3 - 6/2011)

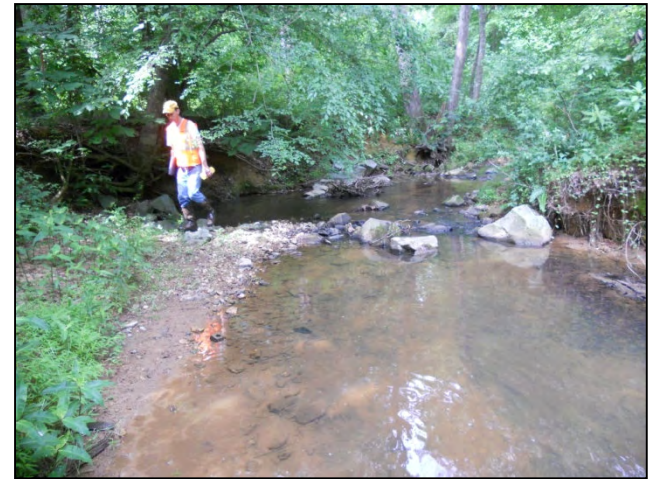
Cross Section 3: View Downstream
(MY 3 - 6/2011)

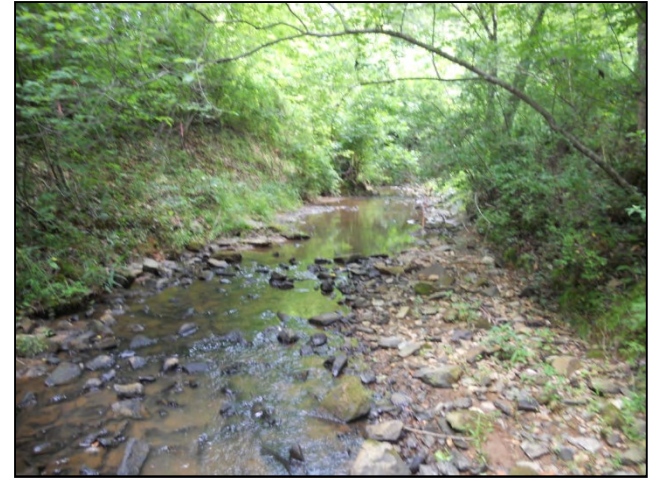
Cross Section 4: View Upstream
(MY 3 - 6/2011)

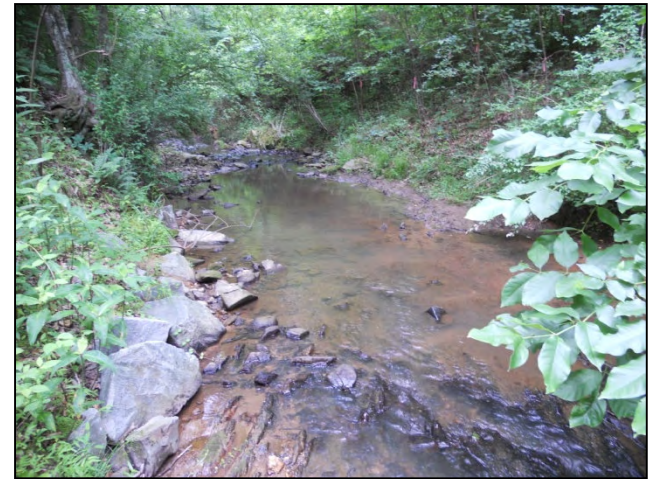
Cross Section 4: View Downstream
(MY 3 - 6/2011)

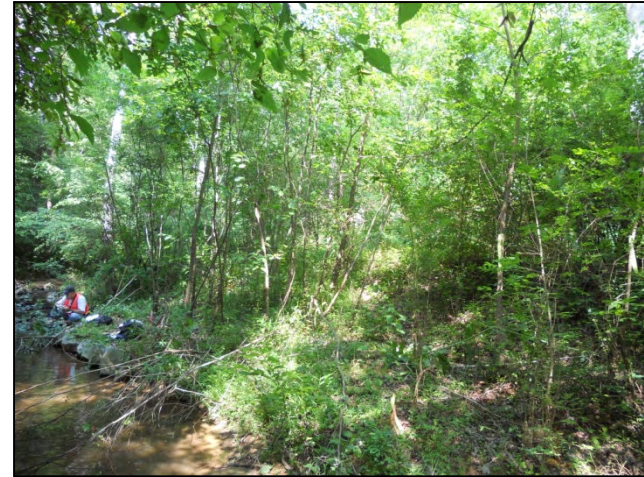
Vegetation Plot 1
(MY 3 - 6/2011)

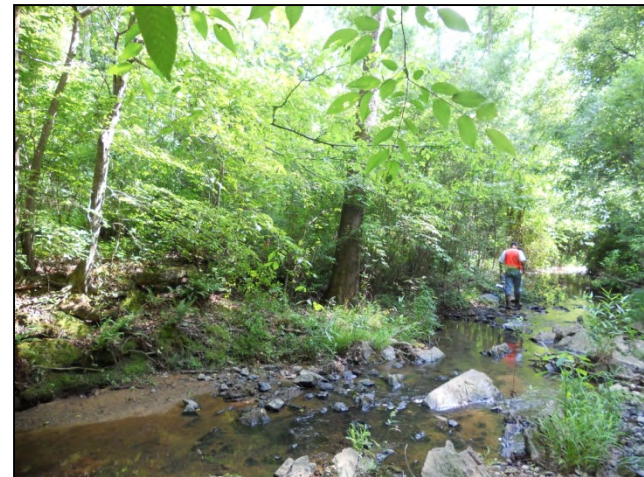
Vegetation Plot 1
(MY 3 - 6/2011)

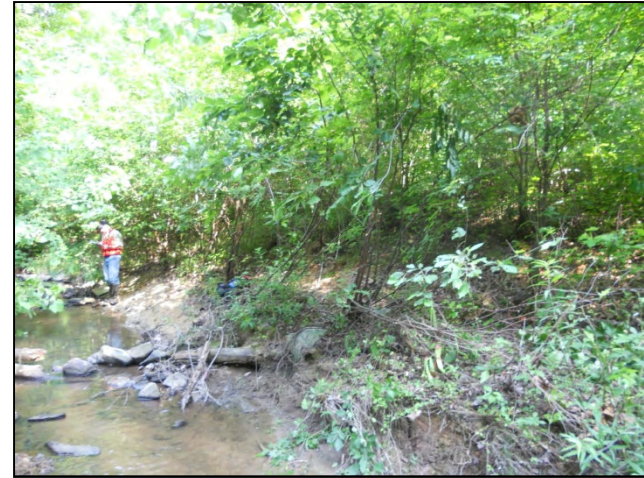
Vegetation Plot 2
(MY 3 - 6/2011)

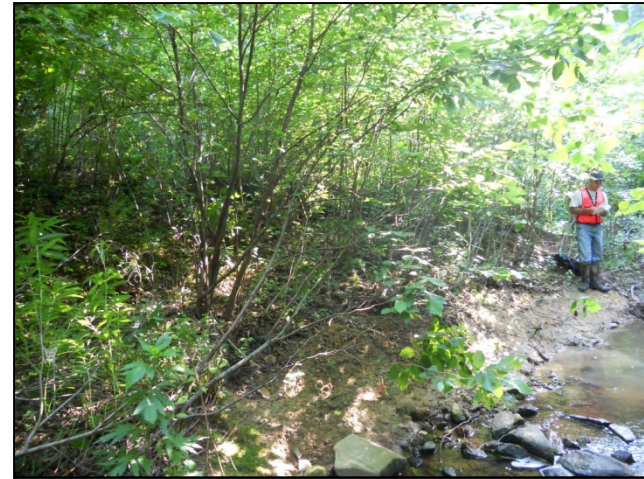
Vegetation Plot 2
(MY 3- 6/2011)

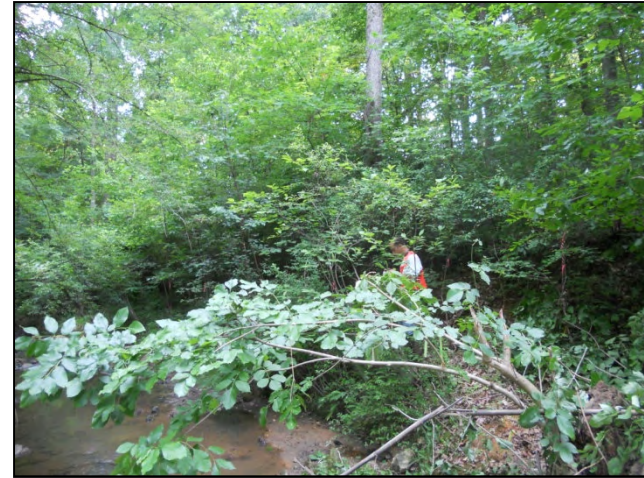
Vegetation Plot 3
(MY 3 - 6/2011)

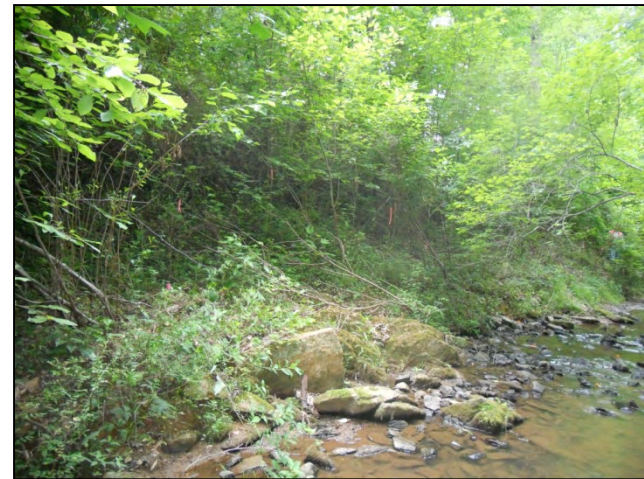
Vegetation Plot 3
(MY 3 - 6/2011)

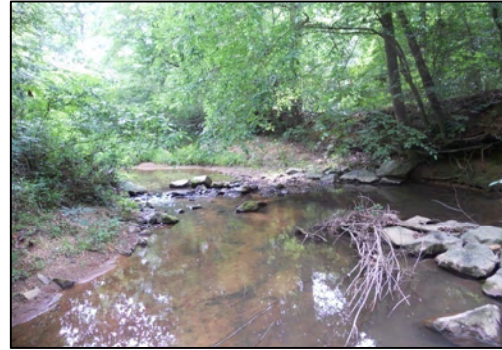
XS-3: View Upstream

Near station 4+00 feet (ft), a debris jam has formed and has temporarily affected the profile. This profile adjustment is most likely temporary. It is anticipated that the debris jam and accumulated sediment will be flushed from the system during future rain events. Other areas that are of some concern include a stressed boulder toe with dislodged boulders and a failing vane structure at the end of the project that is no longer providing adequate bank protection. This structure has become dislodged and is redirecting flow from the thalweg to the outside meander bend. The change in flow vector is resulting in bank erosion, which is compromising bank stability. The structure may need to be adjusted to regain proper functionality or be removed.
