# **Monitoring Report**

Harrell Stream and Wetland Mitigation Site

Monitoring Year 4 (2023)

NCDMS Project No. 100005

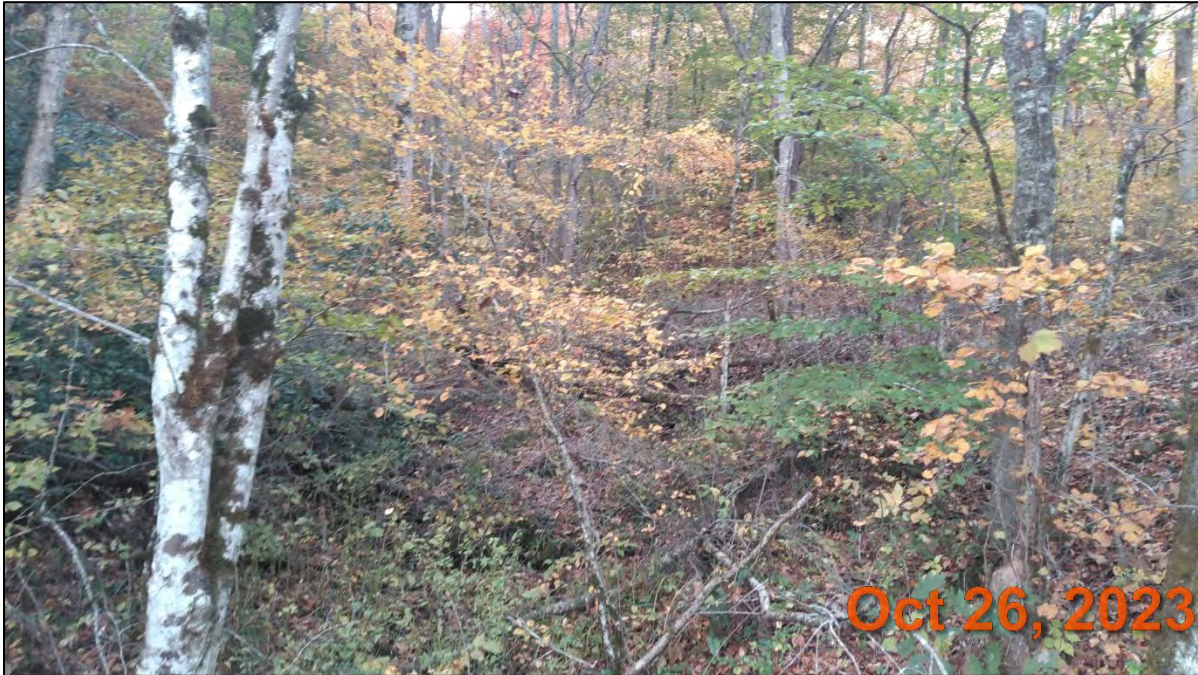
Photo point #1a, facing upstream at Reach 1A.

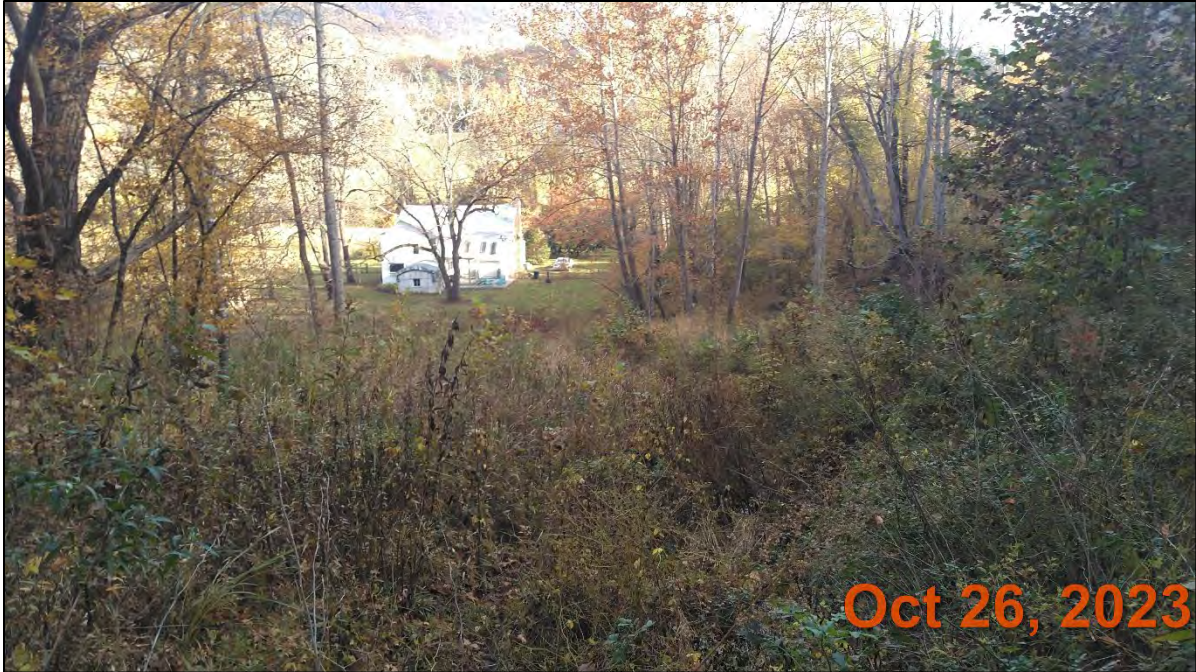
Photo point #1c, facing downstream at Reach 1B.

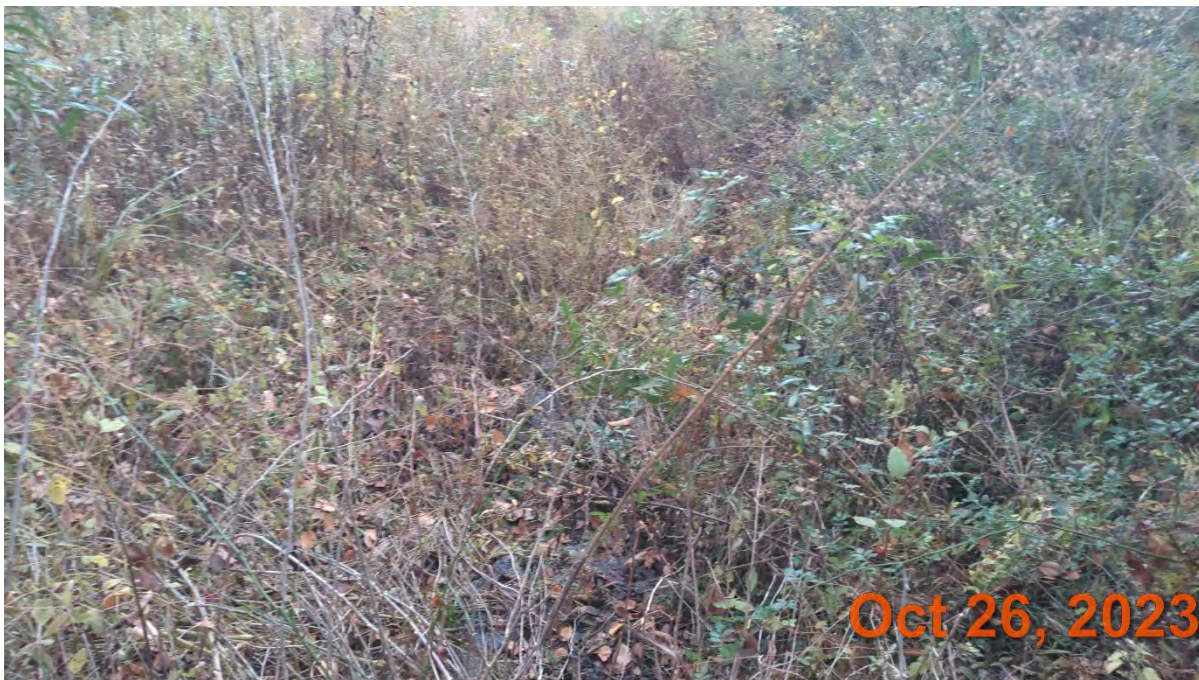
Photo point #1d, facing downstream at Reach 1B channel.

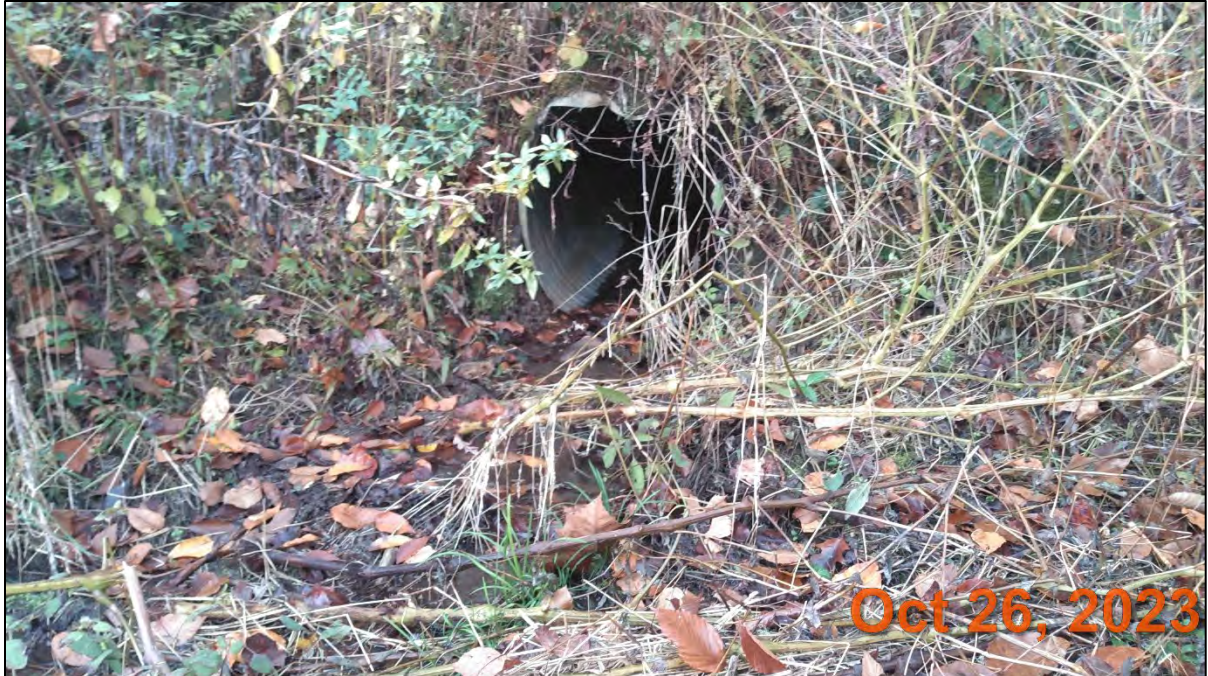
Photo point #1e facing upstream at Reach 1A/B culvert.

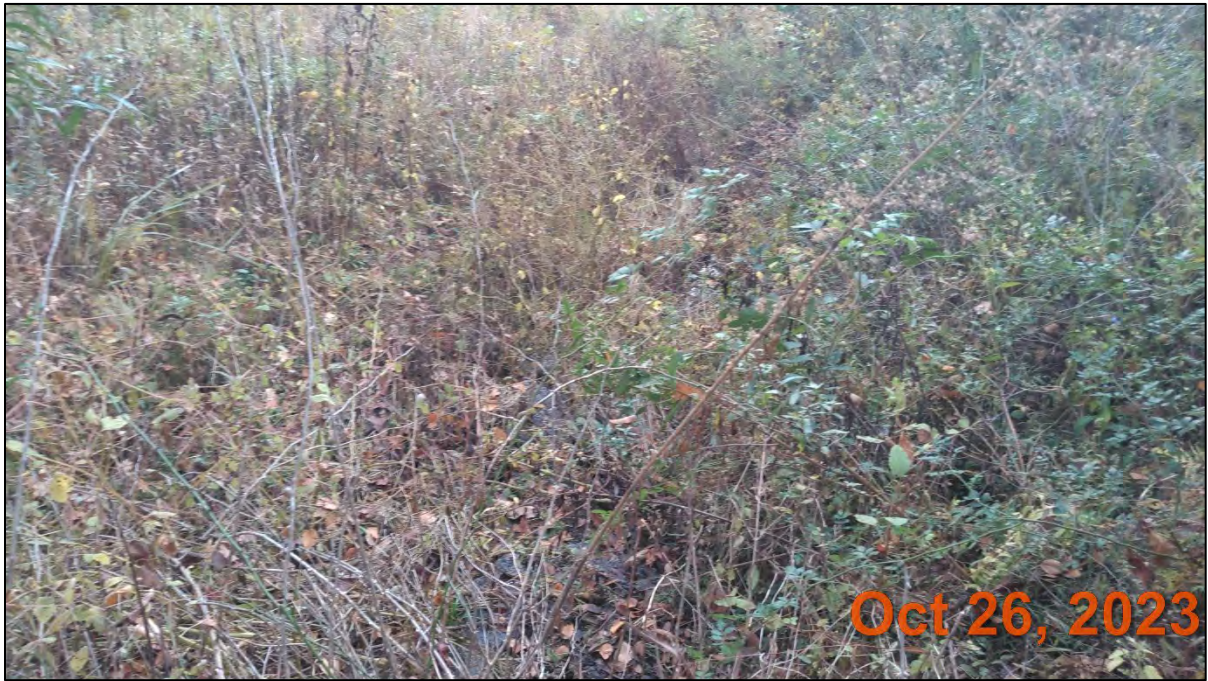
Photo point #1 supplemental, facing downstream from Reach 1B.

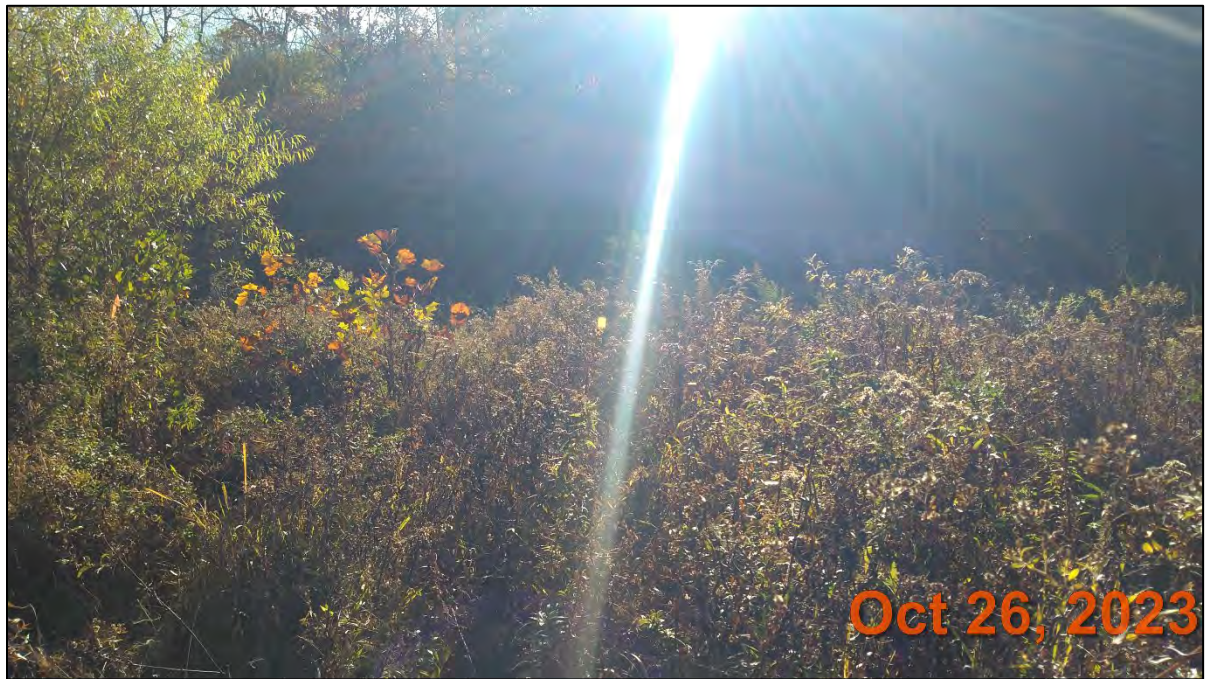
Photo point #2a, facing upstream towards, Reach 1B.

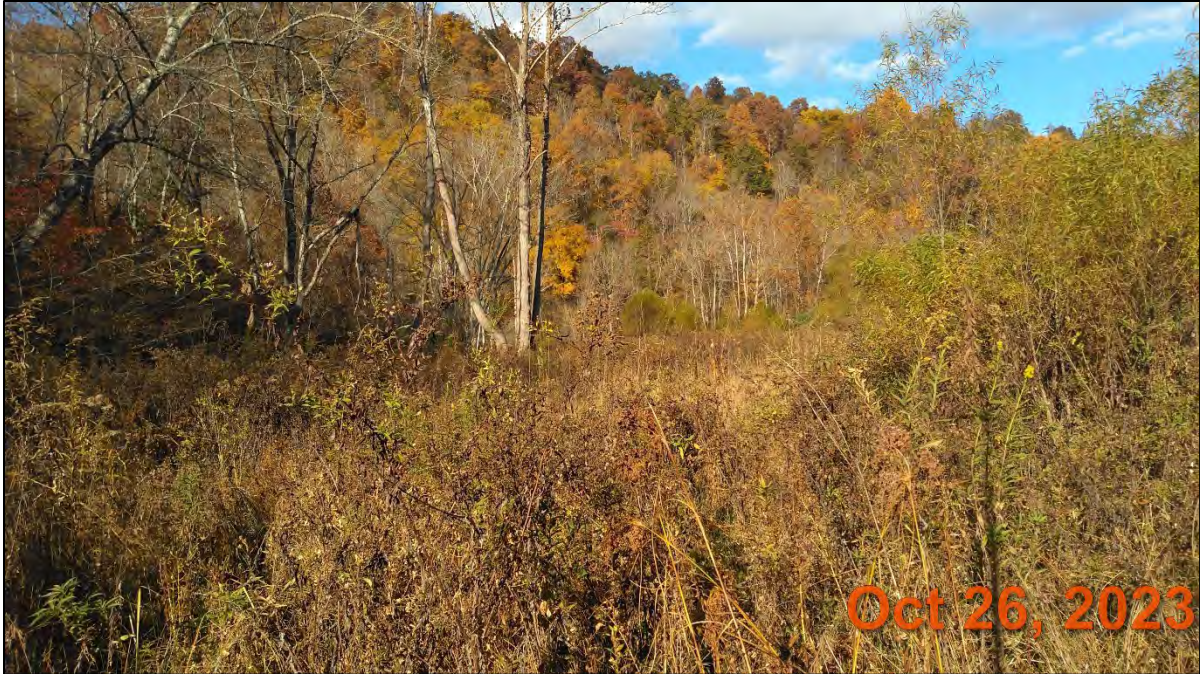
Photo point #2b, facing downstream, Reach 1C and Wetland B.

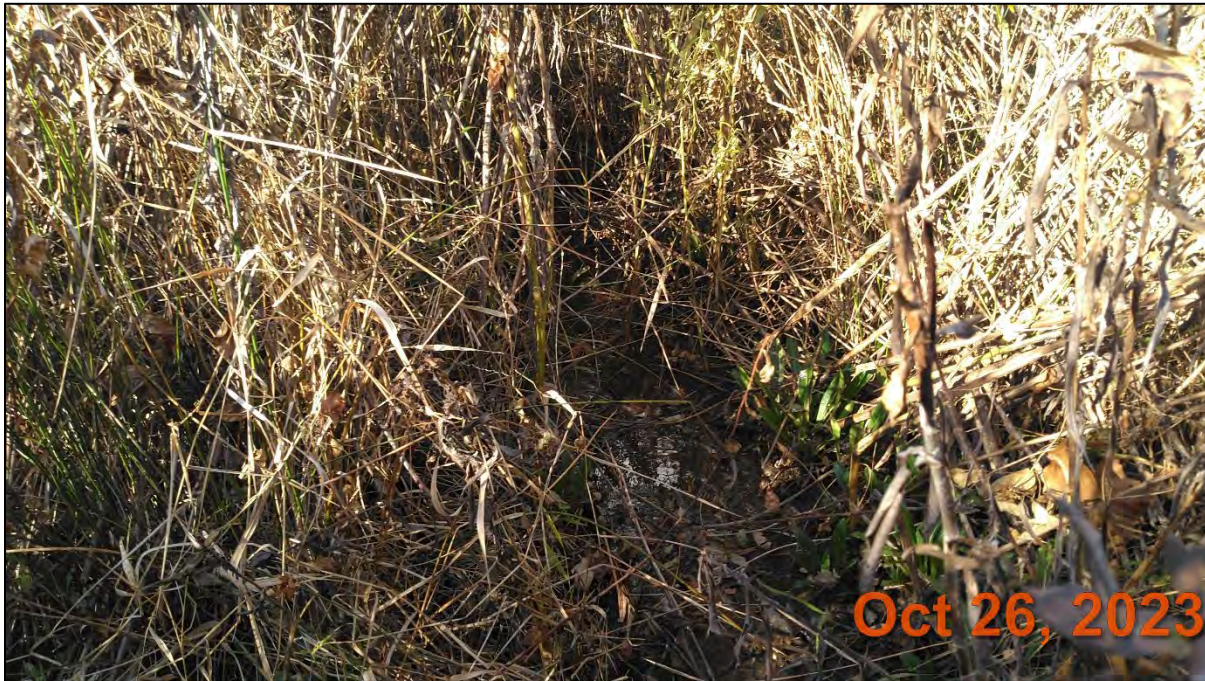
Photo point #2c, Reach 1C channel.

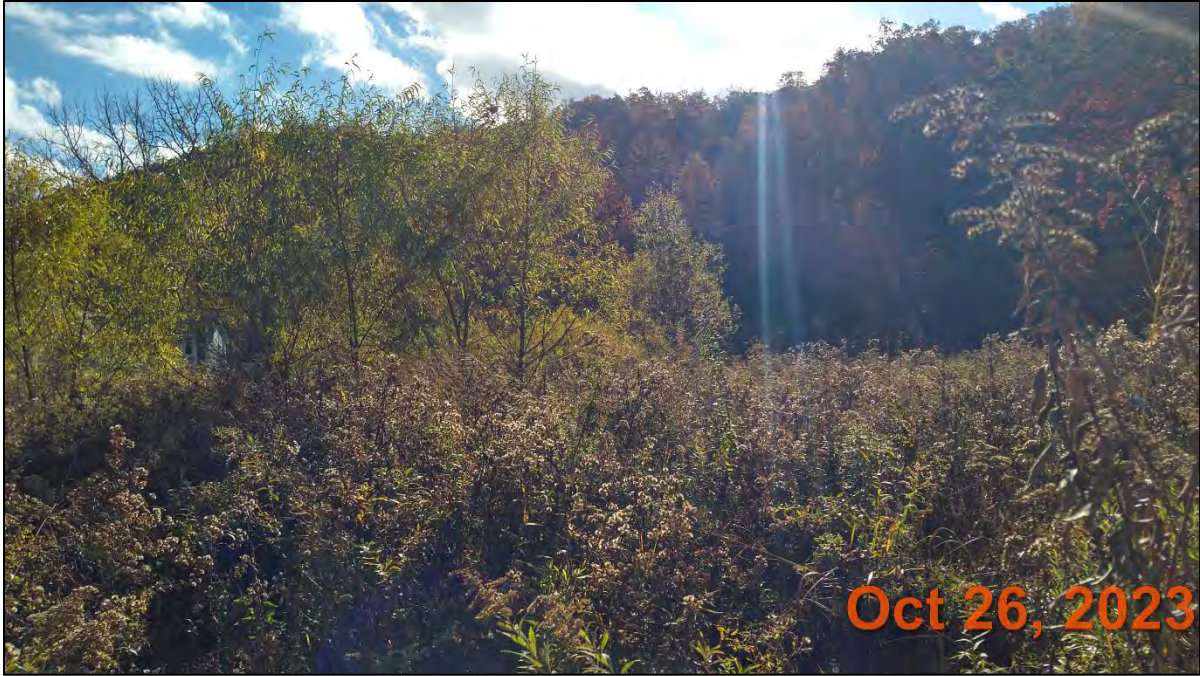
Photo point #3a, facing upstream, Reach 1C and Wetland B

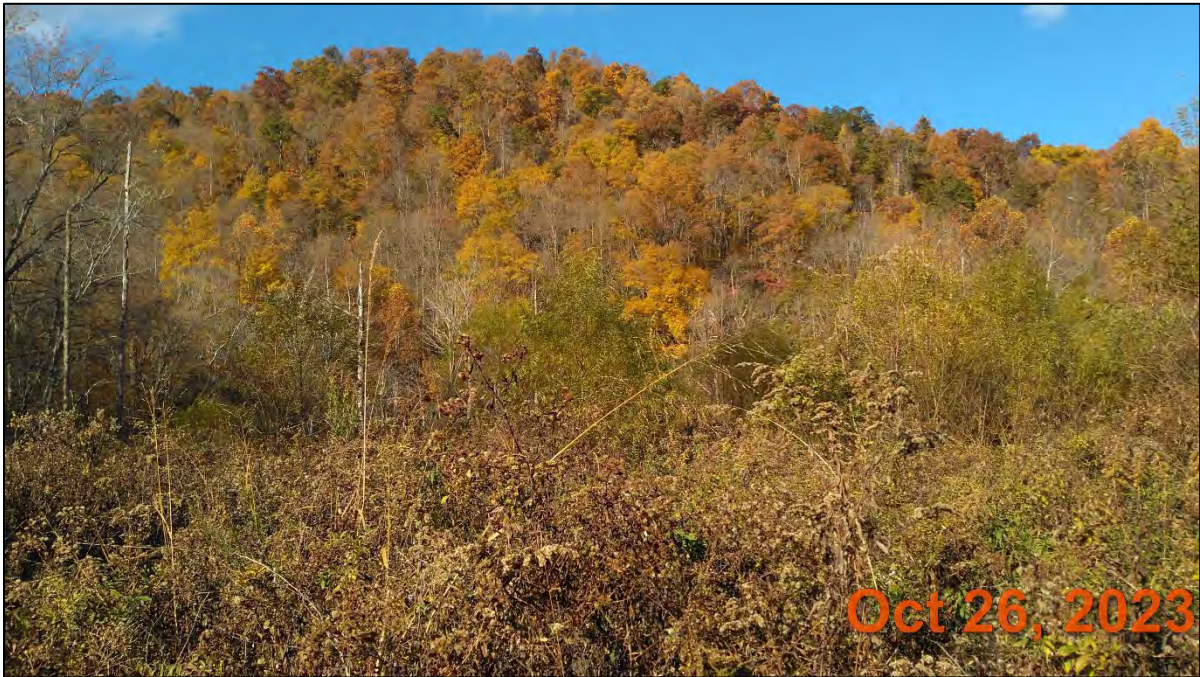
Photo point #3b, facing downstream, Reach 1C and Wetland 1C.

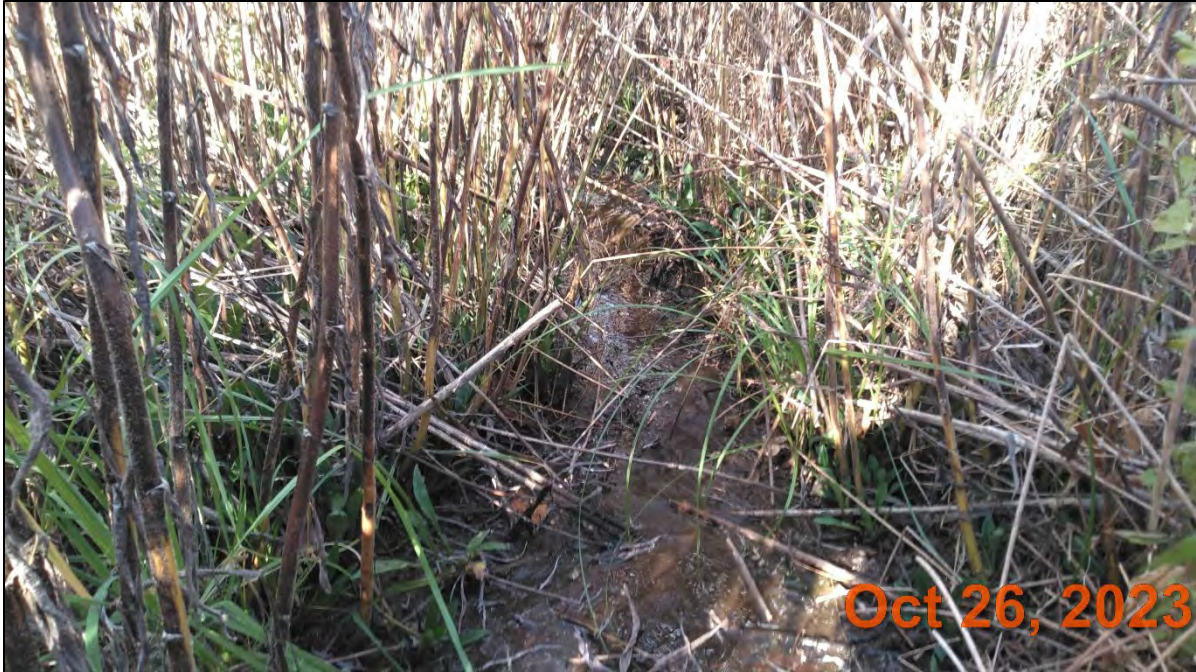
Photo point #3c supplemental, facing upstream Reach 1C channel.

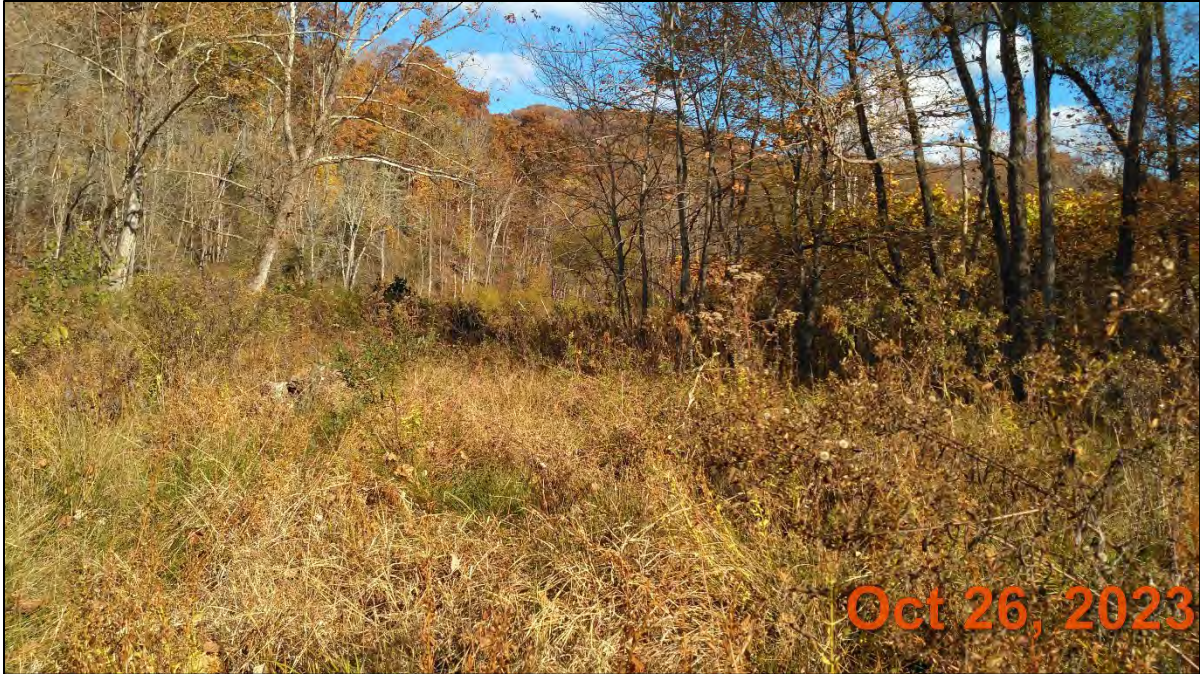
Photo point #4b, facing downstream, Reach 1C and Wetland C.

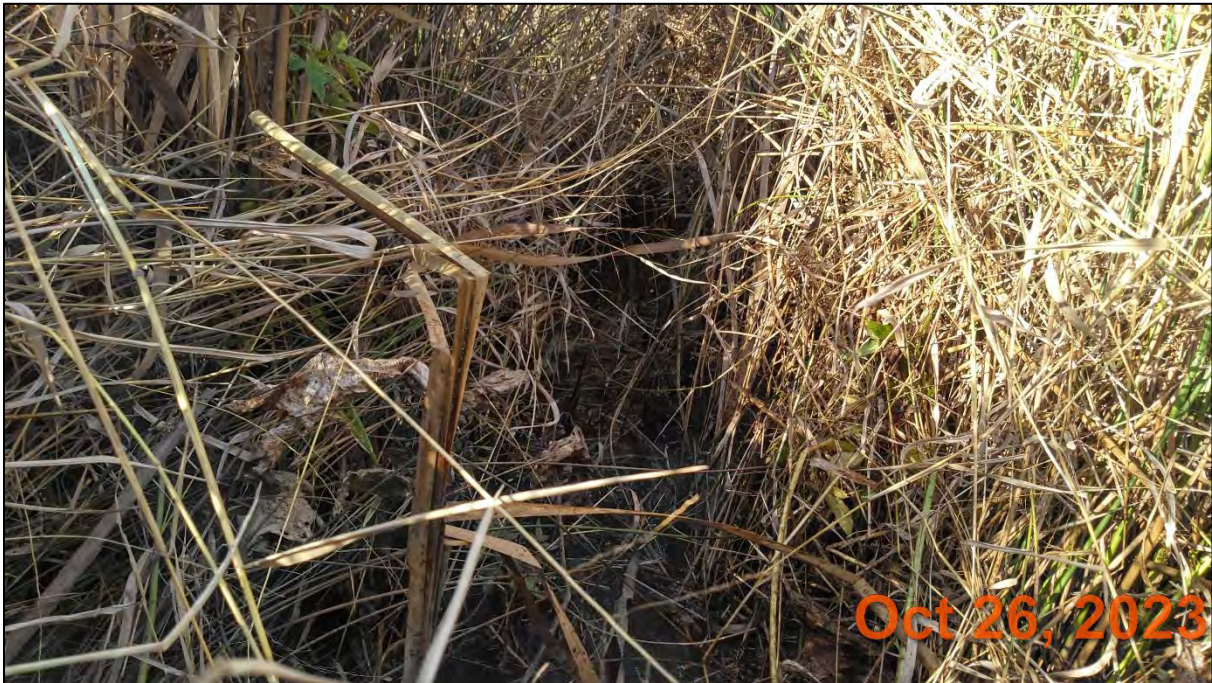
Photo point #4c, facing downstream, Reach 1C channel.

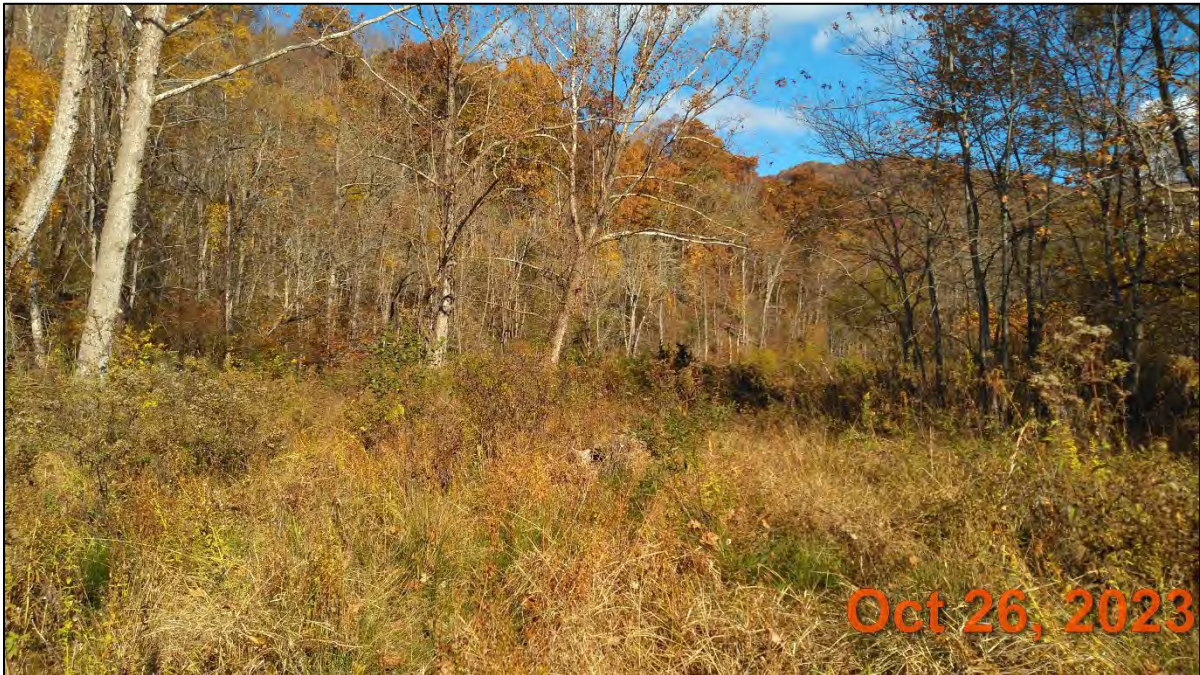
Photo point #5b, facing downstream, Reach 1C and Wetland C.

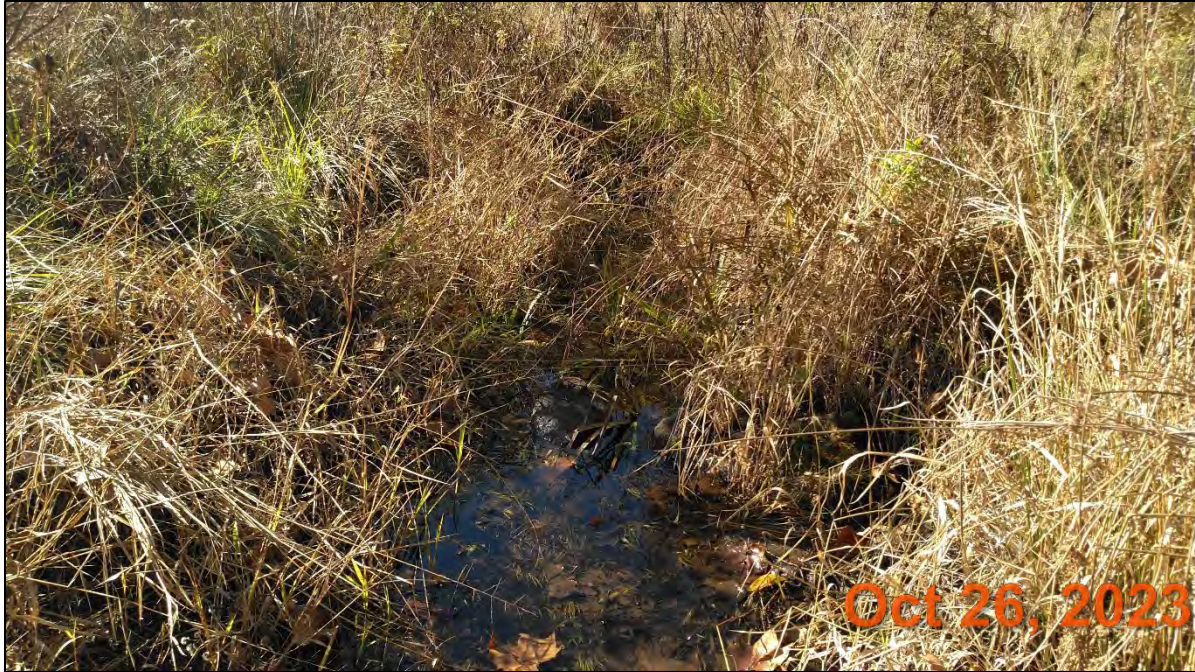
Photo point #5c, facing upstream, Reach 1C channel.

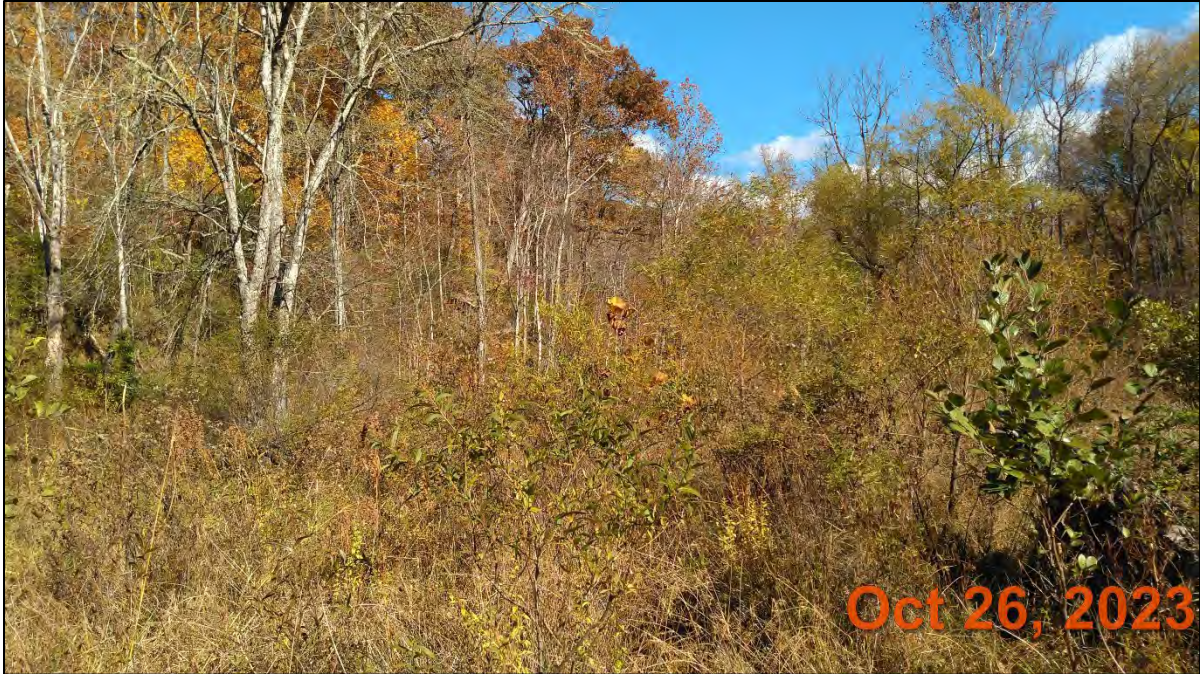
Photo point #6b, facing downstream. Reach 1C and Wetland C.

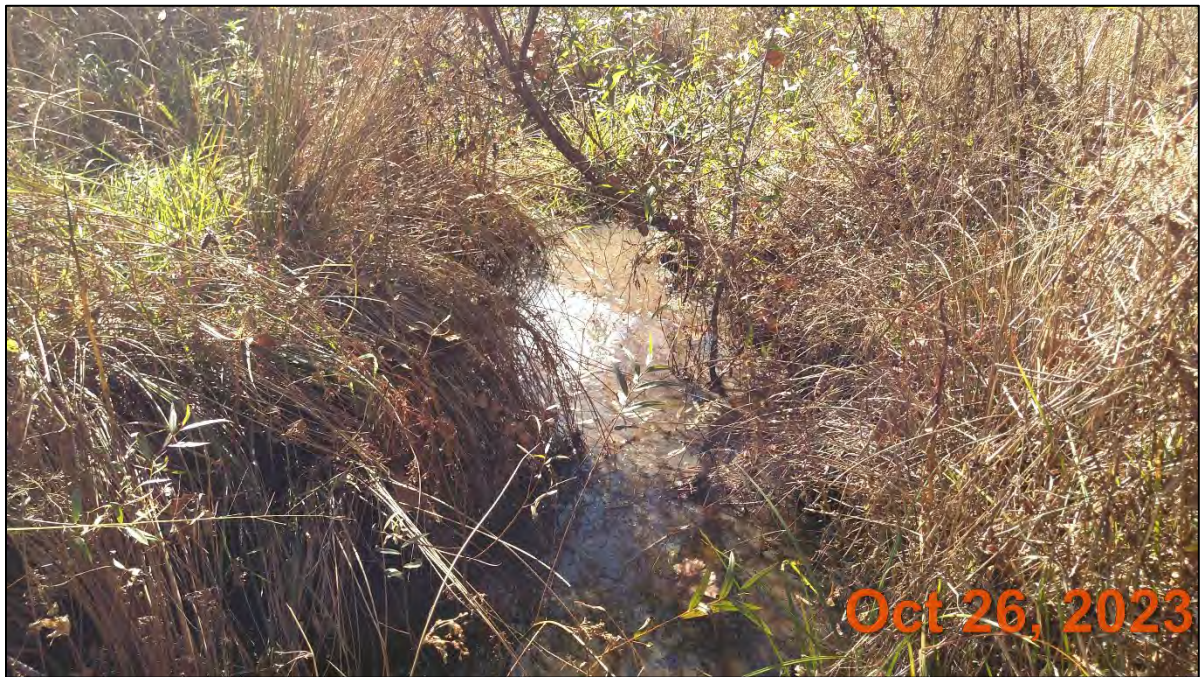
Photo point #6c, facing upstream from XS3, Reach 1C channel.

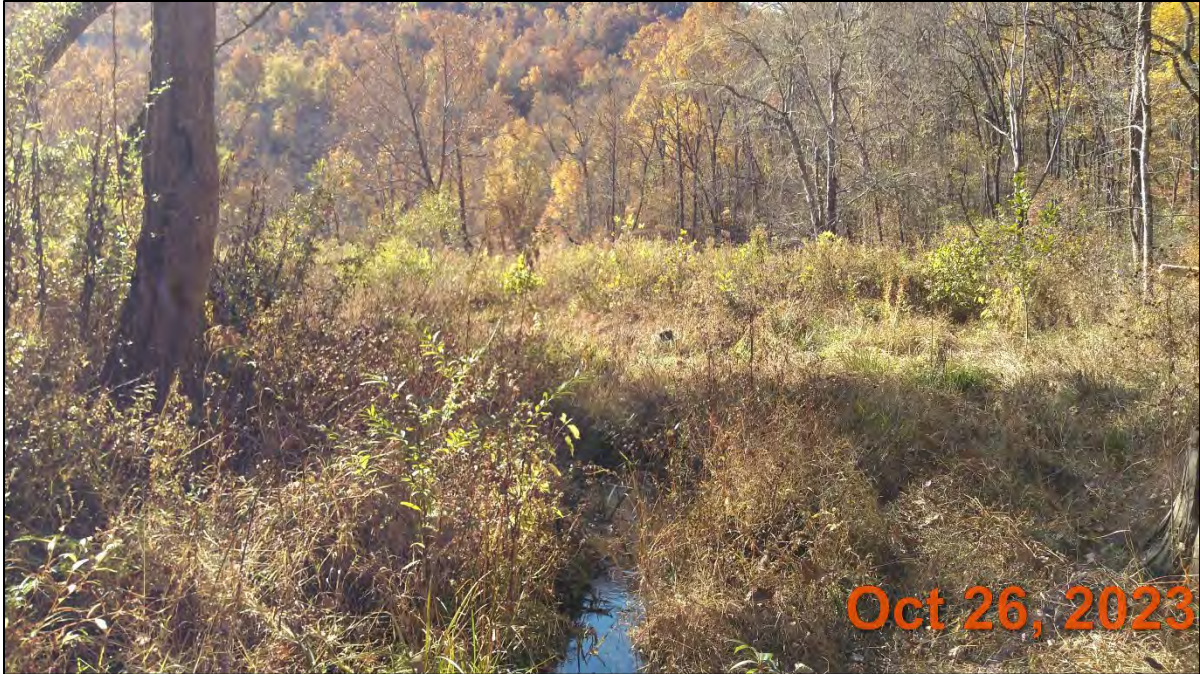
Photo point #7a, facing upstream from XS 5, Reach 1D.

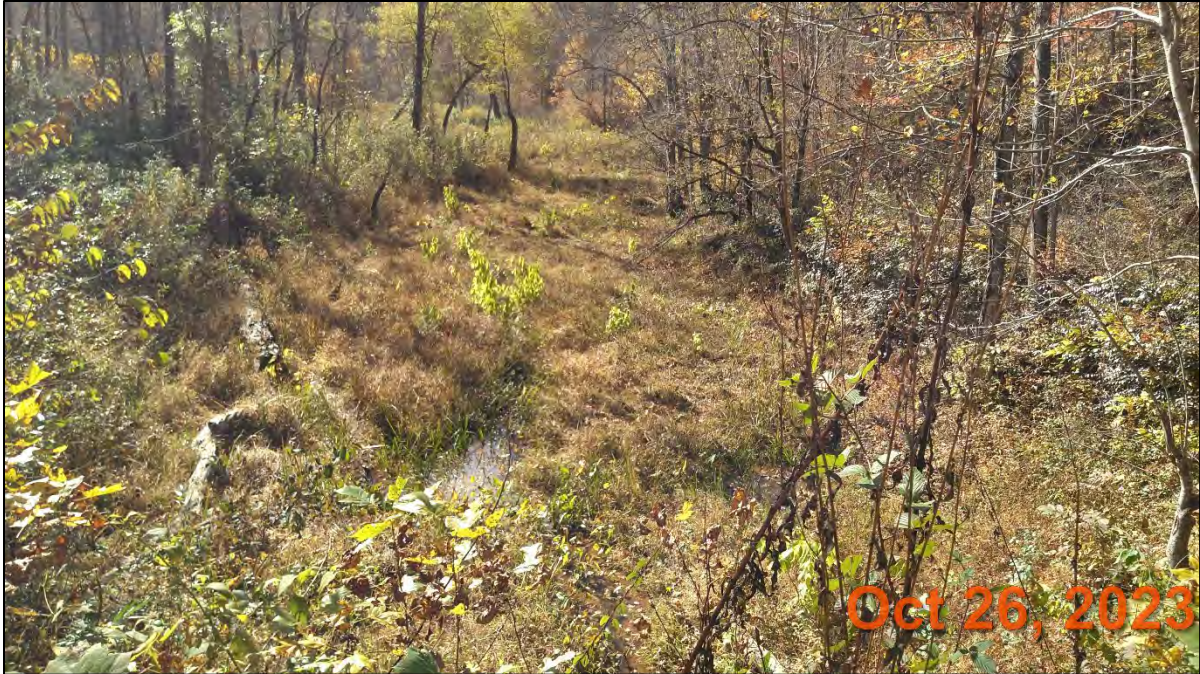
Photo point #8a, facing upstream from Caney Fork Road, Reach 1D.

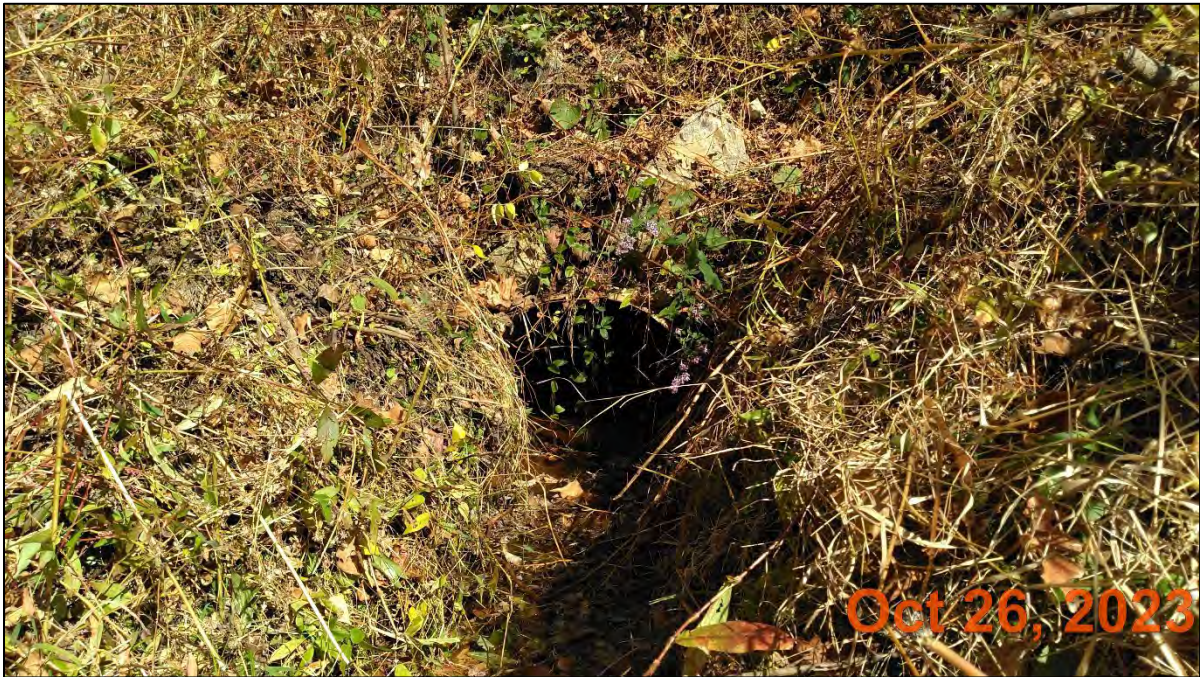
Photo point #8b, facing downstream Caney Fork Road culvert, Reach 1D.
