Harrell Stream and Wetland Restoration Site Monitoring Report – MY01 Edgecombe County, NC

December 2008

EXECUTIVE SUMMARY

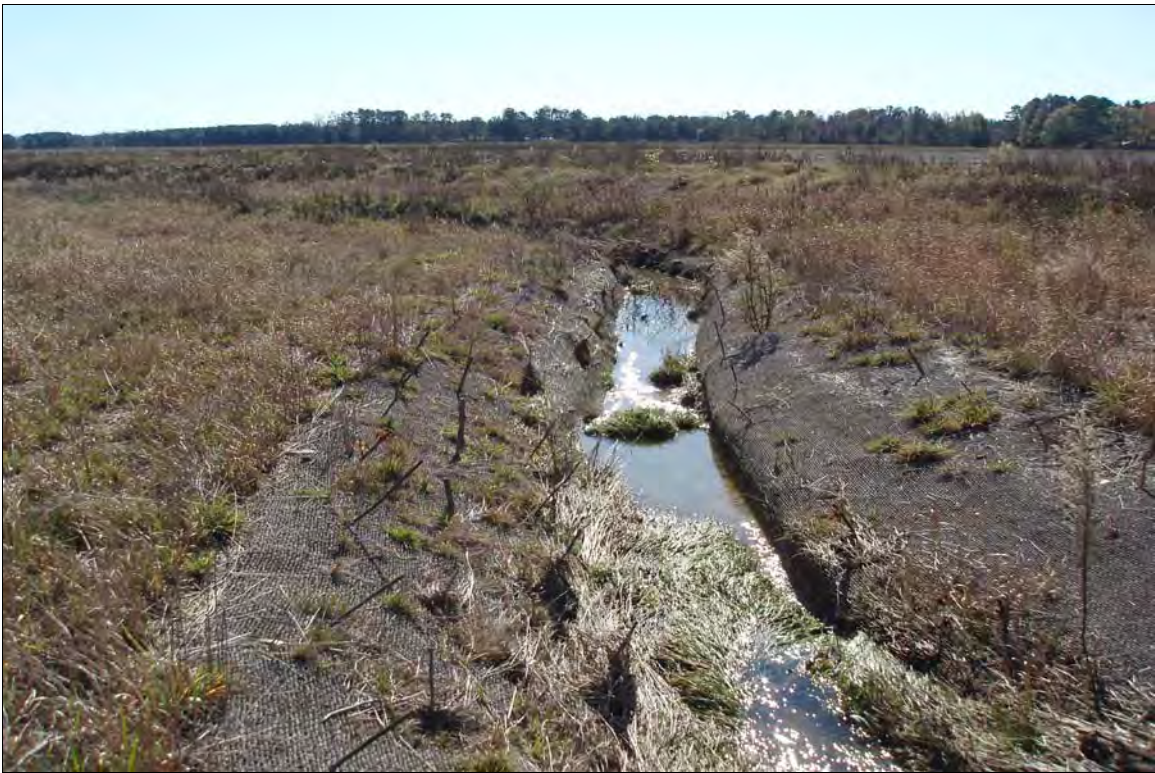
Photo Point S5: View looking downstream near Station 33+35. 11/19/08 – MY-01

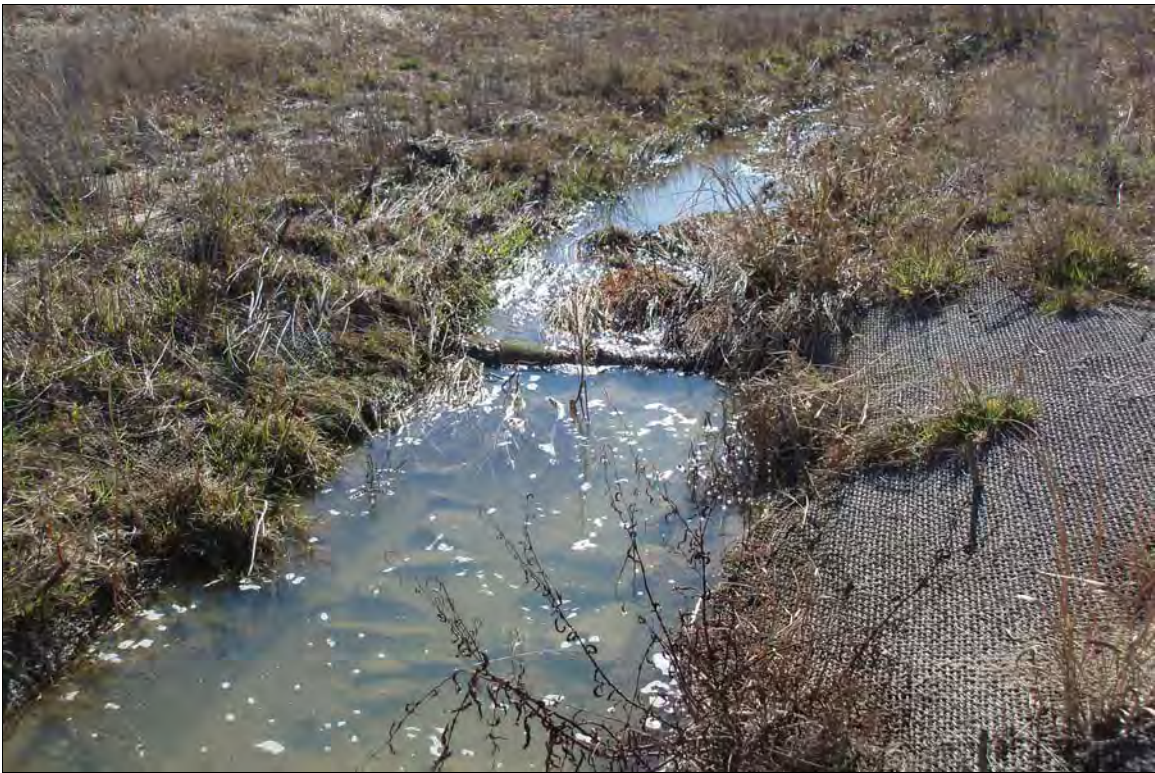
Photo Point S8: View of log drop structure near Station 39+50. 11/19/08 – MY-01

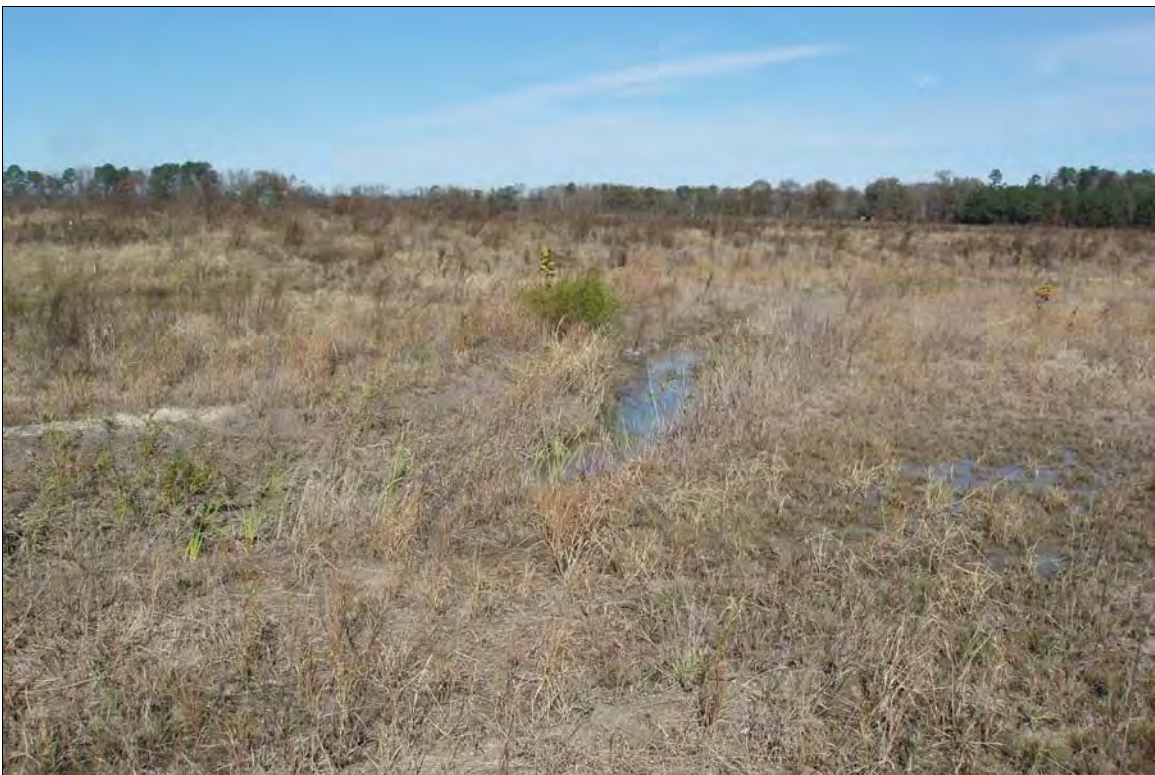
Photo Point S10: View looking downstream near Station 46+15. 11/19/08 – MY-01

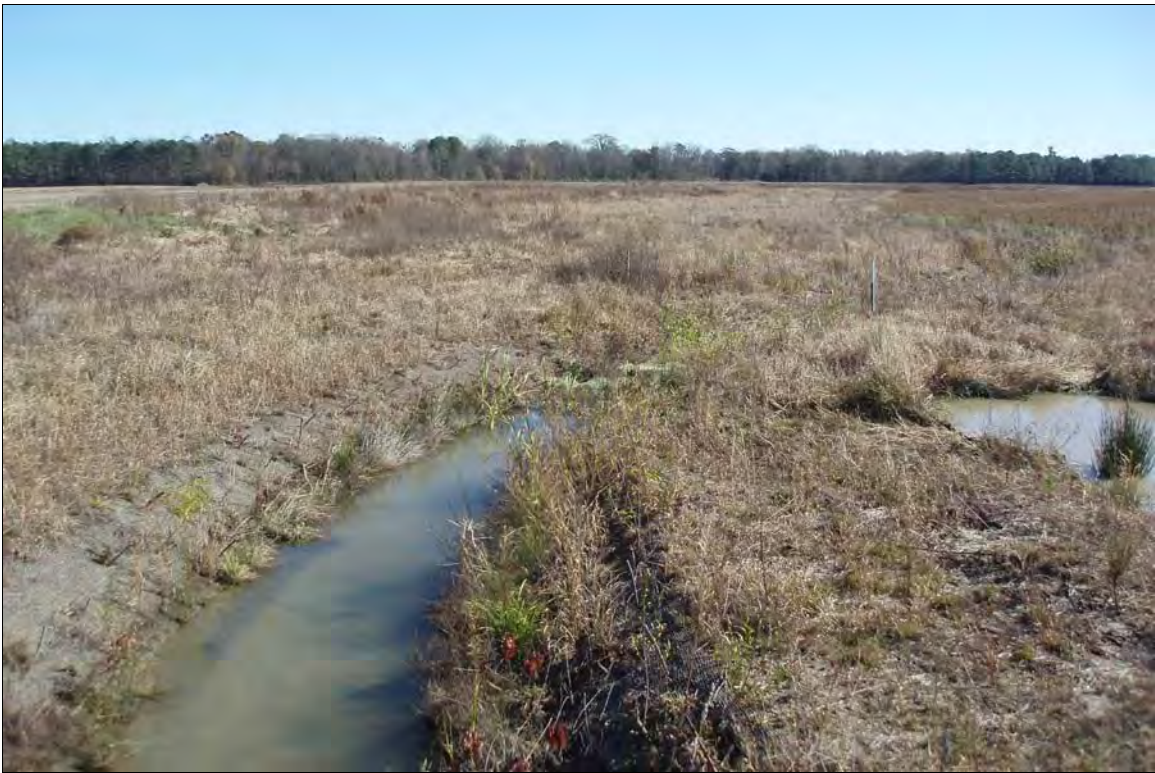
Photo Point S12: View looking downstream near Station 52+00. 11/19/08 – MY-01

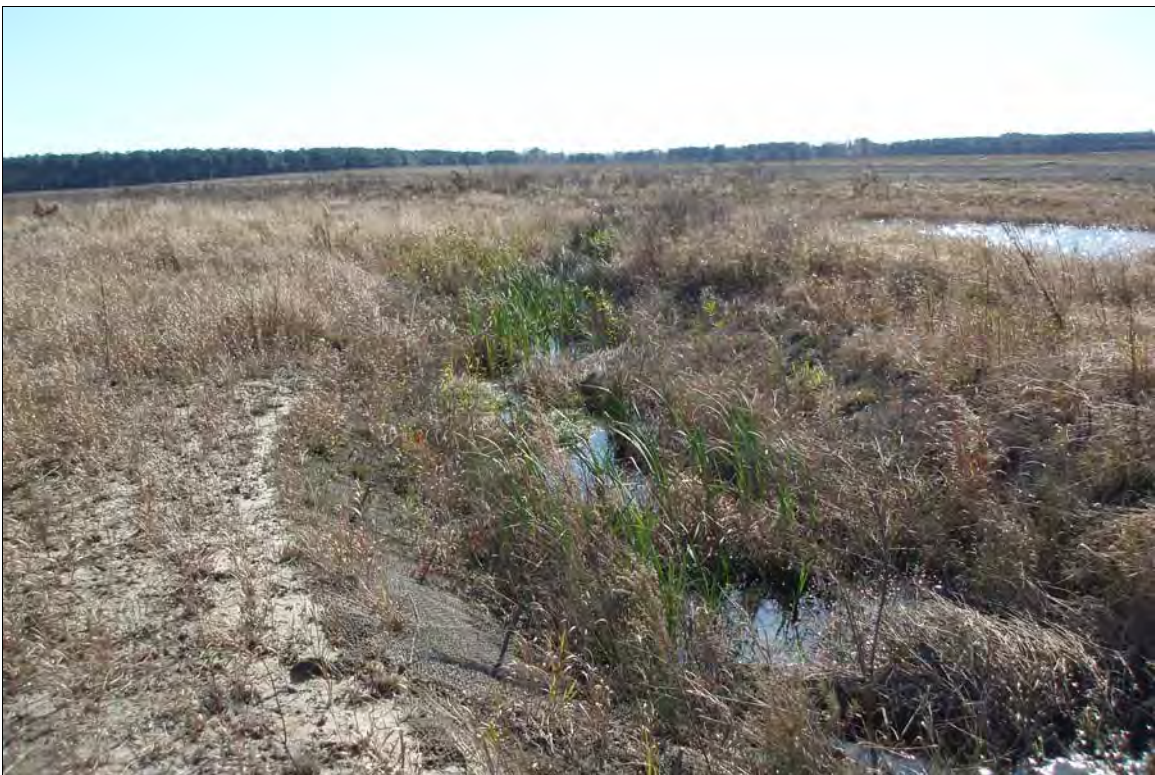
Photo Point S13: View looking downstream near Station 61+50. 11/19/08 – MY-01

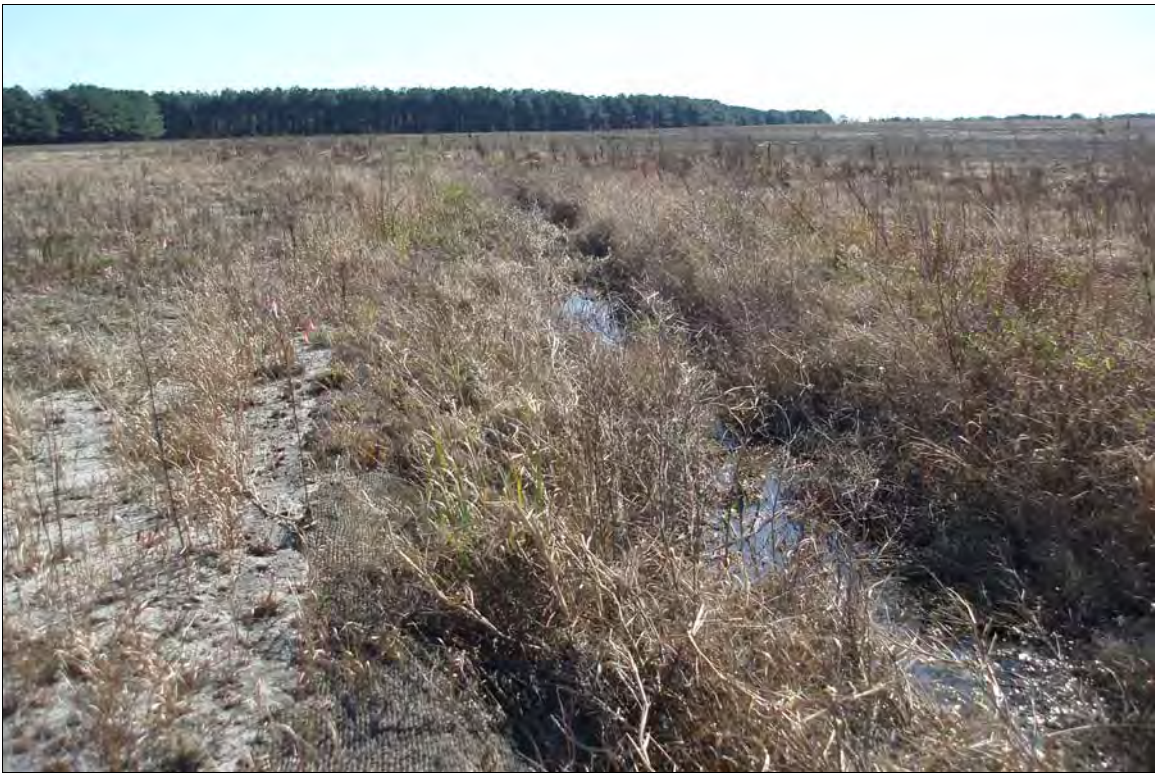
Photo Point S15: View looking downstream near Station 69+00. 11/19/08 – MY-01

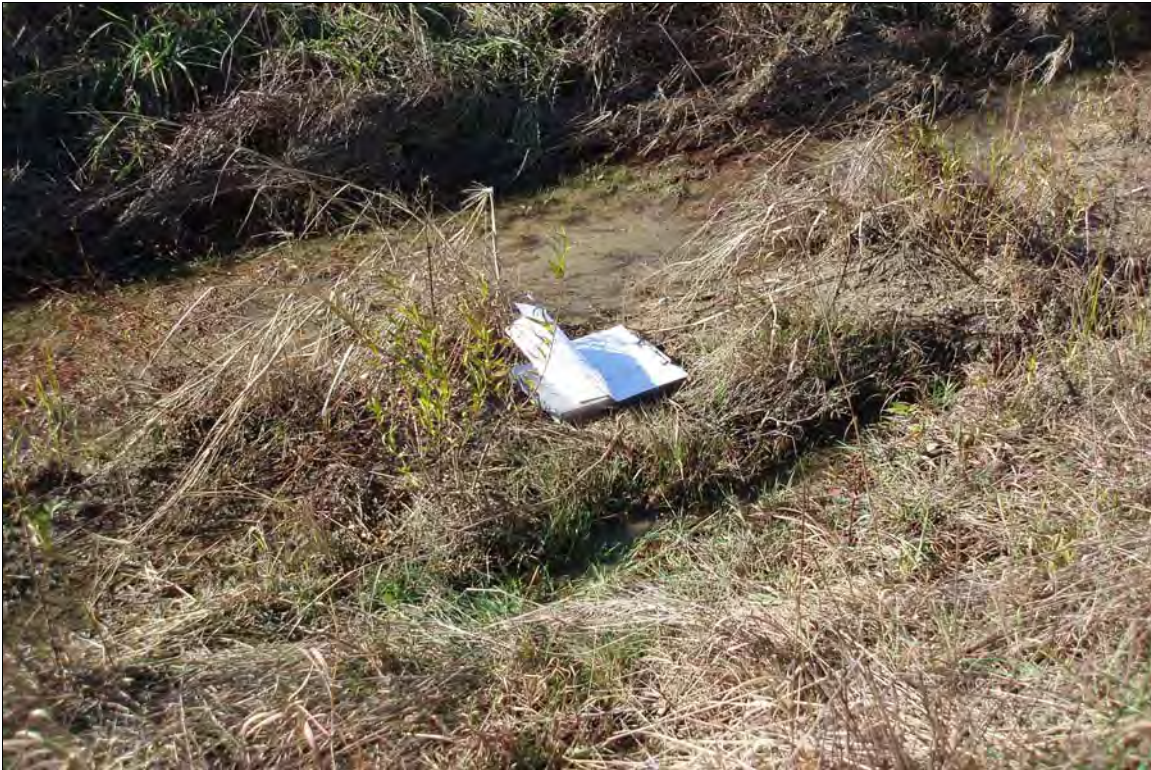
The stream assessment found the stream to be generally stable. Periodic storm events caused isolated bed degradation and aggradation in reaches 1 and 2. Some of these areas are visible on the longitudinal profile and cross-section plots. These patterns are typical for a stream like UT to Swift Creek. A sand bed system, like the project stream, is much more mobile than a gravel stream. Because of this, it is expected that patterns of aggradation and degradation are more dynamic within these systems. These dune/anti-dune streams will experience bed variation over time. The stream banks and floodplain experienced little to no erosion throughout the project. Piping is occurring at one instream structure, but the rest of the structures are performing as designed. Water quality treatment areas are stable and retaining water. All of these stream features will continue to be monitored to make sure that any observed changes are within the range of variability found in stable stream systems.

SP1 – Bed aggradation near Station 14+75. 11/19/08 – MY-01
