Heath Dairy Road Stream Restoration Site Randolph County, North Carolina

DMS Project #170

MY – 05 Fall Monitoring Report

Mogensen Mitigation, Inc.

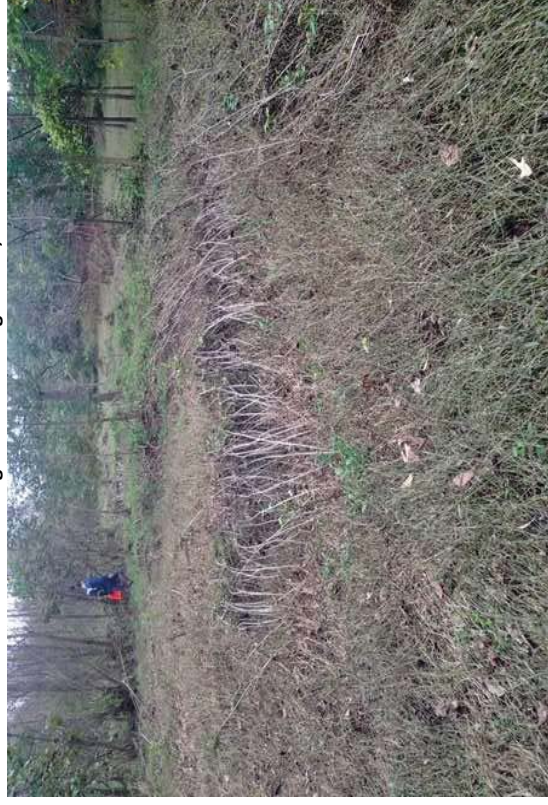
Flattened Vegetation near Veg Plot 14, October 2018
