MONITORING YEAR 7 ANNUAL/CLOSEOUT REPORT

HENRY FORK MITIGATION SITE

Catawba County, NC
DEQ Contract No. 005782
DMS Project No. 96306
USACE No. 2014-00538
DWR No. 20140193

Data Collection Period: January – November 2022
Draft Submission Date: November 30, 2022
Final Submission Date: January 17, 2023

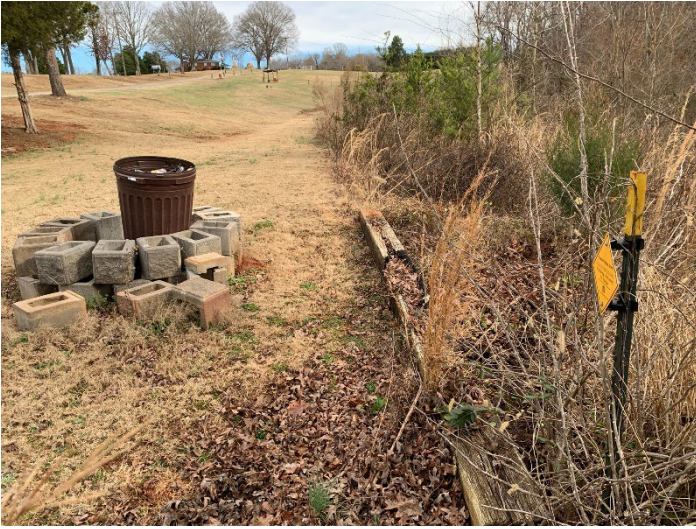
Action Item 1: Cement blocks removed from the easement on UT1B near VP2 - (01/06/2023)

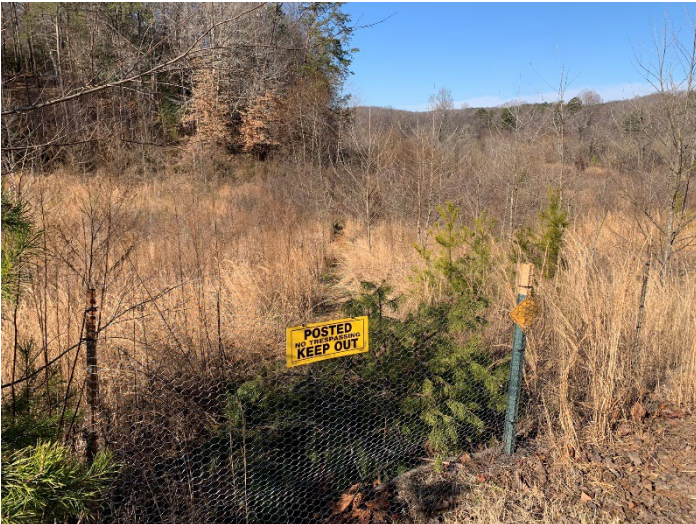
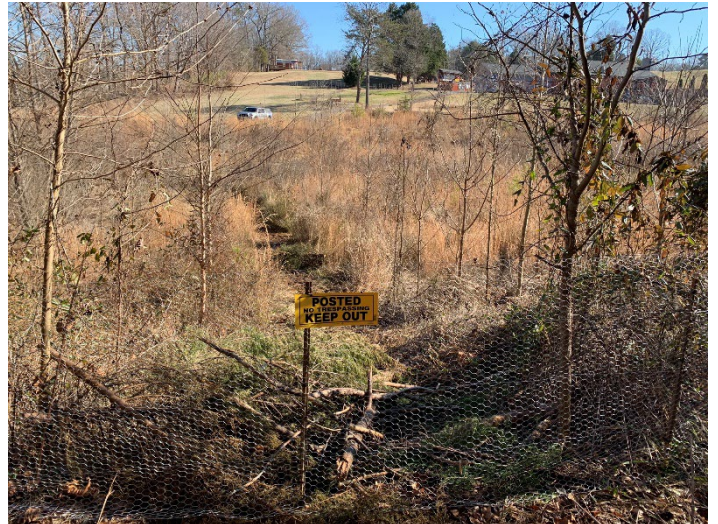
Action Item 2: Physical barrier to the path on both sides of the easement - (01/10/2023)
