**FINAL
MY5 (2023) MONITORING REPORT**

HERON STREAM AND WETLAND MITIGATION SITE

Alamance County, North Carolina
Cape Fear River Basin
Cataloging Unit 03030002

DMS Project ID No. 100014
Full Delivery Contract No. 7192
RFP No. 16-006990
USACE Action ID No. SAW-2017-01471
DWR Project No. 17-0920

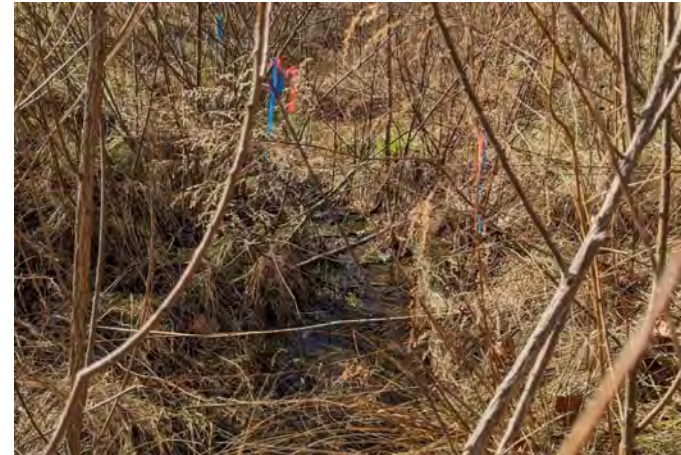
Site	Heron
Watershed:	Cape Fear, 0303002
XS ID	UT 3, XS - 9, Pool
Feature	Pool
Date:	5/17/2023
Field Crew:	Adams, Fleming, Perkinson, Smith

Sediment deposition in pool is natural and is exaggerated by the small size of the channel. This is not considered an area of concern.

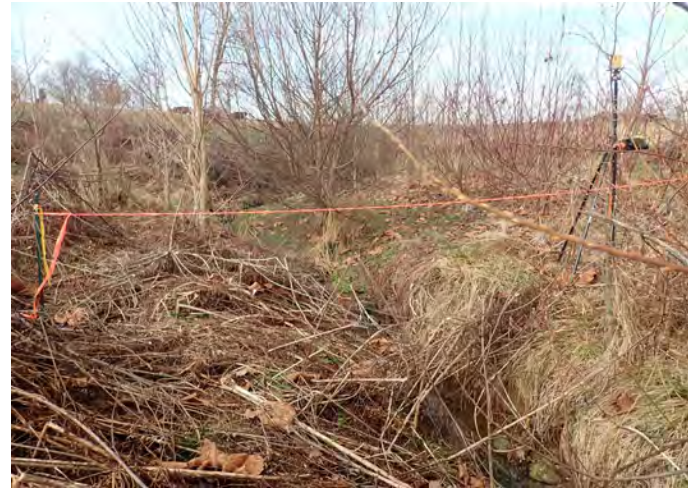
Site	Heron
Watershed:	Cape Fear, 0303002
XS ID	UT 6, XS - 26, Riffle
Feature	Riffle
Date:	5/17/2023
Field Crew:	Perkinson, Adams, Smith, Flemming

SUMMARY DATA	
Bankfull Elevation:	515.5
LTOB Elevation:	515.4
Bankfull Cross-Sectional Area:	3.5
Bankfull Width:	4.7
Flood Prone Area Elevation:	516.7
Flood Prone Width:	40.0
Max Depth at Bankfull:	1.2
Low Bank Height:	1.1
Mean Depth at Bankfull:	0.7
W / D Ratio:	6.3
Entrenchment Ratio:	8.6
Bank Height Ratio:	0.96

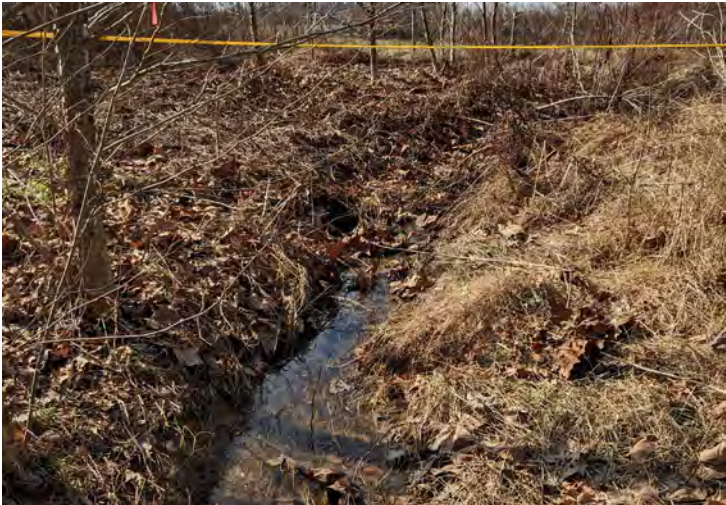
Site	Heron
Watershed:	Cape Fear, 0303002
XS ID	UT 7, XS - 28, Riffle
Feature	Riffle
Date:	5/17/2023
Field Crew:	Perkinson, Adams, Smith, Flemming

Note: The sediment deposition in this pool occurred shortly after construction and has stabilized during Years 1-5. It is not expected to lead to further instability.

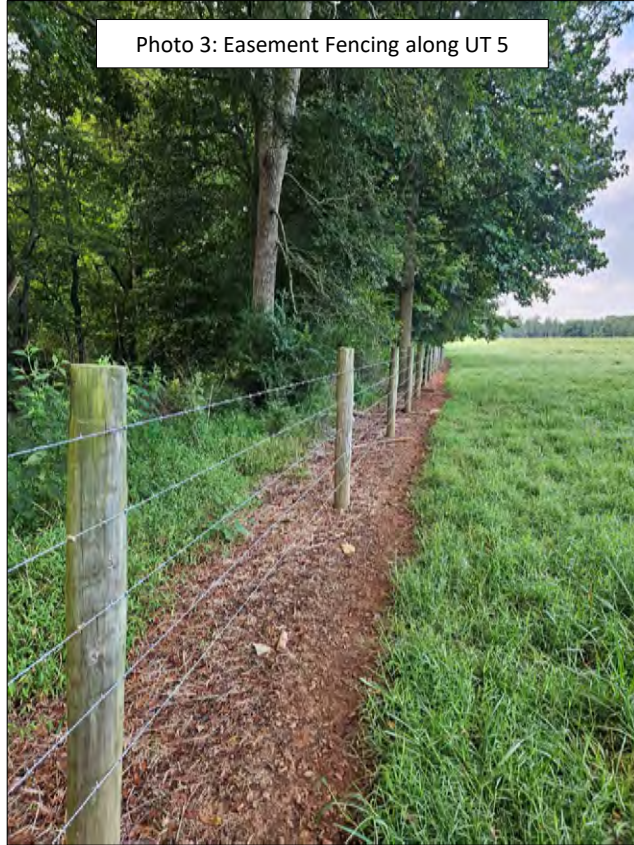
Photo 3: Easement Fencing along UT 5

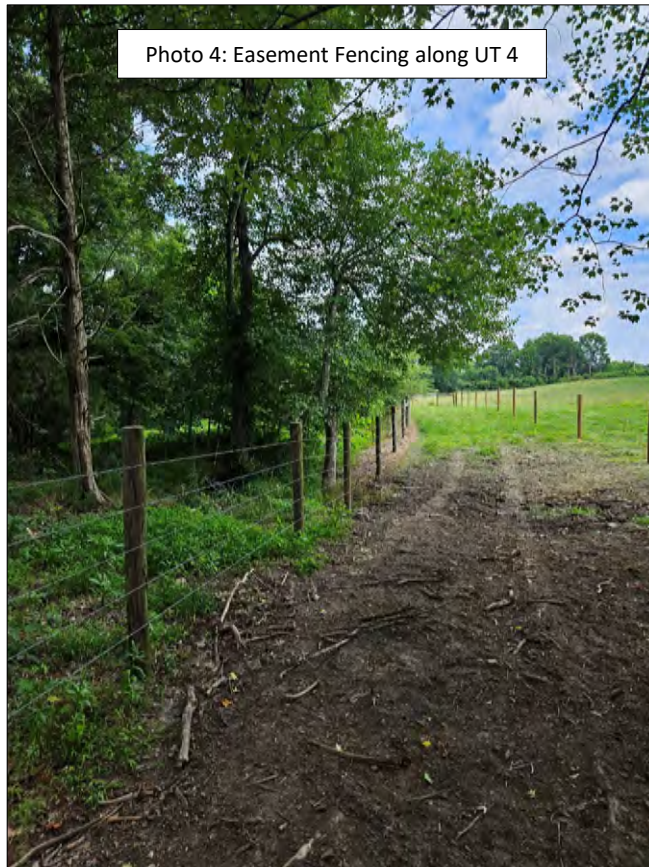
Photo 4: Easement Fencing along UT 4

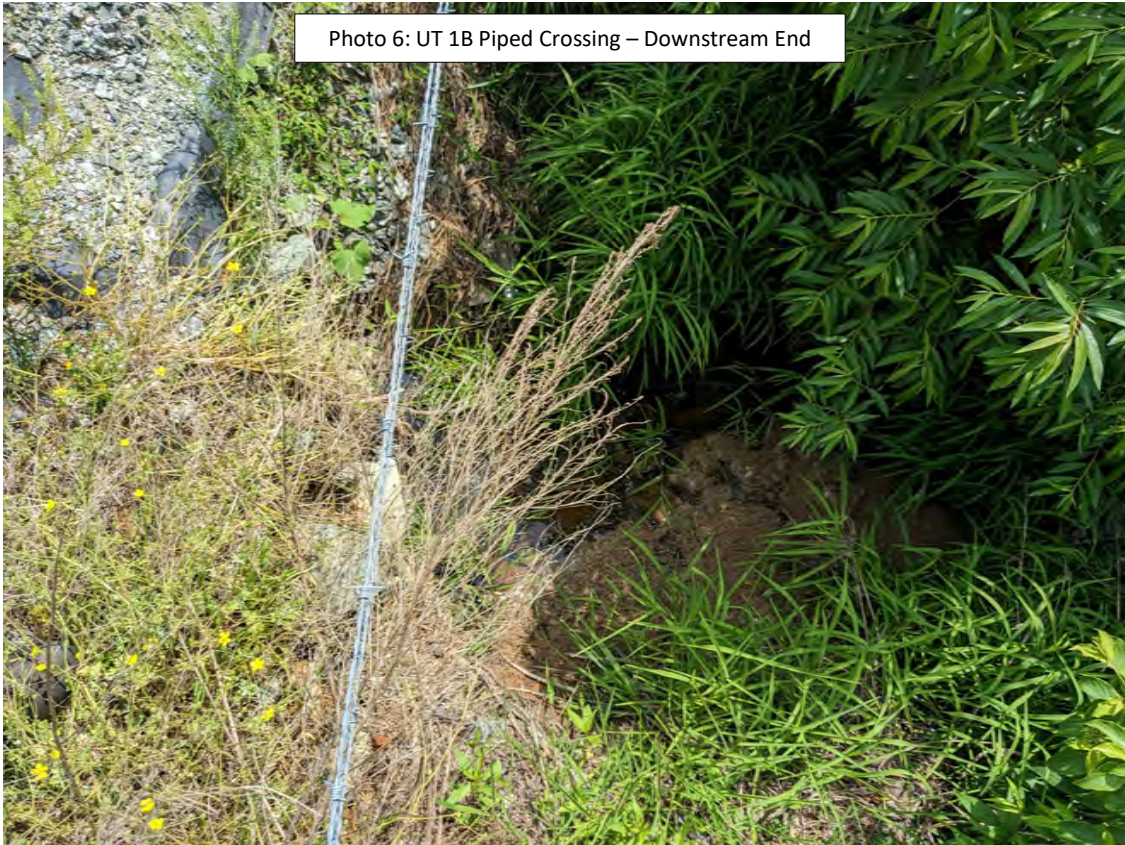
Photo 6: UT 1B Piped Crossing – Downstream End

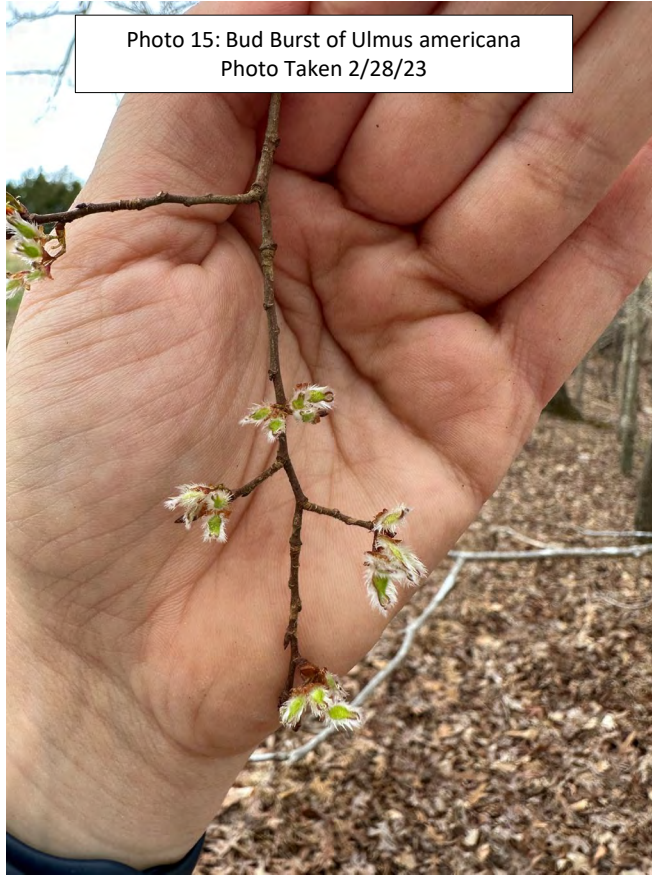
Photo 15: Bud Burst of *Ulmus americana*
Photo Taken 2/28/23

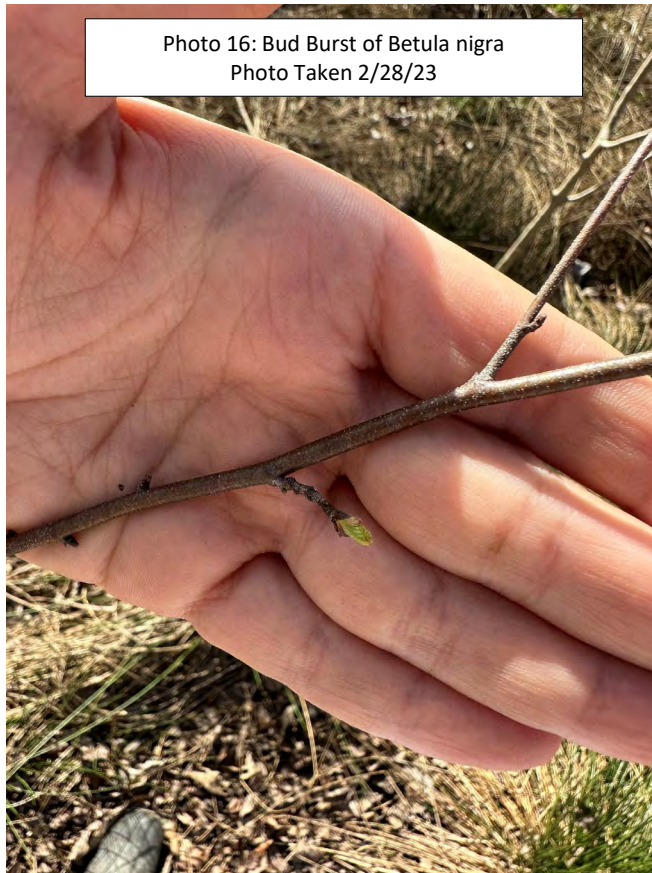
Photo 16: Bud Burst of *Betula nigra*
Photo Taken 2/28/23

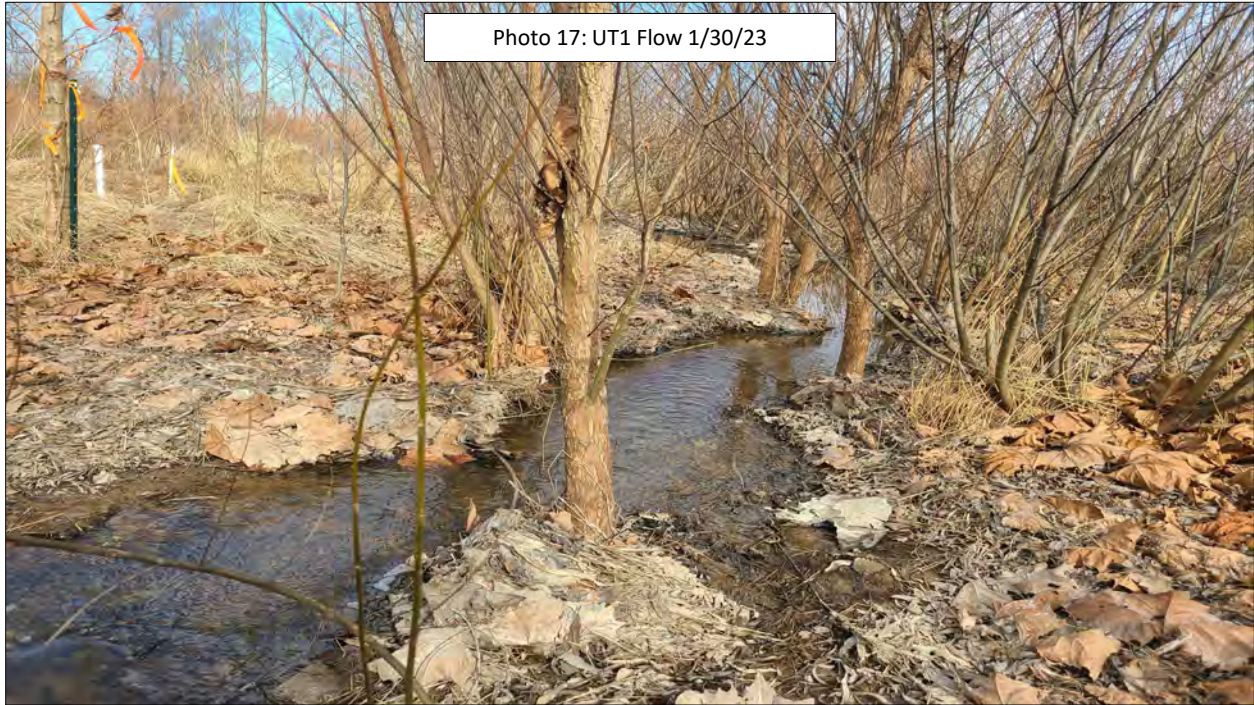
Photo 17: UT1 Flow 1/30/23

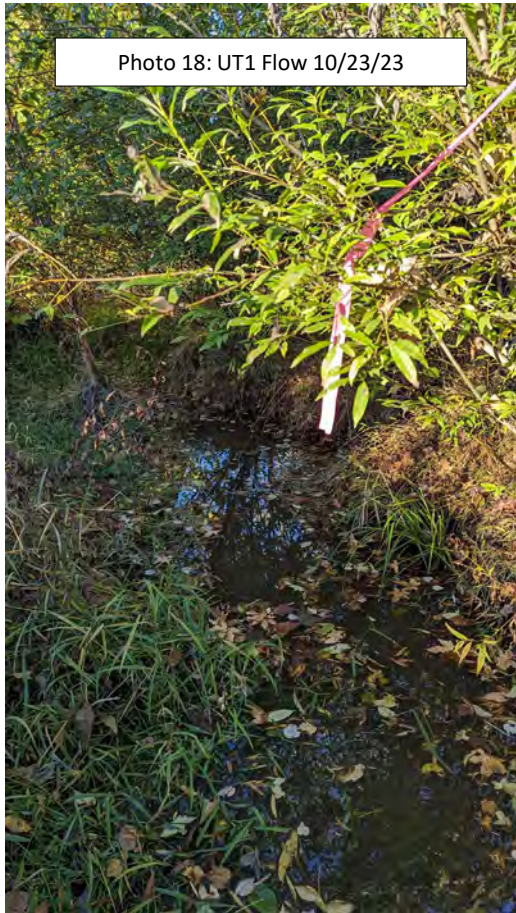
Photo 18: UT1 Flow 10/23/23

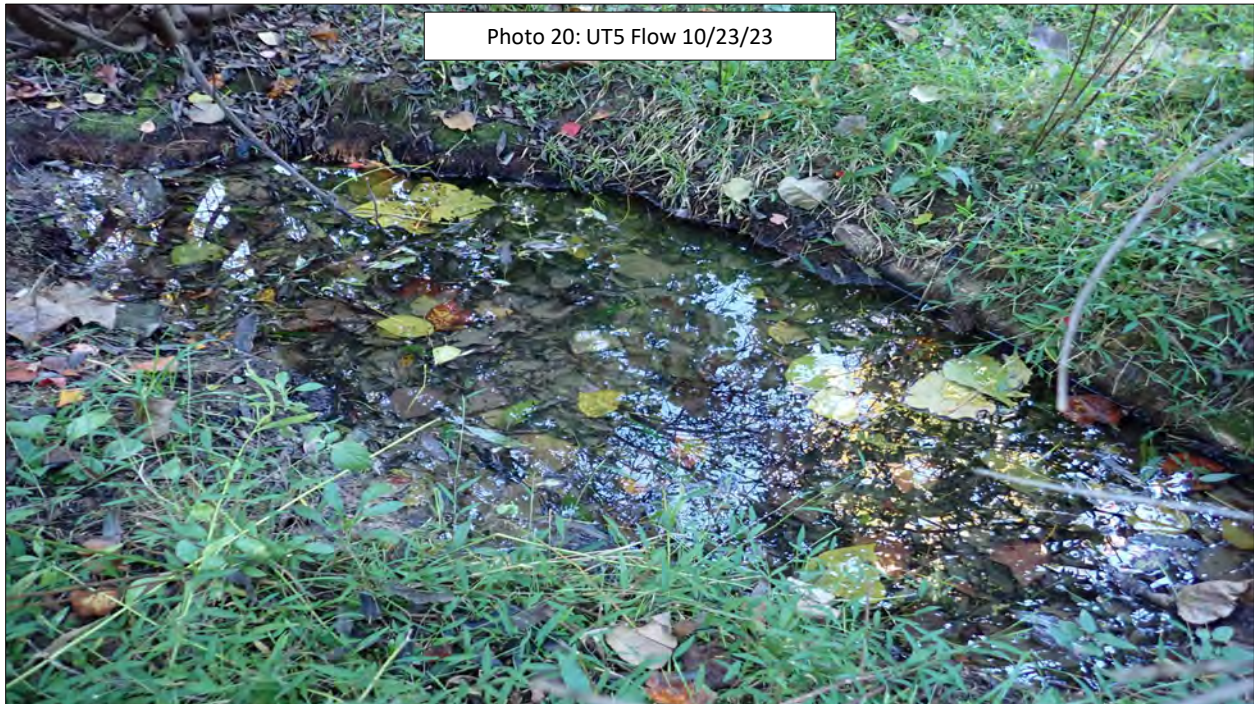
Photo 20: UT5 Flow 10/23/23
