Holly Grove Stream Restoration Site

Guilford County, North Carolina

MONITORING REPORT 2011 (YEAR 3)

Restoration Systems, LLC

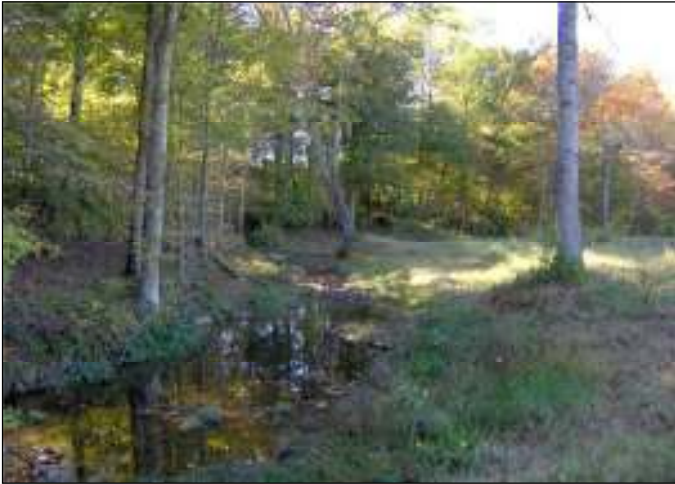
Buckhorn Creek facing upstream
Year 0 Photo No. 5

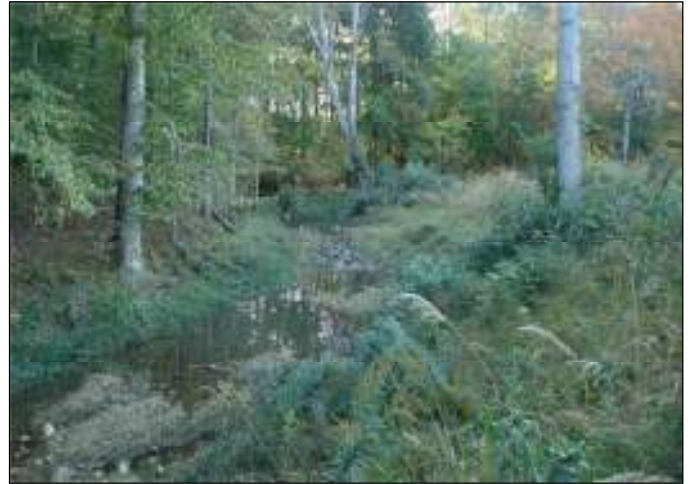
Buckhorn Creek facing upstream
Year 2 Photo No. 7

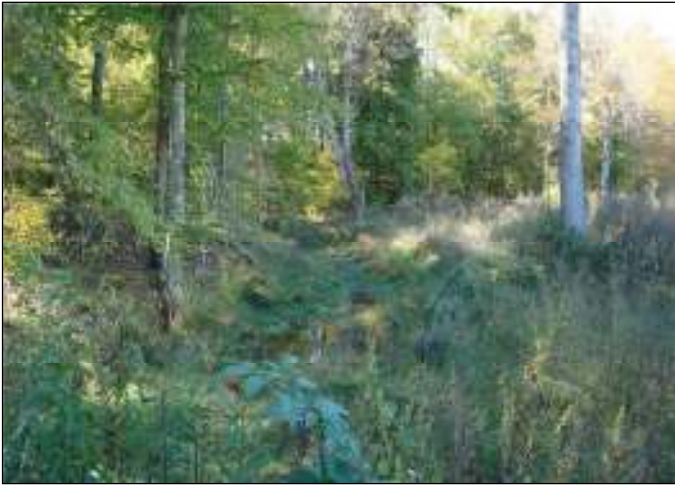
Buckhorn Creek facing upstream
Year 1 Photo No. 6

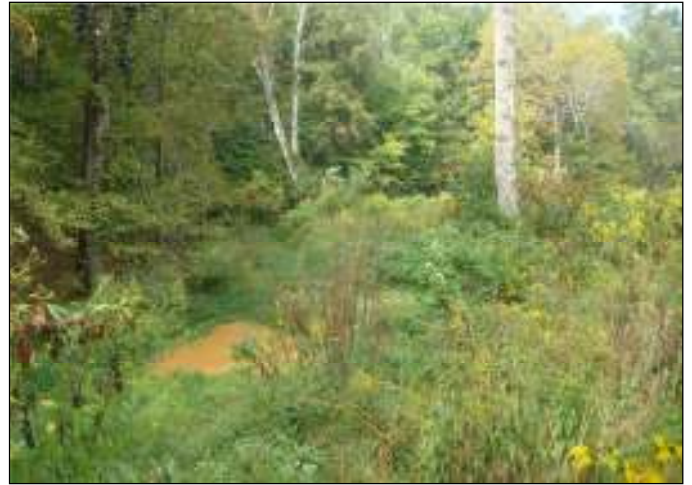
Buckhorn Creek facing upstream
Year 3 Photo No. 8

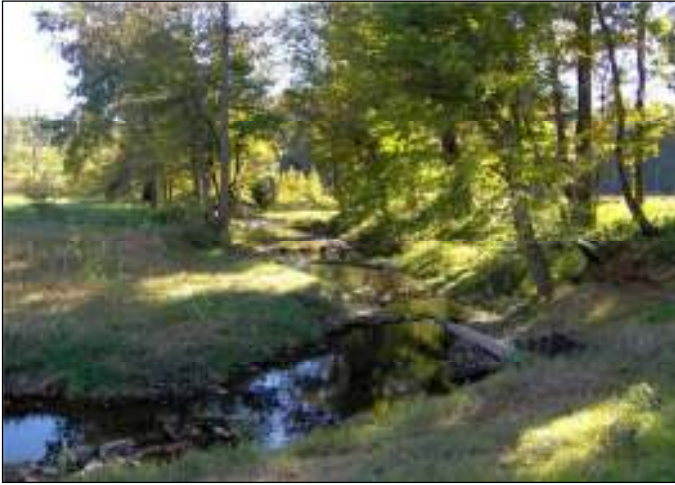
Buckhorn Creek facing upstream
Year 0 Photo No. 9

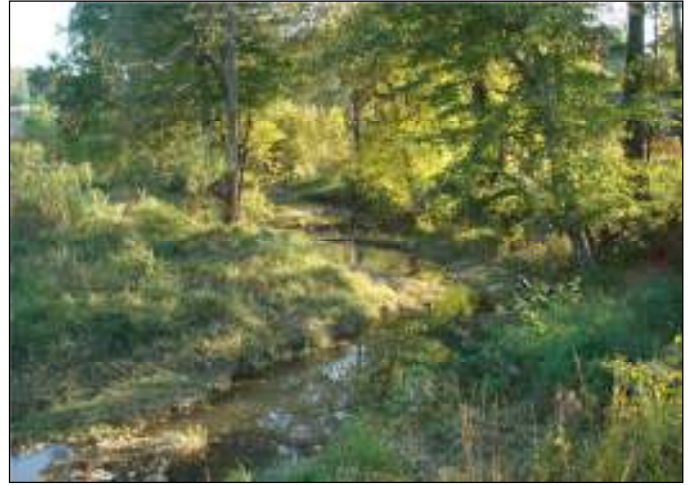
Buckhorn Creek facing upstream
Year 2 Photo No. 11

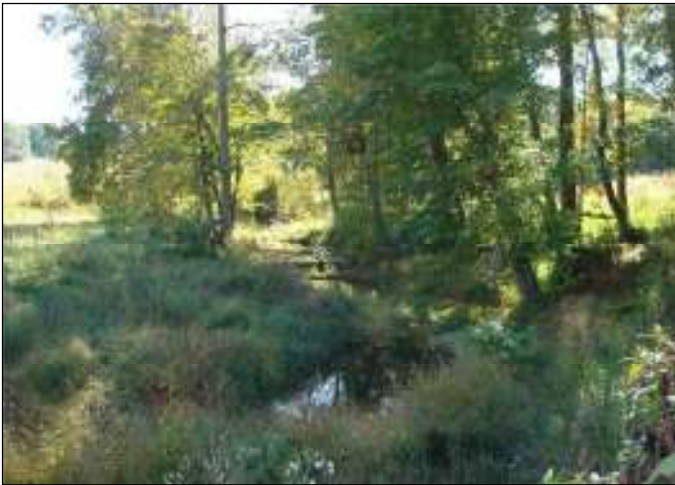
Buckhorn Creek facing upstream
Year 1 Photo No. 10

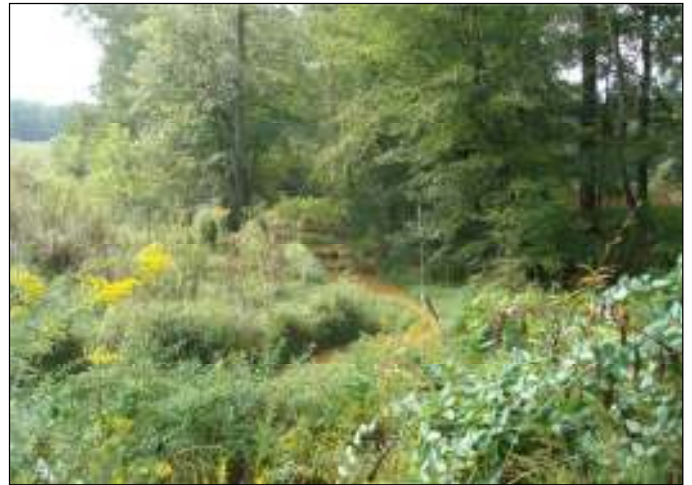
Buckhorn Creek facing upstream
Year 3 Photo No. 12

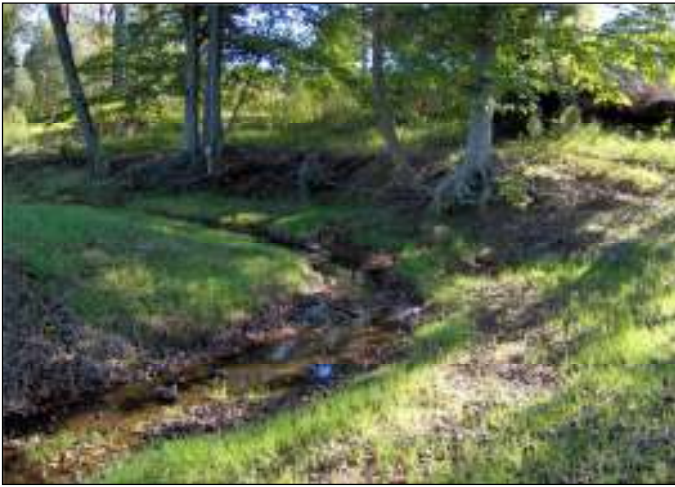
West Branch facing downstream
Year 0 Photo No. 13

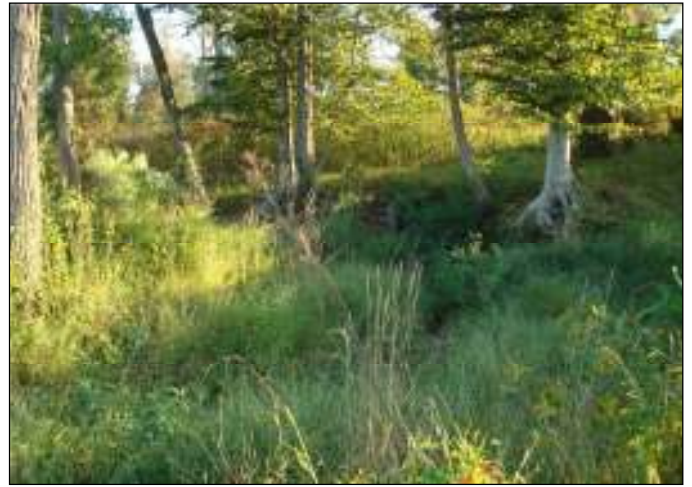
West Branch facing downstream
Year 2 Photo No. 15

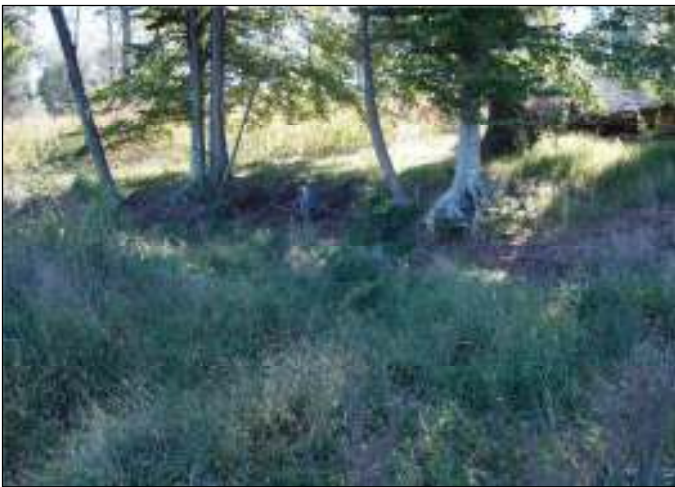
West Branch facing downstream
Year 1 Photo No. 14

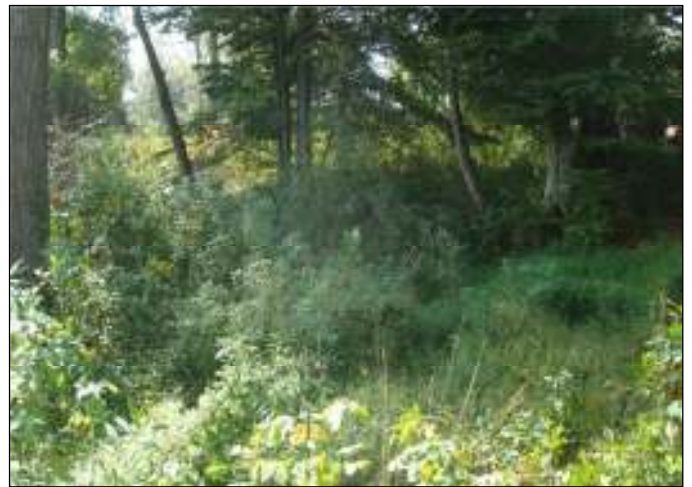
West Branch facing downstream
Year 3 Photo No. 16

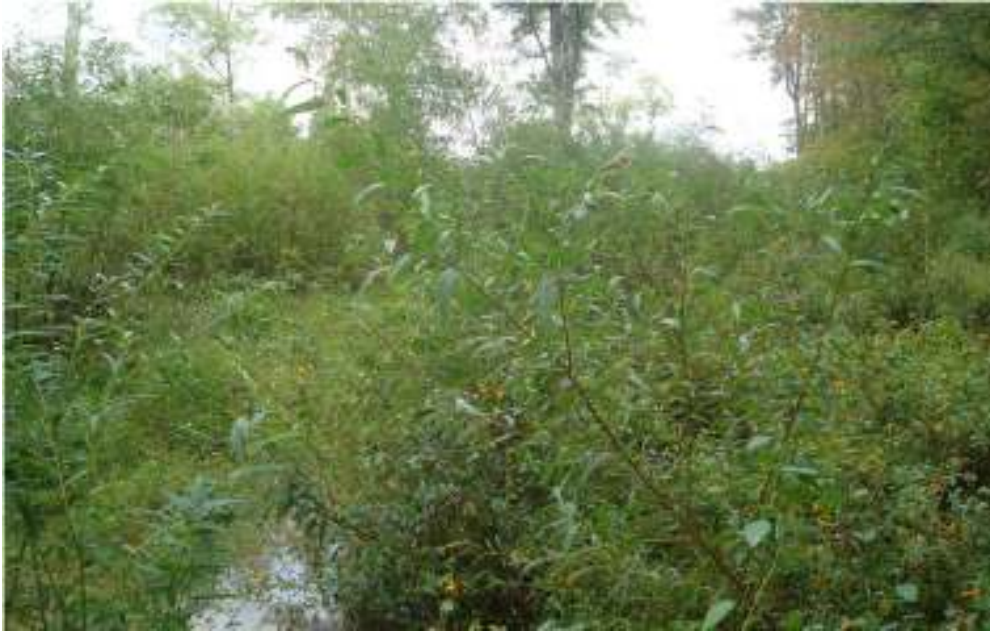
Holly Grove Stream Restoration Site
 Guilford County, NC
 Riffle Cross Section RF1
 Reach 1 - Buckhorn Creek - Sta 11+78.6

As-Built		Year 1		Year 2		Year 3		Year 4		Year 5	
Date	1/8/09	Date	10/20/09	Date	10/11/10	Date	10/5/11	Date	0/0/0	Date	0/0/0
Area	34.3	Area	35.4	Area	35.3	Area	31.3	Area	0.0	Area	0.0
Bkf W	23.4	Bkf W	23.3	Bkf W	23.7	Bkf W	23.7	Bkf W	10	Bkf W	10
Dmean	1.5	Dmean	1.5	Dmean	1.5	Dmean	1.3	Dmean	0.0	Dmean	0.0
Dmax	2.1	Dmax	2.1	Dmax	2.6	Dmax	2.3	Dmax	0.0	Dmax	0.0
W/d	16.0	W/d	15.3	W/d	15.9	W/d	18.0	W/d	0.0	W/d	0.0

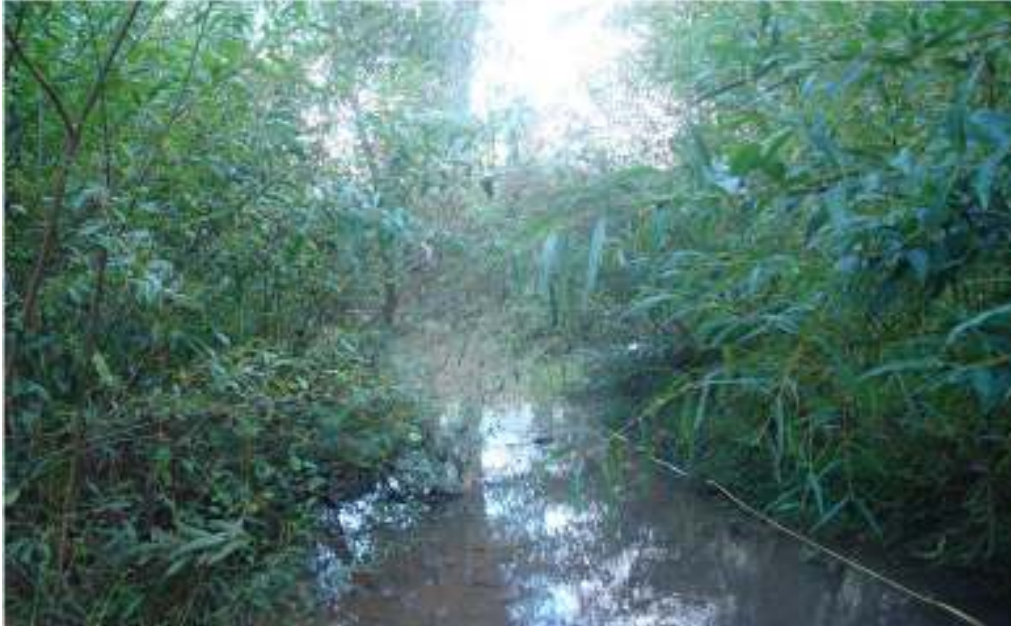
Pool Cross Section PL1

As-Built		Year 1		Year 2		Year 3		Year 4		Year 5	
Date	1/8/09	Date	10/20/09	Date	10/11/10	Date	10/5/11	Date	0/0/0	Date	0/0/0
Area	52.7	Area	48.0	Area	46.8	Area	48.4	Area	0.0	Area	0.0
Bkf W	23.2	Bkf W	22.1	Bkf W	23.4	Bkf W	23.5	Bkf W	10	Bkf W	10
Dmean	2.3	Dmean	2.2	Dmean	2.0	Dmean	2.1	Dmean	0.0	Dmean	0.0
Dmax	4.0	Dmax	3.9	Dmax	4.2	Dmax	4.3	Dmax	0.0	Dmax	0.0
W/d	10.2	W/d	10.2	W/d	11.7	W/d	11.4	W/d	0.0	W/d	0.0

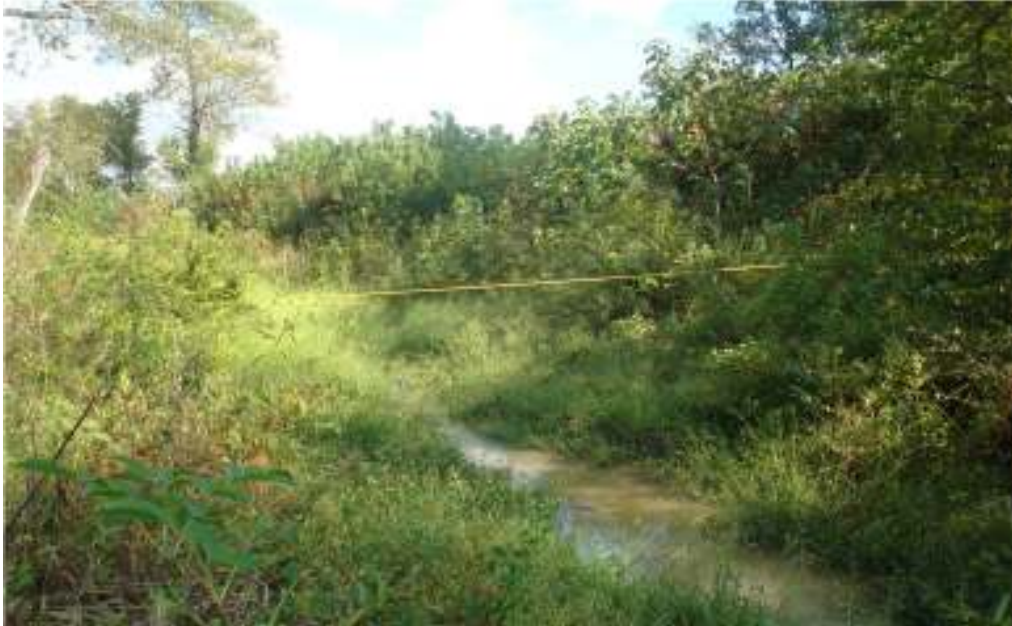
Riffle Cross Section RF2

As-Built		Year 1		Year 2		Year 3		Year 4		Year 5	
Date	1/8/09	Date	10/20/09	Date	10/12/10	Date	10/5/11	Date	0/0/0	Date	0/0/0
Area	26.3	Area	25.4	Area	27.6	Area	21.1	Area	0.0	Area	0.0
Bkf W	19.9	Bkf W	20.4	Bkf W	20.2	Bkf W	19.7	Bkf W	10	Bkf W	10
Dmean	1.3	Dmean	1.2	Dmean	1.4	Dmean	1.1	Dmean	0.0	Dmean	0.0
Dmax	1.7	Dmax	1.7	Dmax	1.9	Dmax	1.6	Dmax	0.0	Dmax	0.0
W/d	15.1	W/d	16.4	W/d	14.8	W/d	18.4	W/d	0.0	W/d	0.0

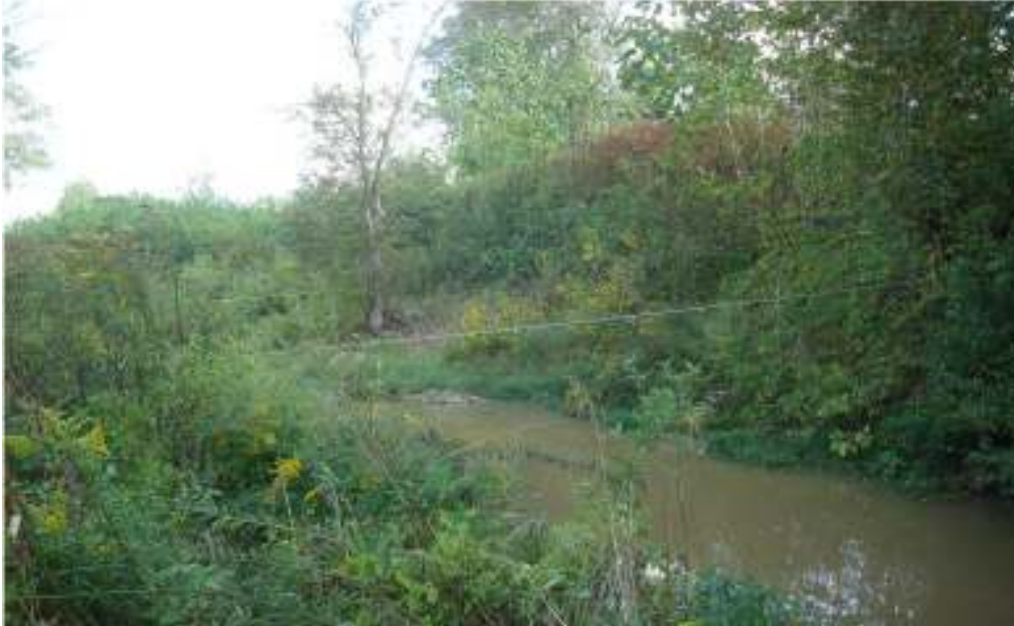
Pool Cross Section PL2

As-Built		Year 1		Year 2		Year 3		Year 4		Year 5	
Date	1/8/09	Date	10/20/09	Date	10/12/10	Date	10/5/11	Date	0/0/0	Date	0/0/0
Area	45.6	Area	43.8	Area	49.1	Area	47.6	Area	0.0	Area	0.0
Bkf W	23.3	Bkf W	22.2	Bkf W	22	Bkf W	22.8	Bkf W	10	Bkf W	10
Dmean	2.0	Dmean	2.0	Dmean	2.2	Dmean	2.1	Dmean	0.0	Dmean	0.0
Dmax	2.8	Dmax	2.9	Dmax	3.1	Dmax	2.9	Dmax	0.0	Dmax	0.0
W/d	11.9	W/d	11.2	W/d	9.9	W/d	10.9	W/d	0.0	W/d	0.0
