Holly Grove Stream Restoration Site

October 28, 2013

MONITORING REPORT 2013 (YEAR 5)

Restoration Systems, LLC

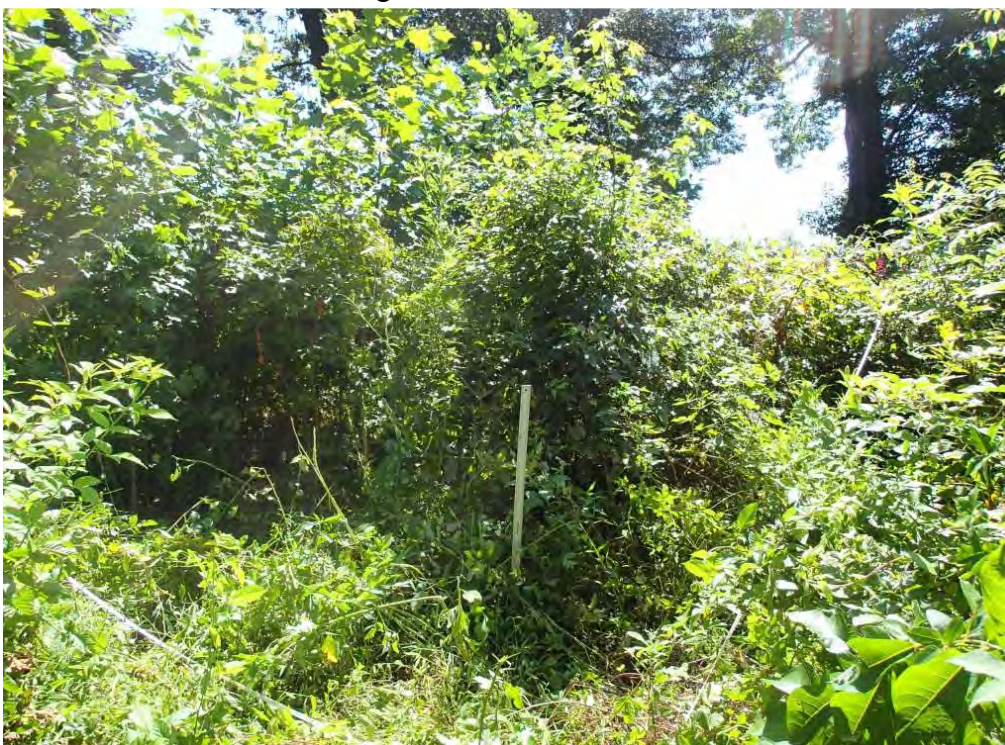
Vegetation Plot 2– Year 5

The vegetation problem areas are composed of areas of low planted stem density in the vicinity of plots 2, 5, 7, and 8 due to the CVS data results. Invasive exotics observed throughout the conservation easement that are a threat to native vegetation include tree of heaven (*Ailanthus altissima*), princess tree (*Paulownia tomentosa*), and Johnson grass (*Sorghum halapense*). Other invasive exotics infrequently observed that did not seem to be an imminent threat include tall fescue (*Schedonurus arundinaceus*), Japanese honeysuckle (*Lonicera japonica*), Multiflora rose (*Rosa multiflora*), and Chinese privet (*Ligustrum sinense*). According to the EEP Invasives of Concern/Interest List, tree of heaven, princess tree, multiflora rose, Chinese privet, and Japanese honeysuckle are all classified as “High Concern” species and fescue as a “Low/Moderate Concern” species. Although these invasive exotic species are given different ranks of severity, the functionality of the project is not expected to be impaired significantly.

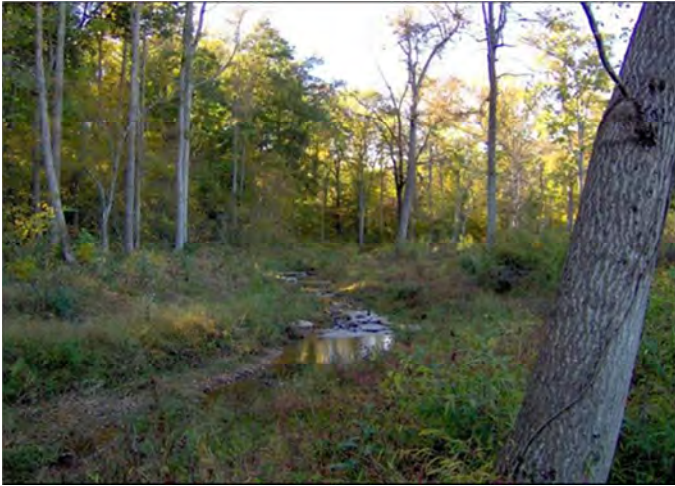
Buckhorn Creek facing upstream Year 0 Photo No. 1

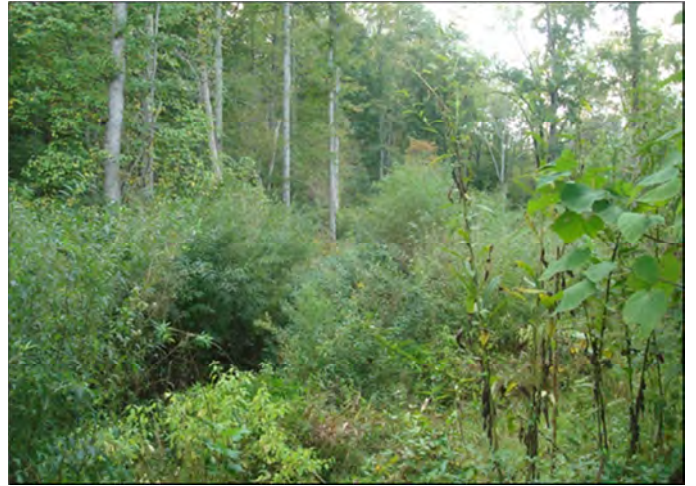
Buckhorn Creek facing upstream Year 3 Photo No. 4

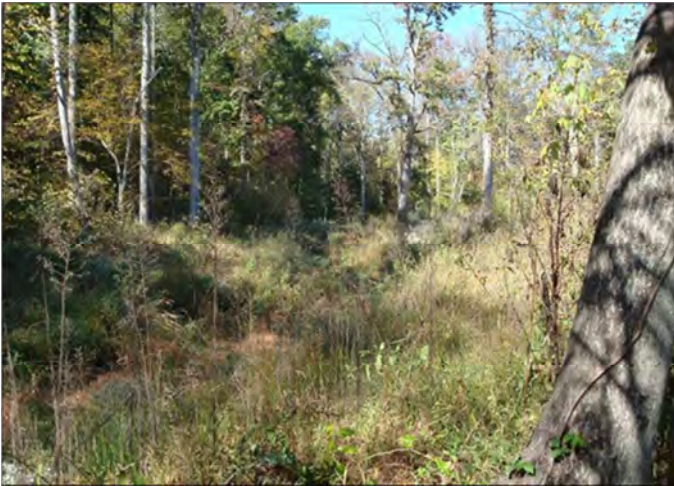
Buckhorn Creek facing upstream Year 1 Photo No. 2

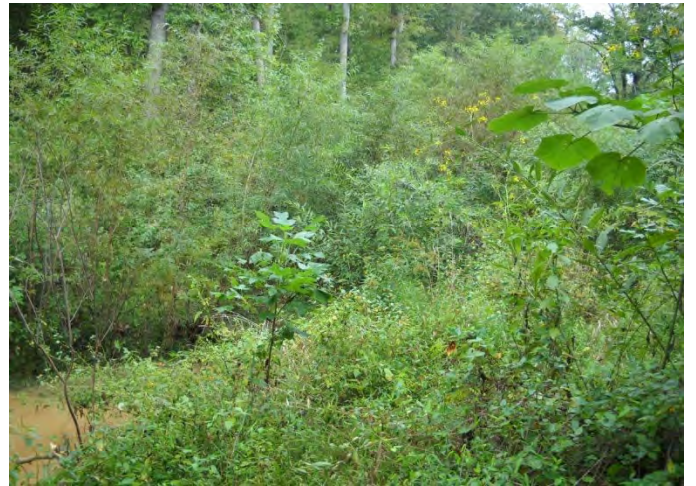
Buckhorn Creek facing upstream Year 4 Photo No. 5

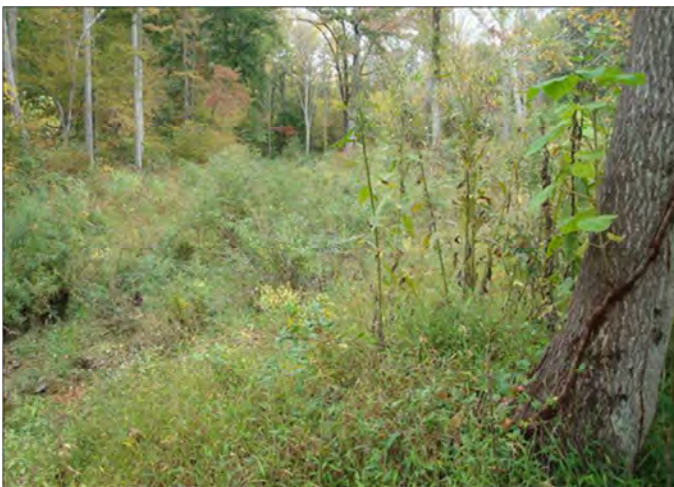
Buckhorn Creek facing upstream Year 2 Photo No. 3

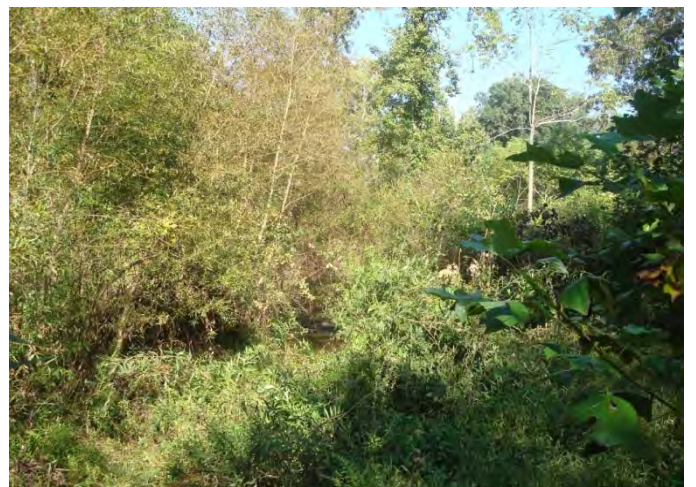
Buckhorn Creek facing upstream Year 5 Photo No. 6

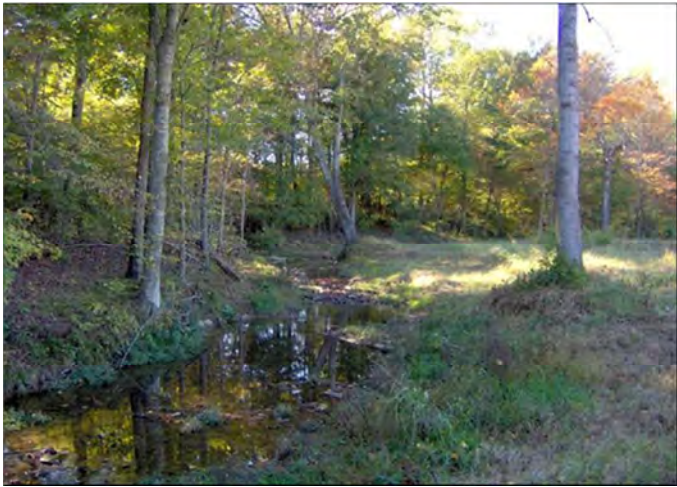
Buckhorn Creek facing upstream Year 0 Photo No. 7

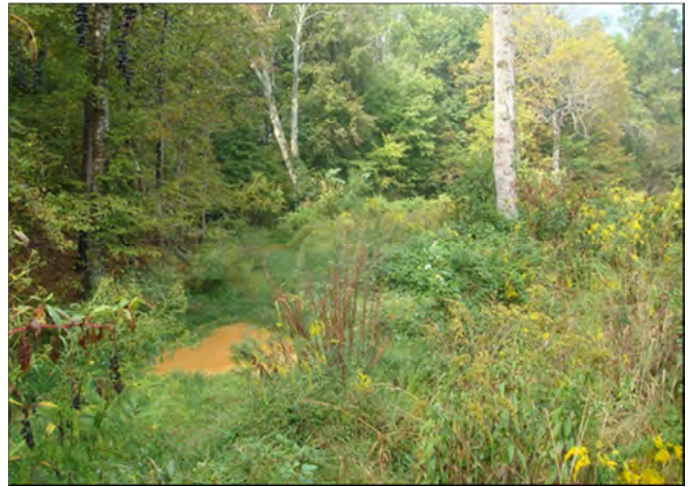
Buckhorn Creek facing upstream Year 3 Photo No. 10

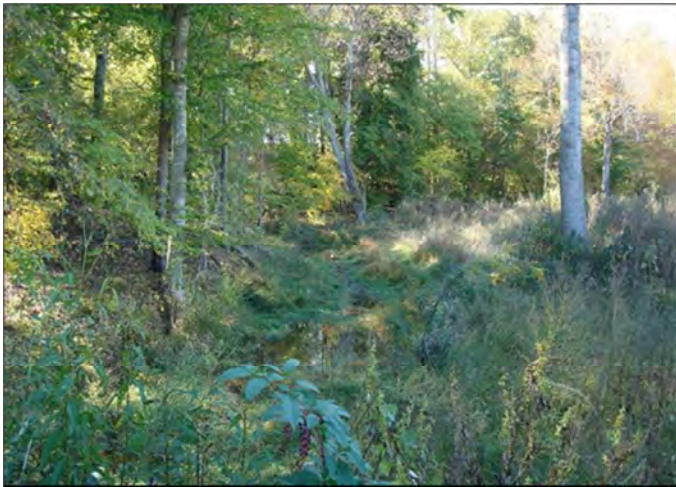
Buckhorn Creek facing upstream Year 1 Photo No. 8

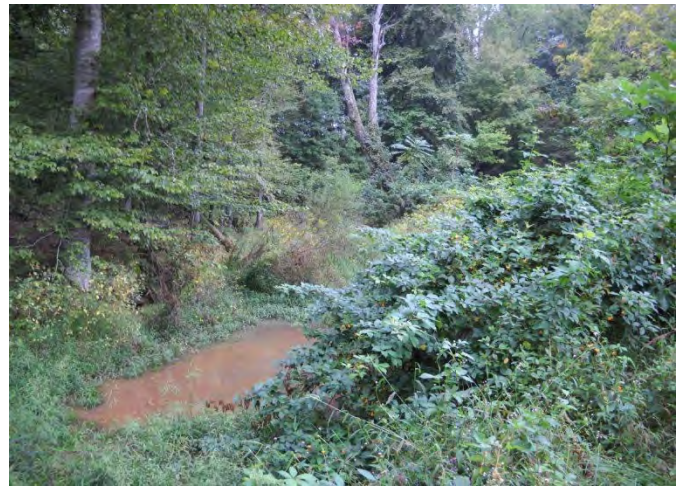
Buckhorn Creek facing upstream Year 4 Photo No. 11

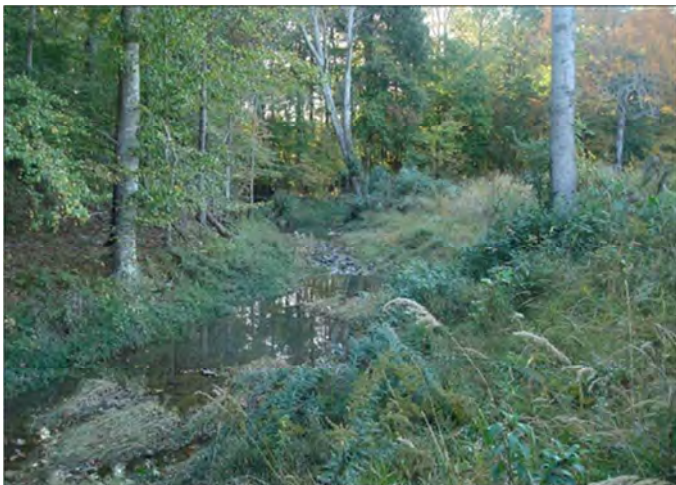
Buckhorn Creek facing upstream Year 2 Photo No. 9

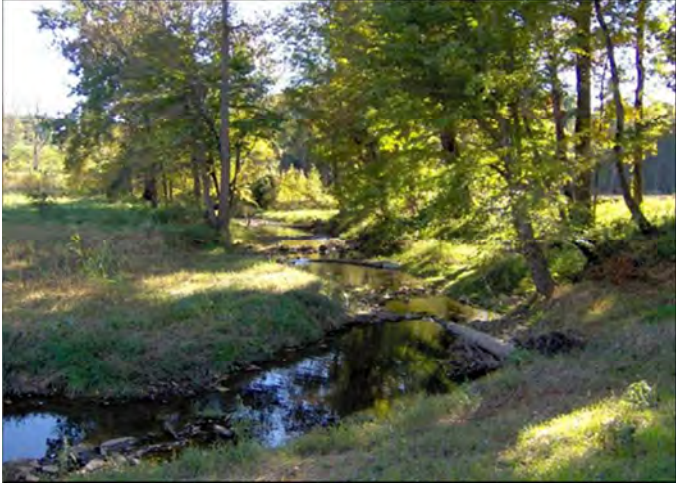
Buckhorn Creek facing upstream Year 0 Photo No. 13

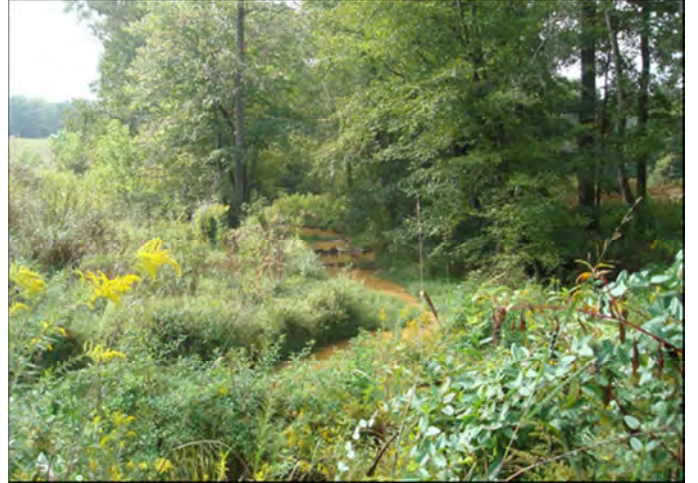
Buckhorn Creek facing upstream Year 3 Photo No. 16

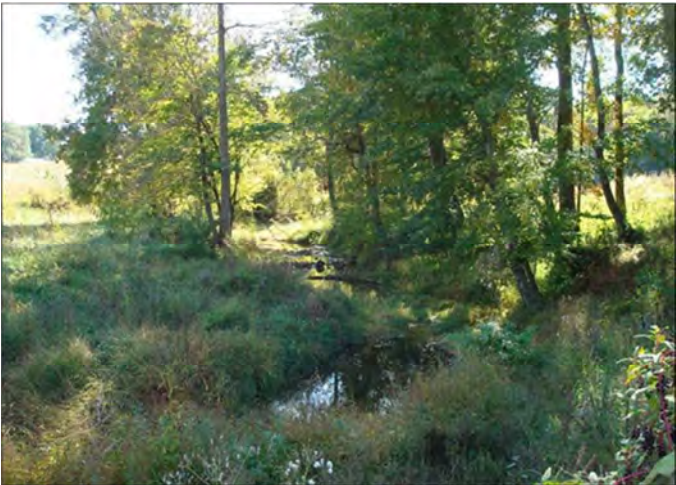
Buckhorn Creek facing upstream Year 1 Photo No. 14

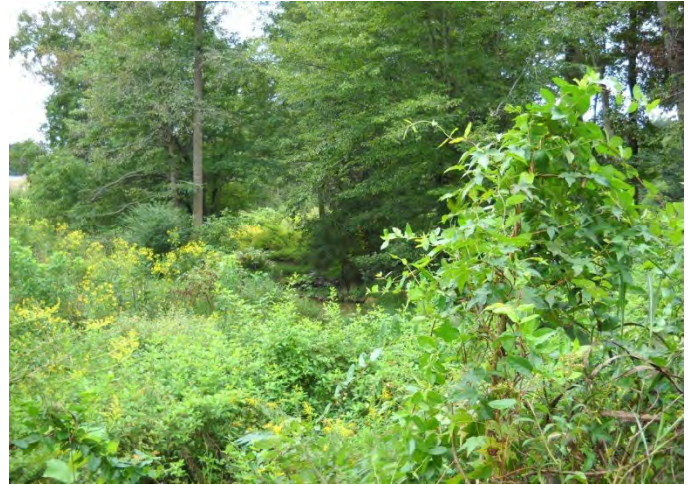
Buckhorn Creek facing upstream Year 4 Photo No. 17

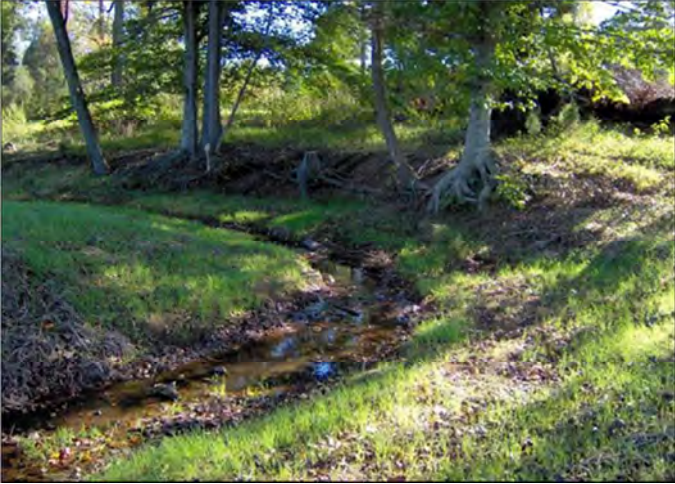
West Branch facing downstream Year 0 Photo No. 19

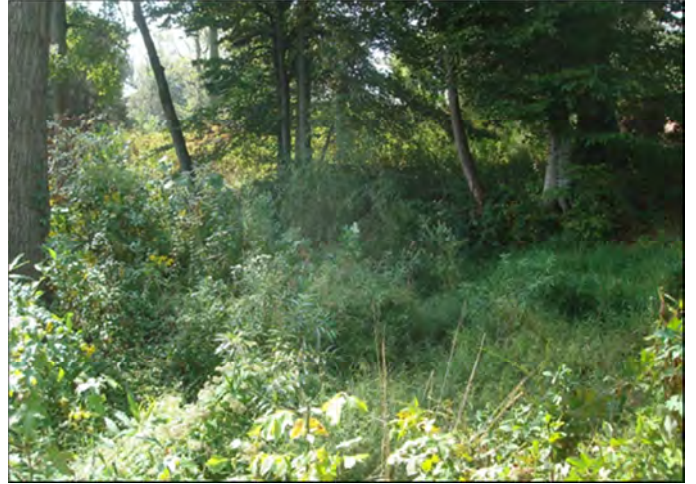
West Branch facing downstream Year 3 Photo No. 22

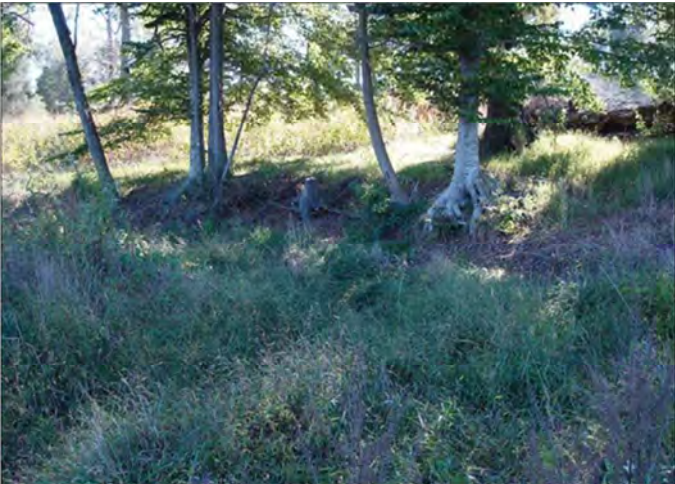
West Branch facing downstream Year 1 Photo No. 20

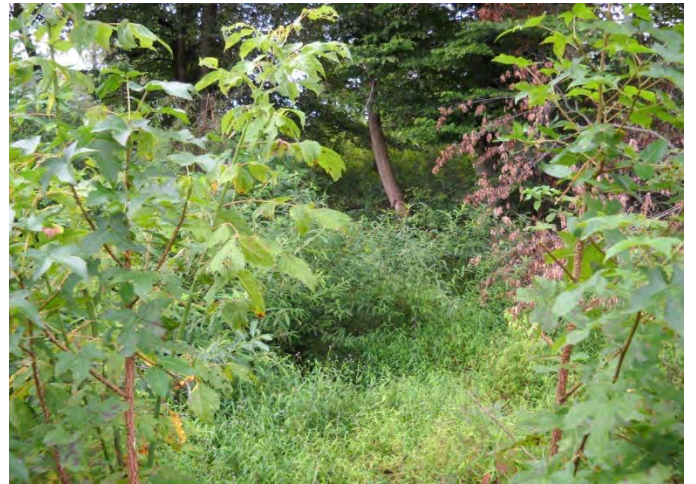
West Branch facing downstream Year 4 Photo No. 23

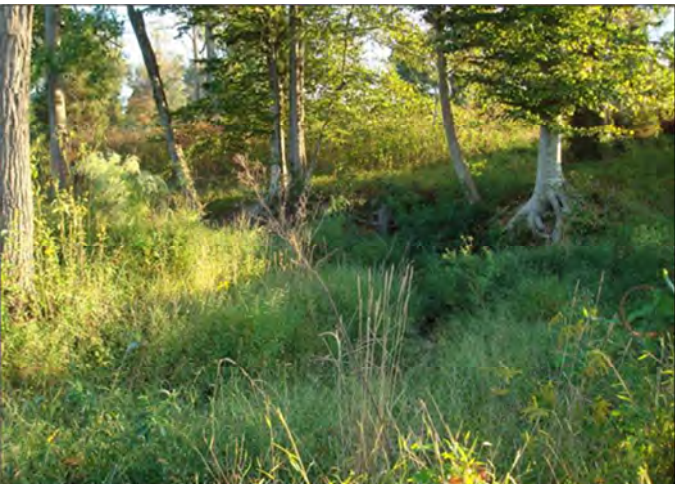
West Branch facing downstream Year 2 Photo No. 21

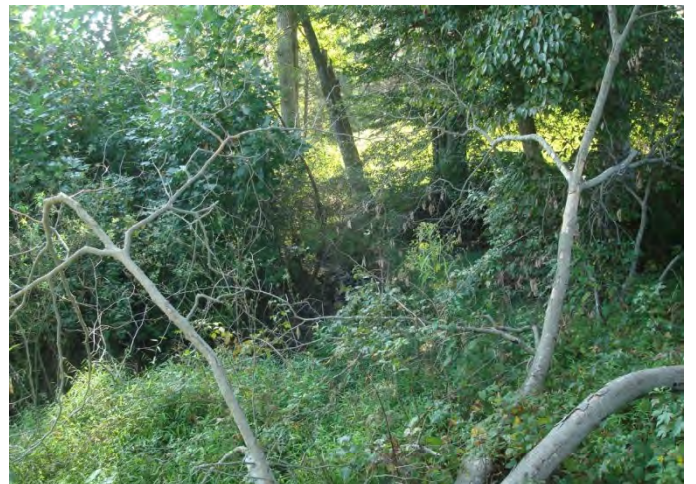
West Branch facing downstream Year 5 Photo No. 24

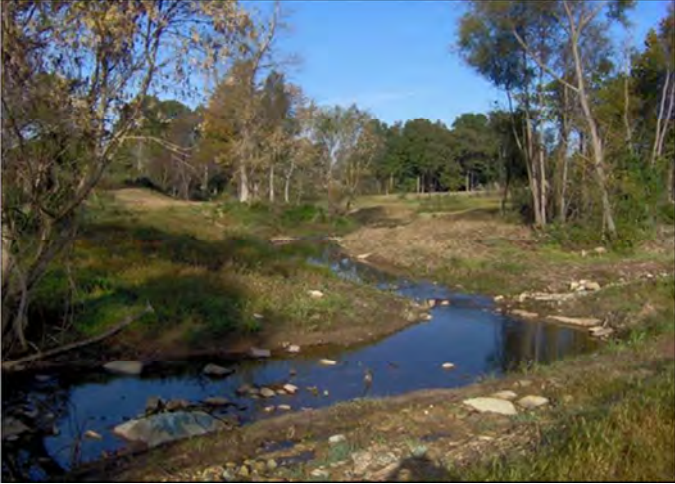
Buckhorn Creek facing upstream Year 0 Photo No. 25

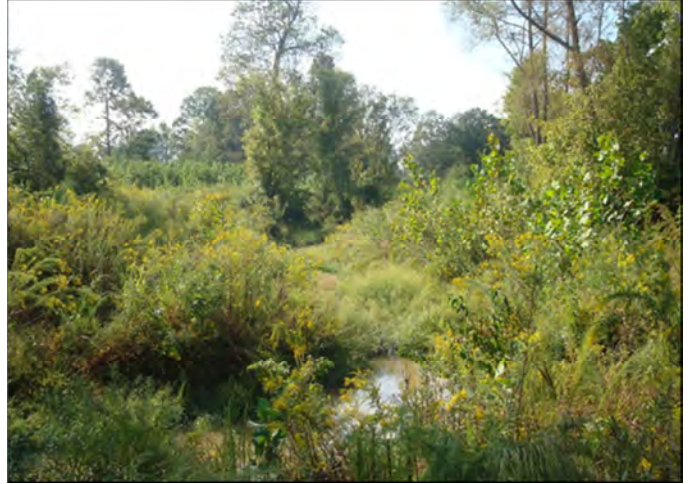
Buckhorn Creek facing upstream Year 3 Photo No. 28

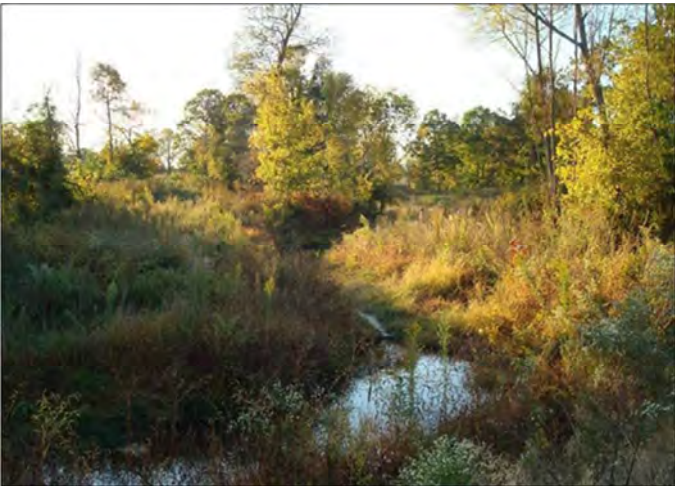
Buckhorn Creek facing upstream Year 1 Photo No. 26

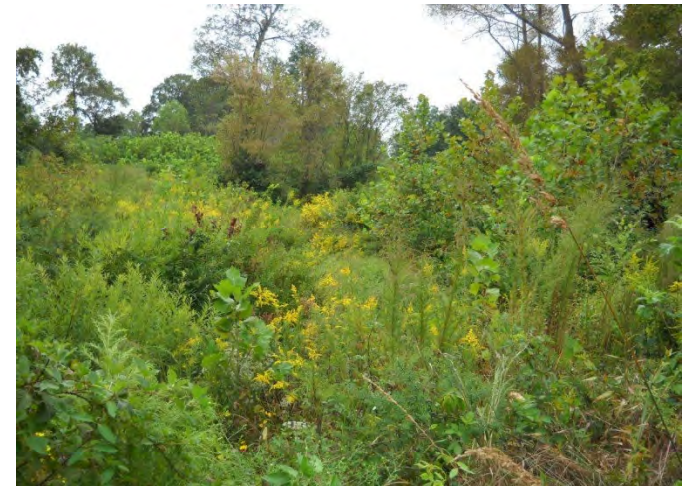
Buckhorn Creek facing upstream Year 4 Photo No. 29

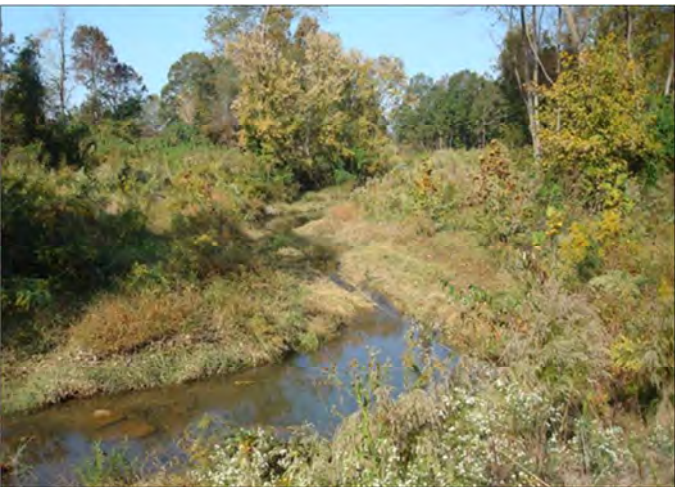
Buckhorn Creek facing upstream Year 2 Photo No. 27

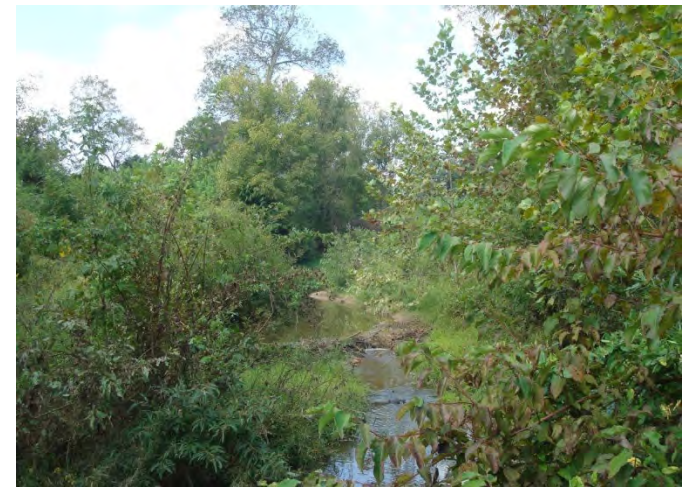
Buckhorn Creek facing upstream Year 5 Photo No. 30

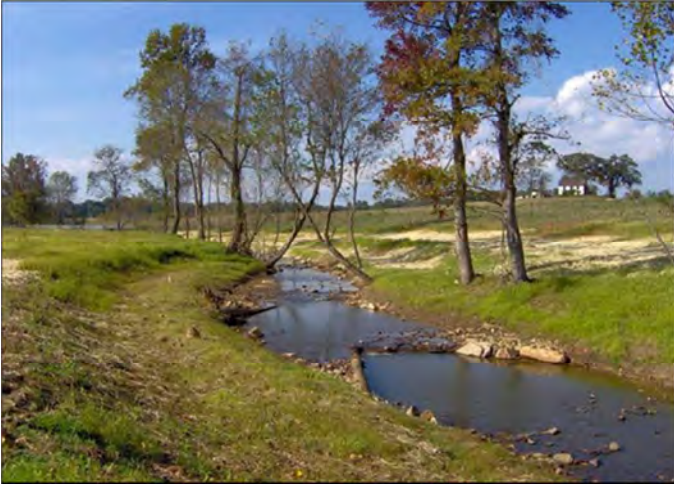
Buckhorn Creek facing upstream Year 0 Photo No. 43

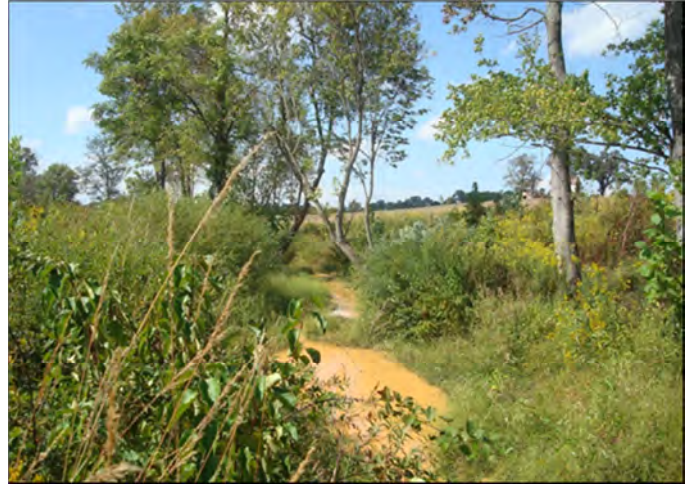
Buckhorn Creek facing upstream Year 3 Photo No. 46

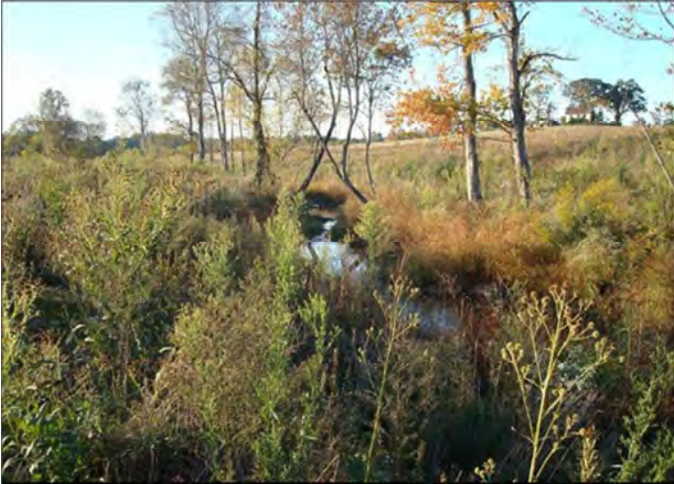
Buckhorn Creek facing upstream Year 1 Photo No. 44

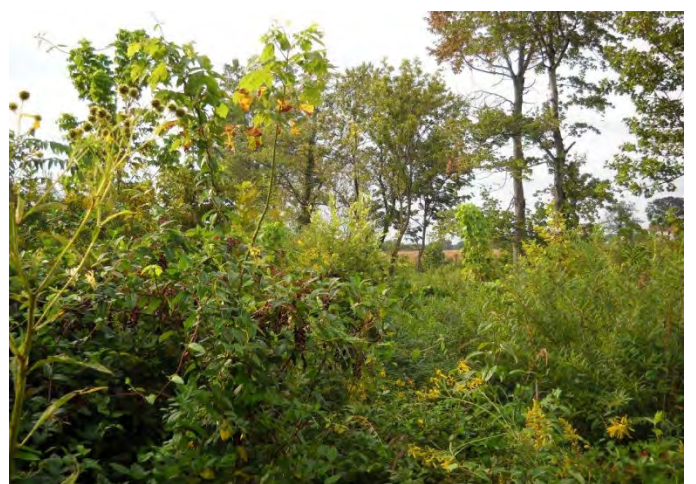
Buckhorn Creek facing upstream Year 4 Photo No. 47

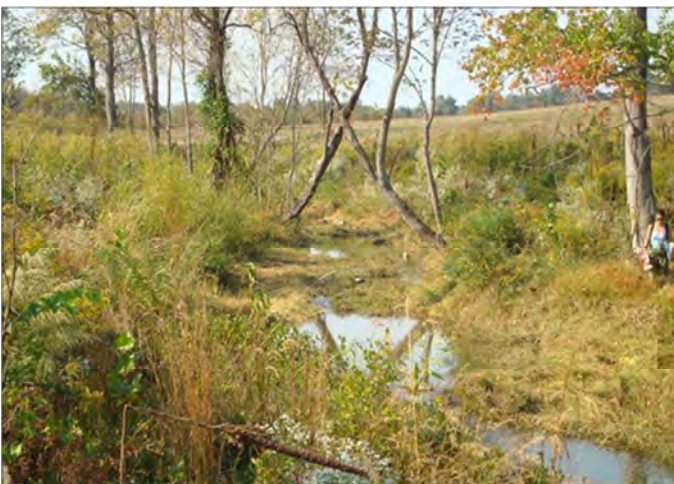
Buckhorn Creek facing upstream Year 2 Photo No. 45
