MONITORING YEAR 2 ANNUAL REPORT

HONEY MILL MITIGATION SITE

Surry County, NC
DEQ Contract No. 7619
DMS Project No. 100083

Data Collection Period: January 2022 – October 2022
FINAL Submission Date: February, 2022

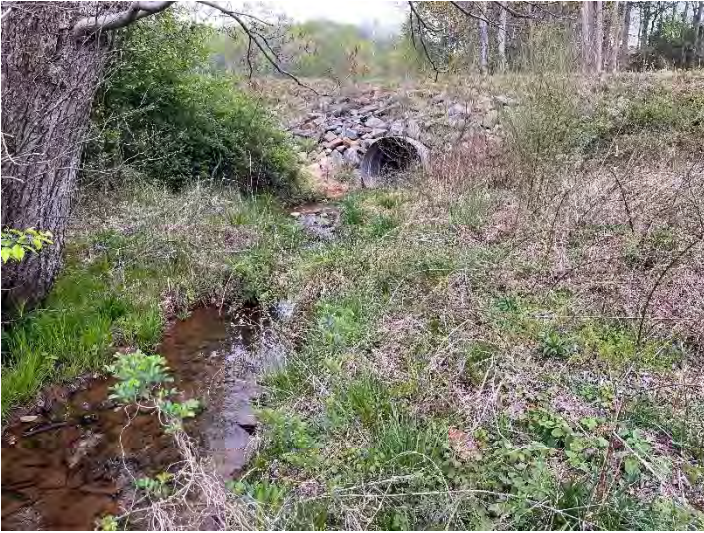
PHOTO POINT 1 Venable Creek R1 – upstream (04/14/2022)

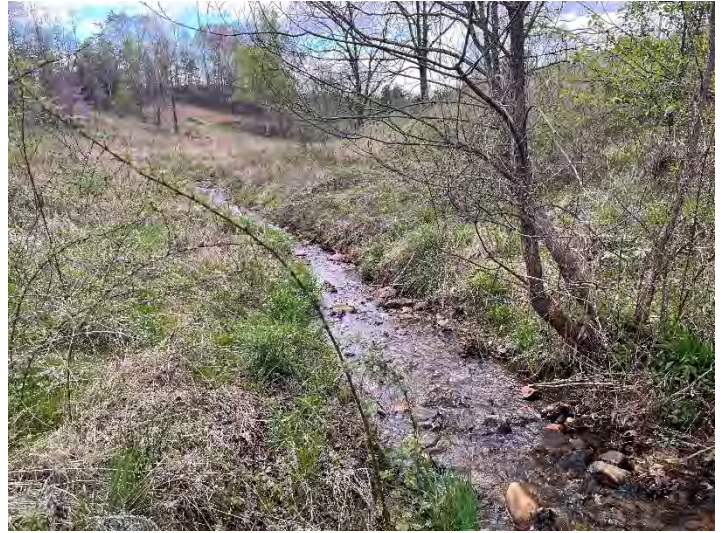
PHOTO POINT 1 Venable Creek R1 – downstream (04/14/2022)

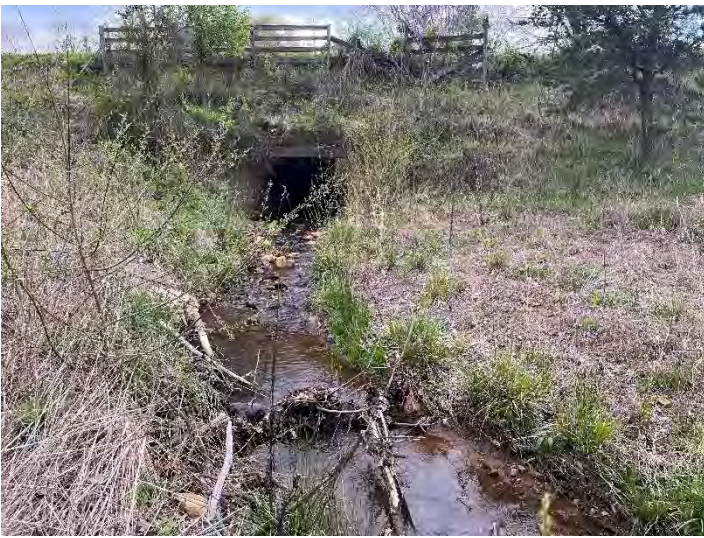
PHOTO POINT 2 UT1 – upstream (04/14/2022)

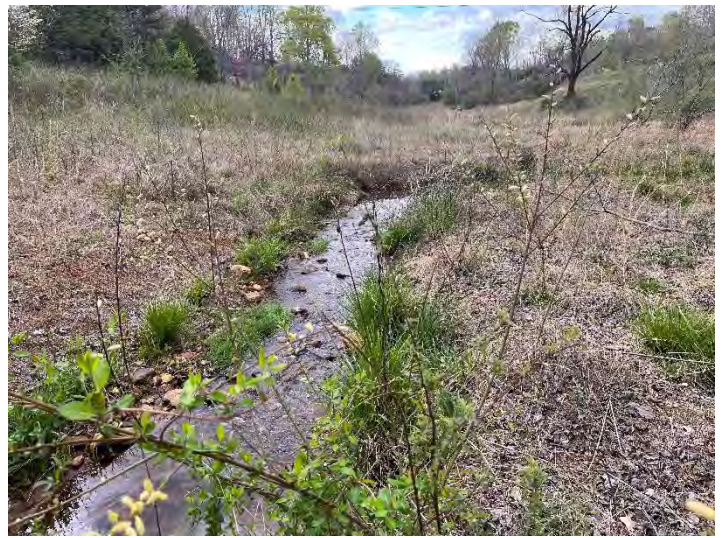
PHOTO POINT 2 UT1 – downstream (04/14/2022)

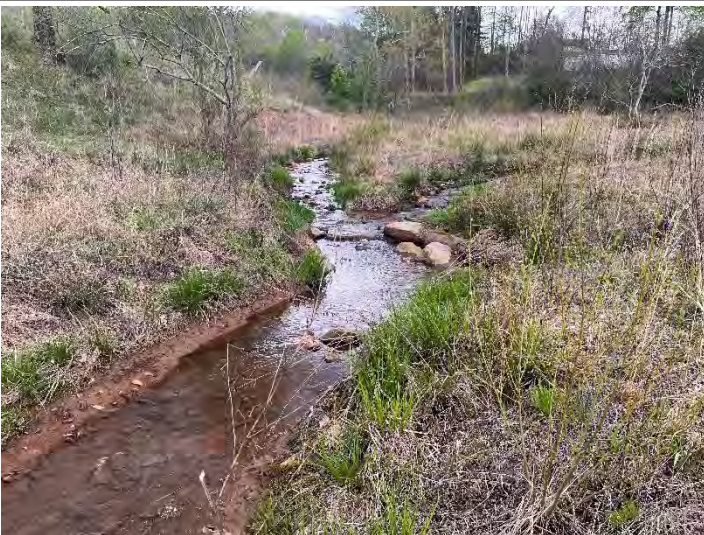
PHOTO POINT 3 Venable Creek R2 – upstream (04/14/2022)

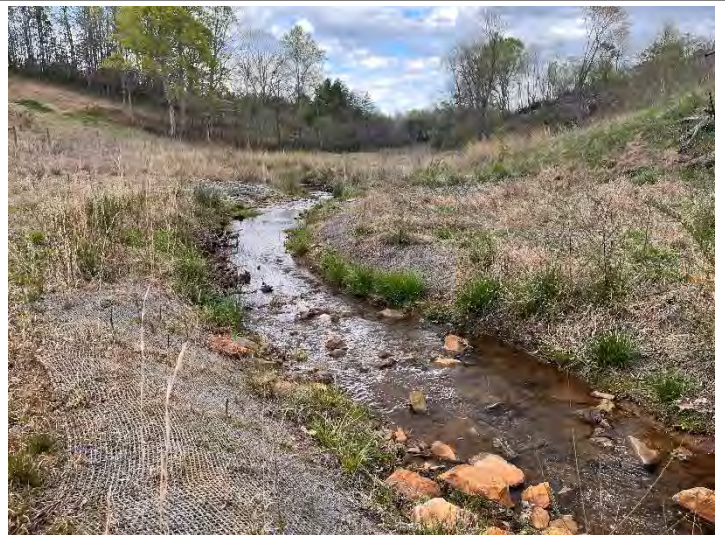
PHOTO POINT 3 Venable Creek R2 – downstream (04/14/2022)

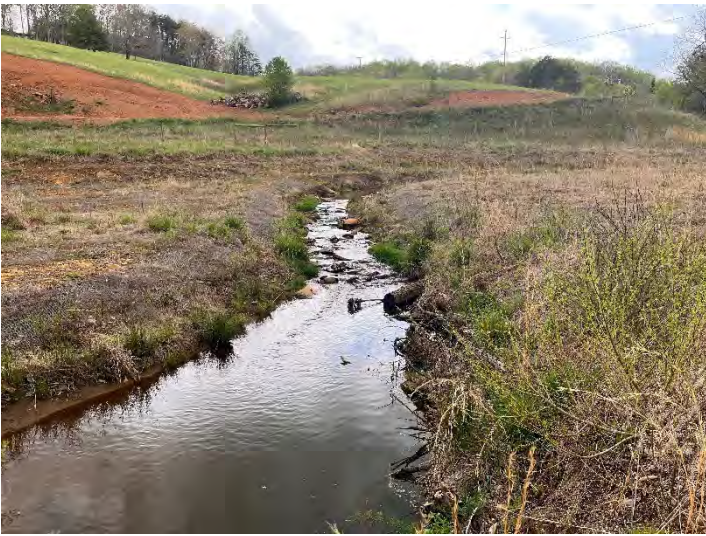
PHOTO POINT 4 Venable Creek R3 – upstream (04/14/2022)

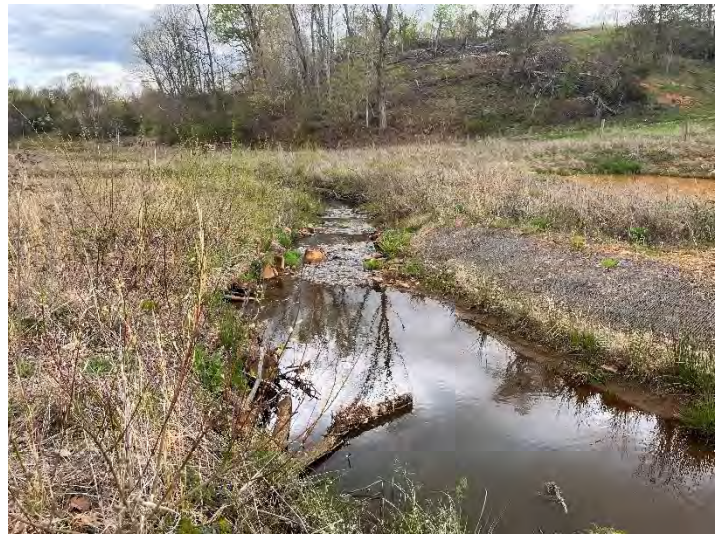
PHOTO POINT 4 Venable Creek R3 – downstream (04/14/2022)

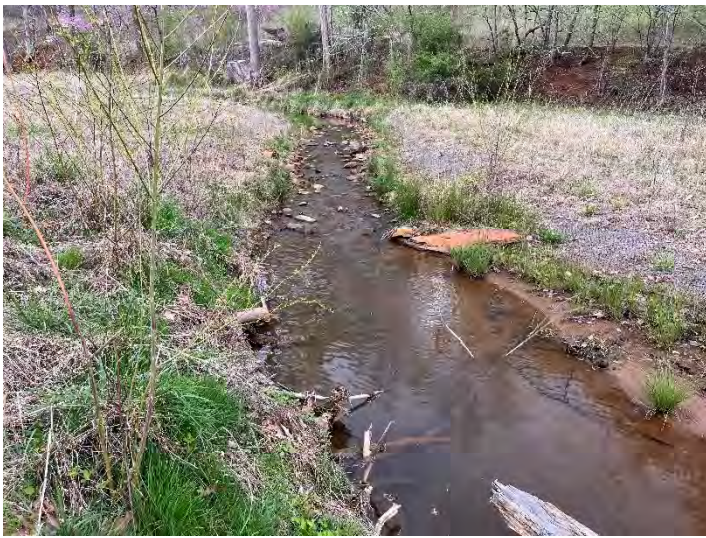
PHOTO POINT 5 Venable Creek R3 – upstream (04/14/2022)

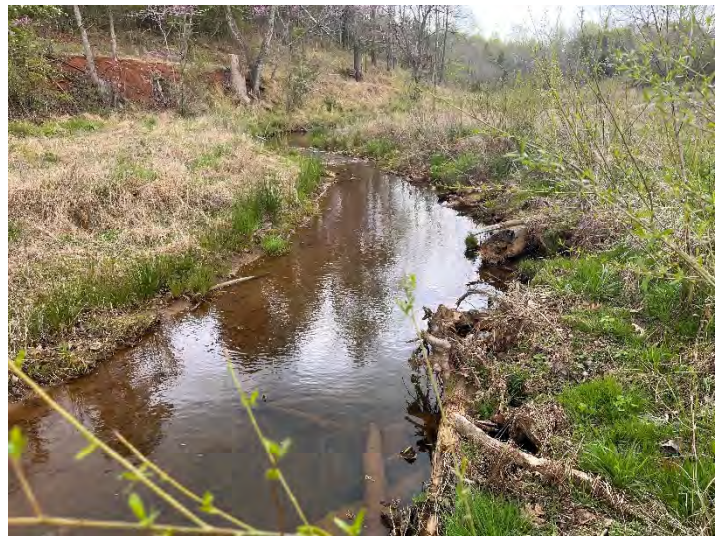
PHOTO POINT 5 Venable Creek R3 – downstream (04/14/2022)

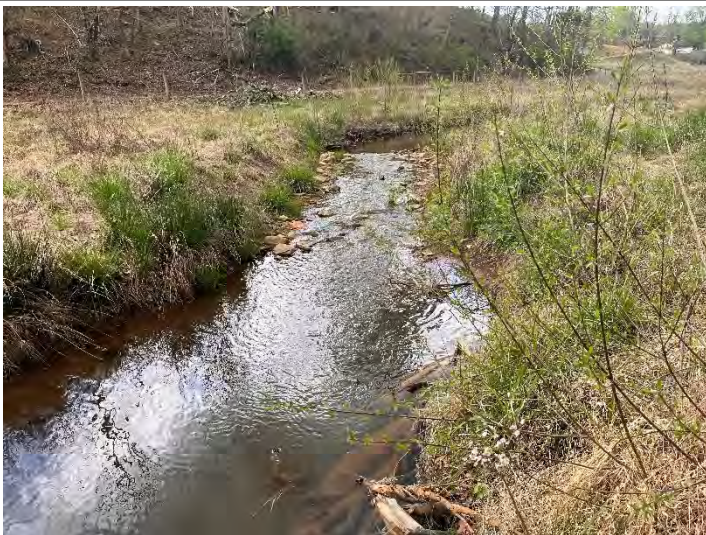
PHOTO POINT 6 Venable Creek R3 – upstream (04/14/2022)

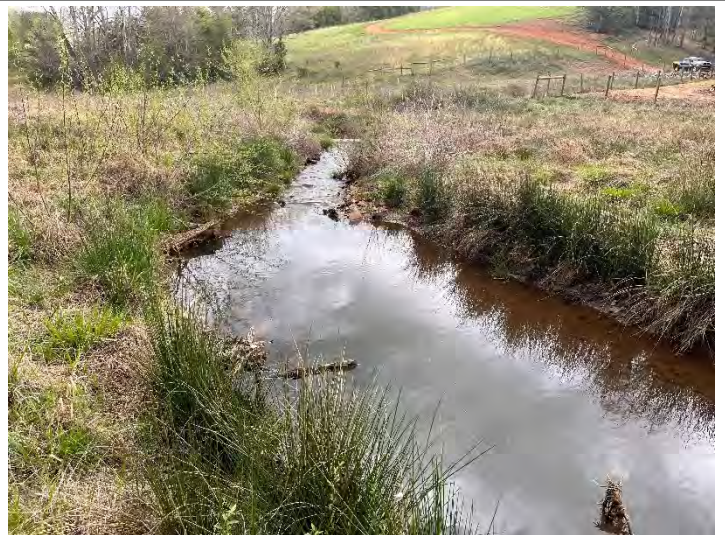
PHOTO POINT 6 Venable Creek R3 – downstream (04/14/2022)

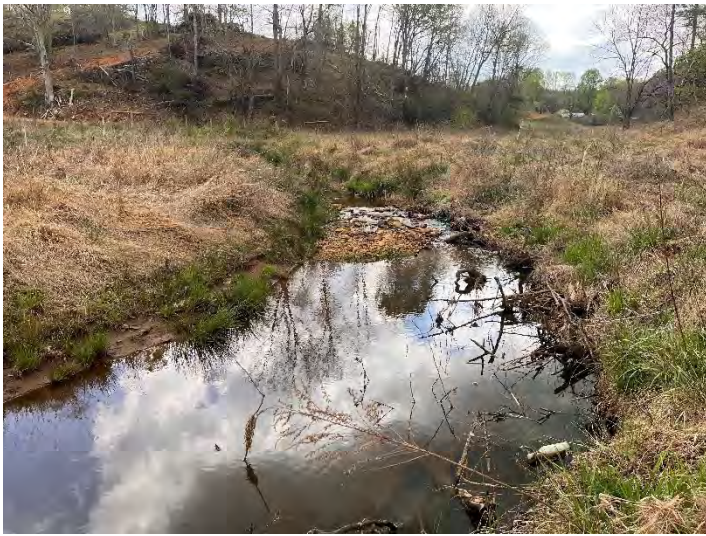
PHOTO POINT 7 Venable Creek R3 – upstream (04/14/2022)

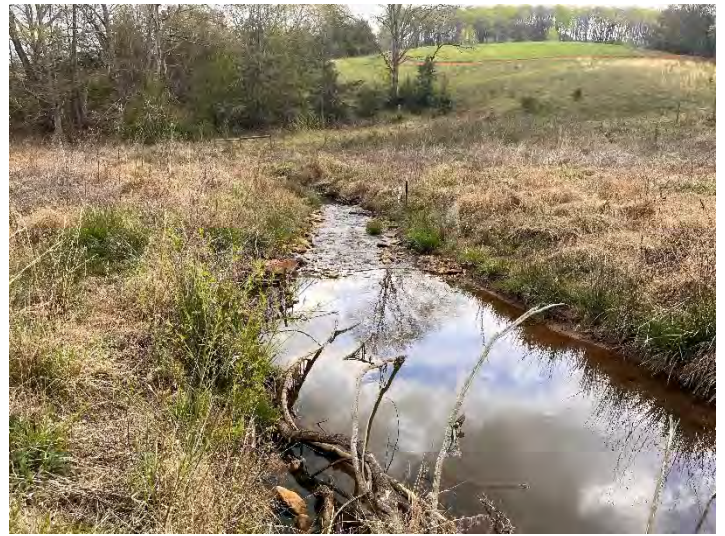
PHOTO POINT 7 Venable Creek R3 – downstream (04/14/2022)

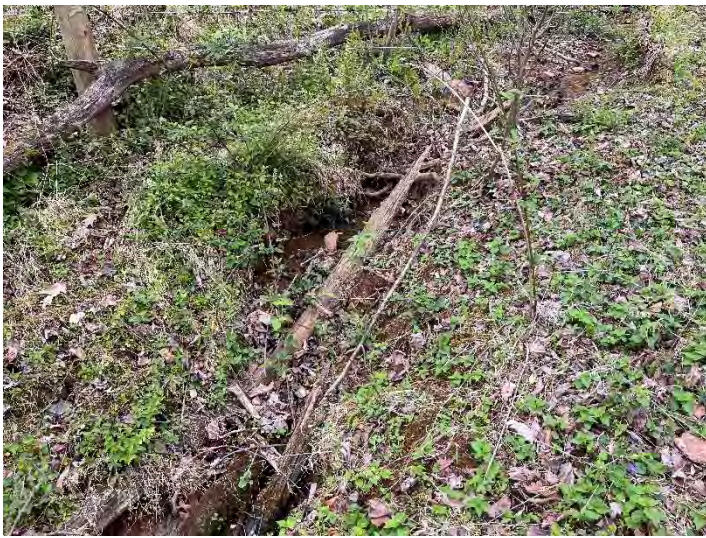
PHOTO POINT 8 UT2 R1 Headcut – upstream (04/14/2022)

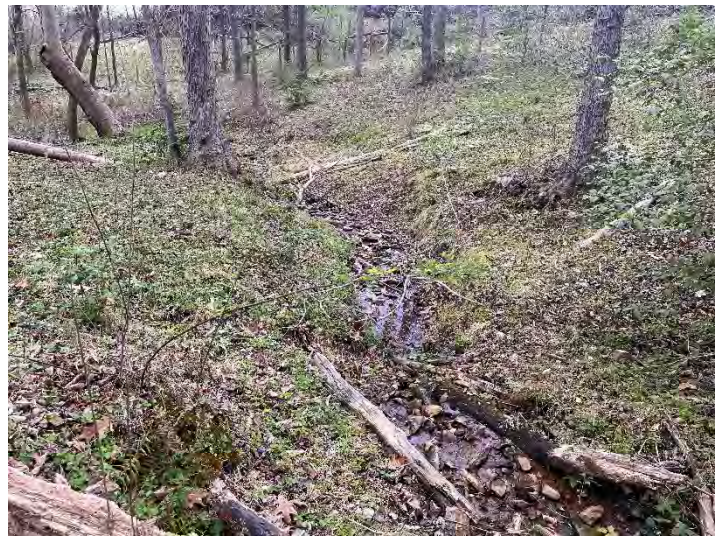
PHOTO POINT 8 UT2 R1 – downstream (04/14/2022)

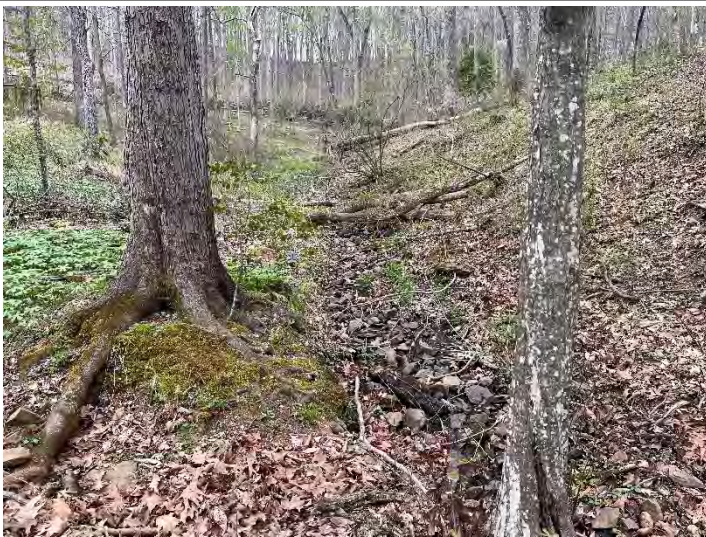
PHOTO POINT 9 UT2 R1 – upstream (04/14/2022)

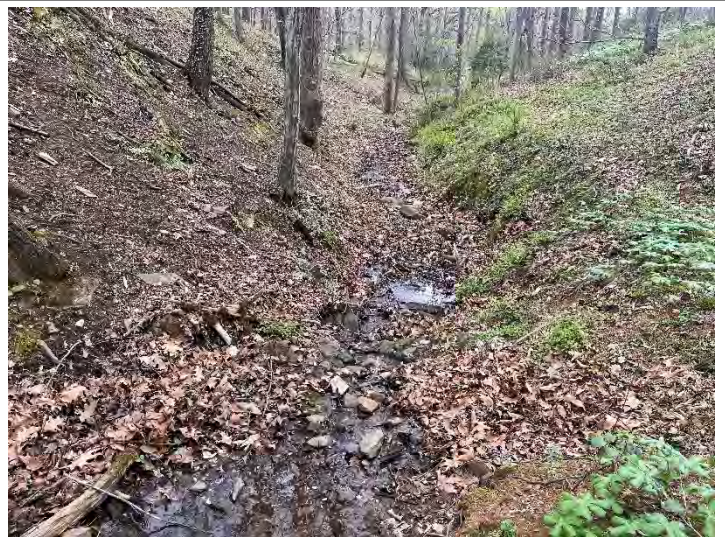
PHOTO POINT 9 UT2 R1 – downstream (04/14/2022)

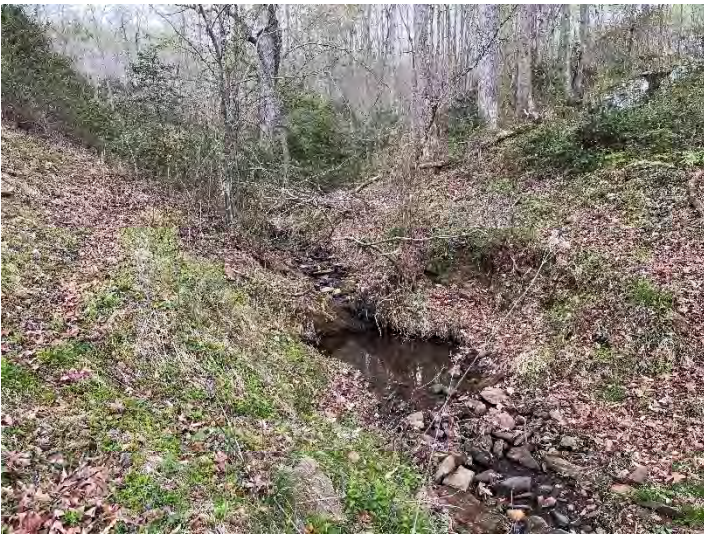
PHOTO POINT 10 UT2 R1 – upstream (04/14/2022)

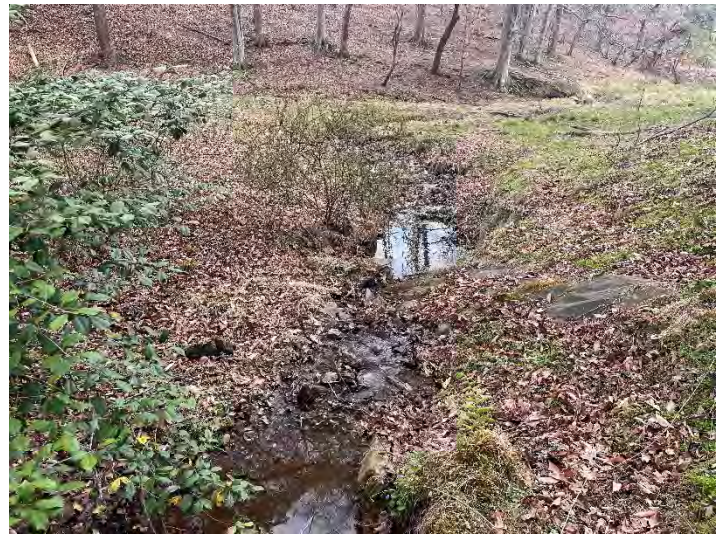
PHOTO POINT 10 UT2 R1 – downstream (04/14/2022)

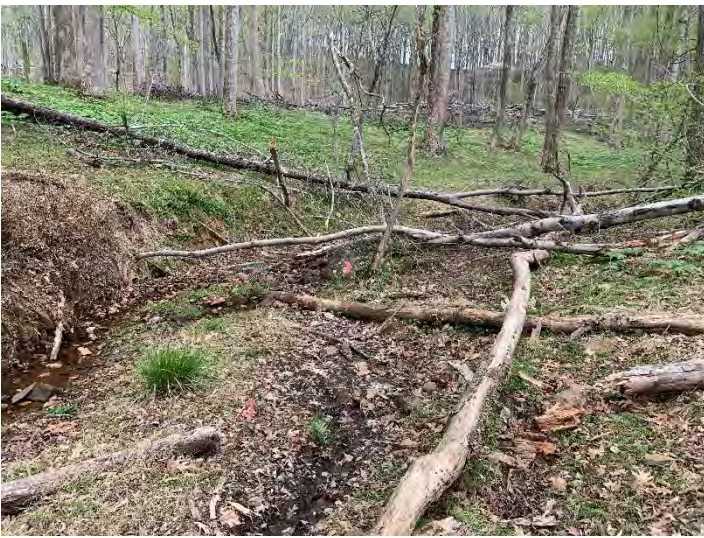
PHOTO POINT 11 UT2A – upstream (04/14/2022)

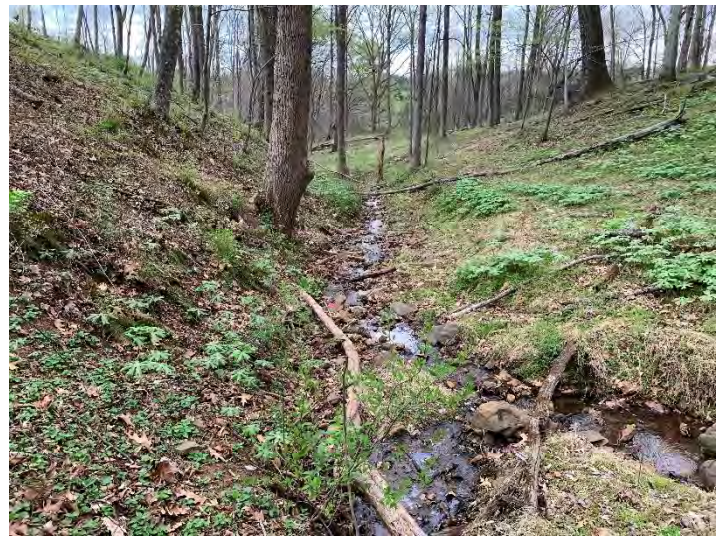
PHOTO POINT 11 UT2A – downstream (04/14/2022)

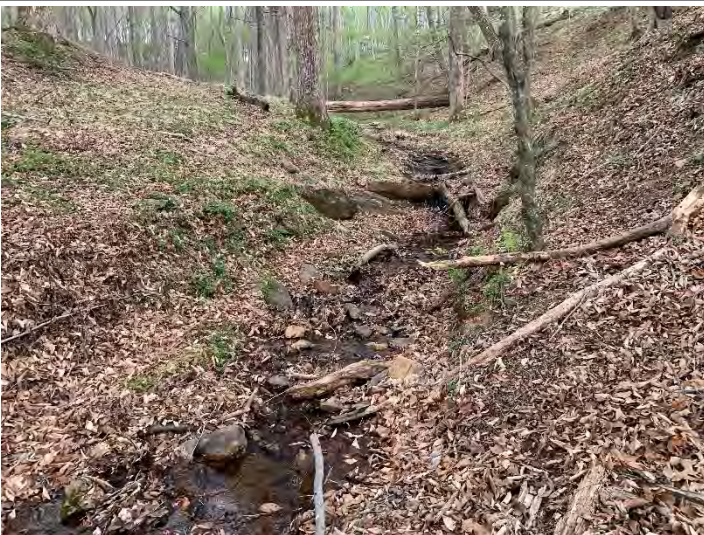
PHOTO POINT 12 UT2A – upstream (04/14/2022)

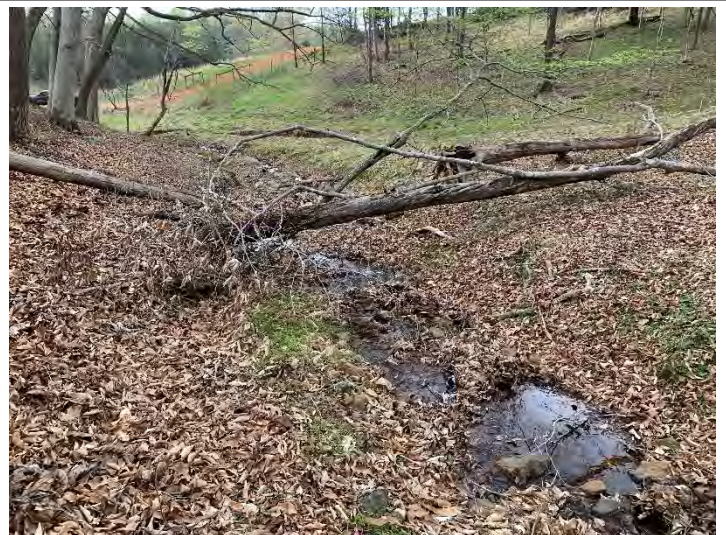
PHOTO POINT 12 UT2A – downstream (04/14/2022)

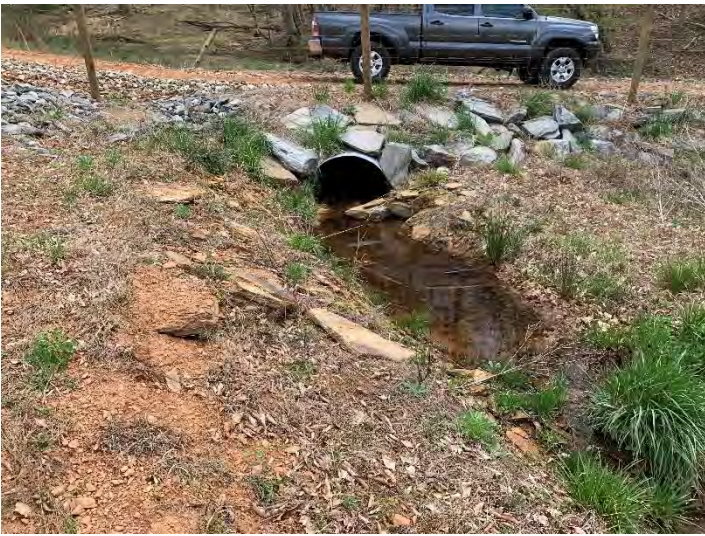
PHOTO POINT 13 UT2 R2 – upstream (04/14/2022)

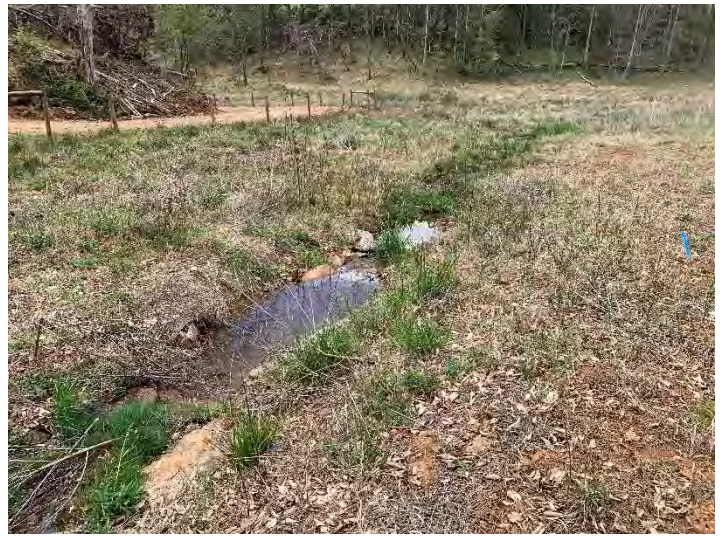
PHOTO POINT 13 UT2 R2 – downstream (04/14/2022)

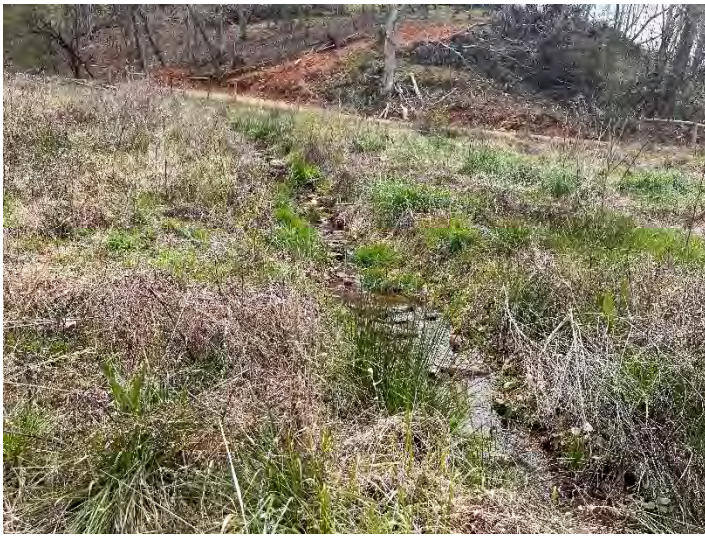
PHOTO POINT 14 UT2 R2 – upstream (04/14/2022)

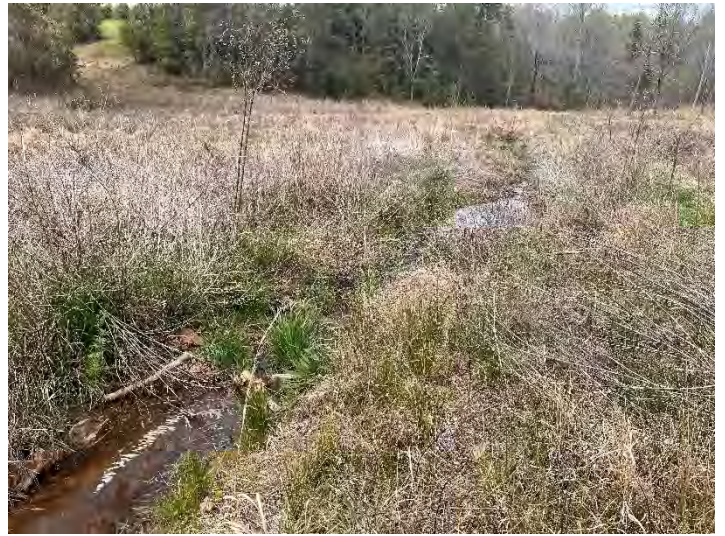
PHOTO POINT 14 UT2 R2 – downstream (04/14/2022)

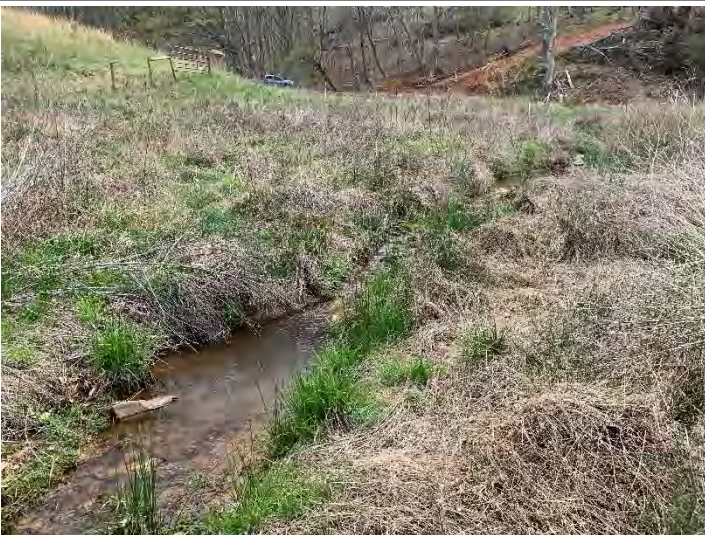
PHOTO POINT 15 UT2 R2 – upstream (04/14/2022)

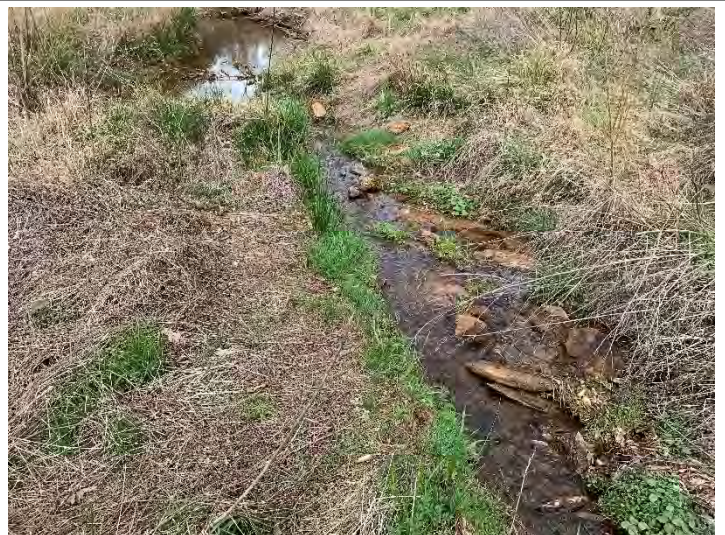
PHOTO POINT 15 UT2 R2 – downstream (04/14/2022)

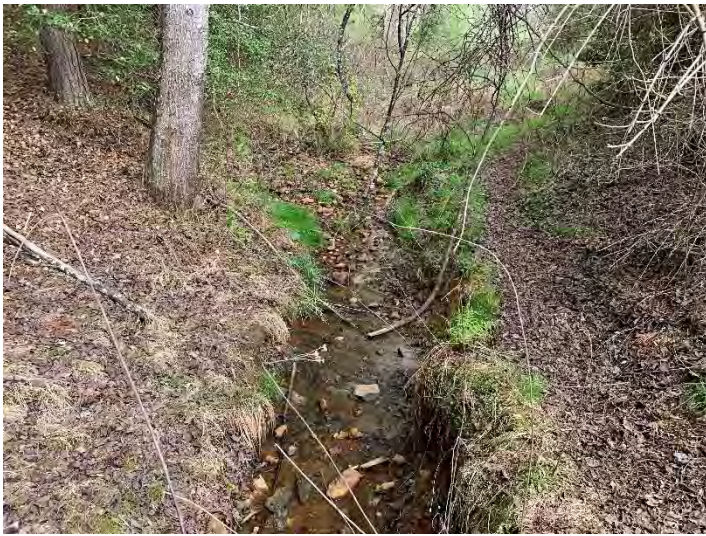
PHOTO POINT 16 UT3 R1 – upstream (04/14/2022)

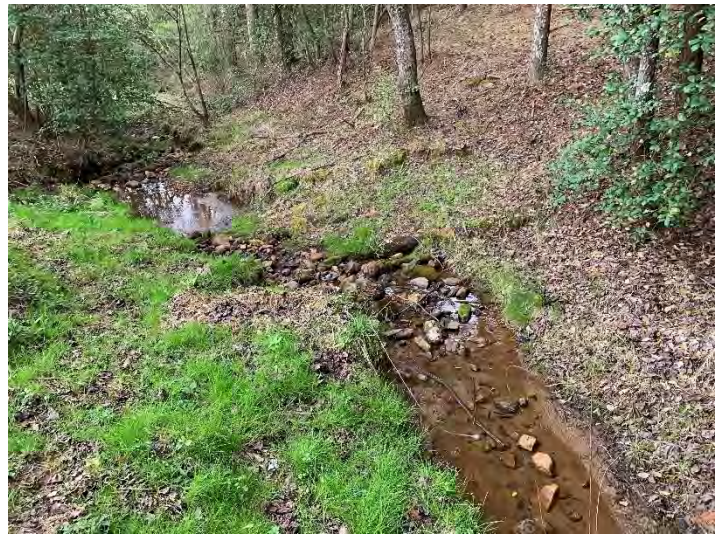
PHOTO POINT 16 UT3 R1 – downstream (04/14/2022)

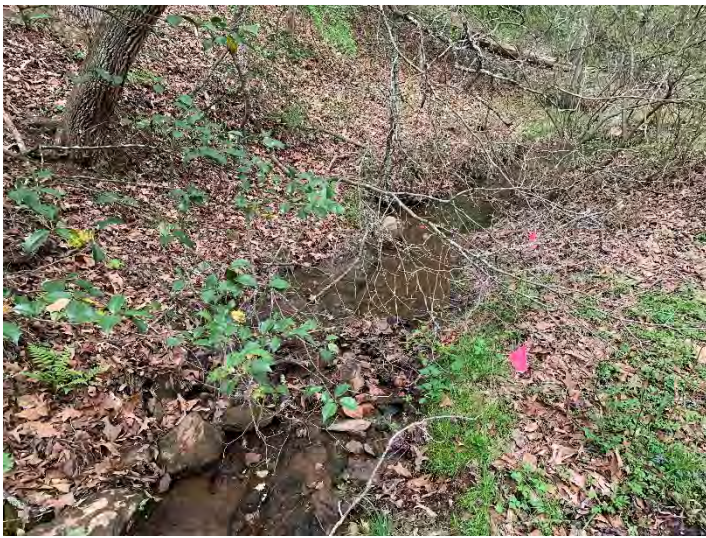
PHOTO POINT 17 UT3 R1 – upstream (04/14/2022)

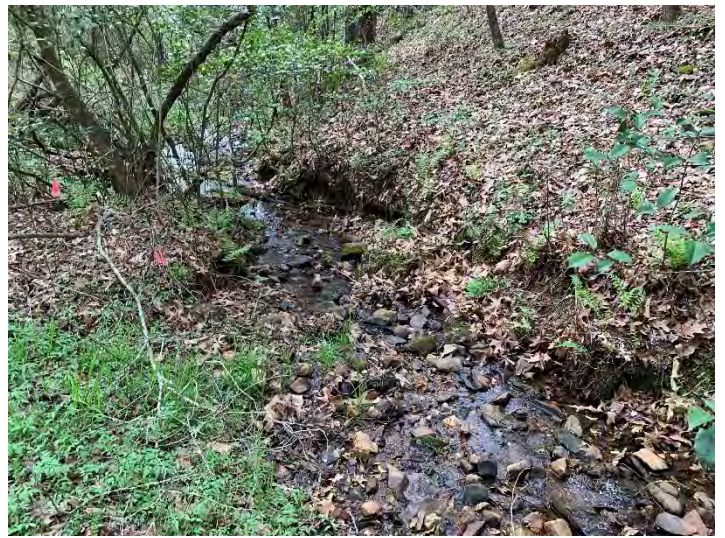
PHOTO POINT 17 UT3 R1 – downstream (04/14/2022)

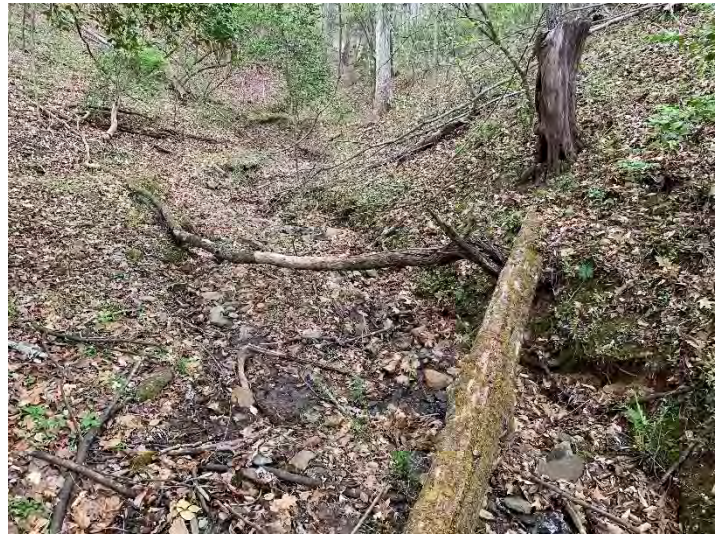
PHOTO POINT 23 UT5 Headcut – upstream (04/14/2022)

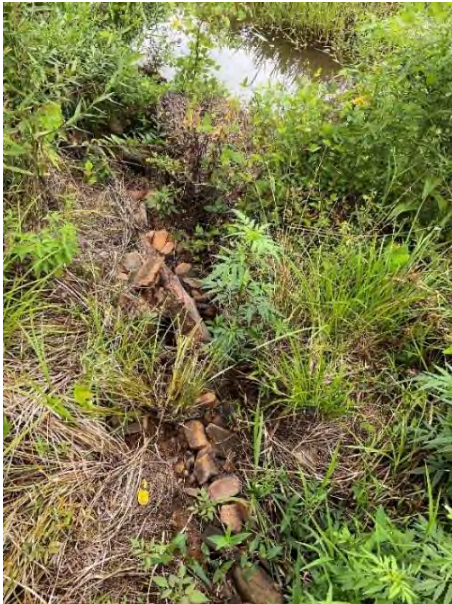
UT2B Dry Channel– upstream (08/16/2022)
