# MONITORING YEAR 3 ANNUAL REPORT

## HONEY MILL MITIGATION SITE

Surry County, NC  
DEQ Contract No. 7619  
DMS Project No. 100083

Data Collection Period: January 2023 – October 2023  
FINAL Submission Date: January, 2024

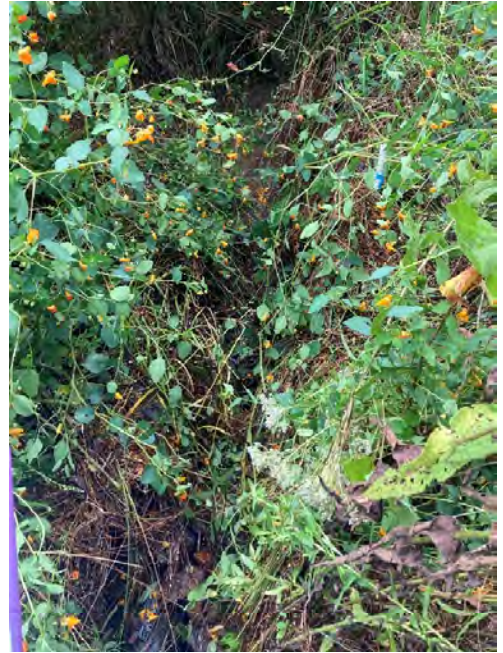
**UT3-** Subsurface Flow to Venable Creek stable upstream (08/30/2023)

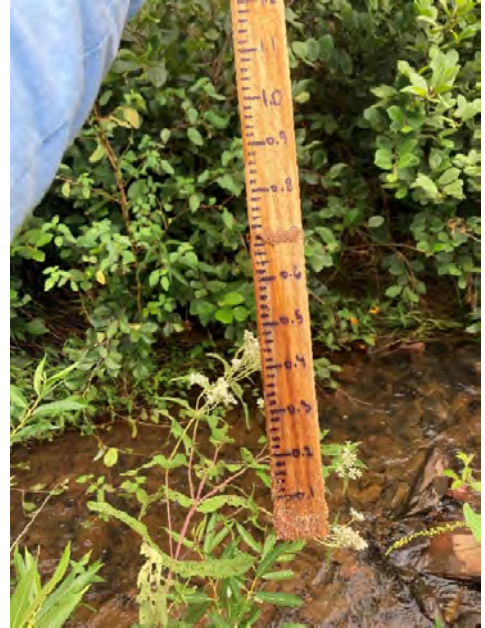
**VC R3-** bankfull event recorded at manual gage (08/30/2023)
