MONITORING YEAR 6 ANNUAL REPORT Final

HOPEWELL STREAM MITIGATION SITE

Randolph County, NC

DMS Project No. 95352

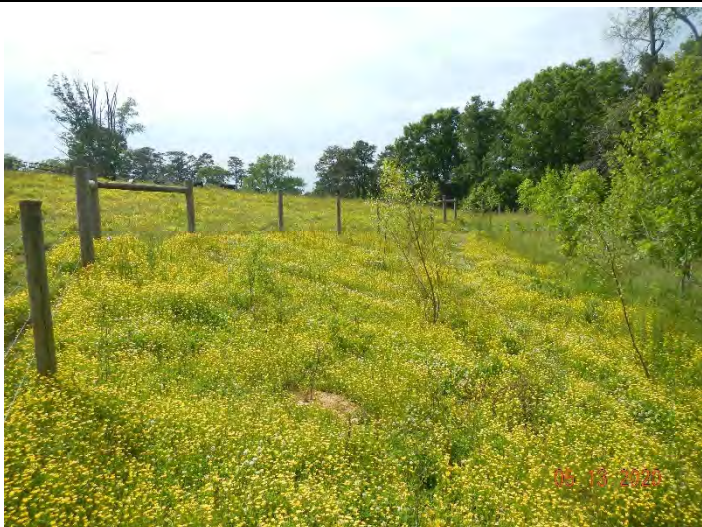
Left easement corner at Station 303+50 – new fencing / plantings (05/13/2020)
