FINAL MONITORING REPORT (MY7) / CLOSEOUT REPORT

HOPEWELL STREAM MITIGATION SITE

Randolph County, NC

DMS Project No. 95352

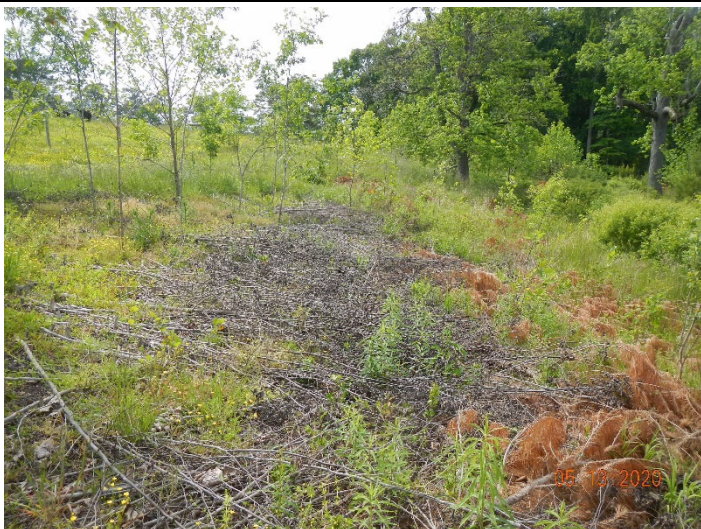
Left hillside at Station 303+50 – sweetgum treatment / plantings (05/13/2020)

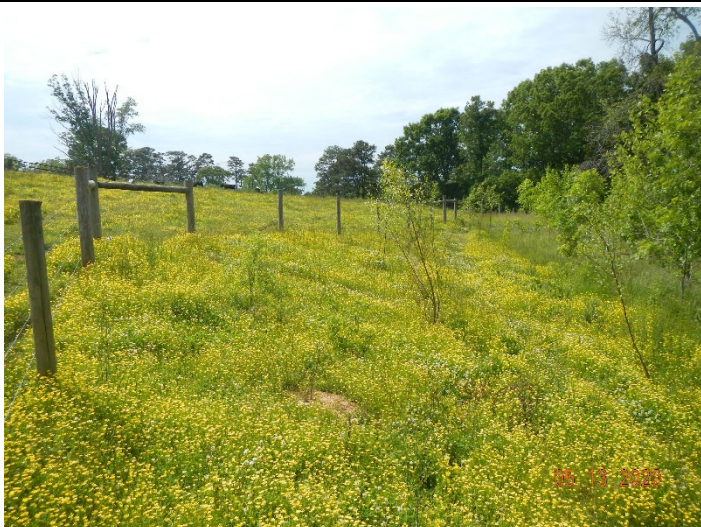
Left easement corner at Station 303+50 – new fencing / plantings (05/13/2020)
