South Muddy Creek Stream Restoration Project Final Baseline Monitoring Document and As-Built Baseline Report

McDowell County, North Carolina

NCEEP Project Numbers - 737 and 92251

Submission Date: June 30, 2011

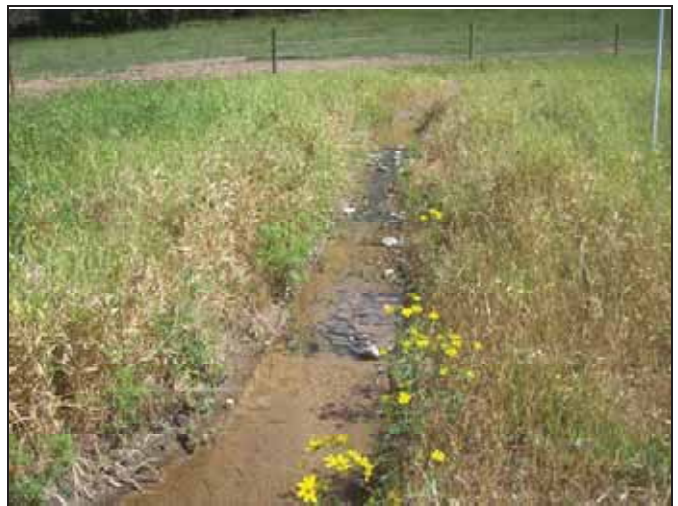
UT1 PID 18 – Constructed Riffle

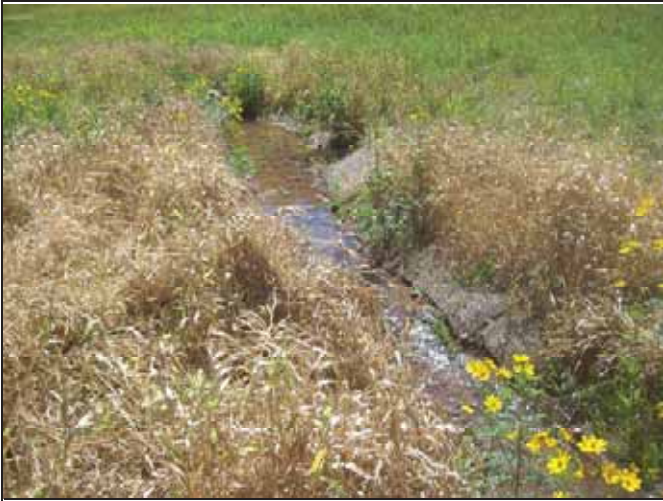
UT1 PID 19 – Constructed Riffle

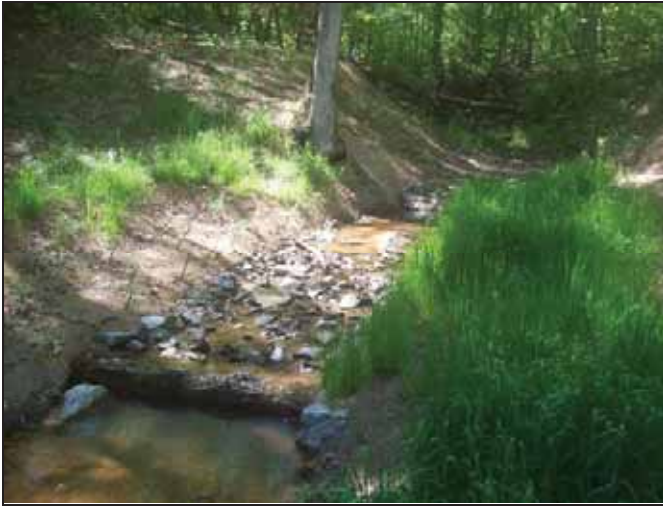
UT2 PID 1 – Constructed Riffle & Log Sill
