Hoppers Creek-Melton Farm Stream Restoration Project

Year 1 Monitoring Report

McDowell County, North Carolina

NCEEP Project Number – 92251

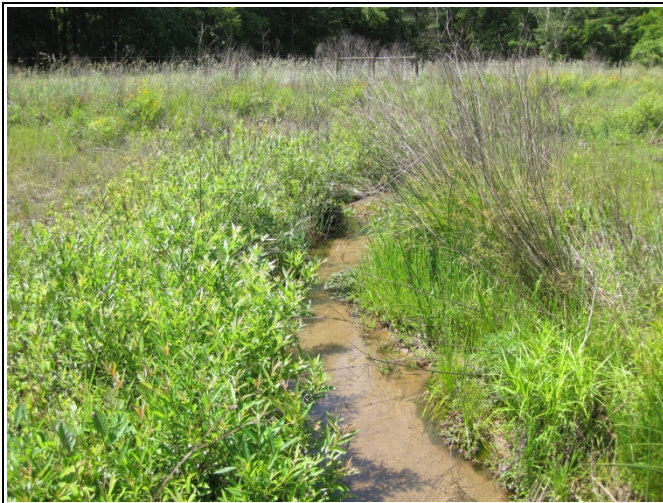
SFHC PID 3 – Log vane in constructed pool

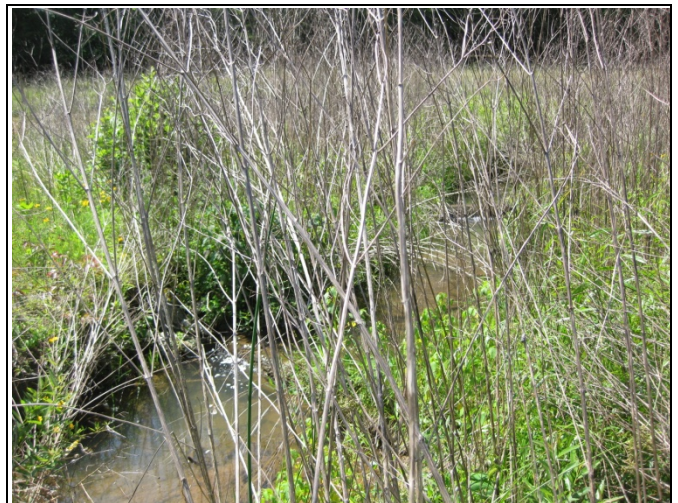
SFHC PID 6 – Log Sills and Root Wad

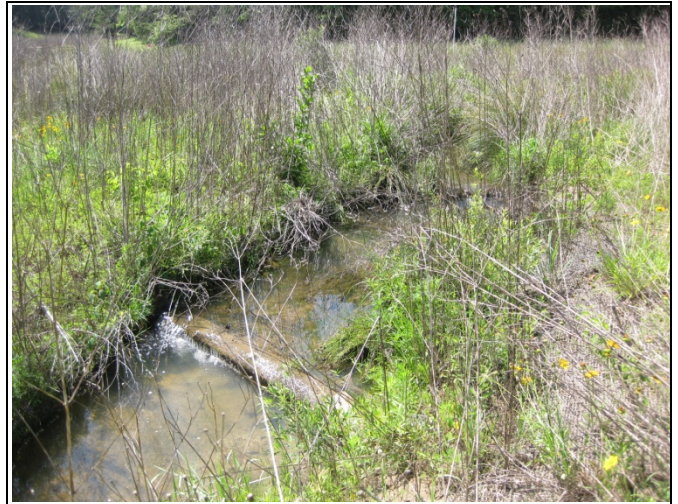
SFHC PID 8 – Log Sills & Root Wad

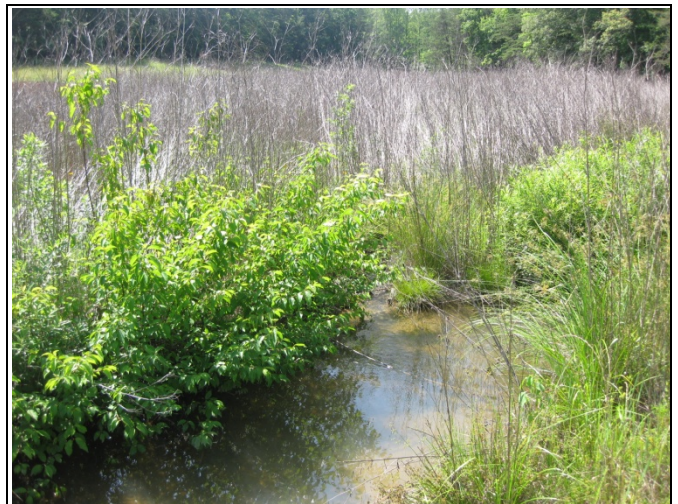
SFHC PID 10 – Confluence of UT1

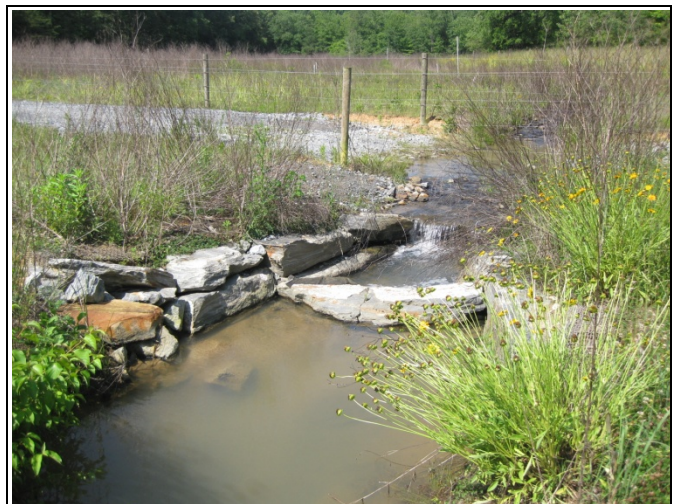
SFHC PID 12 – Double Drop Cross Vane below crossing

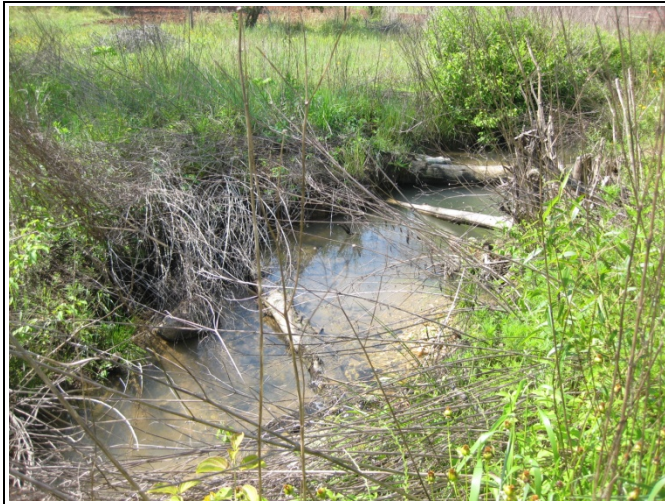
SFHC PID 13 – Log Sills &
Root Wad

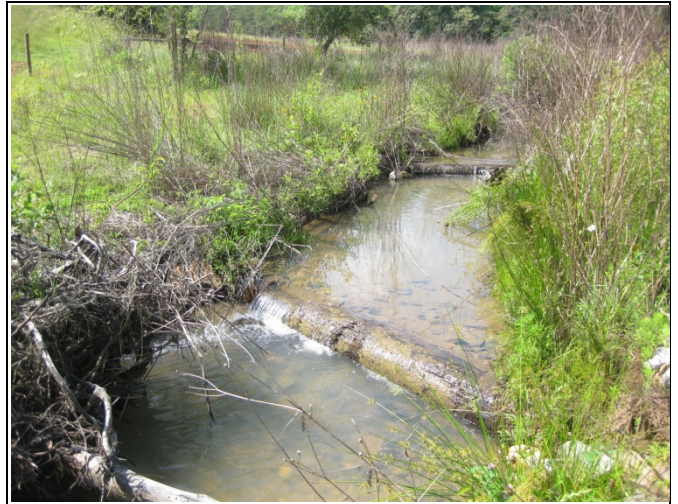
SFHC PID 14 – Log Sills & Root Wad

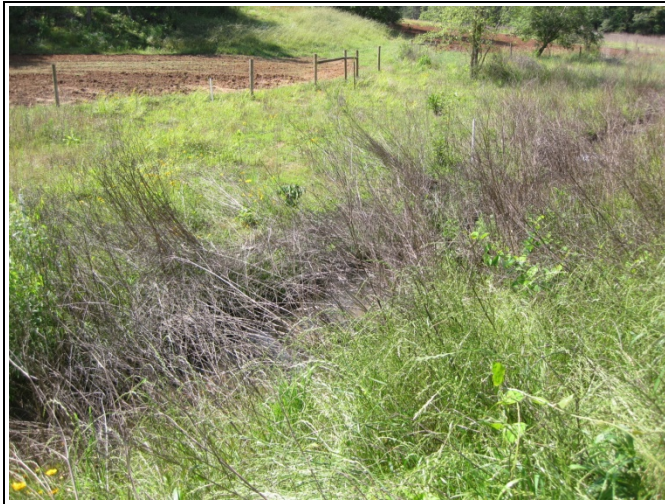
SFHC PID 15 – Log Sills & Root Wads

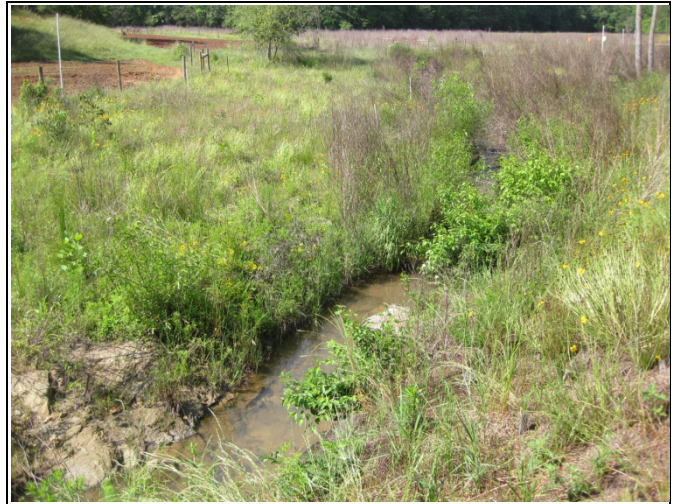
SFHC PID 16 – Log Vane & Matted Bank

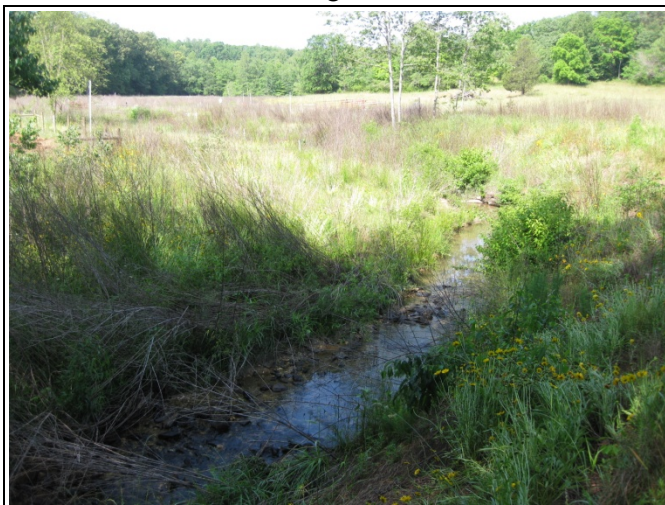
SFHC PID 17 – Constructed Riffle at downstream
terminus of project

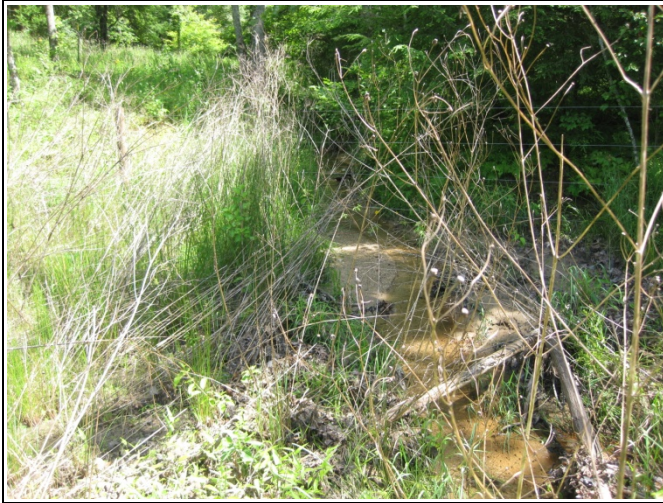
UT1 PID 1 – Constructed Riffle

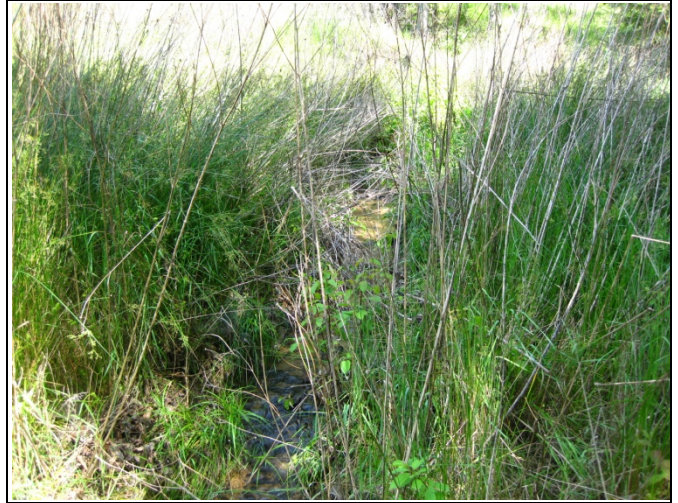
UT1 PID 2 – Constructed Riffle

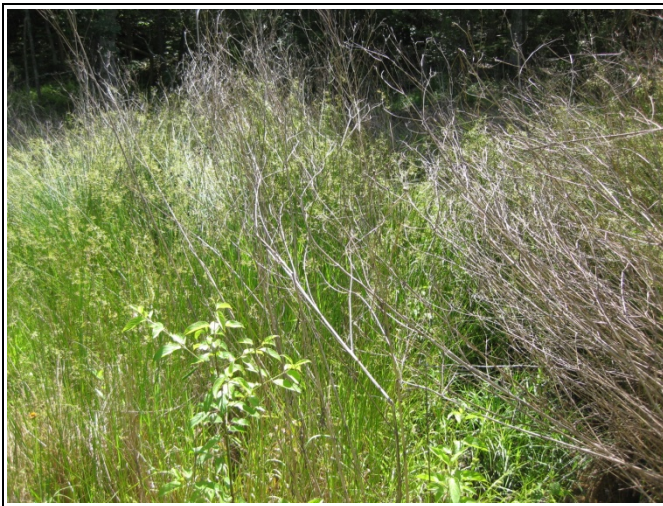
UT1 PID 3 – Constructed Riffle

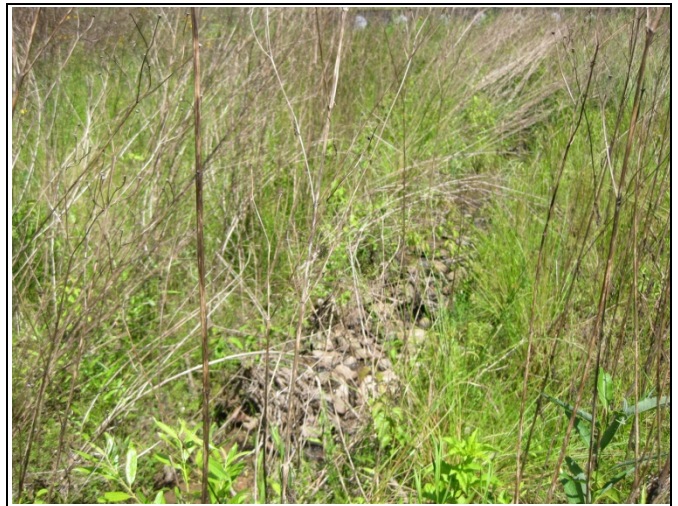
UT1 PID 4 – Constructed Riffle

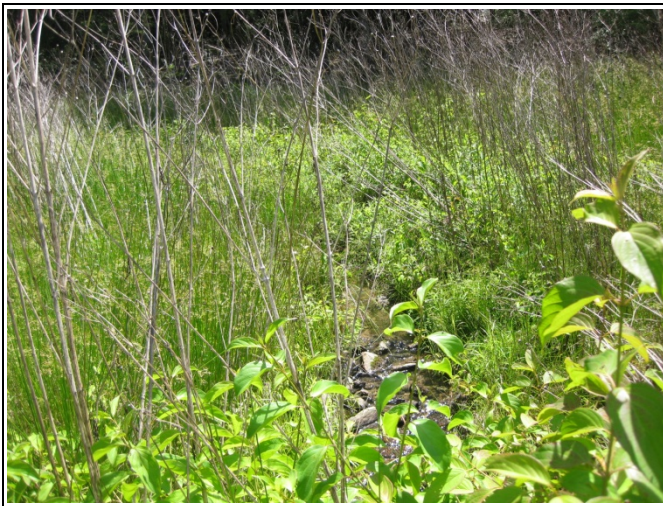
UT1 PID 5 – Constructed Riffle

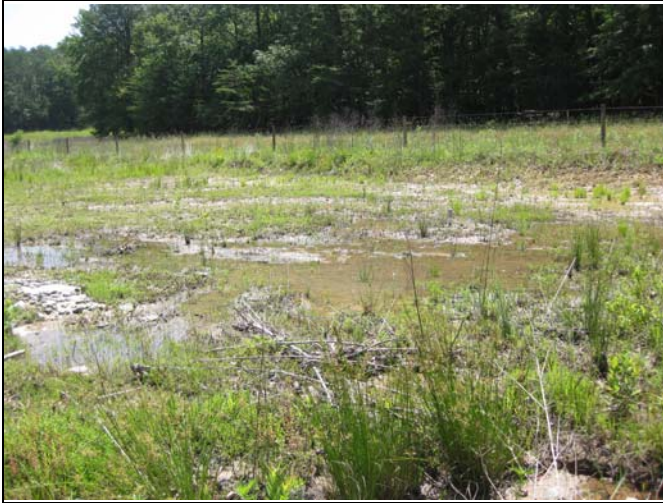
VPA1 – SFHC Reach 1 Bare Floodplain Area

Vegetation conditions for SFHC Reaches 1 and 2, and UT1 Reach B were good and performing close to 100% for both, the planted acreage and invasive/encroachment area categories, as shown in Table 6a. Two bare areas, VPA1 and VPA2, were documented in the wetland area located in the right floodplain along SFHC Reach 1. The combined total area for these VPAs was 0.12 acres, or 2.8% of the planted area acreage for this assessment tract. The two VPAs have remained somewhat bare since construction was completed. This could possibly be due to standing water from frequent inundation and/or the washing away of dispersed seeds by frequent overbank flows.

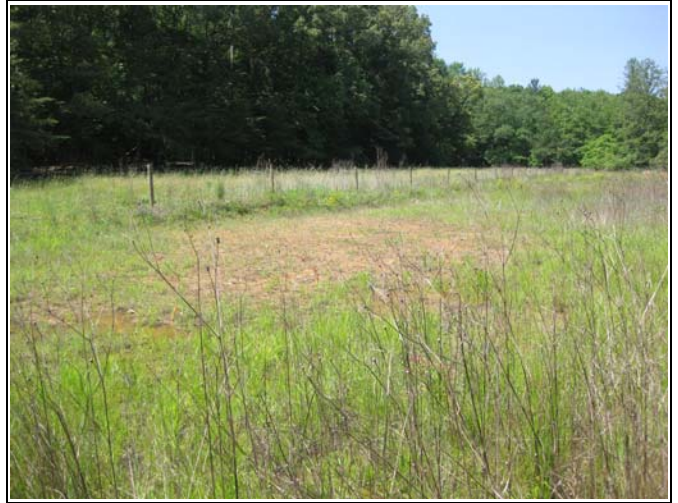
VPA2 – UT2 Reach 1 Bare Floodplain Area

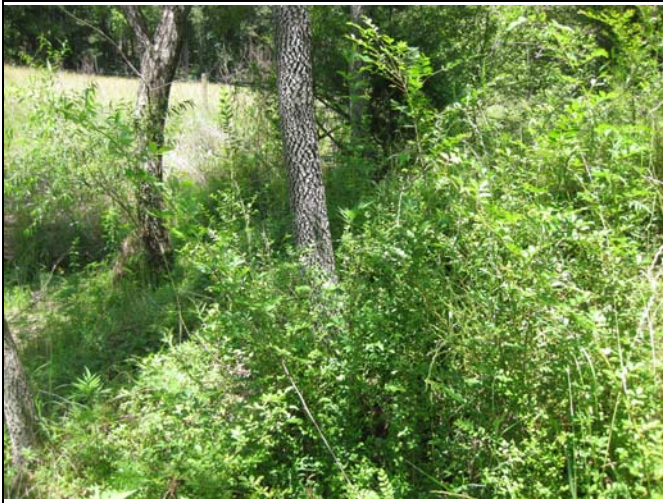
VPA3 – UT2 Reach B Multiflora Rose, Chinese Privet,
Japanese Stilt Grass

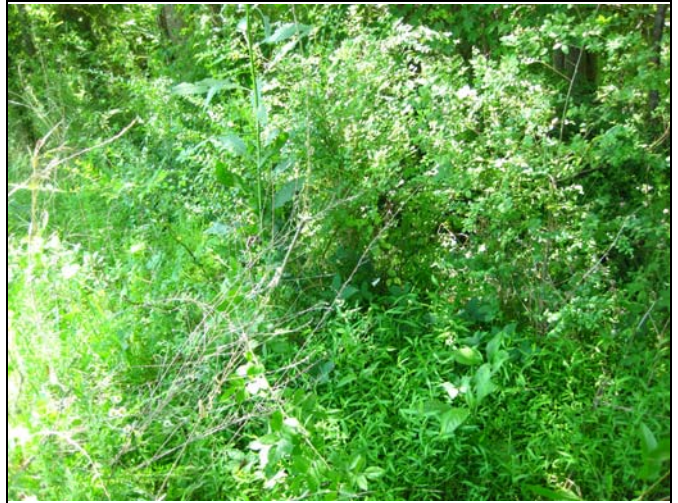
VPA4 – UT2 Reach B Multiflora Rose, Chinese Privet,
Japanese Stilt Grass

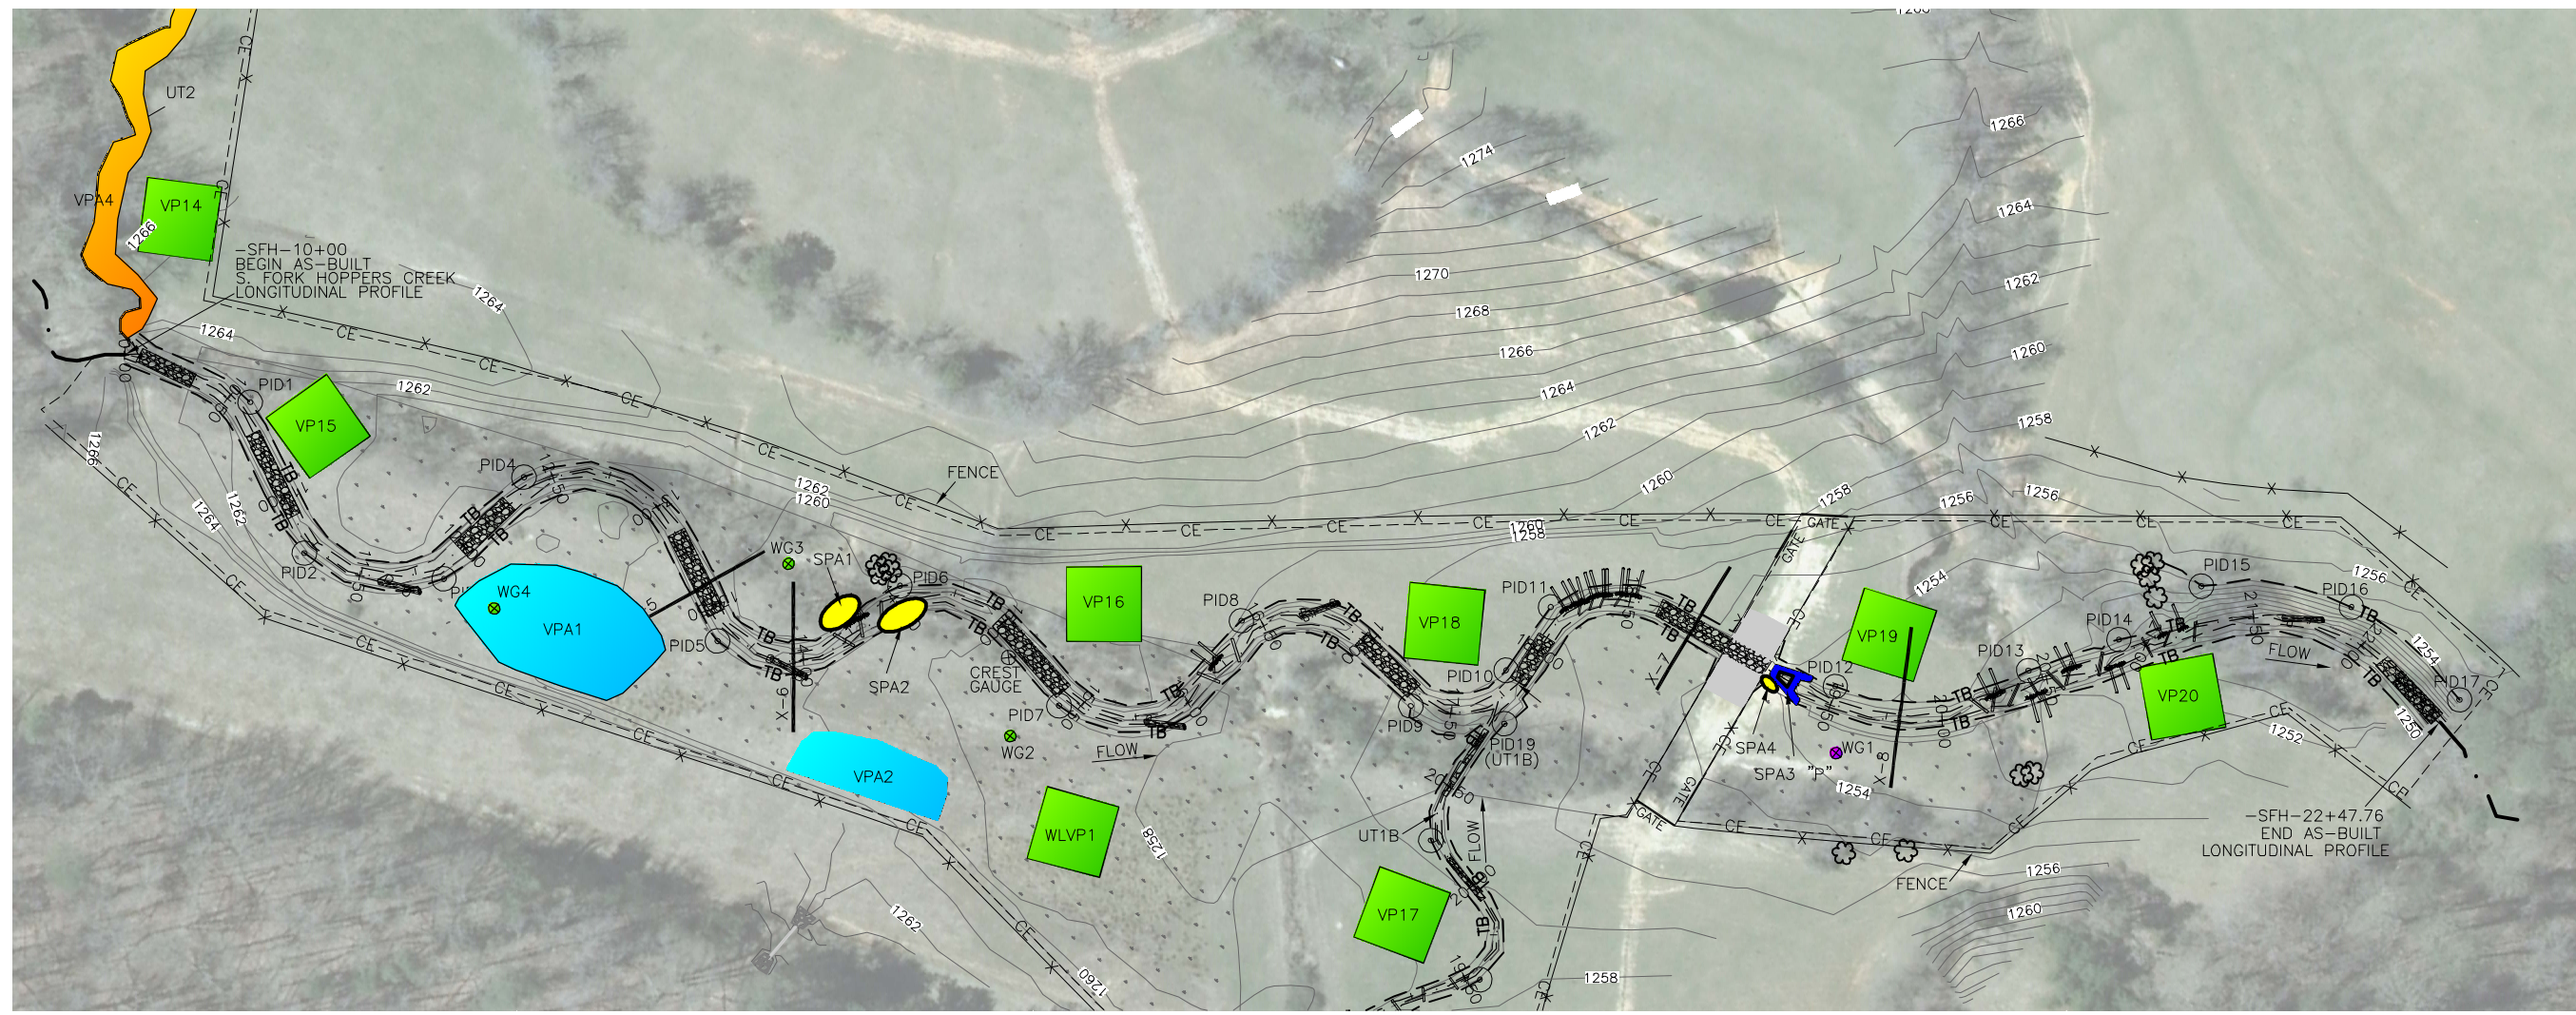
SOUTH FORK HOPPERS CREEK
 CURRENT CONDITION PLAN VIEW
 YEAR 1 MONITORING
 STA. 10+00-22+48

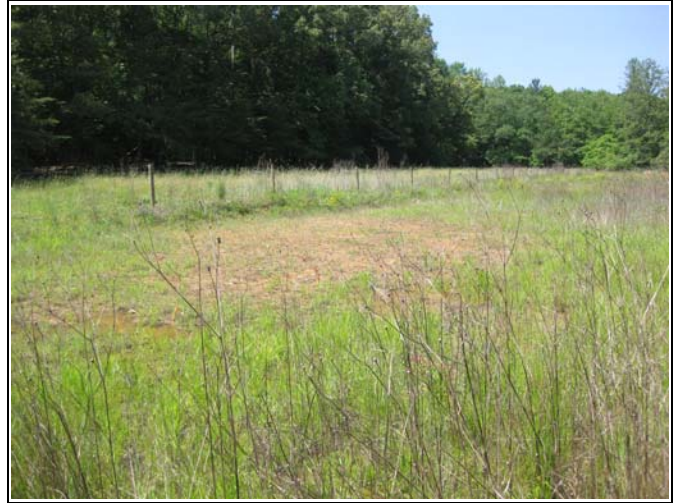
SFHC Reach 1			
Feature Issue	Station No.	Suspected Cause	Photo Number
Bare Floodplain	See Plan View	Standing water from frequent inundation	VPA1
		Unknown	VPA2
UT2 Reach B			
Feature Issue	Station No.	Suspected Cause	Photo Number
Invasive/Exotic Populations	Portion of Veg. Plot 13 to downstream easement crossing (along portions of both banks/terraces)	<i>Rosa multiflora</i> , <i>Ligustrum sinense</i> , and <i>Microstegium vimineum</i> : persisting after treatment	VPA3
	Downstream of easement crossing to confluence with SFHC (left bank/terrace)	<i>Rosa multiflora</i> , <i>Ligustrum sinense</i> , and <i>Microstegium vimineum</i> : persisting after treatment	VPA4

VPA1 – SFHC Reach 1 Bare Floodplain Area

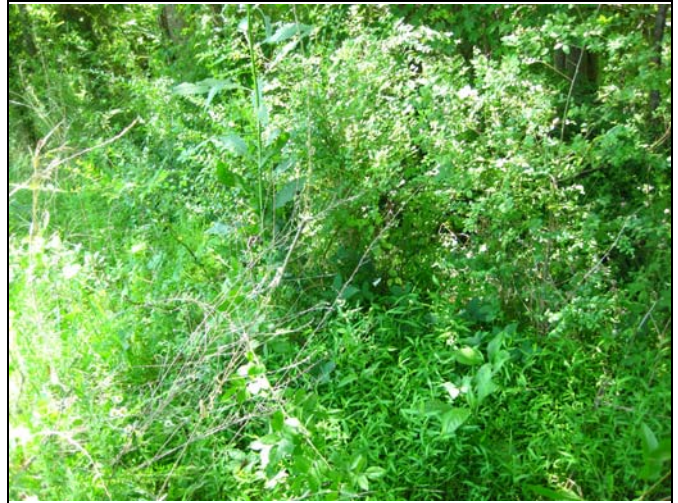
The UT2 vegetation assessment tract did not perform as well because of the widespread infestation of invasive species associated with VPA3 and VPA4. These two invasive VPAs were solely confined to UT2 Reach B and made up a combined total of 0.27 acres, or 18% of the 1.5 acre easement area for the UT2 vegetation assessment tract. Invasive vegetation in

these VPAs includes multiflora rose, privet, and Japanese stilt grass. VPA3 and VPA4 border existing tree lines or stands throughout the UT2 Reach B riparian corridor and generally occupy the tops of both banks and portions of each terrace as well; VPA3 extends into a portion of vegetation monitoring plot 13 where privet was reported. Existing stands of trees (such as those in UT2 Reach B) precluded removal of invasives during construction and these can often be a source of invasive vegetation even after treatment since the soil matrix is undisturbed, leaving roots and seeds intact. These areas were previously treated but were exhibiting new growth and are still persisting.

VPA3 – UT2 Reach B Multiflora Rose, Chinese Privet,
Japanese Stilt Grass
