# Hoppers Creek-Melton Farm Stream Restoration Project

## Year 2 Monitoring Report

**NCEEP Project Number – 92251**

# **Site Assessment Report – Monitoring Year 2**

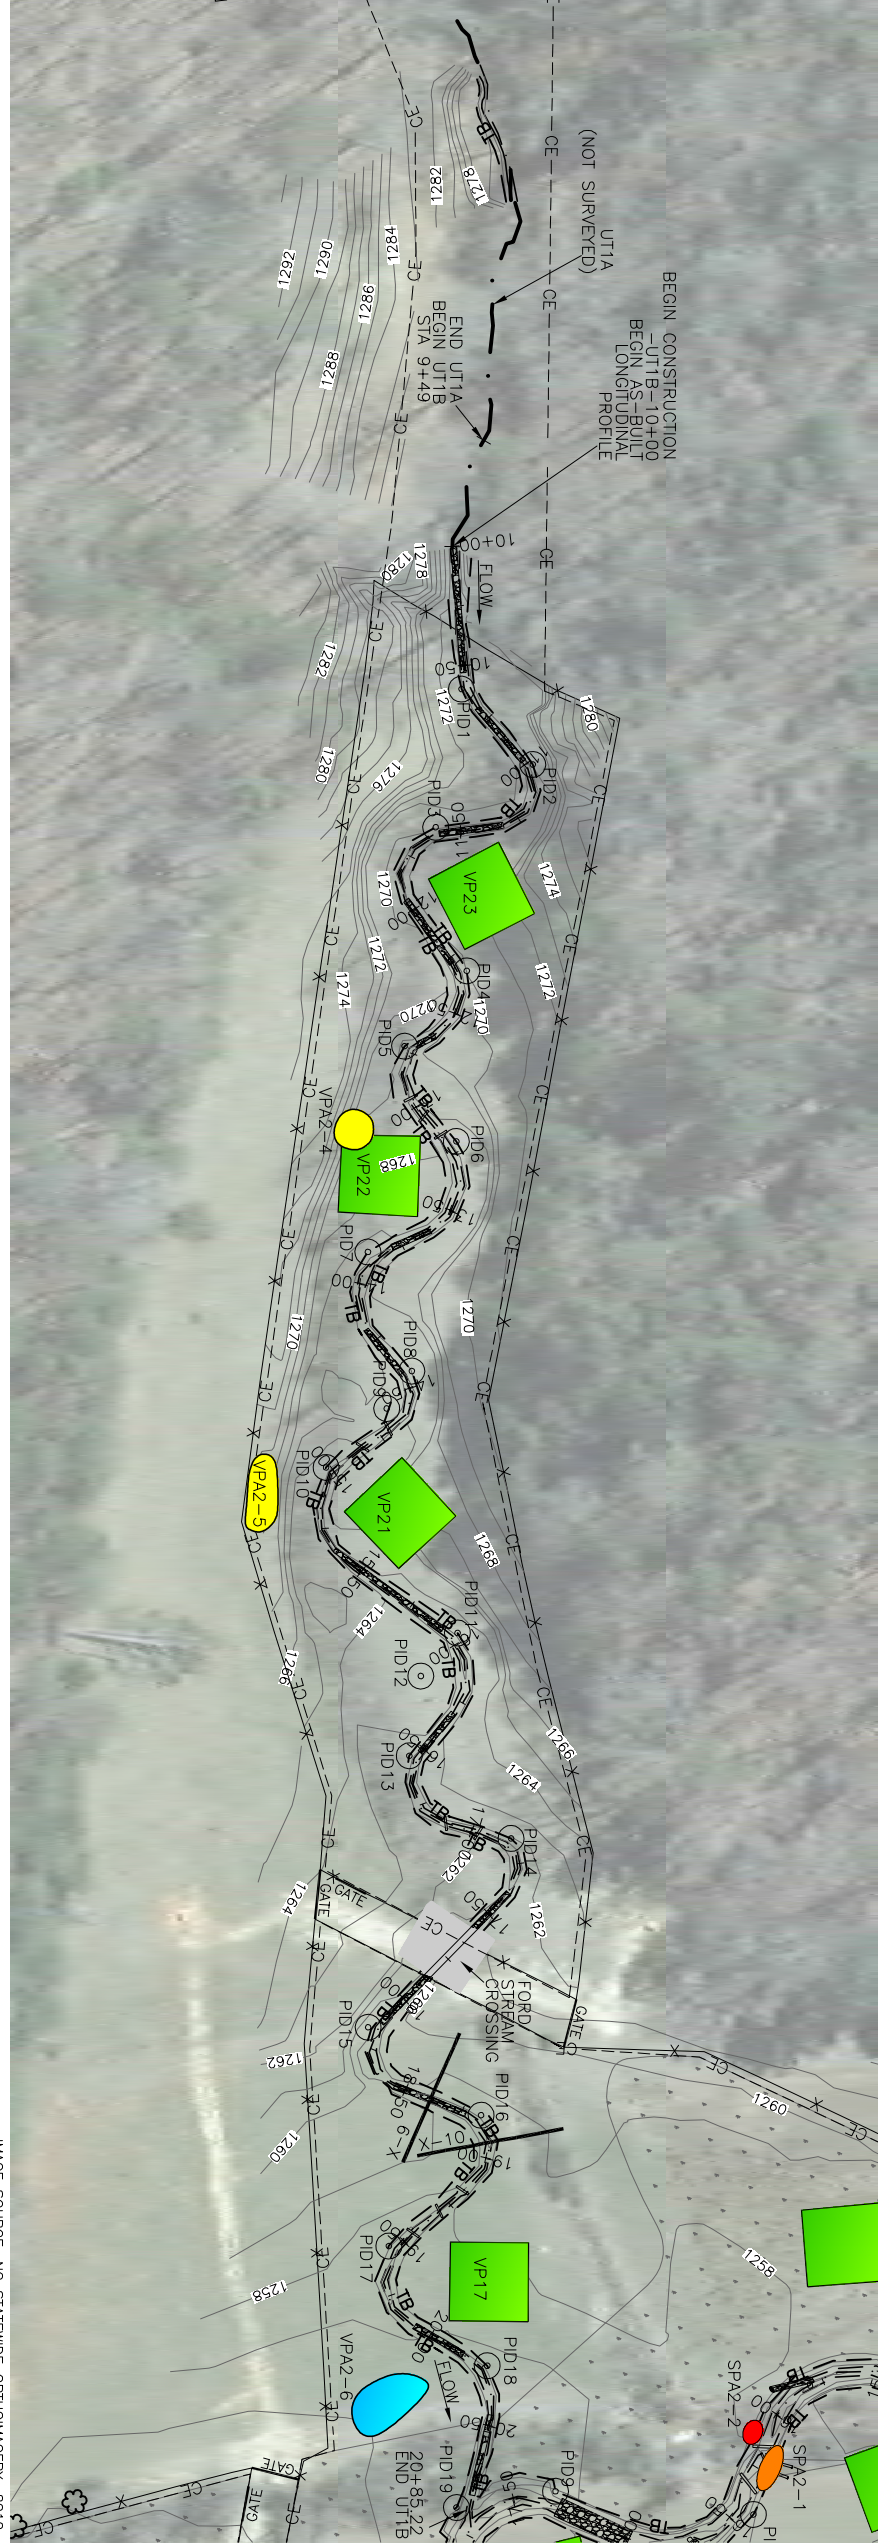
UT1-B  
CURRENT CONDITION PLAN VIEW  
YEAR 2 MONITORING  
STA. 10+00-22+85

It appears that several pine trees were recently cut down just outside of the easement along the left floodplain/terrace of UT1 Reach B. A few of these pine trees fell inside vegetation monitoring plots 21 and 23. These downed trees may have damaged some native buffer plantings located inside and out of the vegetation plots. EEP and the landowner were notified and the trees are to be removed by the landowner before the end of June 2013 in time for the Year 2 vegetation plot counts to be conducted.

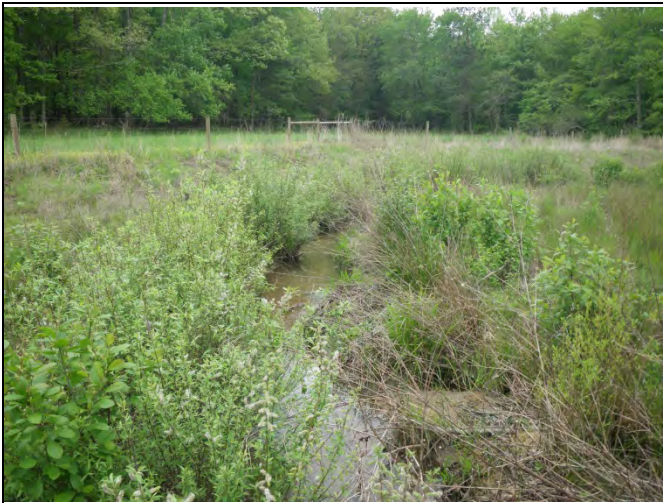
SFHC PID 3 – Log vane in constructed pool

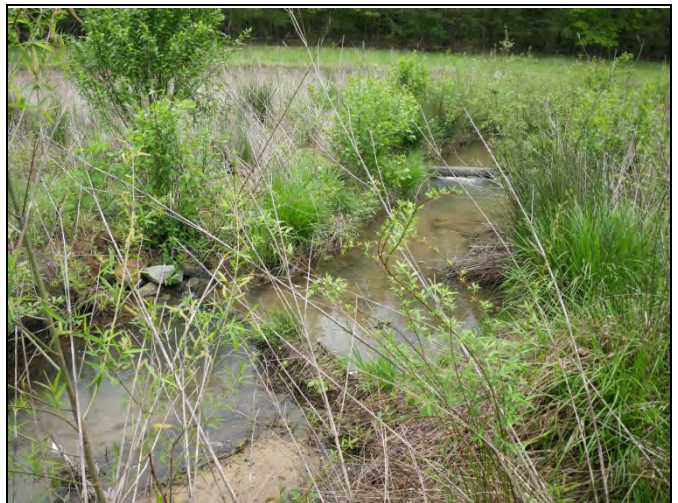
SFHC PID 6 – Log Sills and Root Wad

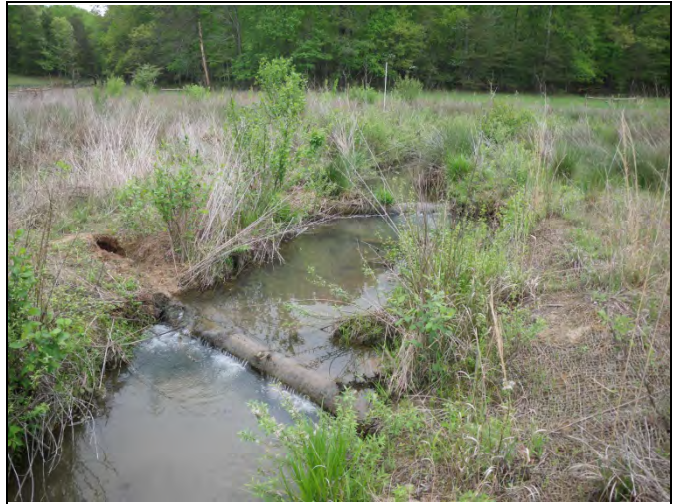
SFHC PID 8 – Log Sills & Root Wad

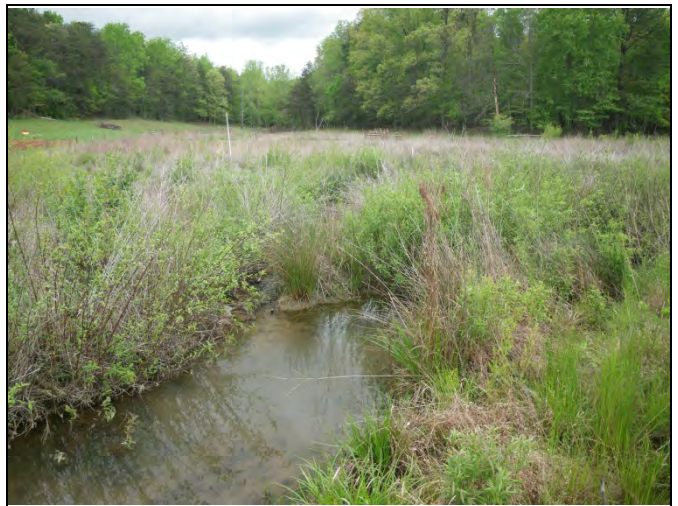
SFHC PID 10 – Confluence of UT1

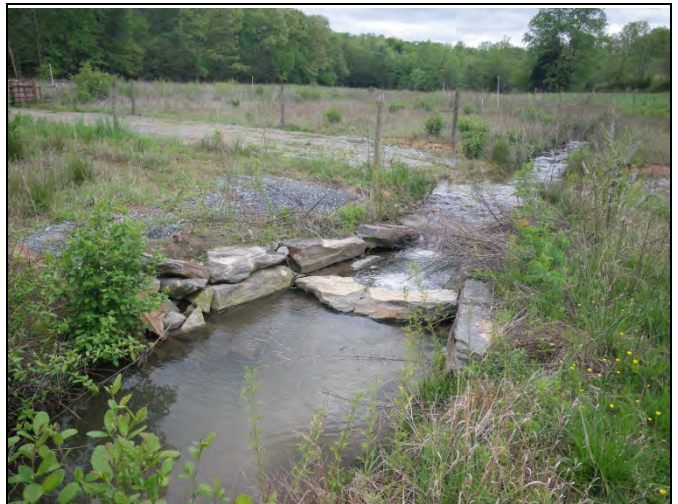
SFHC PID 12 – Double Drop Cross Vane below crossing

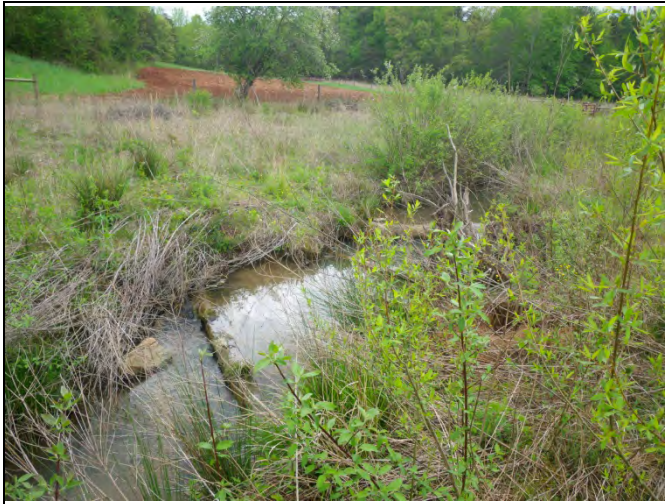
SFHC PID 13 – Log Sills &  
Root Wad

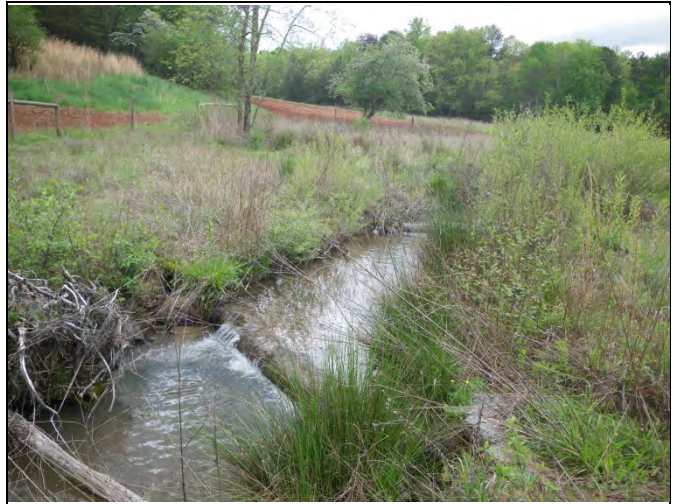
SFHC PID 14 – Log Sills & Root Wad

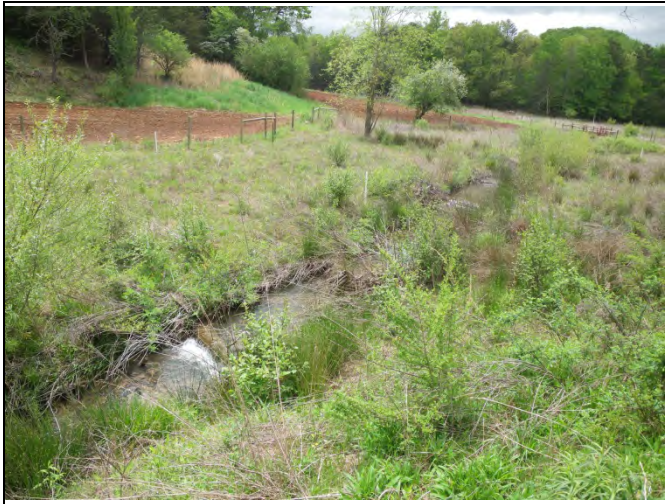
SFHC PID 15 – Log Sills & Root Wads

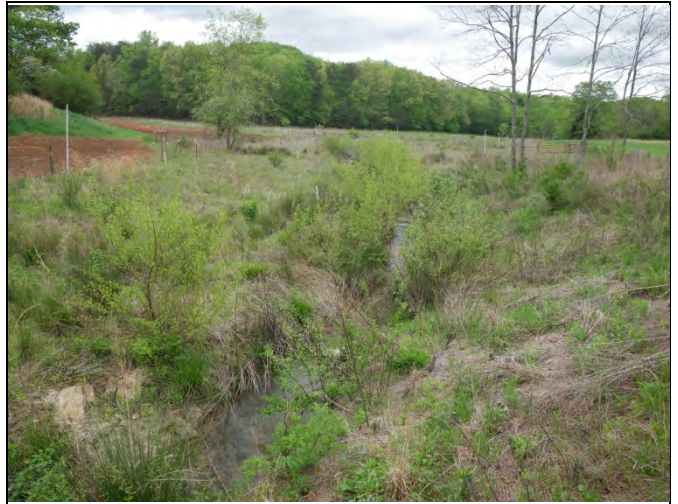
SFHC PID 16 – Log Vane & Matted Bank

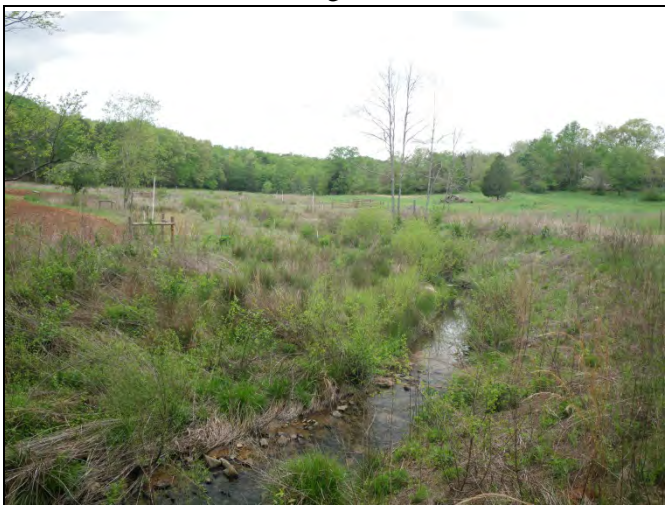
SFHC PID 17 – Constructed Riffle at downstream  
terminus of project

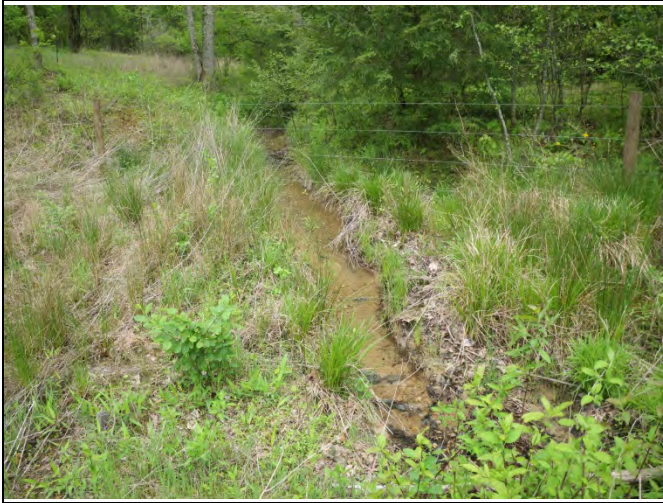
UT1 PID 1 – Constructed Riffle

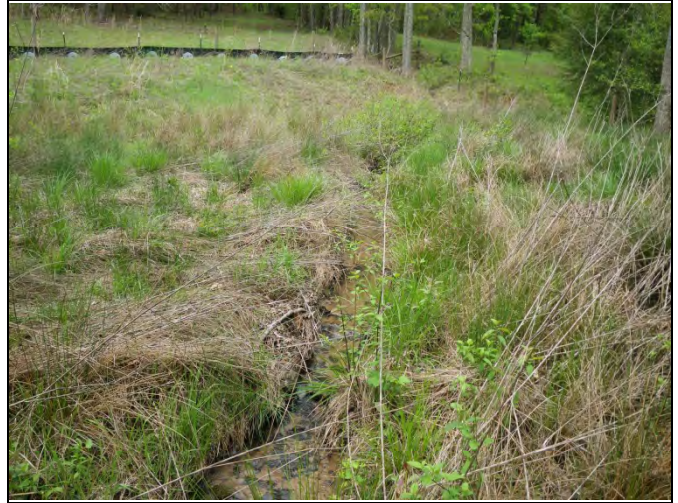
UT1 PID 2 – Constructed Riffle

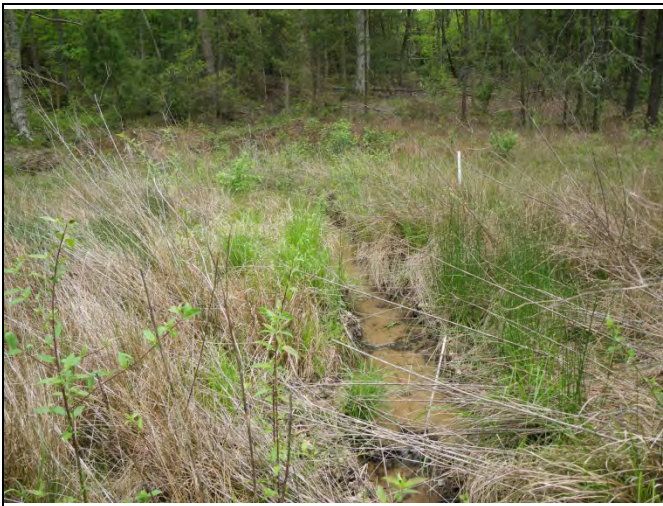
UT1 PID 3 – Constructed Riffle

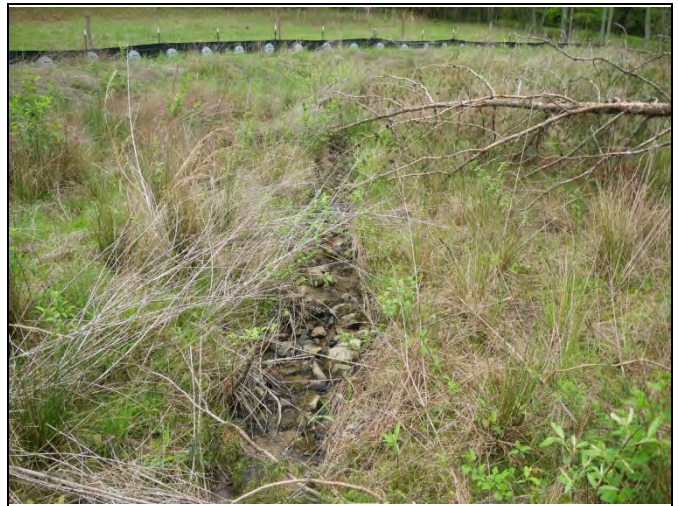
UT1 PID 4 – Constructed Riffle

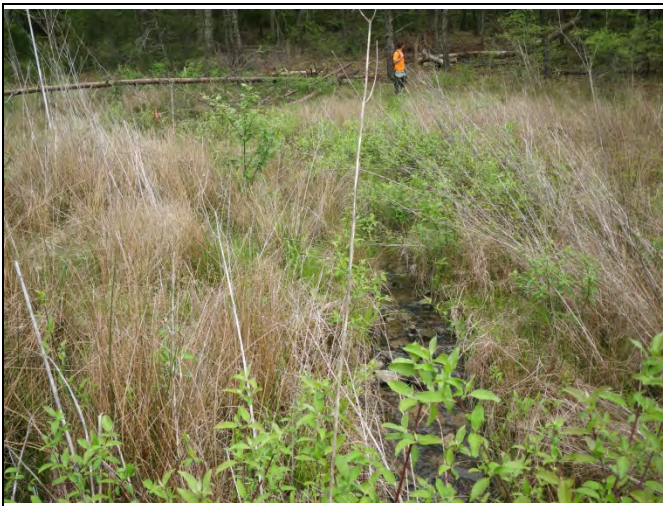
UT1 PID 5 – Constructed Riffle

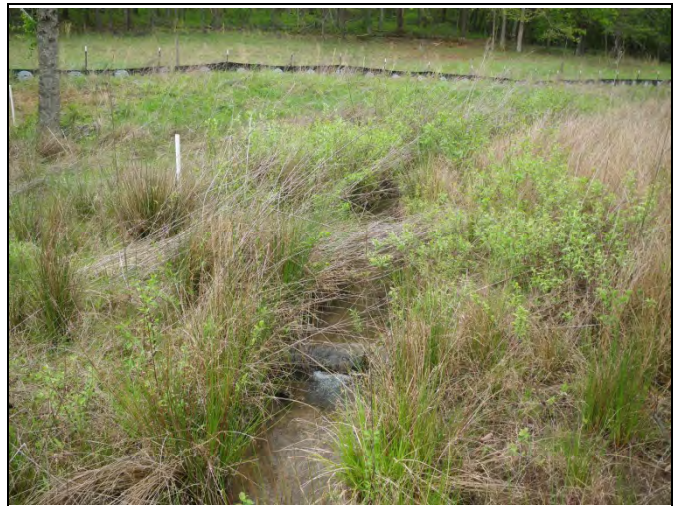
UT1 PID 6 – Log Sills

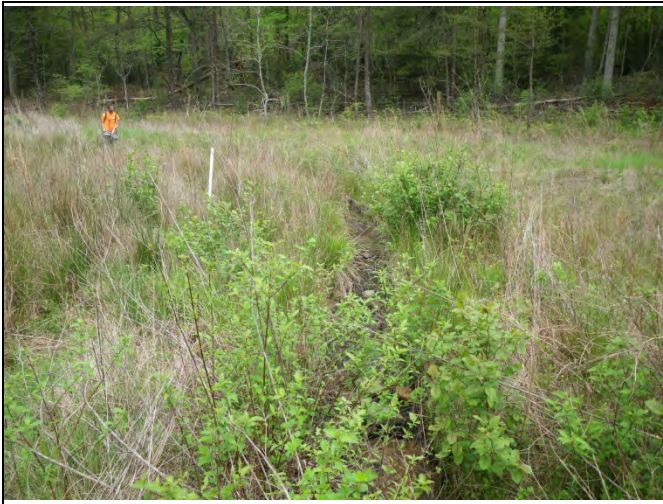
UT1 PID 7 – Constructed Riffle

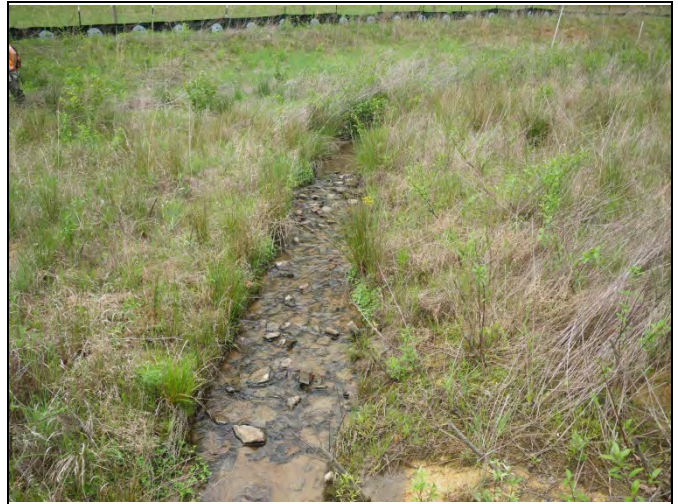
UT1 PID 8 – Constructed Riffle

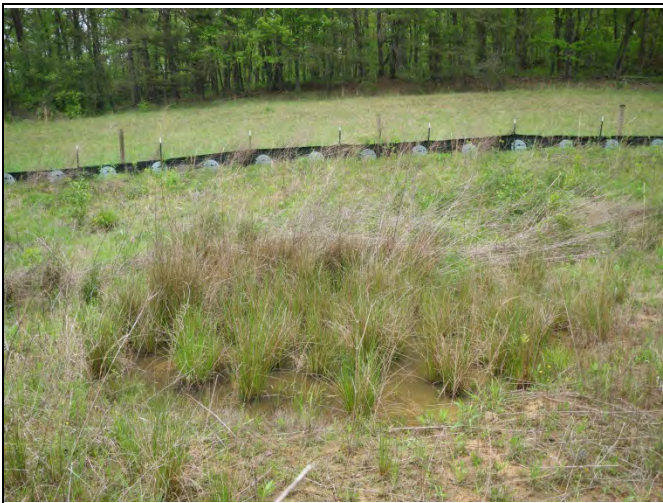
UT1 PID 9 – Ephemeral Pool in Right Floodplain

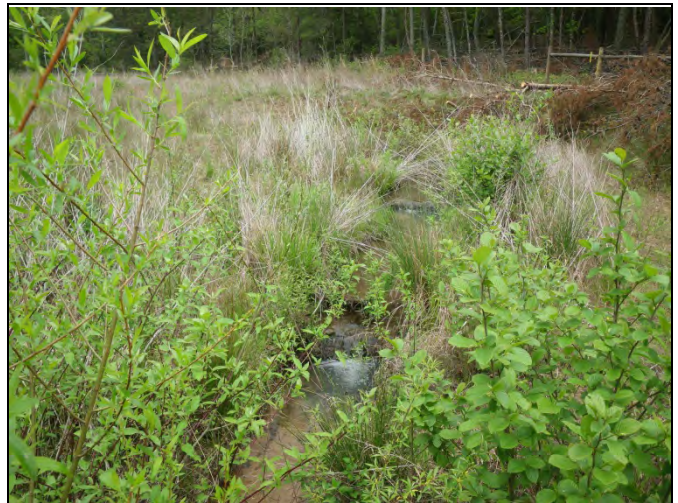
UT1 PID 10 – Log Sills

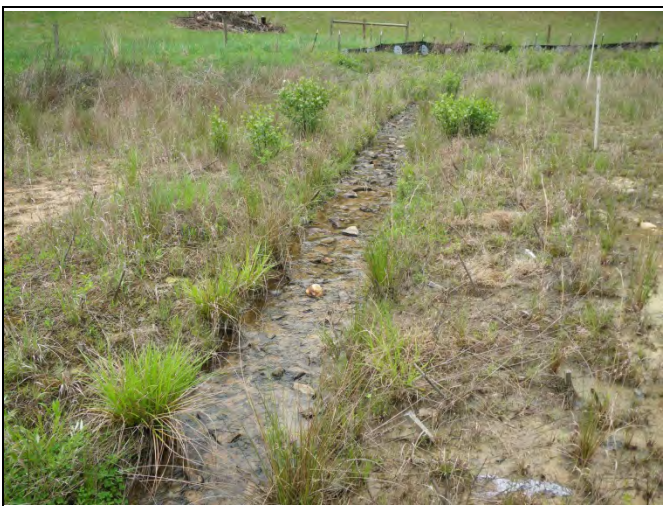
UT1 PID 11 – Constructed Riffle

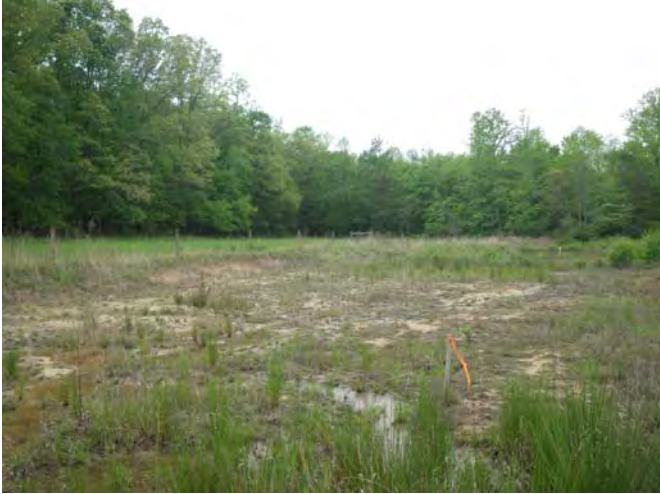
VPA1-1 – SFHC Reach 1 Bare Floodplain Area

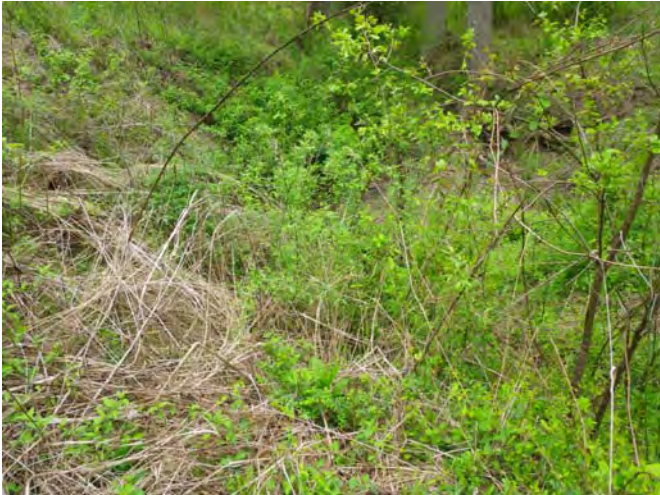
VPA1-3 – UT2 Reach B Multiflora Rose, Chinese Privet, Japanese Stilt Grass

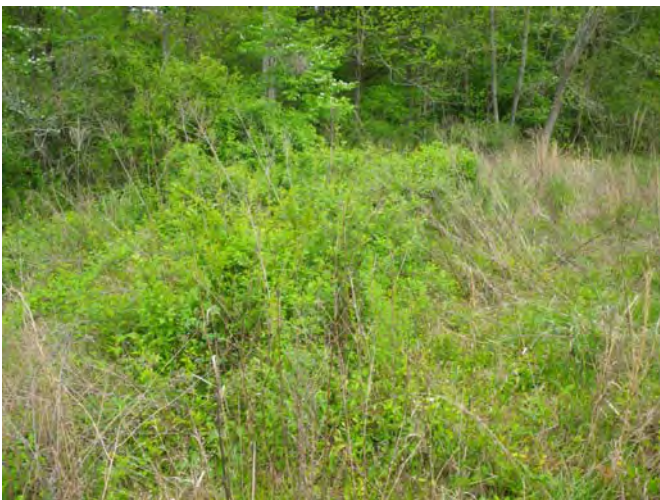
VPA2-1 – SFHC Reach 1 Multiflora Rose and Chinese Privet

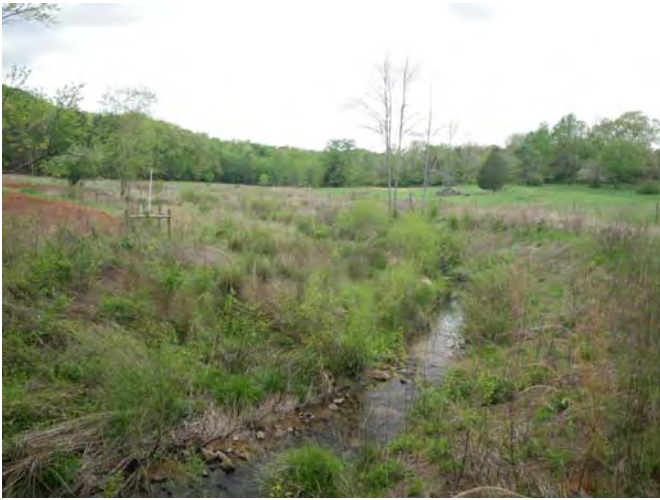
VPA2-3 – SFHC Reach 2 Multiflora Rose and Chinese Privet
