Hoppers Creek-Melton Farm Stream Restoration Project

Year 3 Monitoring Report

McDowell County, North Carolina

NCEEP Project Number – 92251

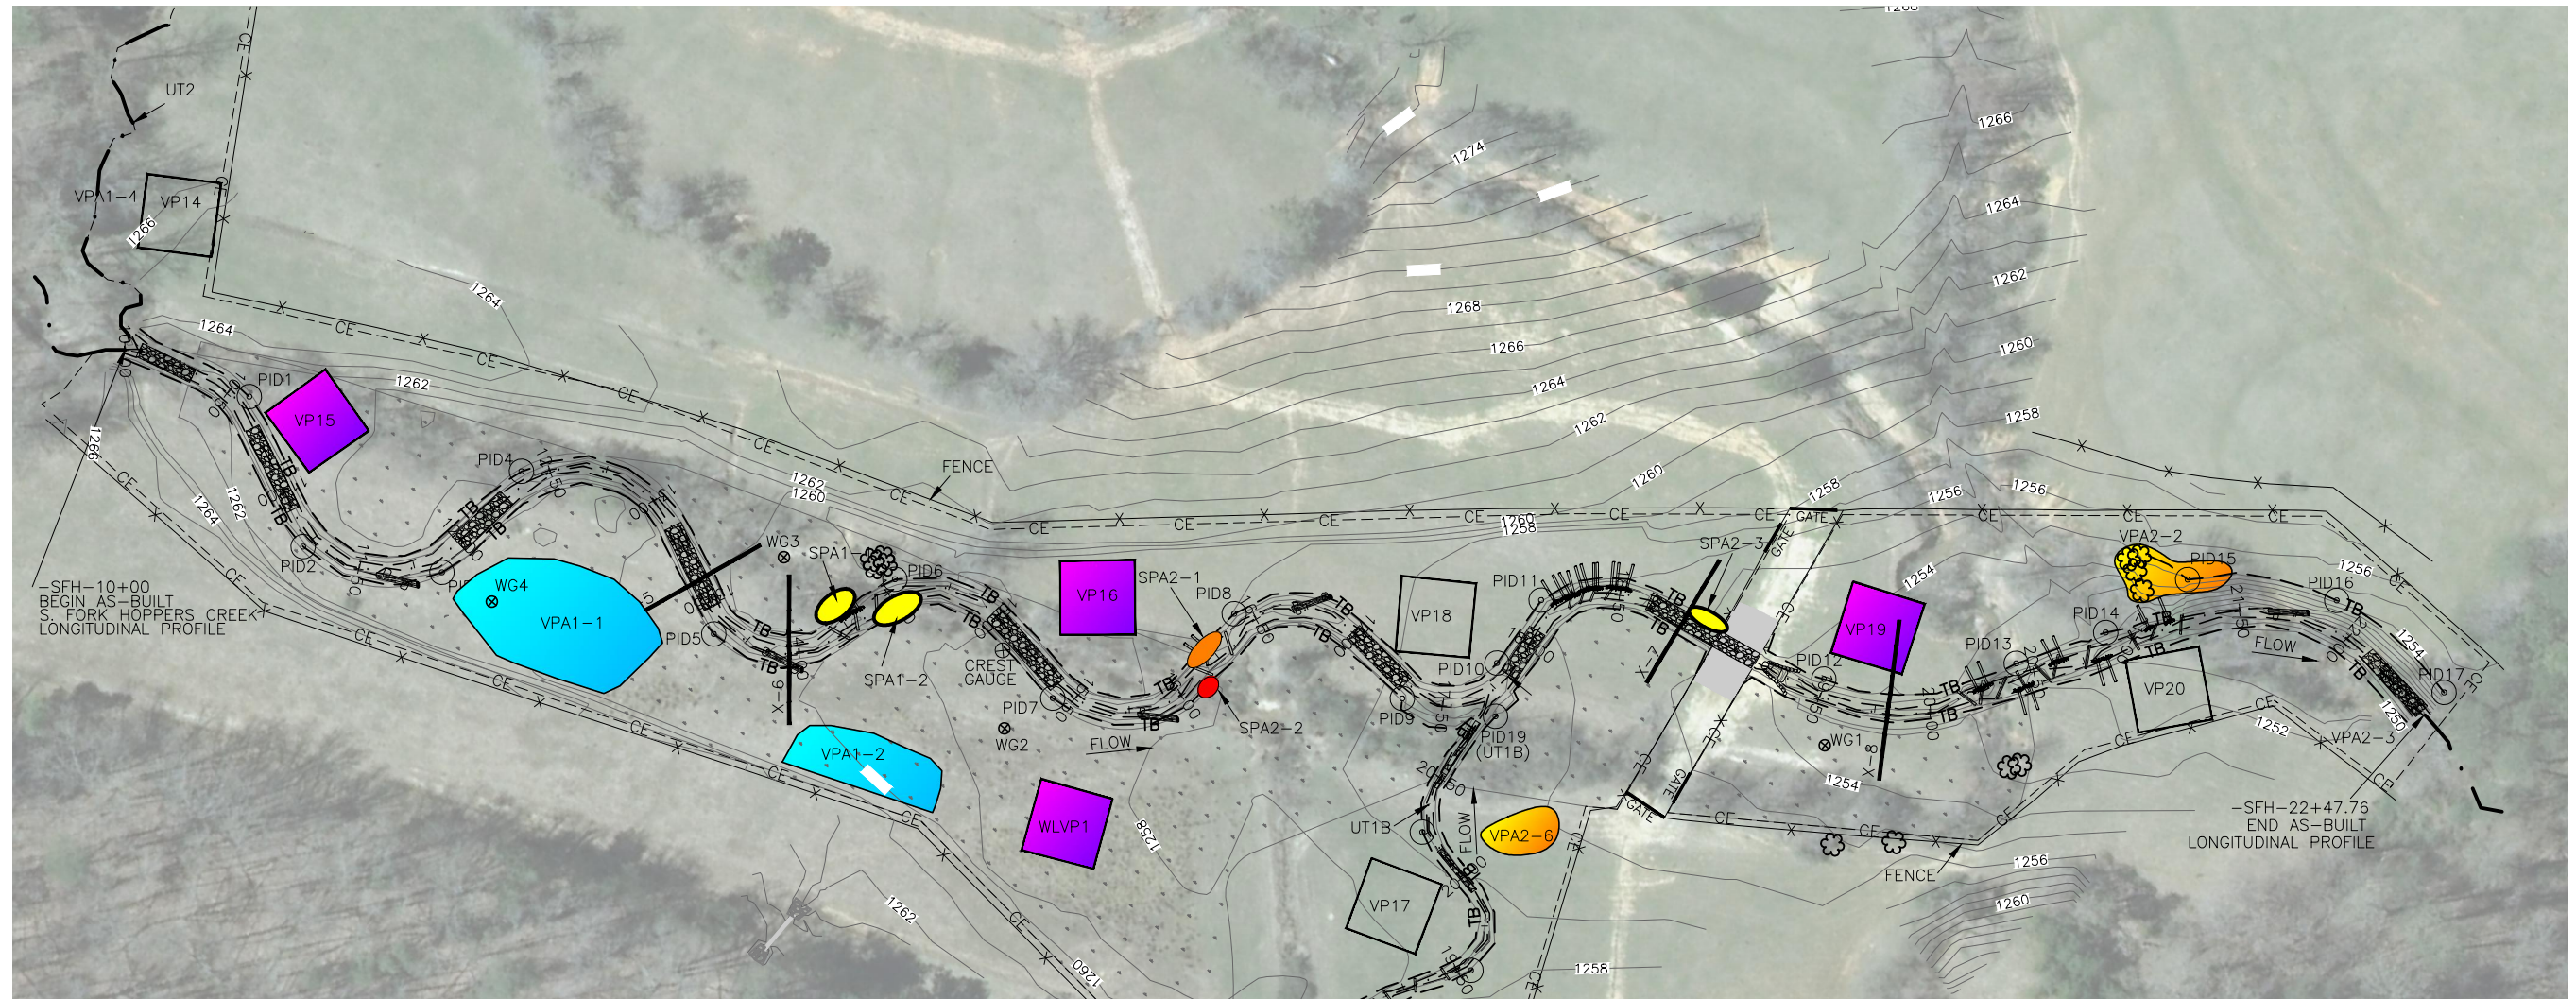
FIGURE 2

SOUTH FORK HOPPERS CREEK
CURRENT CONDITION PLAN VIEW
YEAR 3 MONITORING
STA. 10+00-22+48

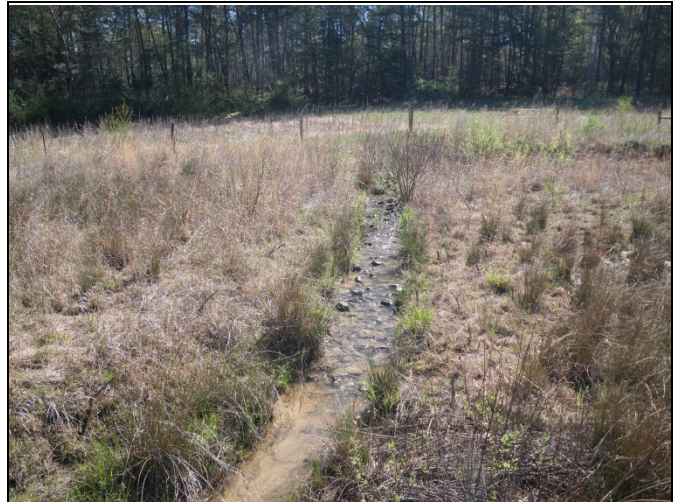
UT1 PID 16 – Constructed Riffle

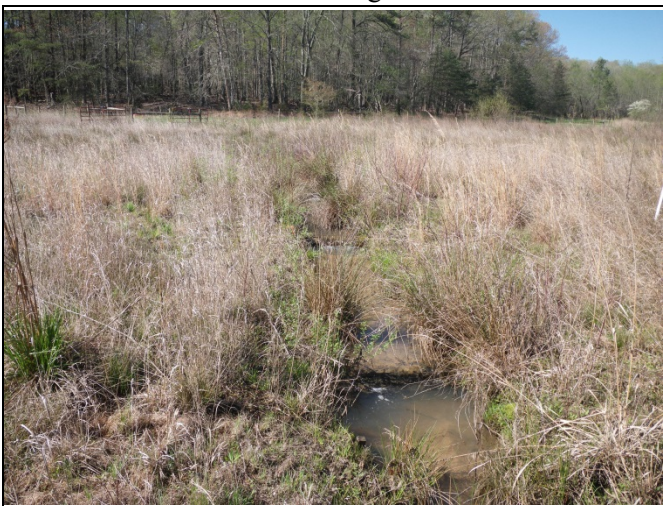
UT1 PID 17 – Log Sills

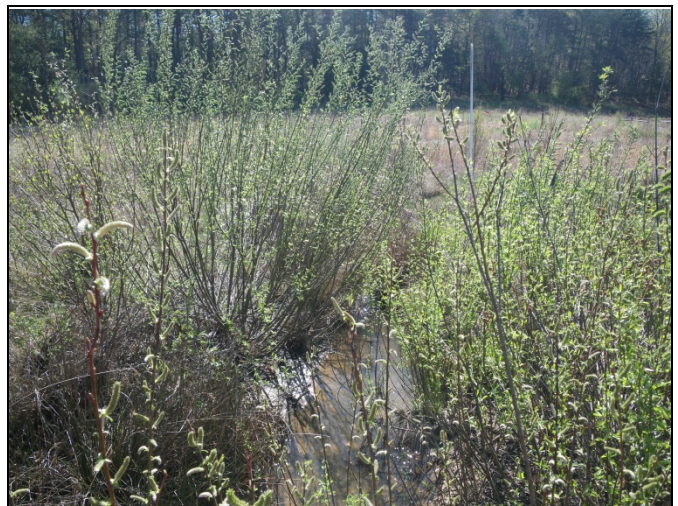
UT1 PID 18 – Constructed Riffle

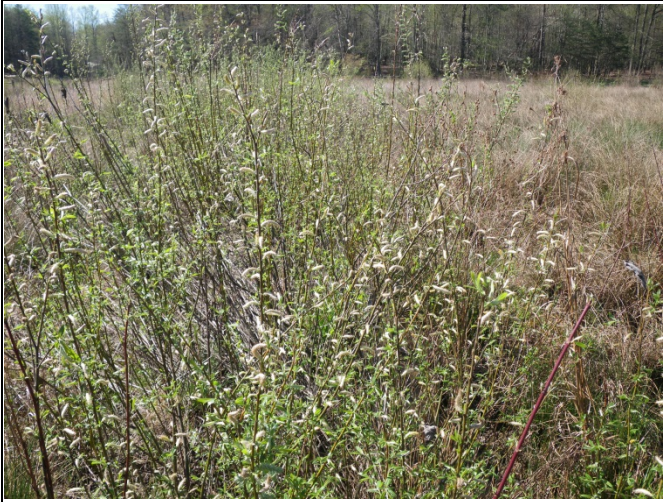
UT1 PID 19 – Constructed Riffle

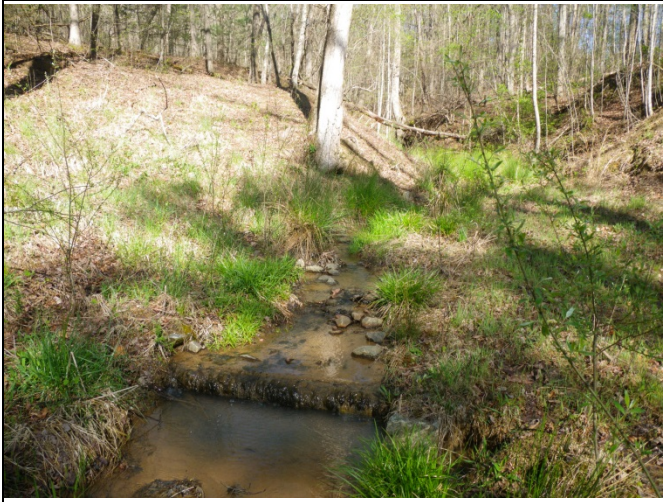
UT2 PID 1 – Constructed Riffle & Log Sill

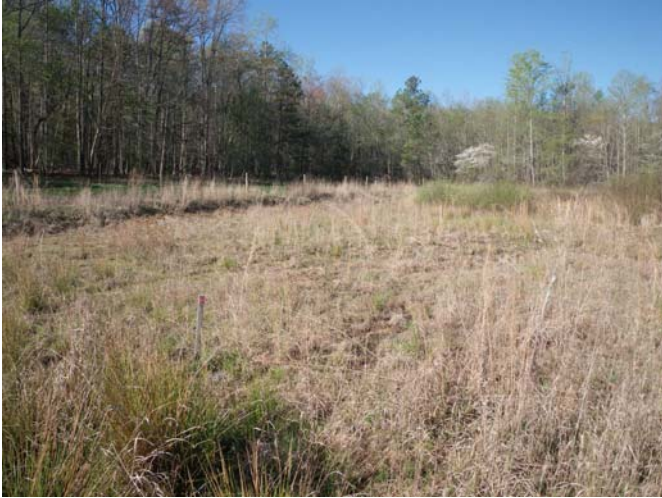
SFHC Reach 1			
Feature Issue	Station No.	Suspected Cause	Photo Number*
Bare Floodplain	See Plan View Figure	Standing water from frequent inundation	VPA1-1
		Unknown	VPA1-2
SFHC Reach 2			
Feature Issue	Station No.	Suspected Cause	Photo Number
Invasive/Exotic Populations	See Plan View Figure	<i>Rosa multiflora</i> and <i>Ligustrum sinense</i> : persisting after treatment within existing tree stand	VPA2-2
UT1 Reach B			
Feature Issue	Station No.	Suspected Cause	Photo Number
Invasive/Exotic Populations	See Plan View Figure	<i>Rosa multiflora</i> and <i>Lonicera japonica</i> : persisting after treatment from existing tree stand	VPA2-4
		<i>Rosa multiflora</i> : persisting after treatment	VPA2-5
		<i>Rosa multiflora</i> : persisting after treatment	VPA2-6
UT2 Reach B			
Feature Issue	Station No.	Suspected Cause	Photo Number

VPA1-1 – SFHC Reach 1 Bare Floodplain Area

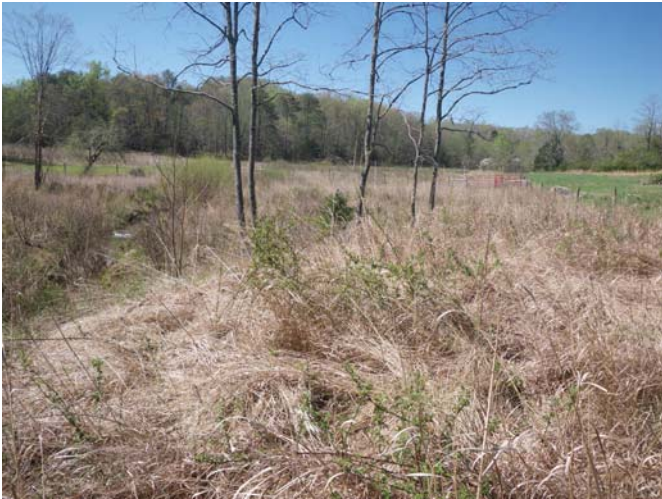
VPA2-2 is a small area of invasive species located on the left floodplain of SFHC Reach 2. The primary invasive is multiflora rose (*Rosa multiflora*) and privet (*Ligustrum sinense*). VPA2-2 appears to have been caused by a combination of invasives persisting after treatment and from intact seed sources contained within the existing tree stand in which VPA2-2 is situated. The three VPAs reported within UT1 Reach B (VPA2-2, VPA2-5, and VPA2-6) are all located in the right floodplain or terrace and are composed primarily of multiflora rose (*Rosa multiflora*) that seems to have persisted after prior treatment. VPA2-4 is located on the eastern periphery of vegetation monitoring plot 22 and may have proliferated from seed sources contained within the existing tree stand located just outside the vegetation plot. The combined total area for these 4 VPAs is 0.04 acres, or 0.5% of the planted area acreage for this assessment tract.

VPA2-2 – SFHC Reach 2 Multiflora Rose

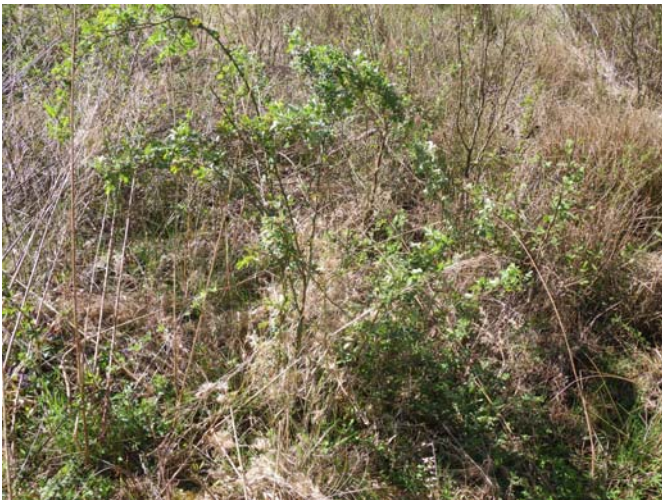
VPA2-5 – UT1B Multiflora Rose
