South Fork Hoppers Creek - Melton Farm Stream Restoration Project Year 4 Monitoring Report

NCDMS Project Number – 92251

FINAL

Report Prepared and Submitted by Michael Baker Engineering, Inc.

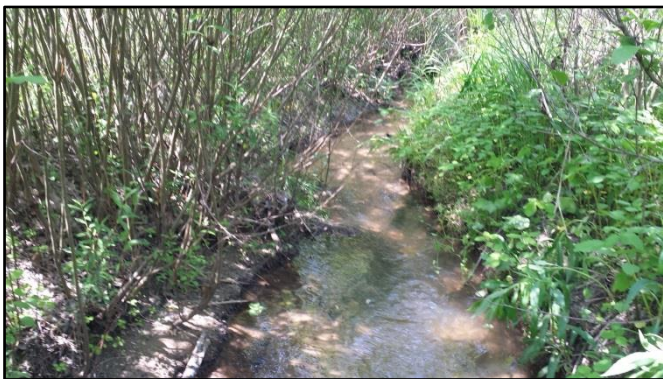
SFHC PID 3 – Log vane in constructed pool

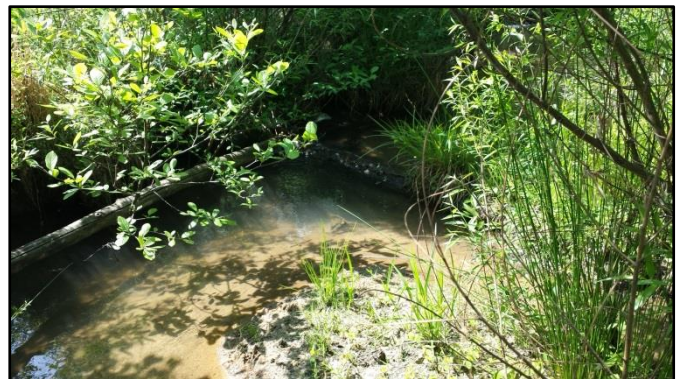
SFHC PID 6 – Log sills and root wad

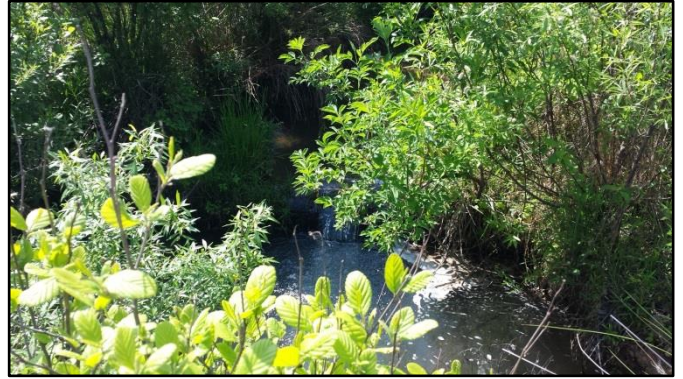
SHFC PID 8 – Log sills & root wad

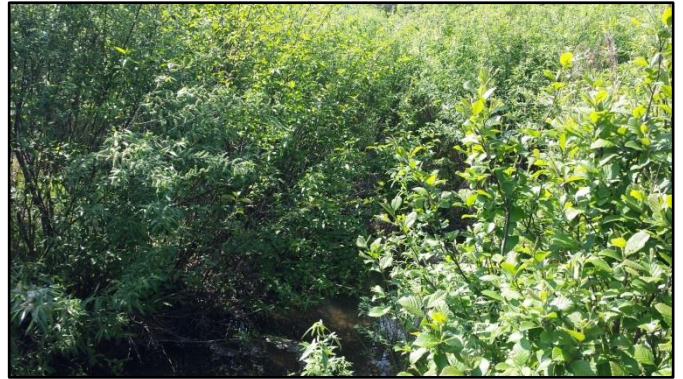
SFHC PID 10 – Confluence of UT1

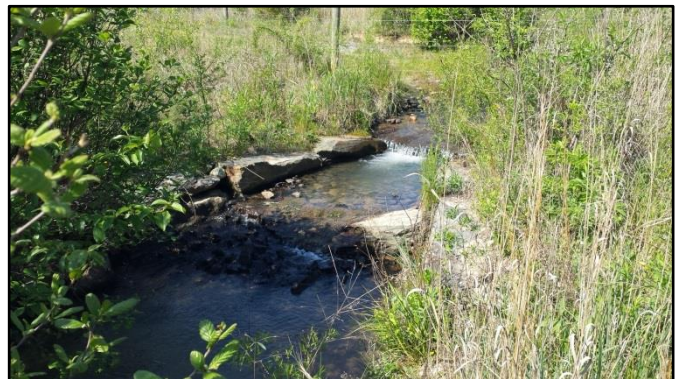
SFHC PID 12 – Double drop cross vane below crossing

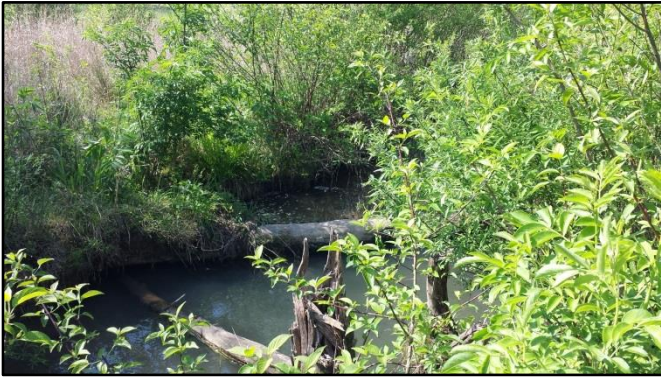
SFHC PID 13 – Log sills & root wad

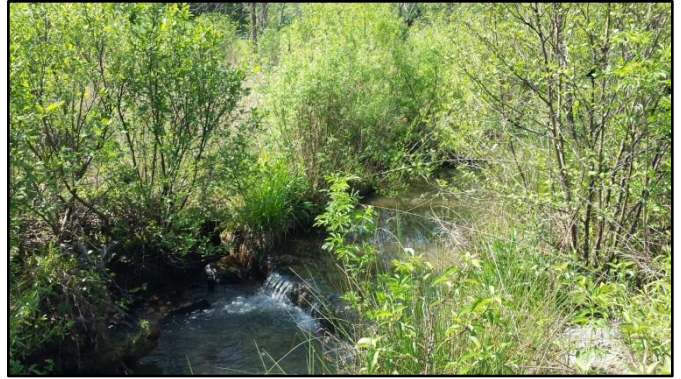
SFHC PID 14 – Log sills & root wad

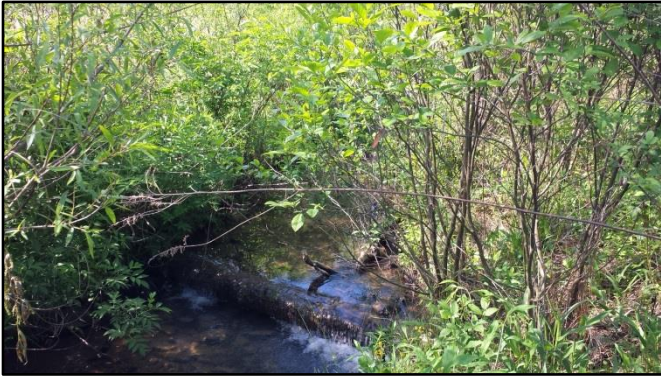
SFHC PID 15 – Log sills & root wads

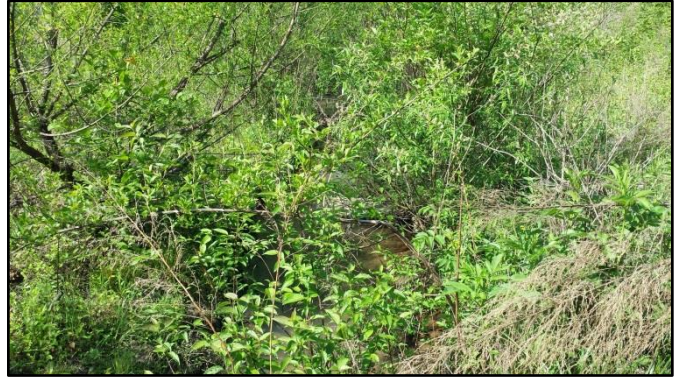
SFHC PID 16 – Log vane & matted bank

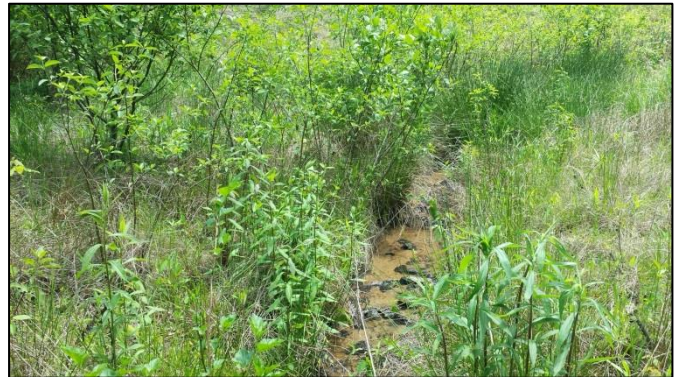
UT1 PID 4 – Constructed riffle

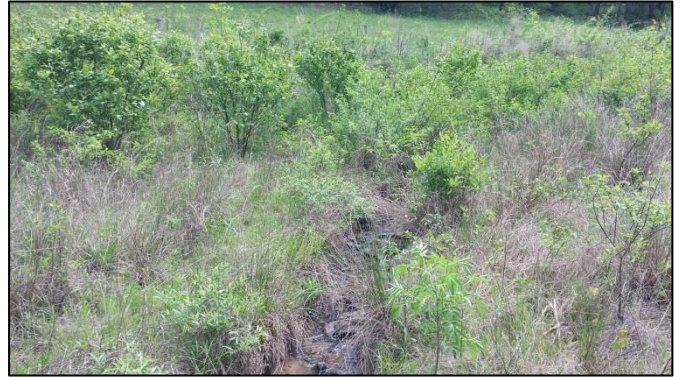
UT1 PID 8 – Constructed riffle

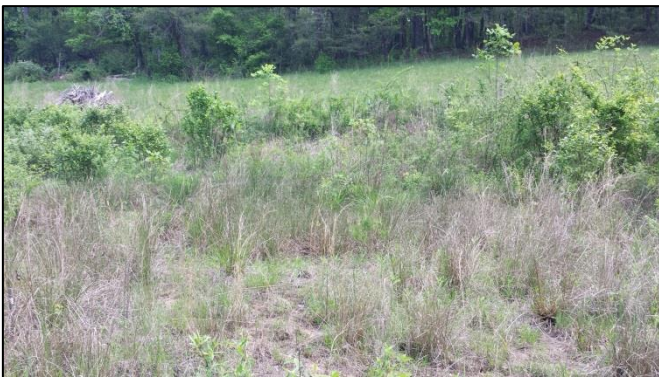
UT1 PID 9 – Ephemeral pool in right floodplain

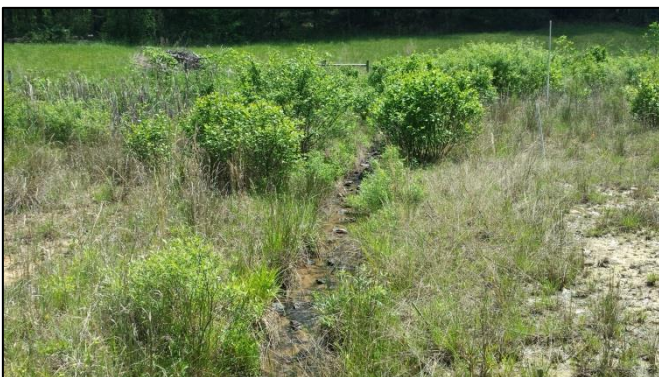
UT1 PID 11 – Constructed riffle

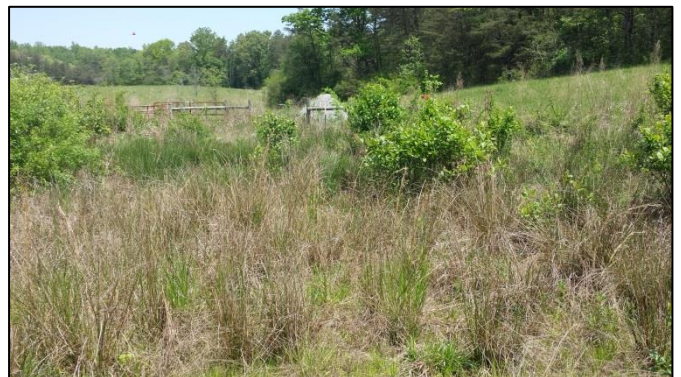
UT1 PID 12 – Ephemeral pool in right floodplain

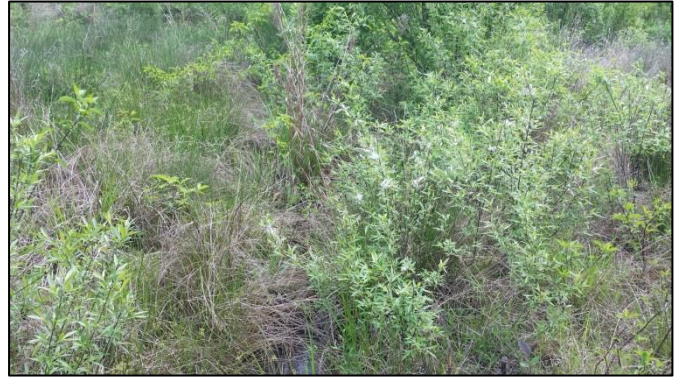
UT1 PID 14 – Log sill

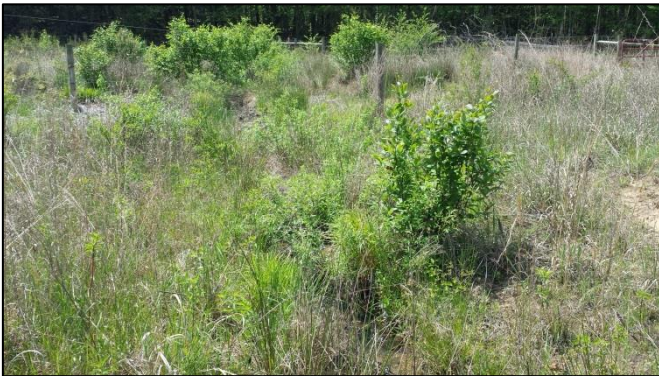
UT1 PID 15 – Constructed riffle below stream crossing

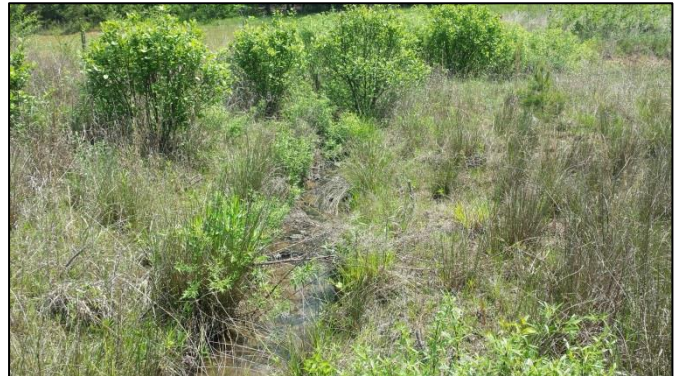
UT1 PID 16 – Constructed riffle

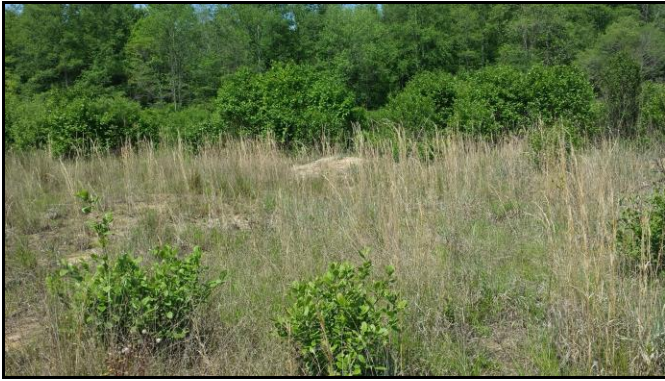
SFHC Reach 1			
Feature Issue	Station No.	Suspected Cause	Photo Number*
Bare Floodplain	See Plan View Figure	Standing water from frequent inundation	VPA1-1
		Standing water from frequent inundation	VPA1-2
SFHC Reach 2			
Feature Issue	Station No.	Suspected Cause	Photo Number
Invasive/Exotic Populations	See Plan View Figure	<i>Rosa multiflora</i> : persisting after treatment within existing tree stand	VPA2-2
		<i>Rosa multiflora</i> : persisting after treatment and encroaching from outside easement	VPA4-1
		<i>Lonicera japonica</i> : persisting after treatment and encroaching from outside easement	VPA4-2
UT1 Reach B			
Feature Issue	Station No.	Suspected Cause	Photo Number
Invasive/Exotic Populations	See Plan View Figure	<i>Rosa multiflora</i> and <i>Lonicera japonica</i> : persisting after treatment	VPA2-4
		<i>Rosa multiflora</i> and <i>Lonicera japonica</i> :	VPA2-5
		<i>Lonicera japonica</i> : persisting after treatment and encroaching from outside easement .	VPA4-9

VPA1-1 – SFHC Reach 1: Bare floodplain area

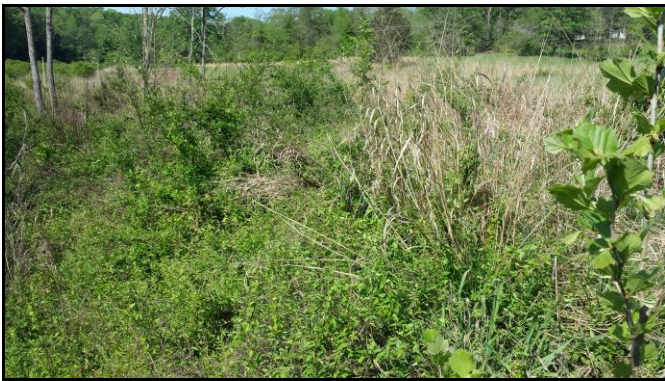
VPA2-2 – SFHC Reach 2: Multiflora rose

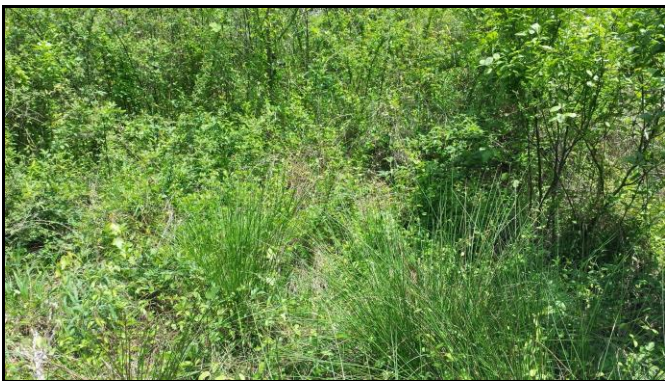
VPA2-5 – UT1B: Multiflora rose and Japanese honeysuckle

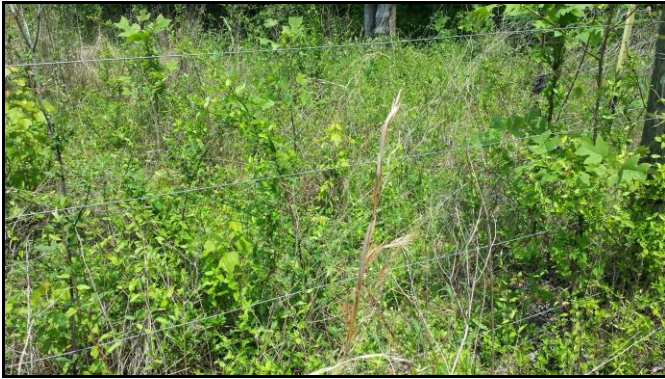
VPA4-2 – SFHC Reach 2: Japanese honeysuckle

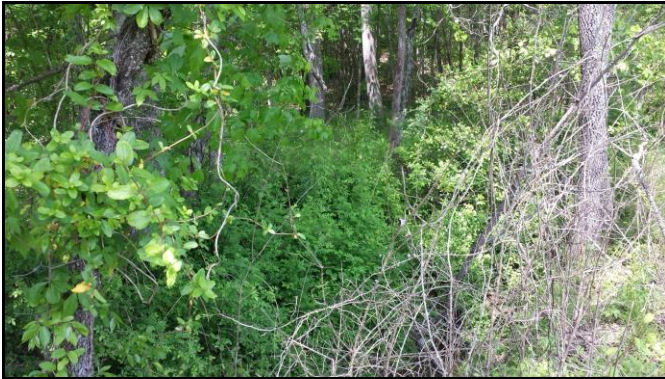
VPA4-4 – UT2: Multiflora rose on RTB

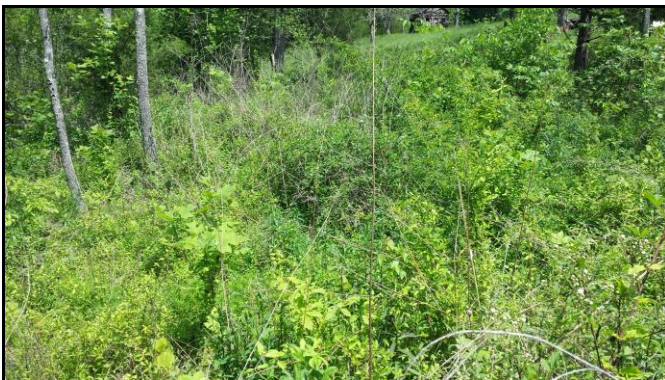
VPA4-6 – UT2: Japanese honeysuckle in left floodplain

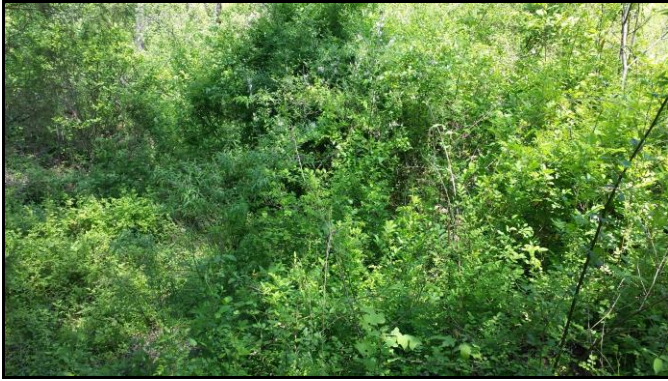
UT2 Reach B			
Feature Issue	Station No.	Suspected Cause	Photo Number
Invasive/Exotic Populations	See Plan View Figure	<i>Rosa multiflora</i> and <i>Lonicera japonica</i> : persisting after treatment.	VPA4-3
		<i>Rosa multiflora</i> : persisting after treatment	VPA4-4
		<i>Lonicera japonica</i> : persisting after treatment.	VPA4-5
		<i>Lonicera japonica</i> : persisting after treatment.	VPA4-6
		<i>Lonicera japonica</i> : persisting after treatment.	VPA4-7
		<i>Rosa multiflora</i> : persisting after treatment	VPA4-8

VPA4-8 – UT2: Multiflora rose in left floodplain
