Monitoring Report
FINAL VERSION
Horne Creek Tributaries Mitigation Project
Monitoring Year 1
Calendar Year of Data Collection: 2020

NCDEQ DMS Project Identification # 100026
NCDEQ DMS Contract # 7181
Yadkin River Basin (Cataloging Unit 03040101)
USACE Action ID Number: SAW-2017-01510
NCDEQ DWR Project # 2017-1156
Surry County, NC
Contracted Under RFP # 16-006993
Data Collection Period: November 2020
Submission Date: December 2020

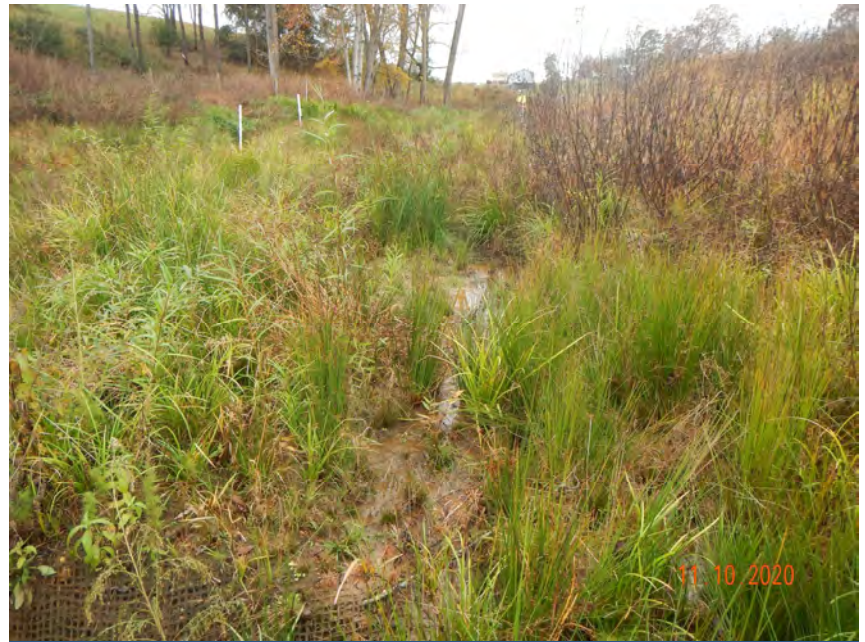
SPA3, R1 Left Floodplain, Minor Avulsion (MY-01)

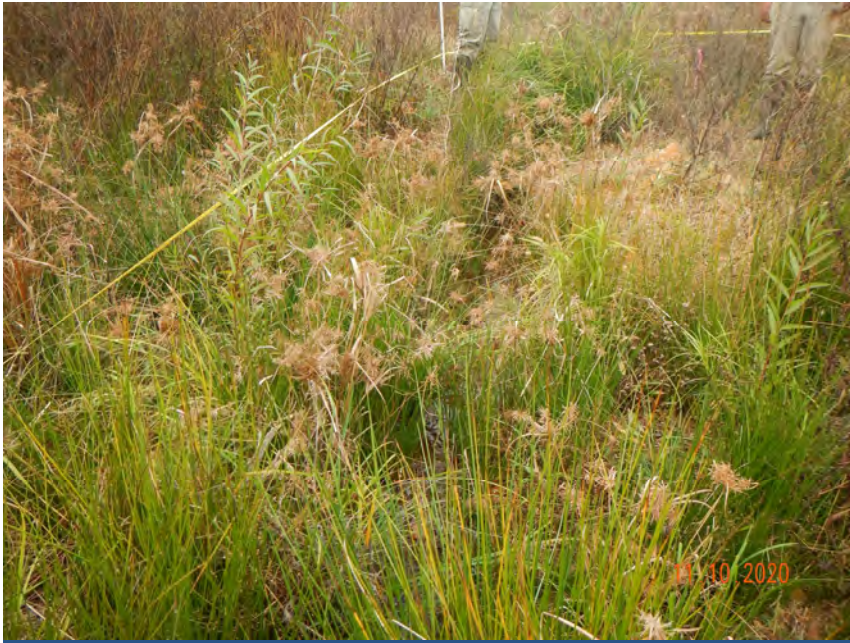
SPA6, R5 Right Floodplain, VP10, Secondary Channelization (MY-01)

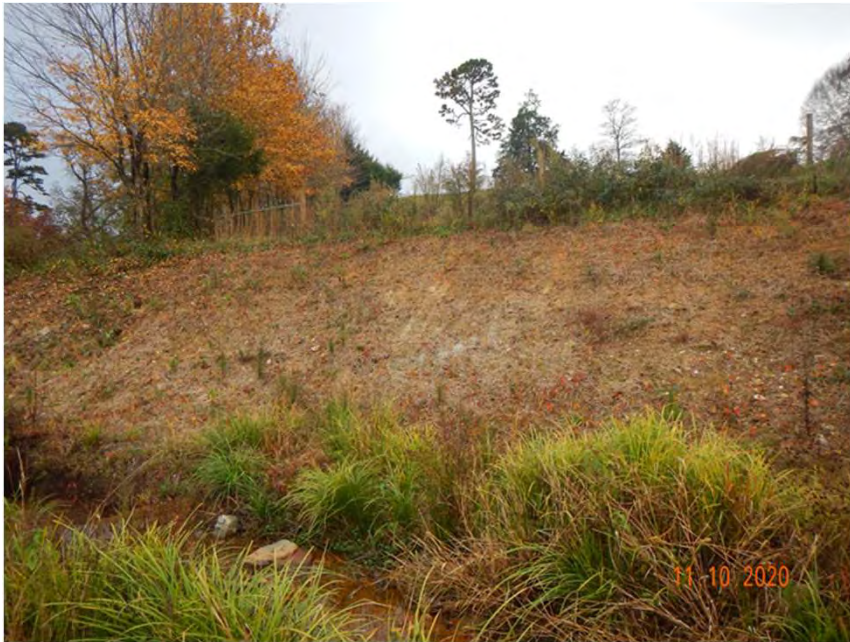
Bare Area, R1, Right Floodplain (MY-01)

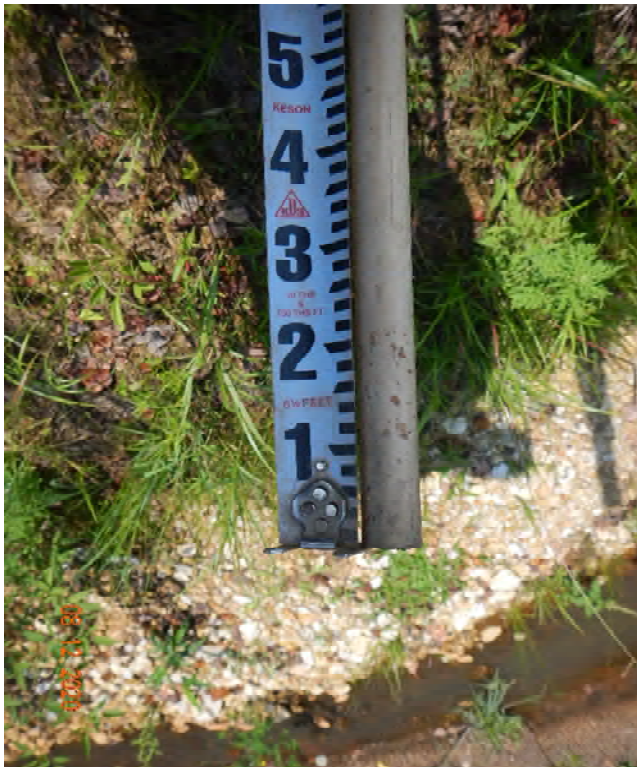
Date of Collection	Date of Occurrence	Method	Photos	Measurement above bankfull (feet)
9/15/2020	8/21/2020	Pressure Transducer	No	0.18
11/5/2020	9/17/2020	Pressure Transducer	No	0.18
11/5/2020	10/11/2020	Pressure Transducer	No	0.28
11/5/2020	10/29/2020	Pressure Transducer	No	0.11
8/12/2020	Unknown	Cork Gauge	Yes	0.20
11/5/2020	Unknown	Cork Gauge	Yes	0.35
