# **MONITORING YEAR 1 ANNUAL REPORT FINAL**

## **HUNTSMAN MITIGATION SITE**

Wilkes County, NC  
Yadkin River Basin  
HUC 03040102

DMS Project No. 100123

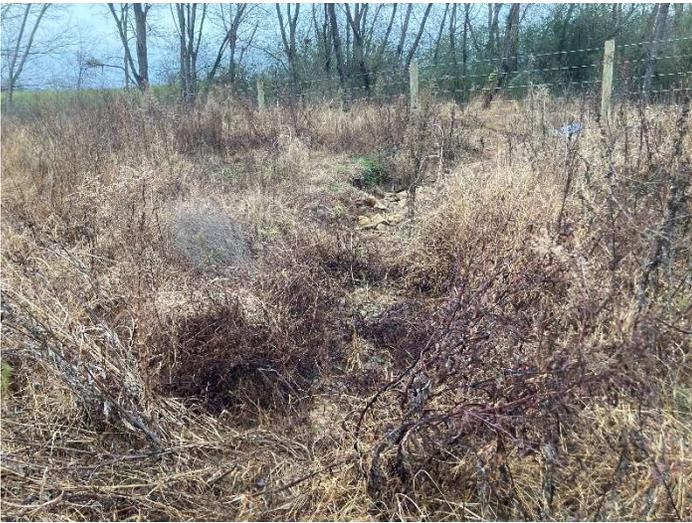
**Photo Point 1a** – Stabilized swale, view up valley (12/09/2022)

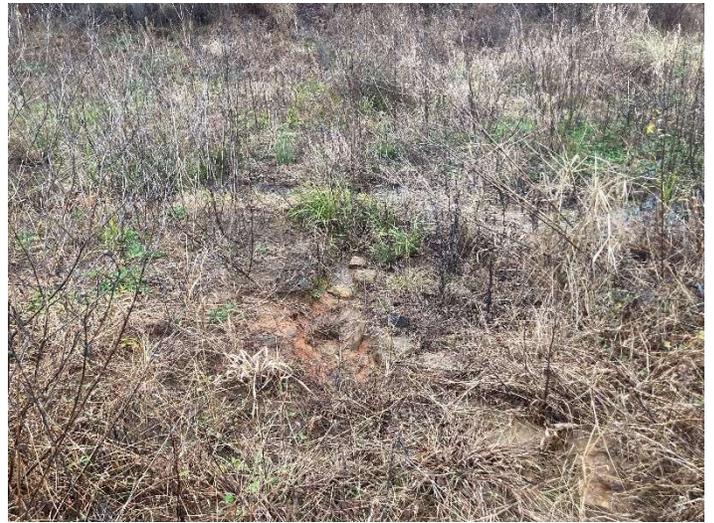
**Photo Point 1a** – Stabilized swale, view down valley (12/09/2022)

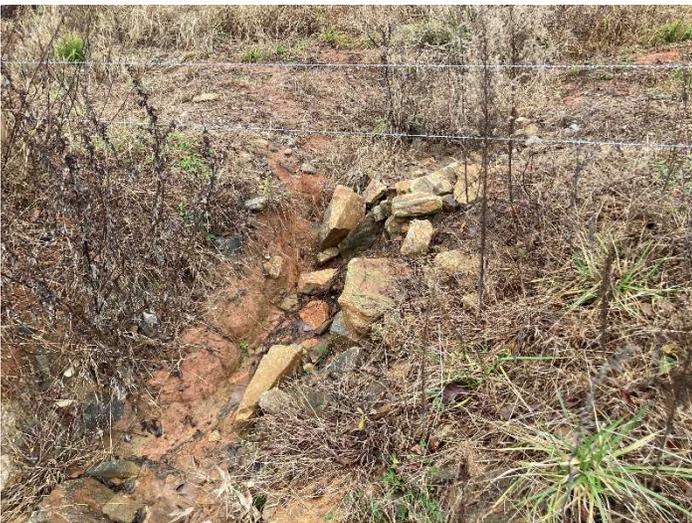
**Photo Point 2a** – Stabilized swale, view up valley (12/09/2022)

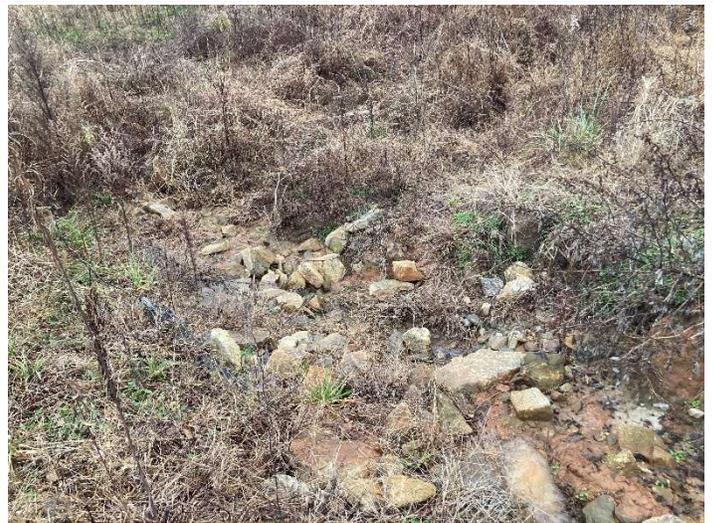
**Photo Point 2a** – Stabilized swale, view down valley (12/09/2022)

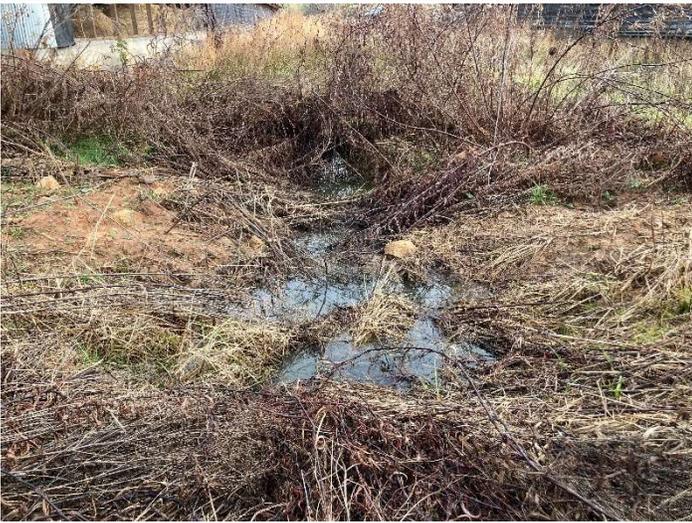
**Photo Point 3a** – Stabilized swale, view up valley (12/09/2022)

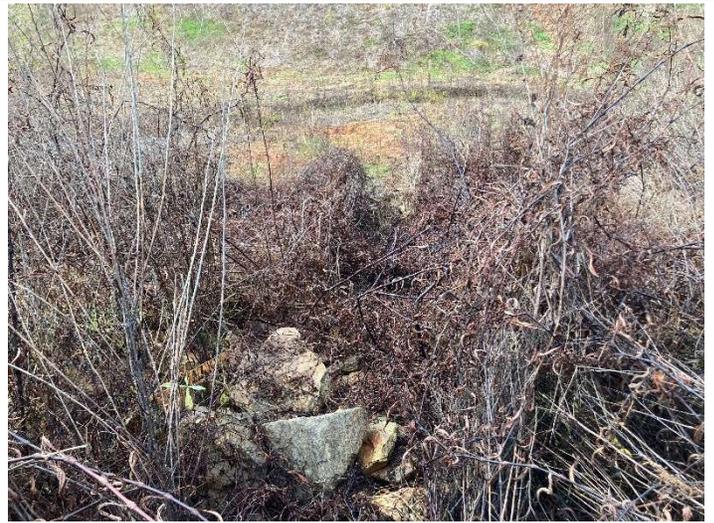
**Photo Point 3a** – Stabilized swale, view down valley (12/09/2022)

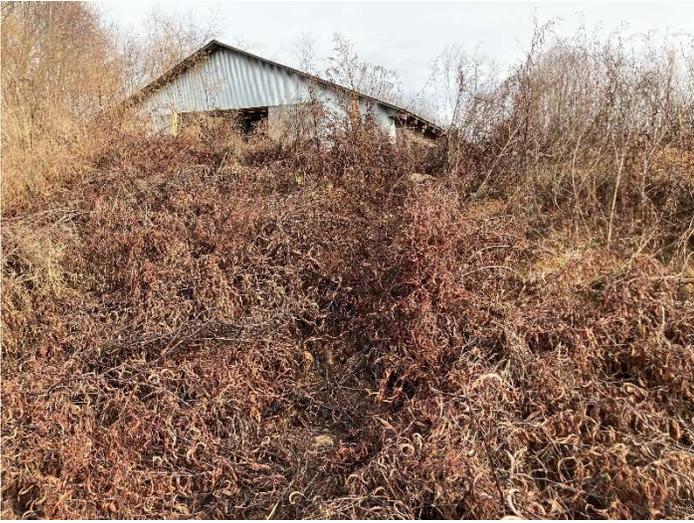
**Photo Point 4a** – Stabilized swale, view up valley (12/09/2022)

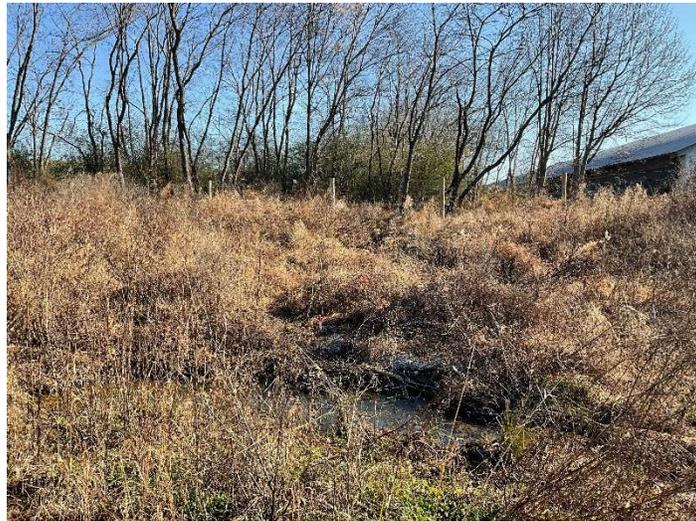
**Photo Point 5a** – Stabilized swale, view up valley (12/09/2022)

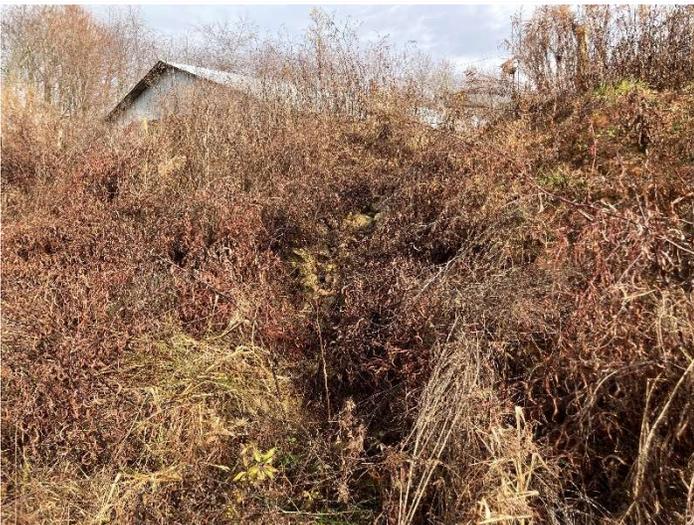
**Photo Point 6a** – Stabilized swale, view up valley (12/09/2022)

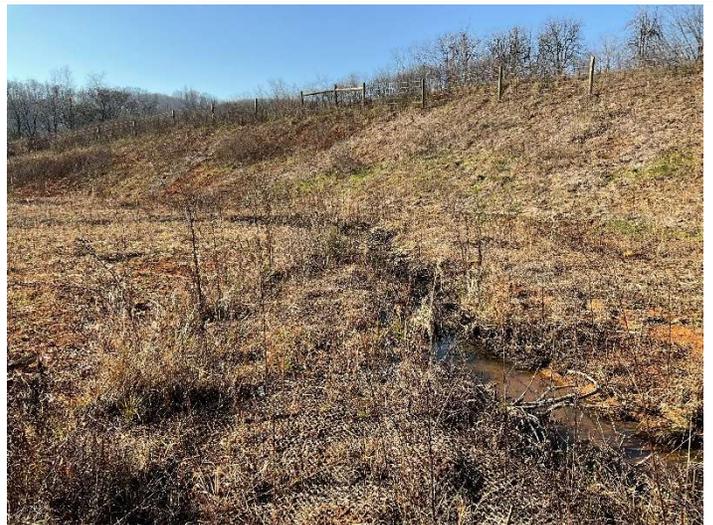
**Photo Point 6a** – Stabilized swale, view down valley (12/09/2022)

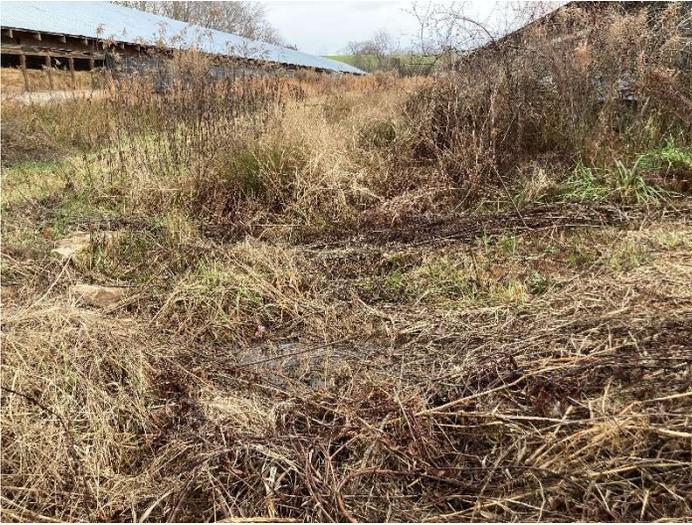
**Photo Point 7a** – Stabilized swale, view up valley (12/09/2022)

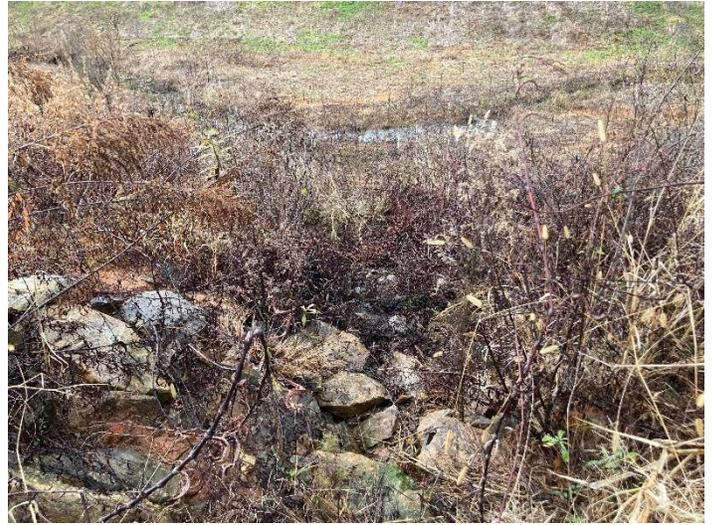
**Photo Point 7a** – Stabilized swale, view down valley (12/09/2022)

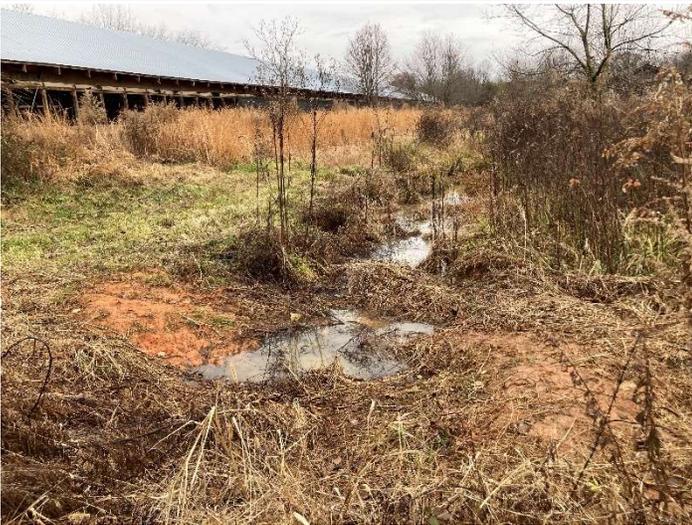
**Photo Point 8a** – Stabilized swale, view up valley (12/09/2022)

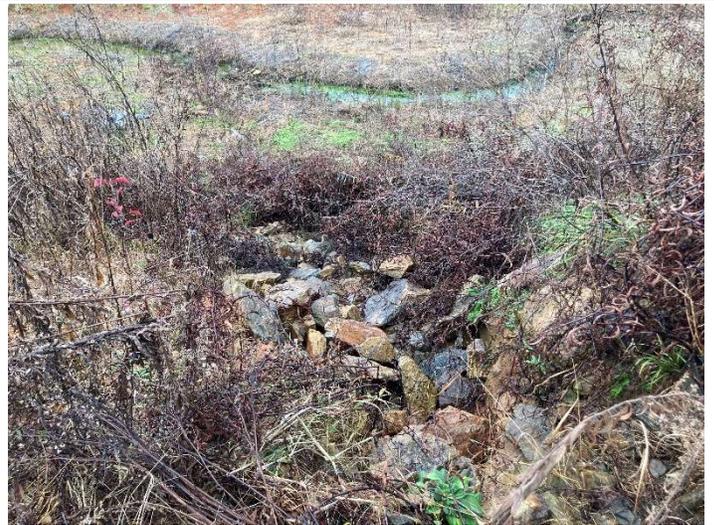
**Photo Point 8a** – Stabilized swale, view down valley (12/09/2022)

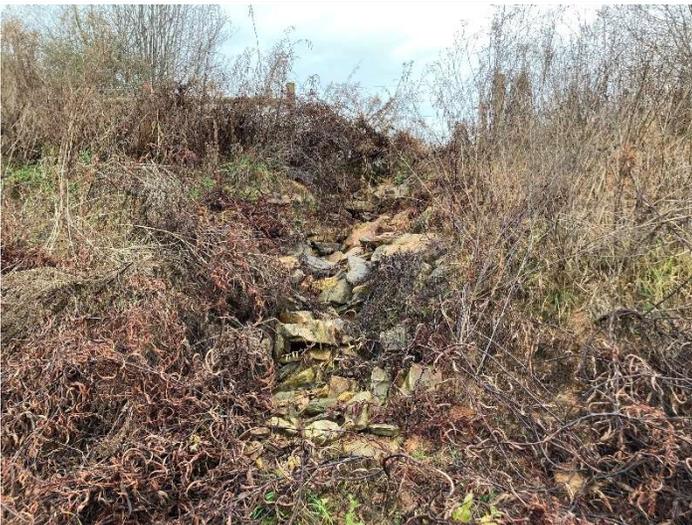
**Photo Point 9a** – Stabilized swale, view up valley (12/09/2022)

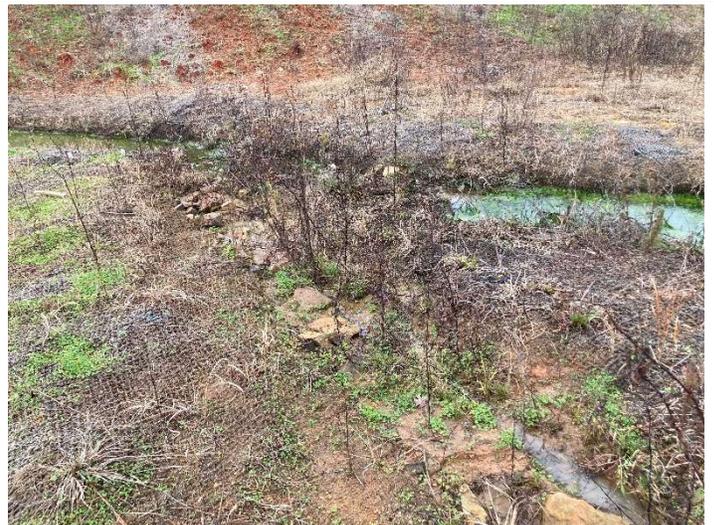
**Photo Point 9a** – Stabilized swale, view down valley (12/09/2022)

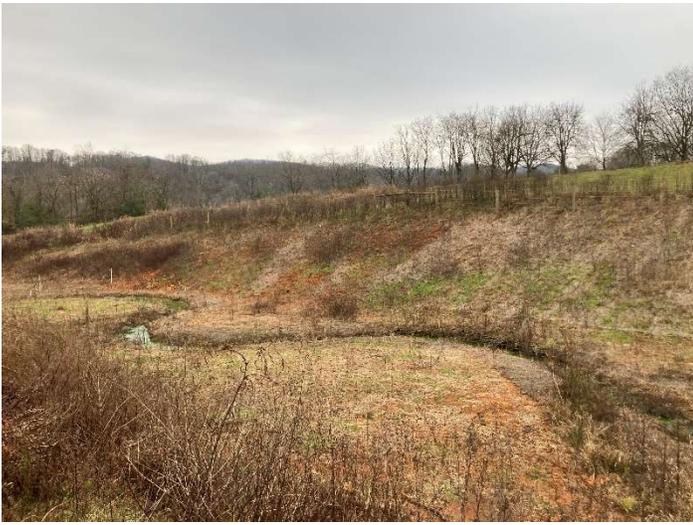
**UT1 Reach 1, station 207+00 to 210+50 – Low stem Density (12/8/22)**

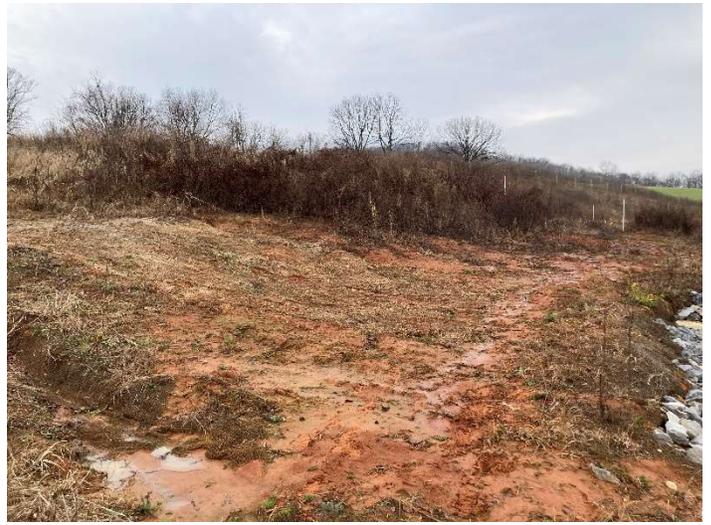
**UT1 Reach 1, station 213+00 to 214+00 - Bare areas (12/8/22)**

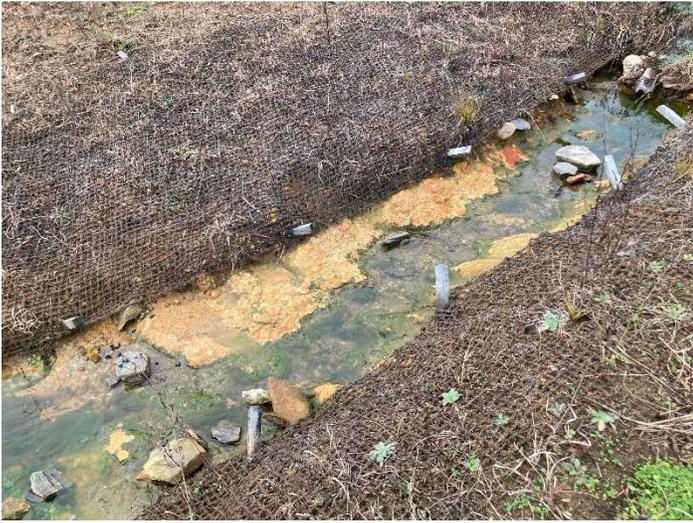
**UT1 Reach 3, station 210+50 - Bed scour (12/8/22)**

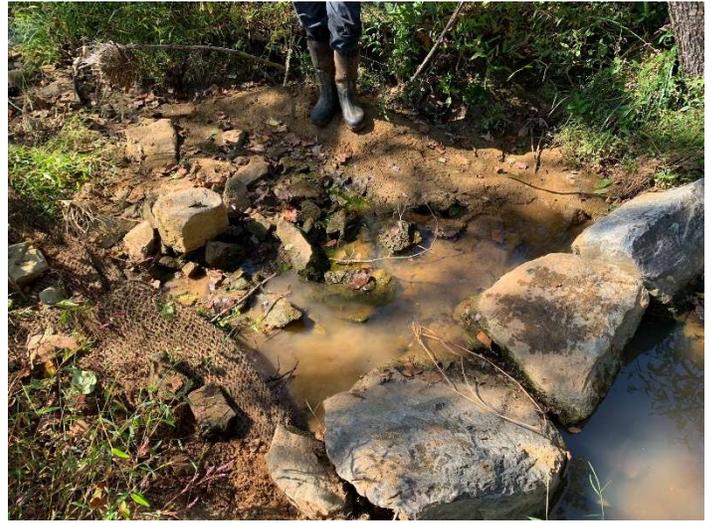
**UT1 Reach 3, station 218+15 - Structure piping (10/5/22)**

- a) Attendees viewed the sill on UT1 downstream of the culvert under Ingle Hollow Road. Aaron explained that the sill was designed and installed 6" higher than the culvert invert but has failed since construction. Water is piping around the end of the sill, which lowered the baseflow elevation. Wildlands plans on repairing the sill to the design elevation.

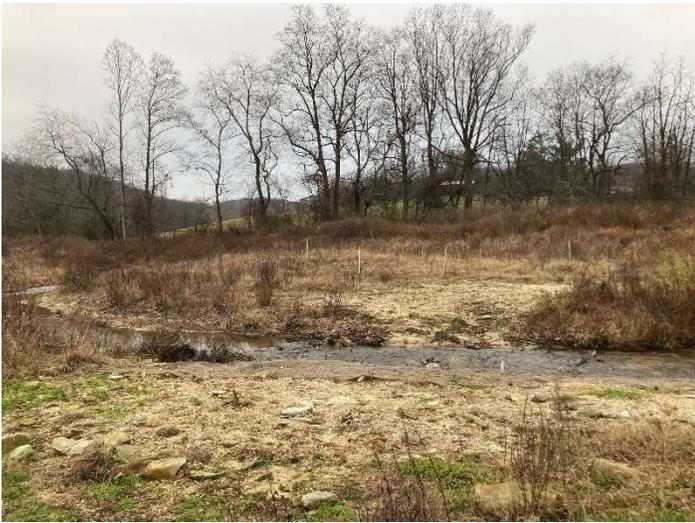
**NLHC Reach 1, station 102+00 to 103+00 - Bare areas (12/8/22)**

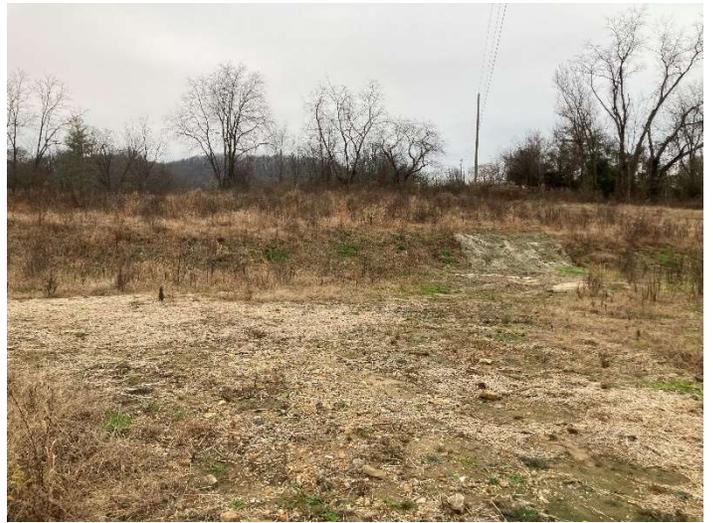
**NLHC Reach 1, station 103+00 to 105+00 - Bare areas (12/8/22)**

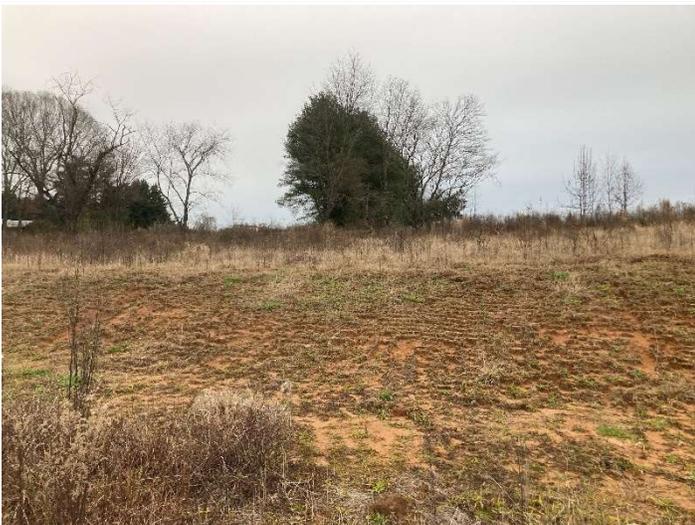
**NLHC Reach 2, station 112+50 to 117+00 - Bare areas (12/8/22)**

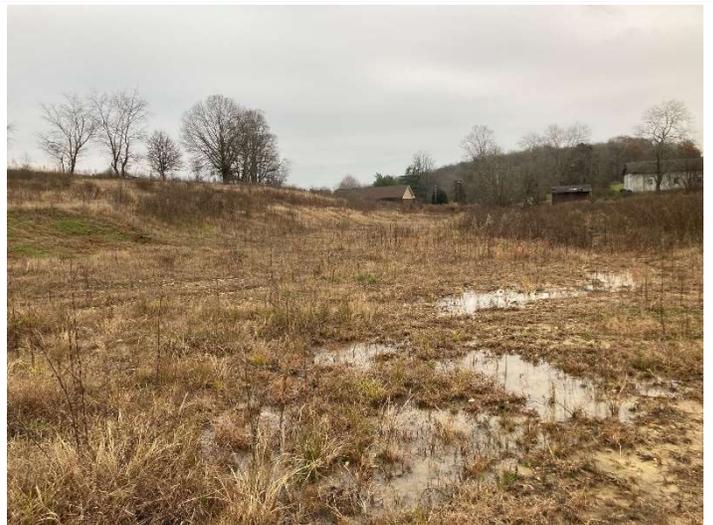
**NLHC Reach 2, station 112+20 to 117+50 - Bare Areas (12/8/22)**

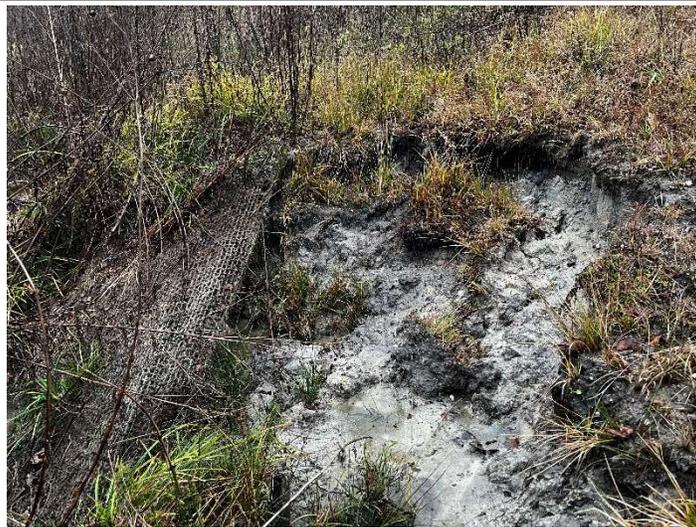
**UT2 Reach 3, station 308+00 - Bank scour (12/8/22)**

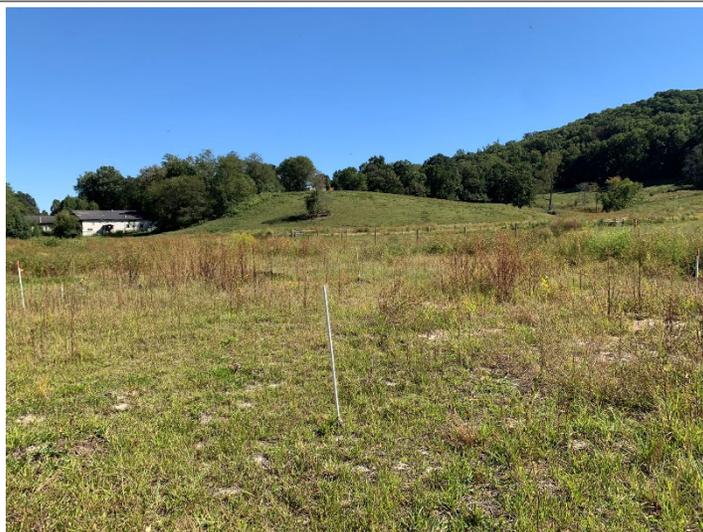
**NCDWR Comment 2 (Erin Davis) – VP2, North Little Hunting Creek Reach 2 – Herbaceous cover has become well established in this area (10/03/2022).**
