Jacksonville Country Club Stream Restoration and Enhancement Project

**SCO No. 070715501
DEQ Contract No. D08049S
DMS Project No. 194
Action ID# 2006-40325-067
Onslow County, North Carolina**

**Year 2 of 5 Monitoring Report
Data Collection: January through December 2015
Submission Date: April 13, 2016**

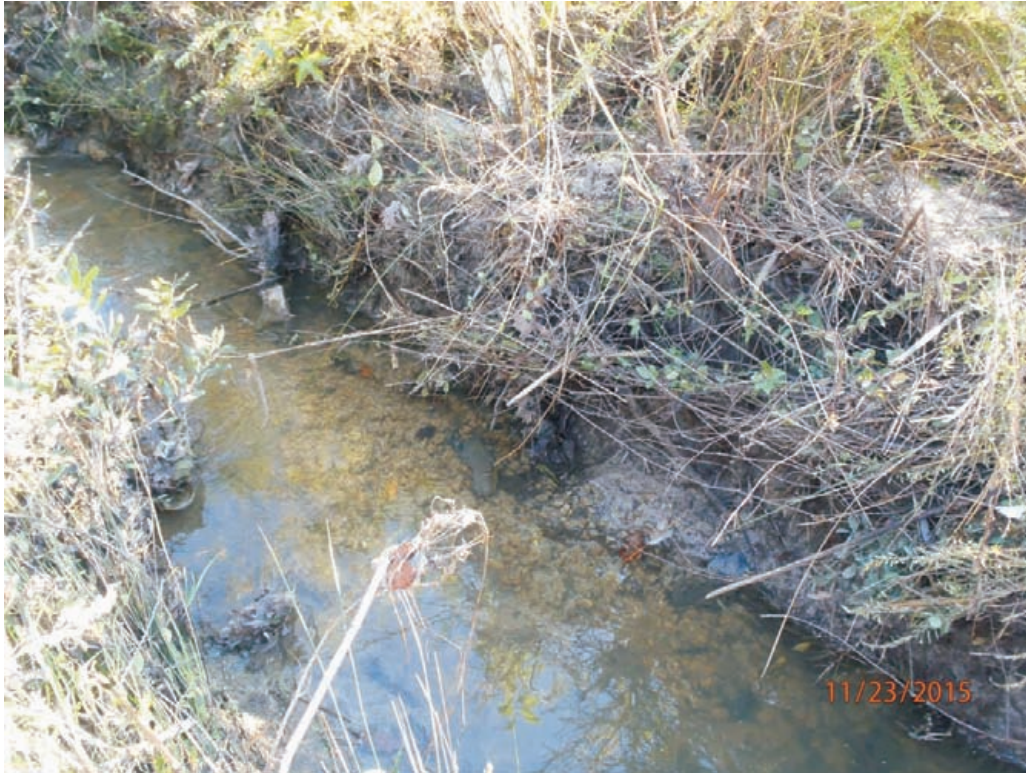
Reach 1A - Stream Problem Area #19; Mass Wasting

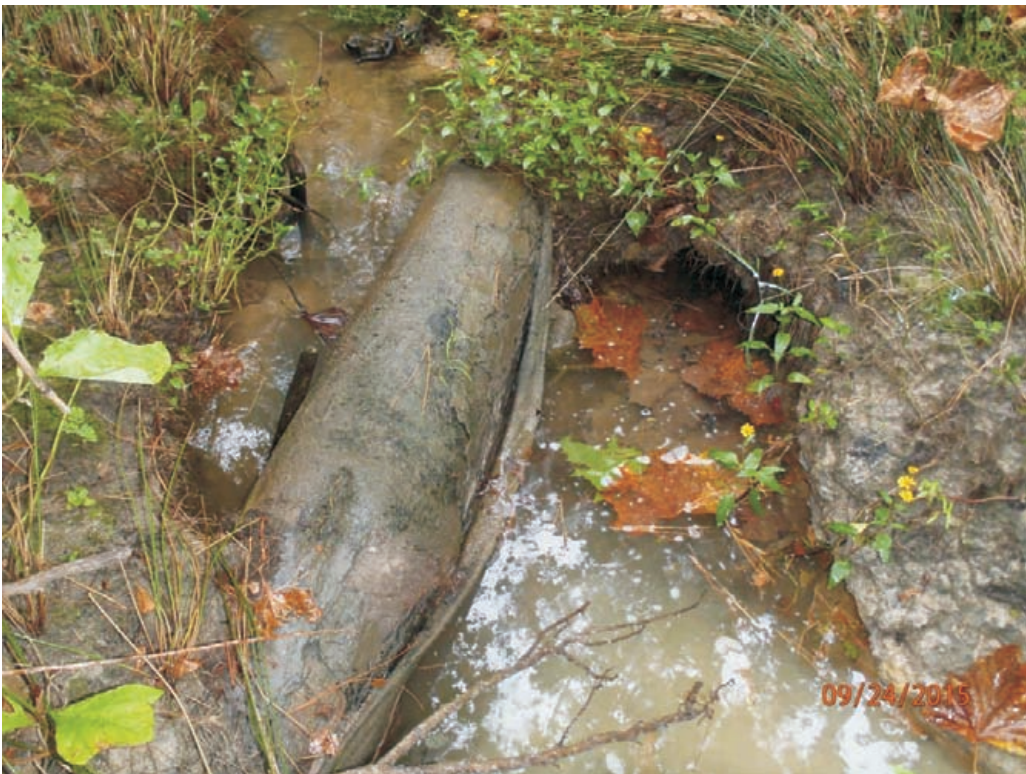
Reach 2A - Stream Problem Area #30; Log Vane Scour

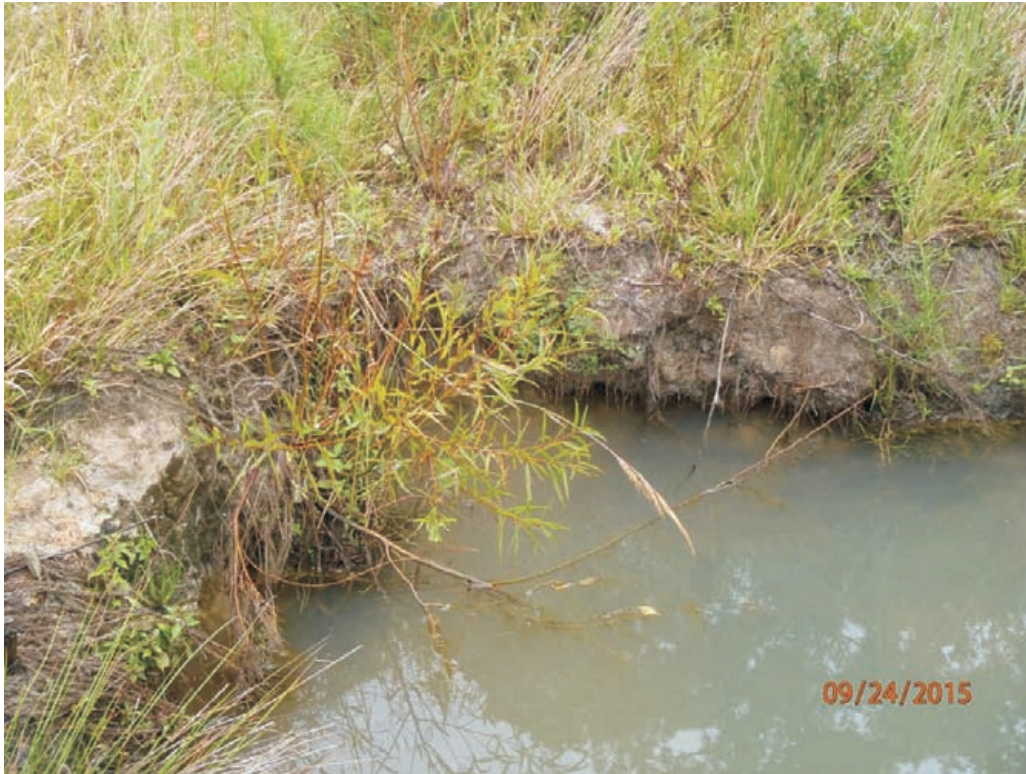
Reach 2A - Stream Problem Area #49; Mass Wasting
