Jacksonville Country Club Stream Restoration and Enhancement Project

**SCO No. 070715501
DEQ Contract No. D08049S
DMS Project No. 194
Action ID# 2006-40325-067
Onslow County, North Carolina**

**Year 3 of 5 Monitoring Report
Data Collection: January through December 2016
Submission Date: February 9, 2017**

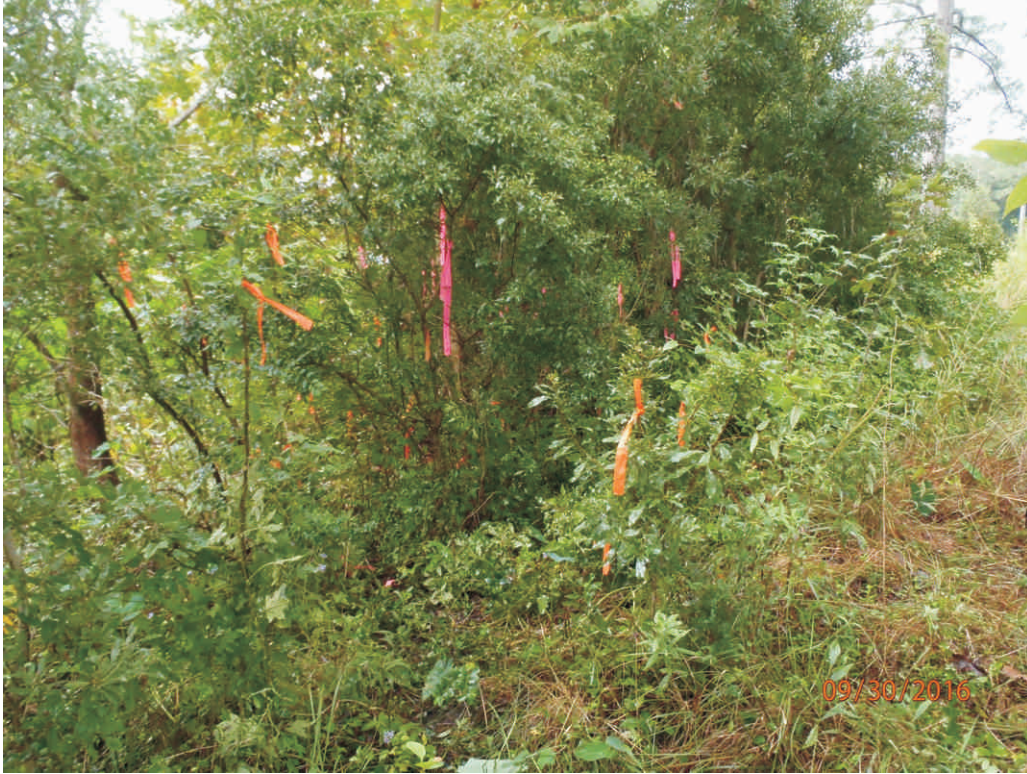
Vegetation Plot 5 - X-axis

It should also be noted that several survey markers were missing or were unstable. At Plot 5, the origin plot marker was missing. Three plot markers were missing at Plot 6. At Plot 7, two markers were missing. One of these was the northeast plot marker, which likely eroded into the channel (mass wasting area).

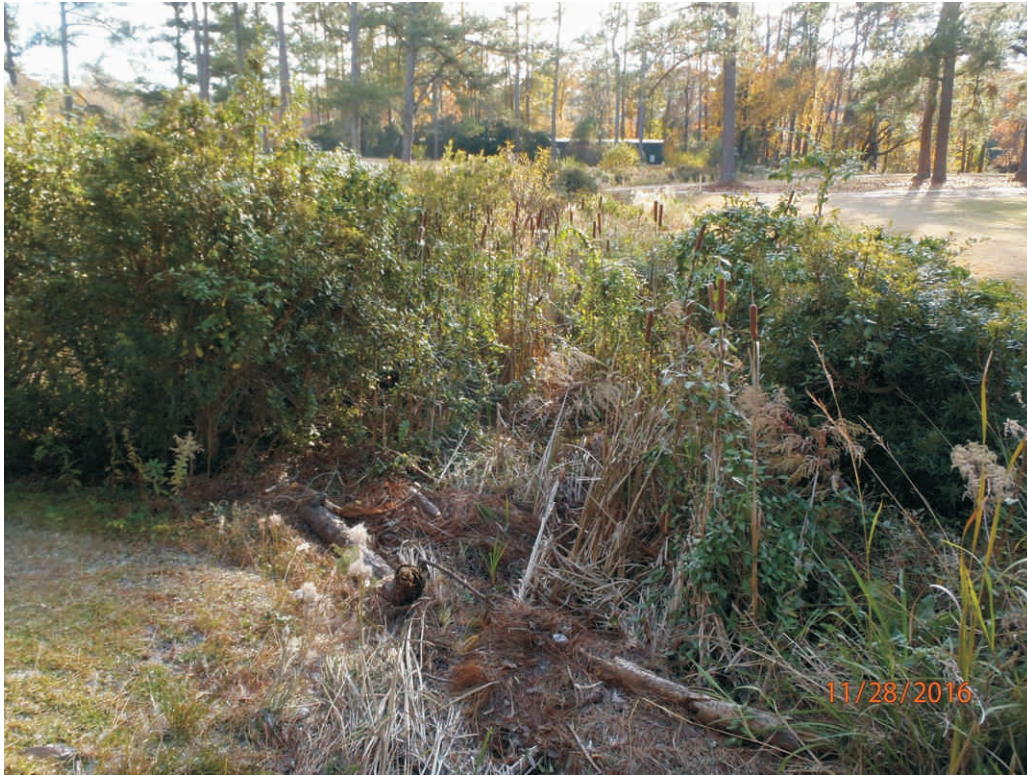
The enhancement reach is a small channel and it contains a great deal of vegetative debris. Three areas of aggradation and two scour holes were noted within this channel.

Stream Enhancement Reach - Looking South Along Channel

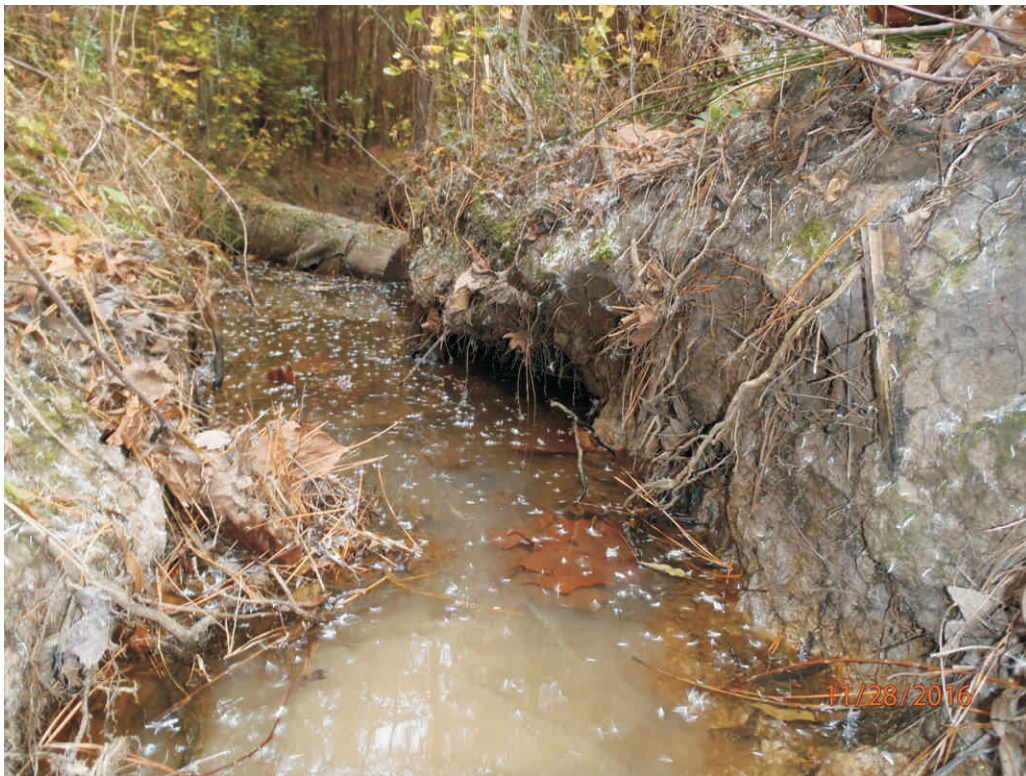
Reach 2A - Stream Problem Area #34; Log Vane Undercut

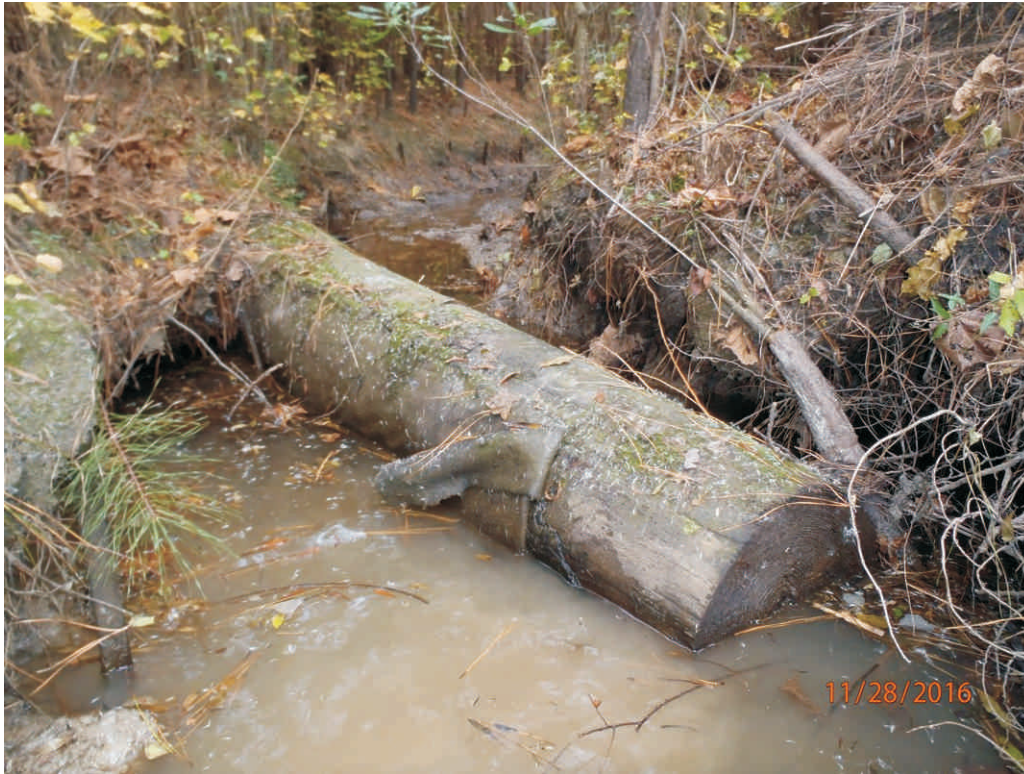
Reach 2A - Stream Problem Area #35; Log Vane Mass Wasting

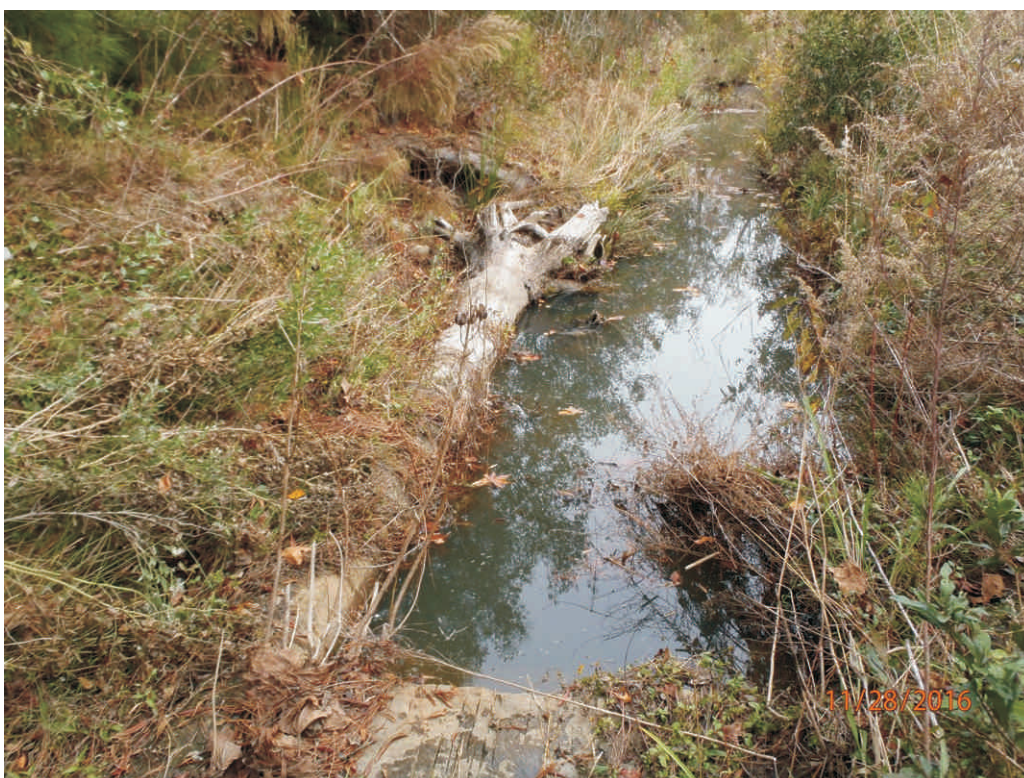
Reach 2A - Stream Problem Area #42; Mass Wasting

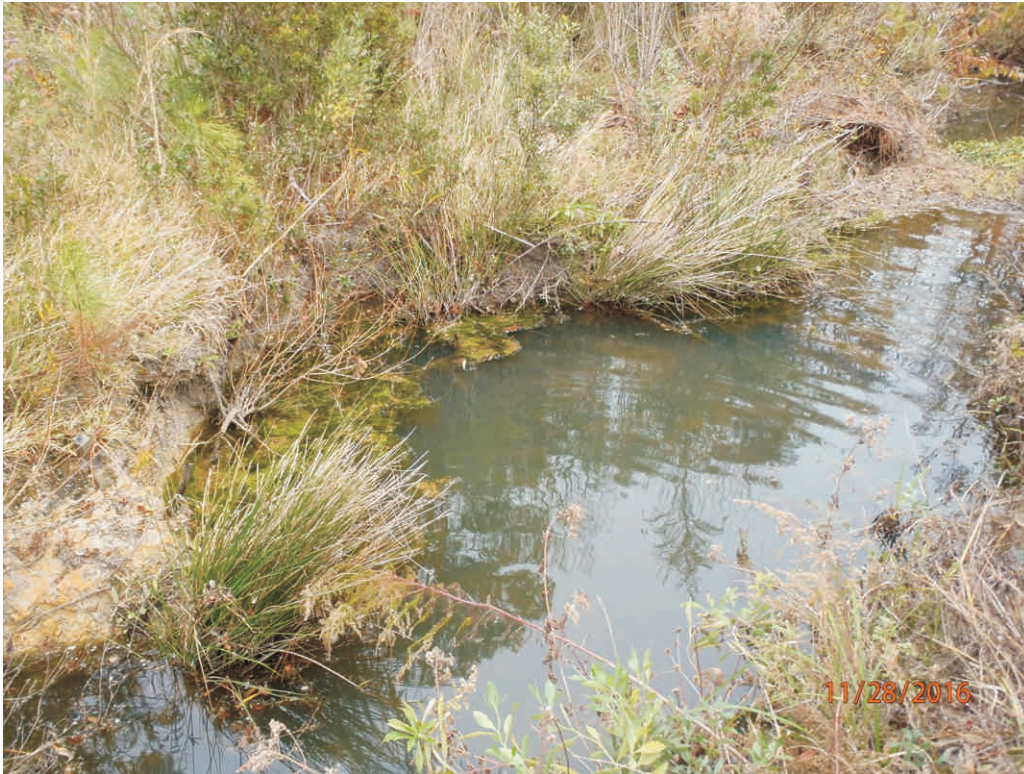
Reach 2A - Stream Problem Area #49; Mass Wasting

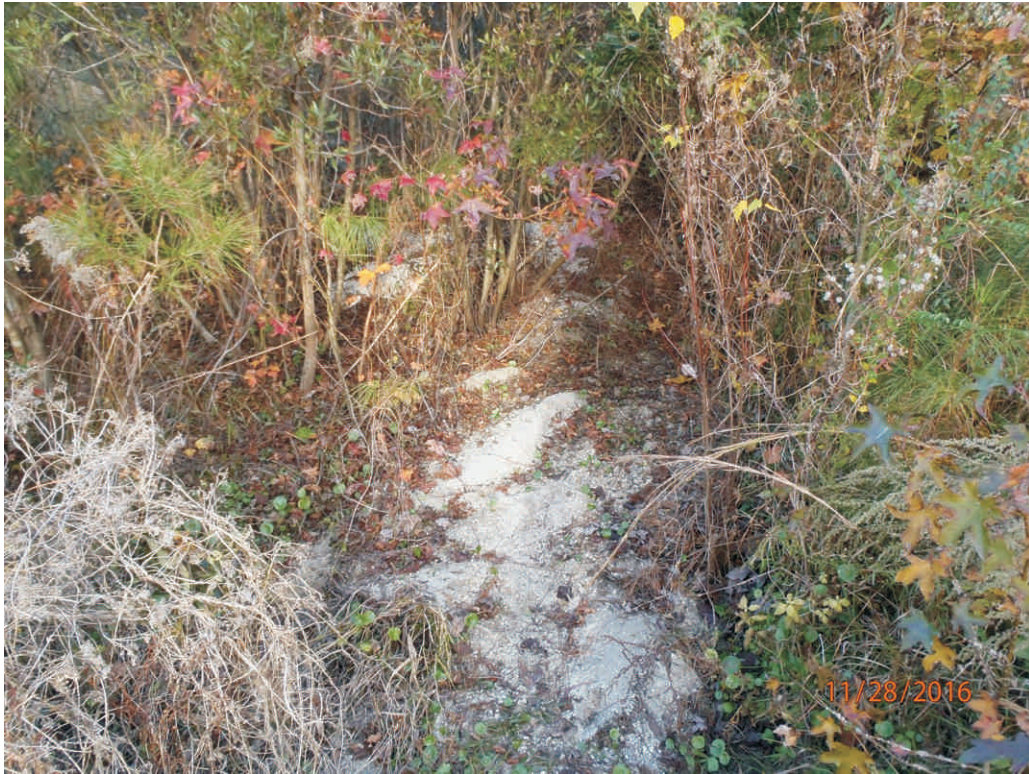
Enhancement Reach - Stream Problem Area #57b; Aggradation
