Jacksonville Country Club Stream Restoration and Enhancement Project

**SCO No. 070715501
DEQ Contract No. D08049S
DMS Project No. 194
Action ID# 2006-40325-067
Onslow County, North Carolina**

**Year 4 of 5 Monitoring Report
Data Collection: January through December 2017
Submission Date: March 9, 2018**

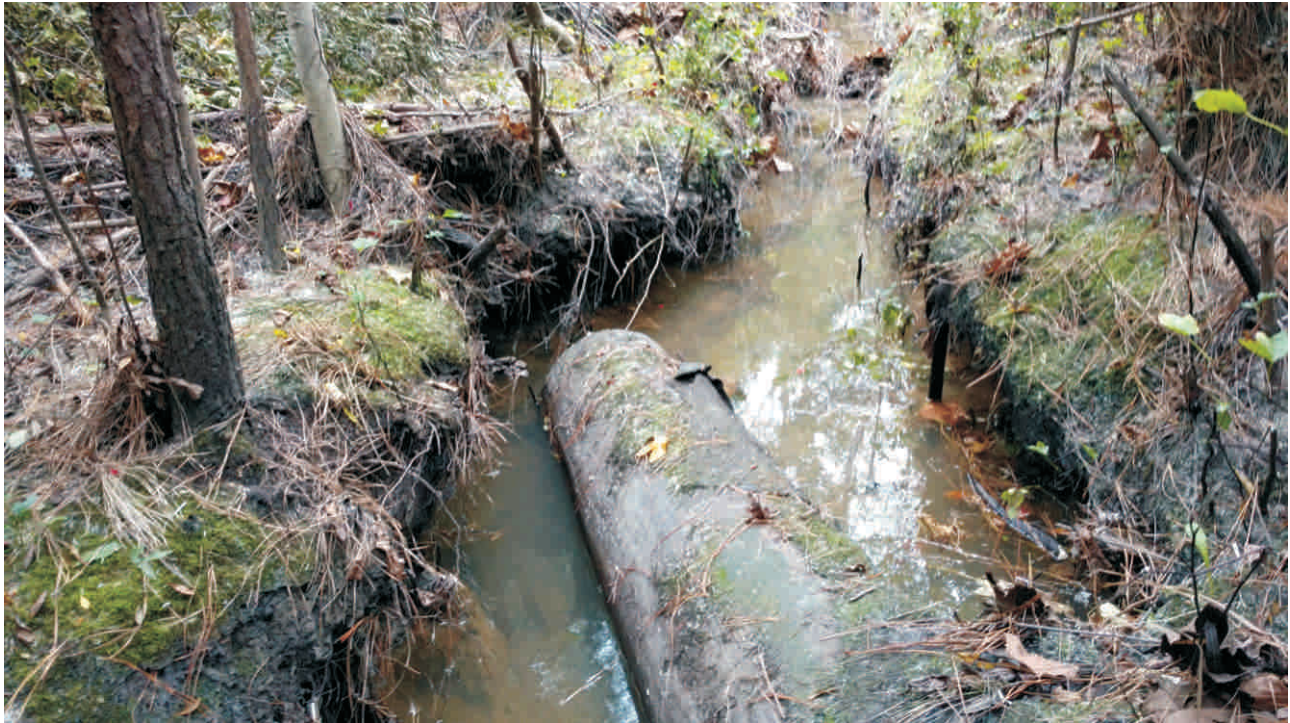
Reach 2A - Stream Problem Area #34; Log Vane Undercut

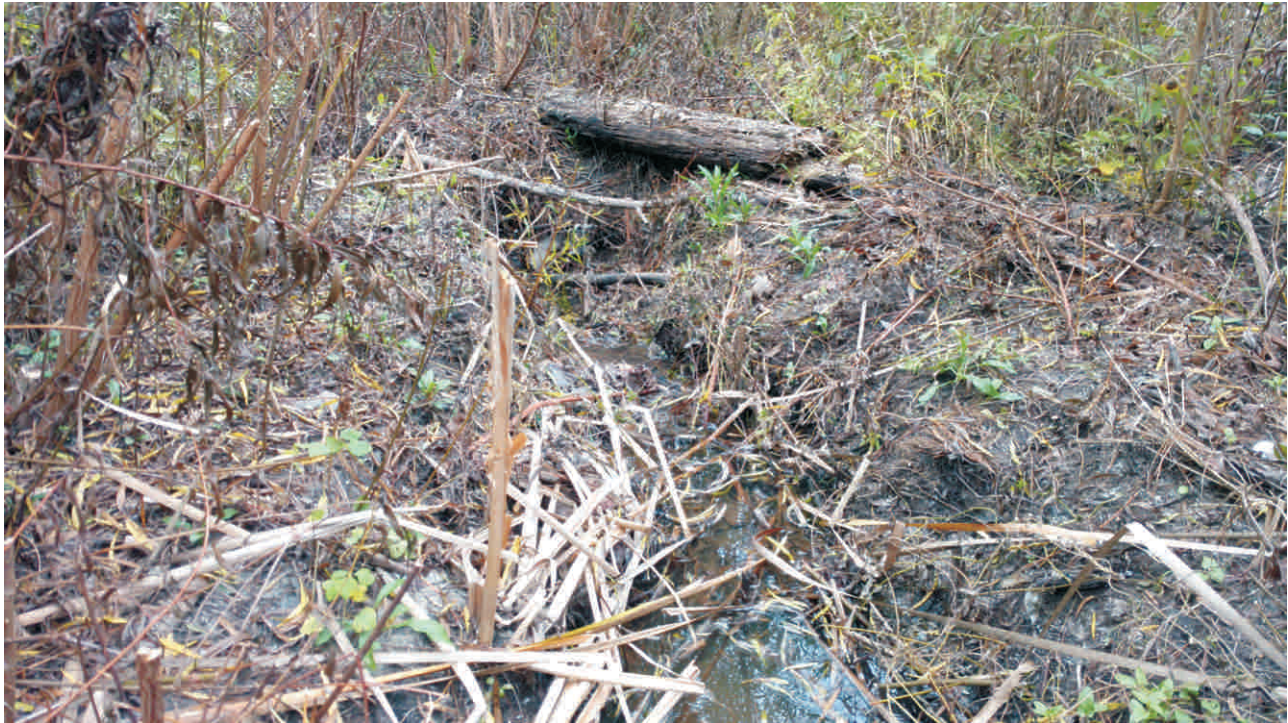
Reach 2A - Stream Problem Area #50a; Scour below Log Vane

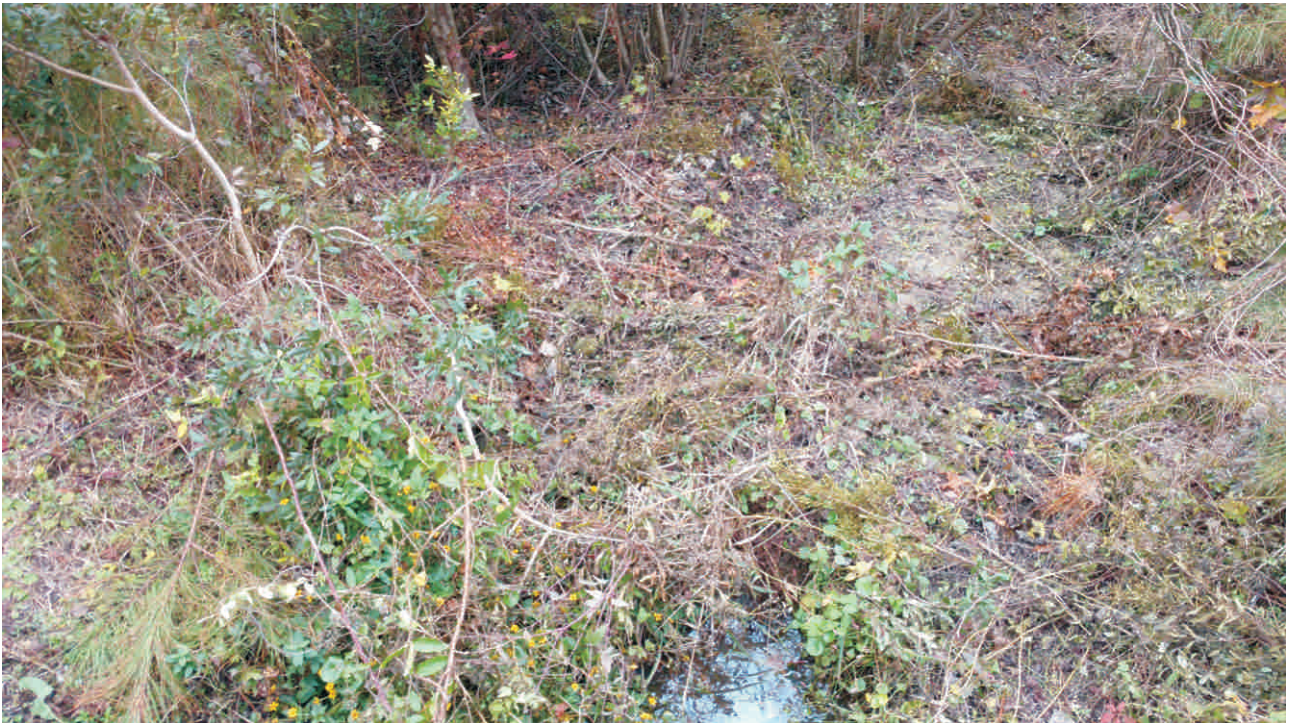
Reach B - Stream Problem Area #55; Undercut becoming Scour

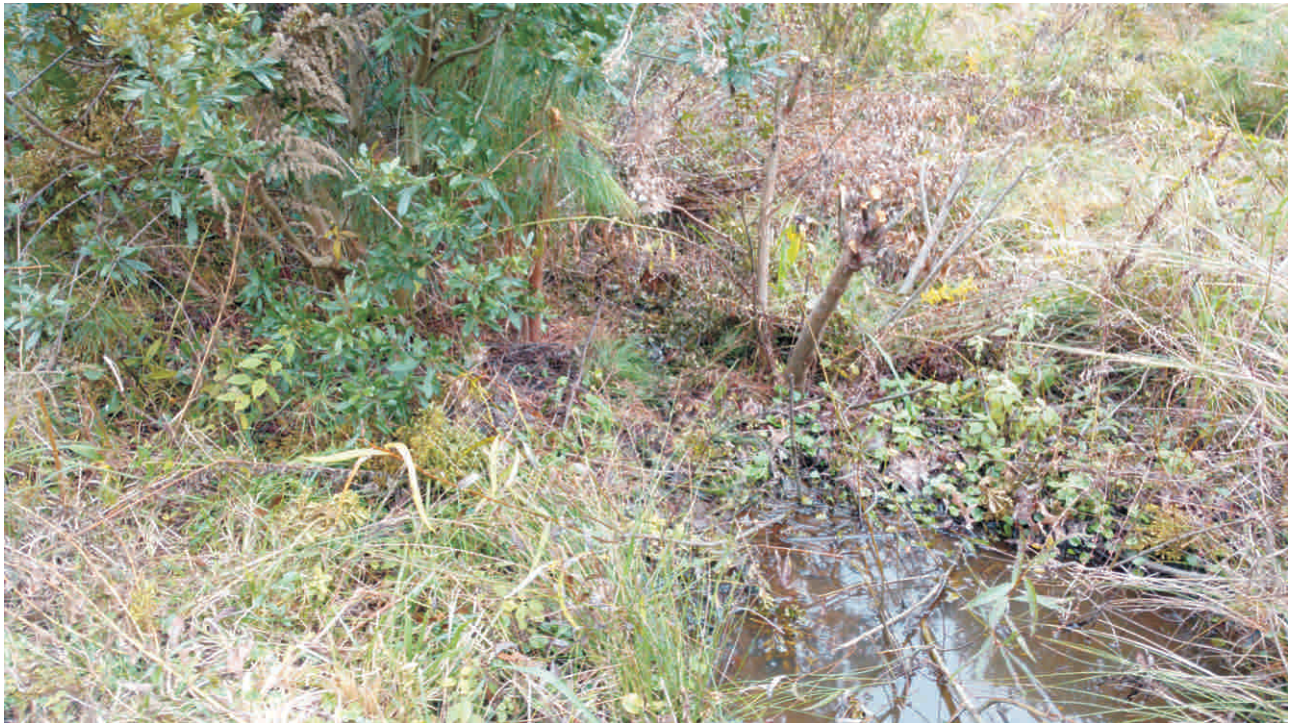
Enhancement Reach - Stream Problem Area #57a; Scour

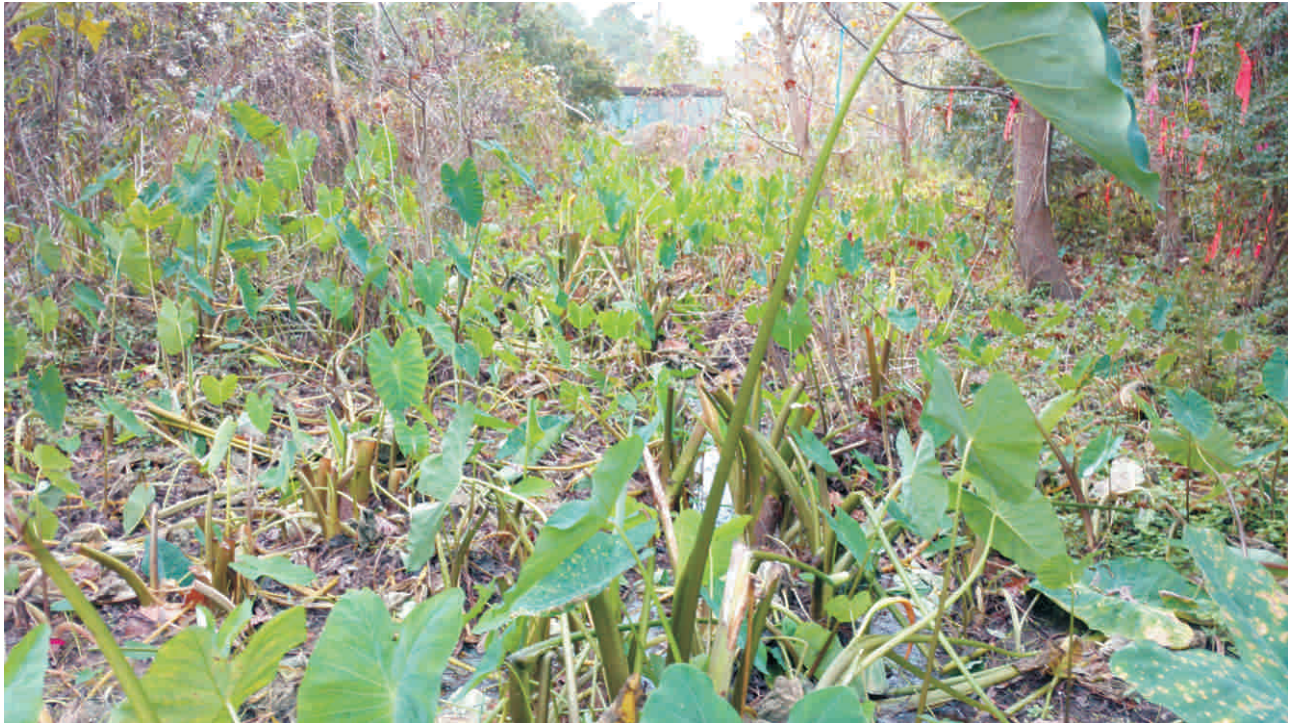
Enhancement Reach - Stream Problem Area #57c; Scour (difficult to see through vegetation)
