# **Jacksonville Country Club Stream Restoration and Enhancement Project**

**SCO No. 070715501  
DEQ Contract No. D08049S  
DMS Project No. 194  
Action ID# 2006-40325-067  
Onslow County, North Carolina**

**Year 5 of 5 Monitoring Report  
Data Collection: January through December 2018  
Submission Date: February 13, 2019**

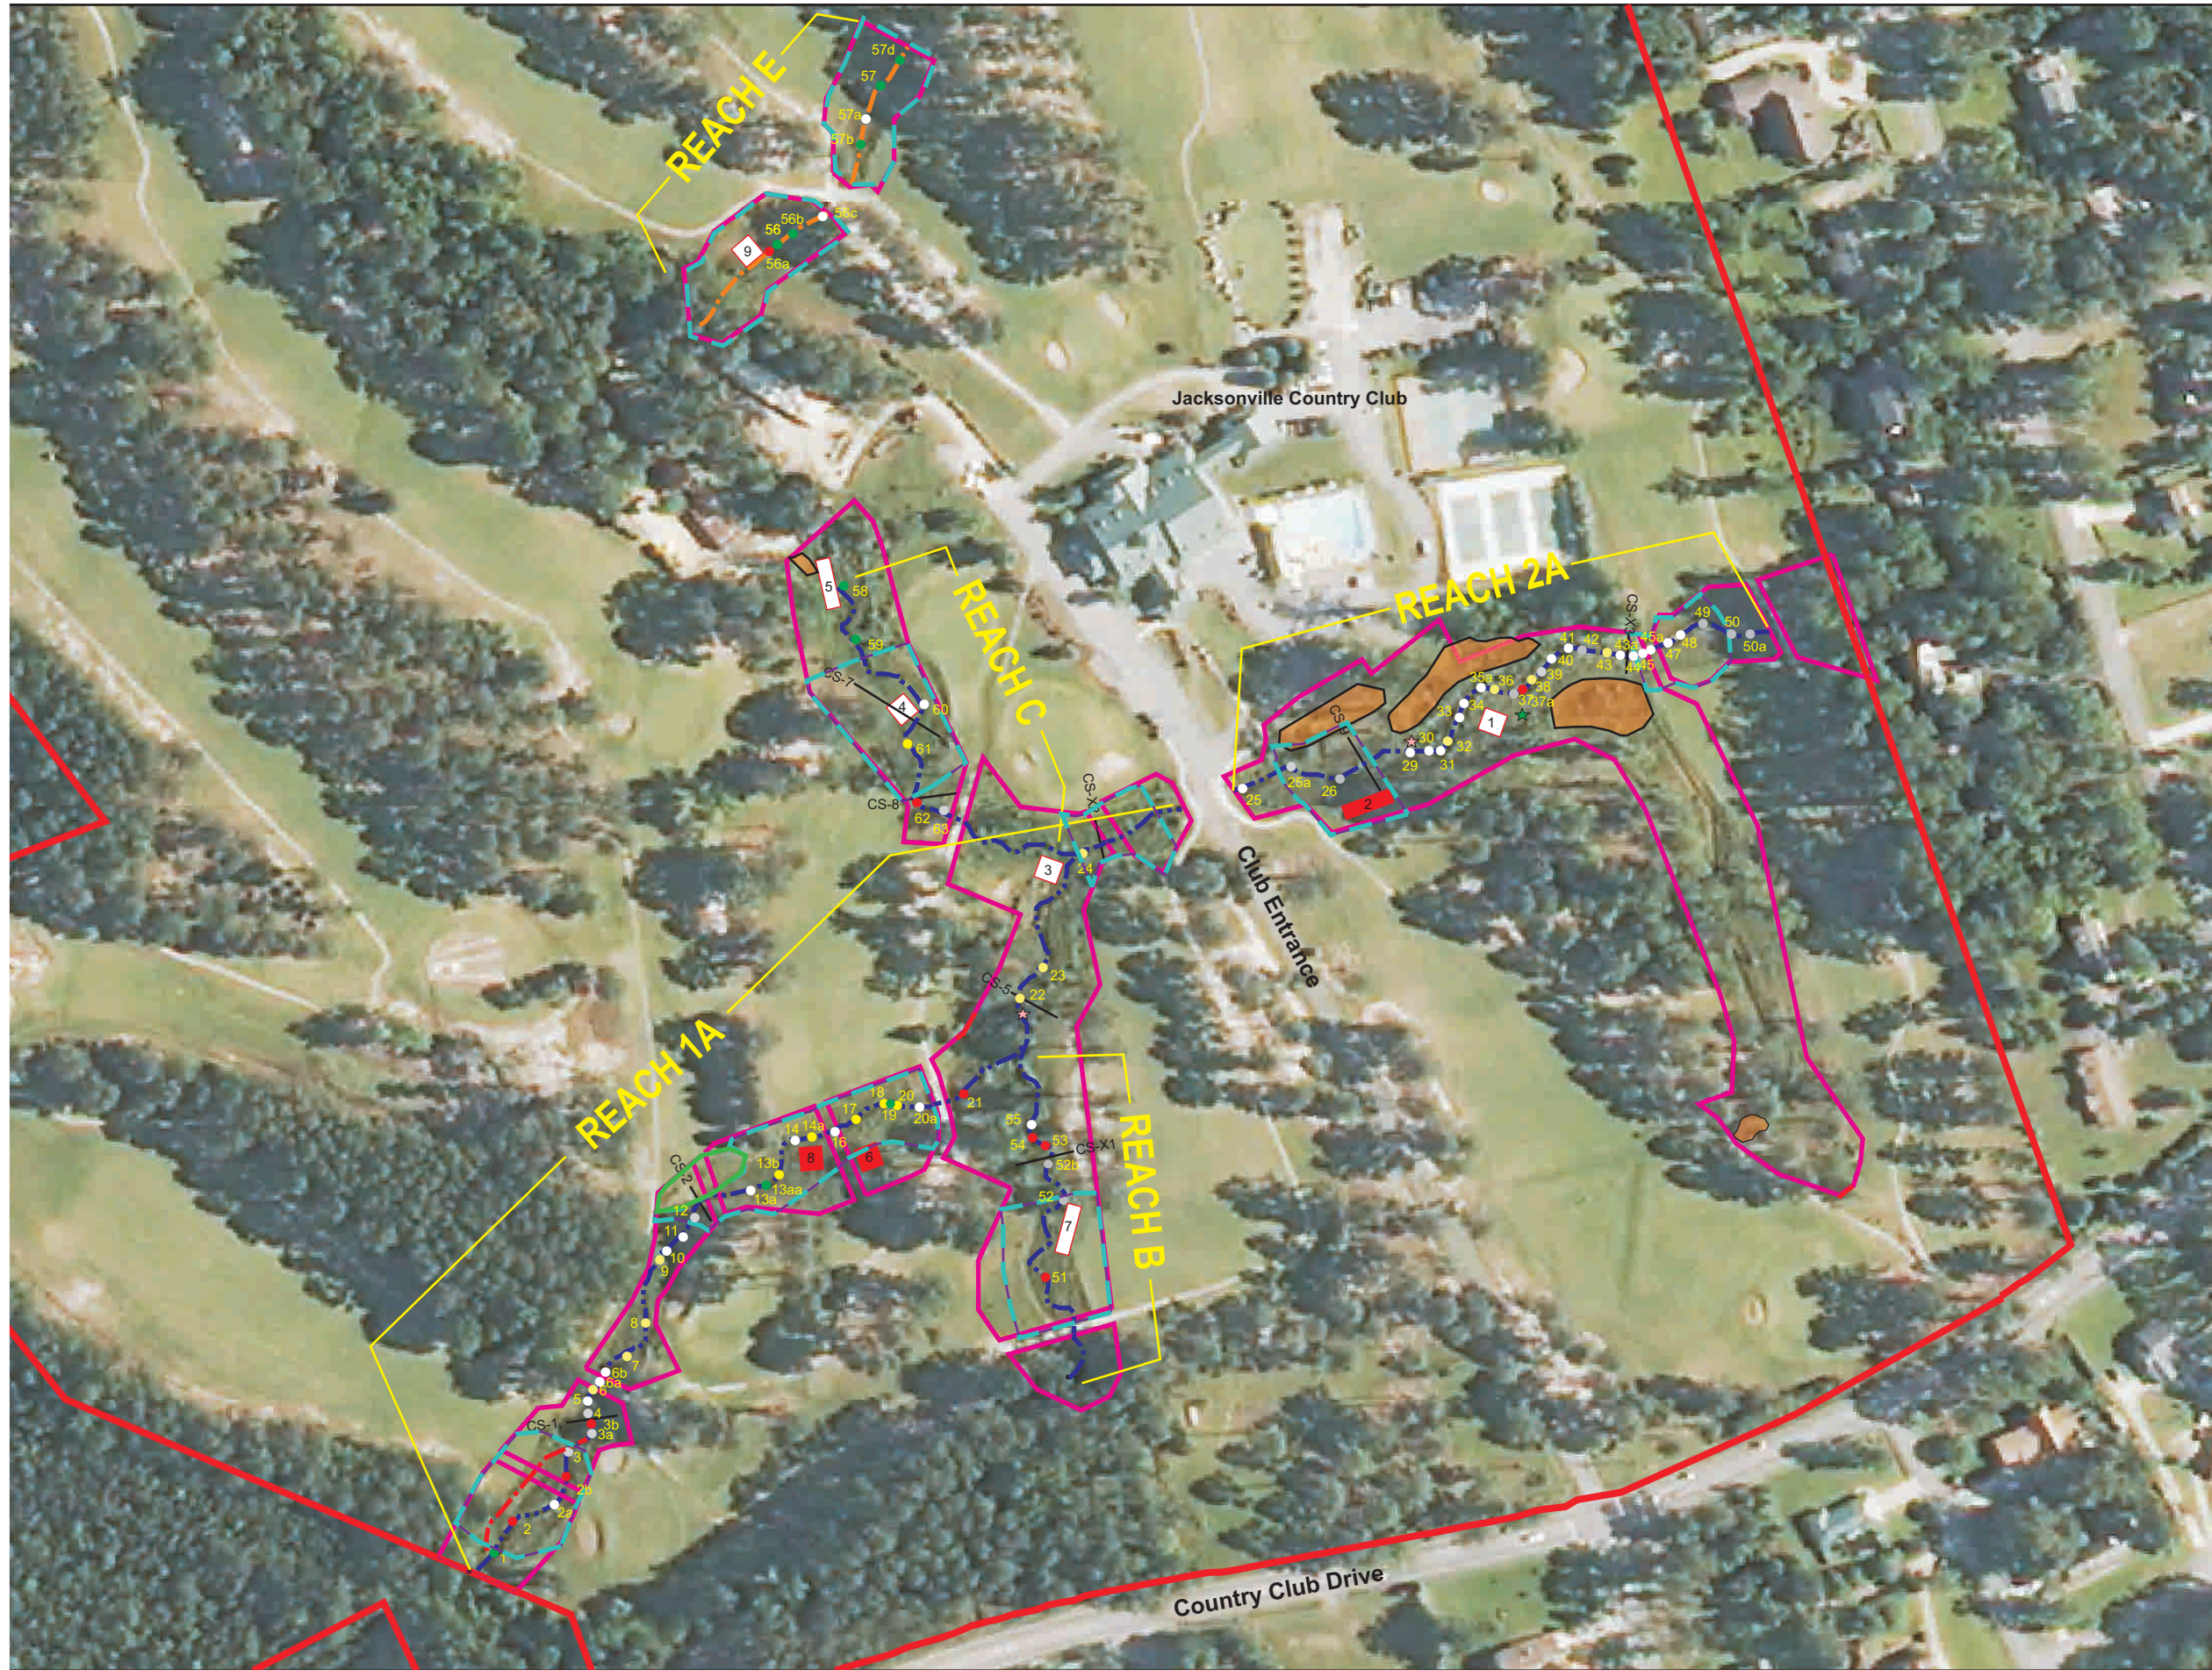
Current Conditions Plan View

Stream monitoring in MY5 (2018) consisted of both visual and morphological (i.e. survey) assessment of the channels. A visual inspection of the restored and enhanced stream channels and the BMP areas was conducted in December of 2018. Please see Appendix B for stream morphology assessment tables and photos. The BMP areas were stable. However, the BMP along the north side of 2A is actively managed because of the playover and trees are kept to a minimum height. Additionally, the outlet of the central BMP along Reach 2A is degraded.

As observed in the baseline and annual monitoring evaluations, many problem areas were identified along the four restored stream reaches (1A, 2A, B & C) and the enhancement reach during the visual inspection. Appendix B contains photographs of the problem areas and Figure 2 depicts the GPS location of specific points noted below.

LMG staff observed vegetation maintenance in several locations within the project area. Most of the maintenance occurred around the playover areas and consisted of cutting the tops of the trees so that greens are visible to the golfers (total of approximately 3.2 acres). Trees were generally cut to approximately 5' in height, although it varied based on the topography of the area. Some mowing, where vegetation was cleared to the ground, also occurred in one area near Vegetation Plot #8 (total of approximately 0.1 acre) (see Figure 2). The mowed area is considered an encroachment.

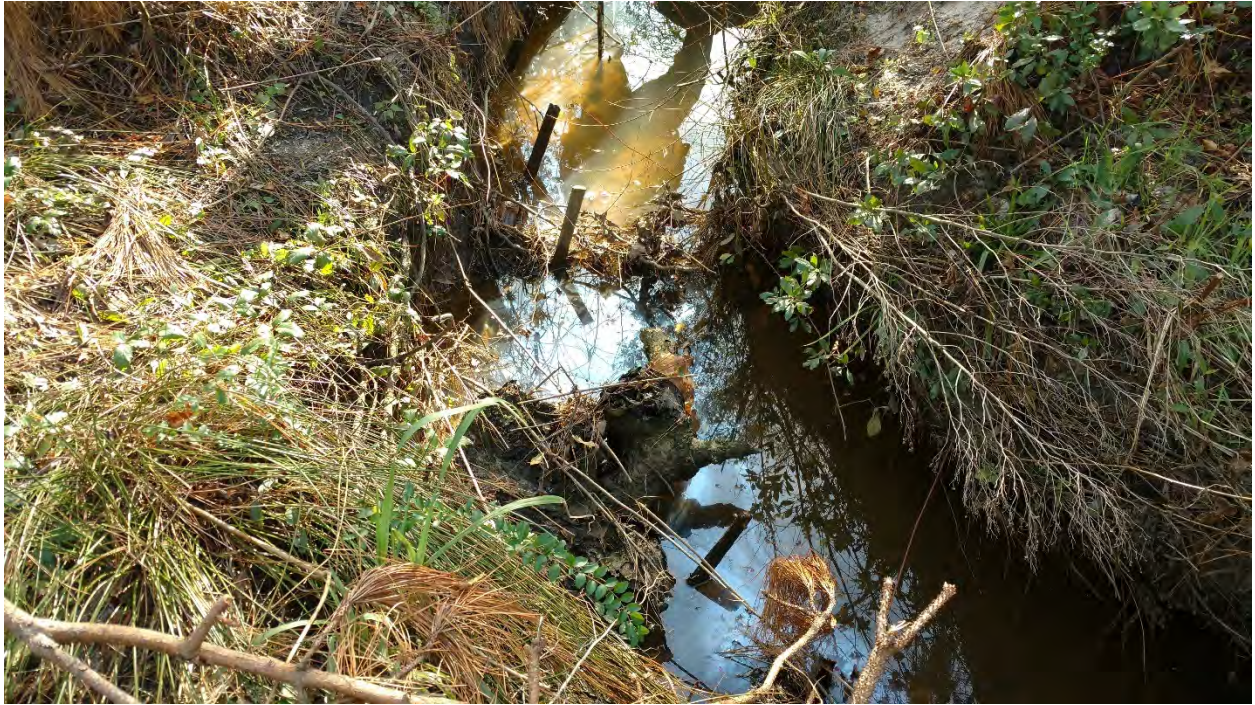
**Reach B: Stream Problem Area 52 – Mass Wasting**

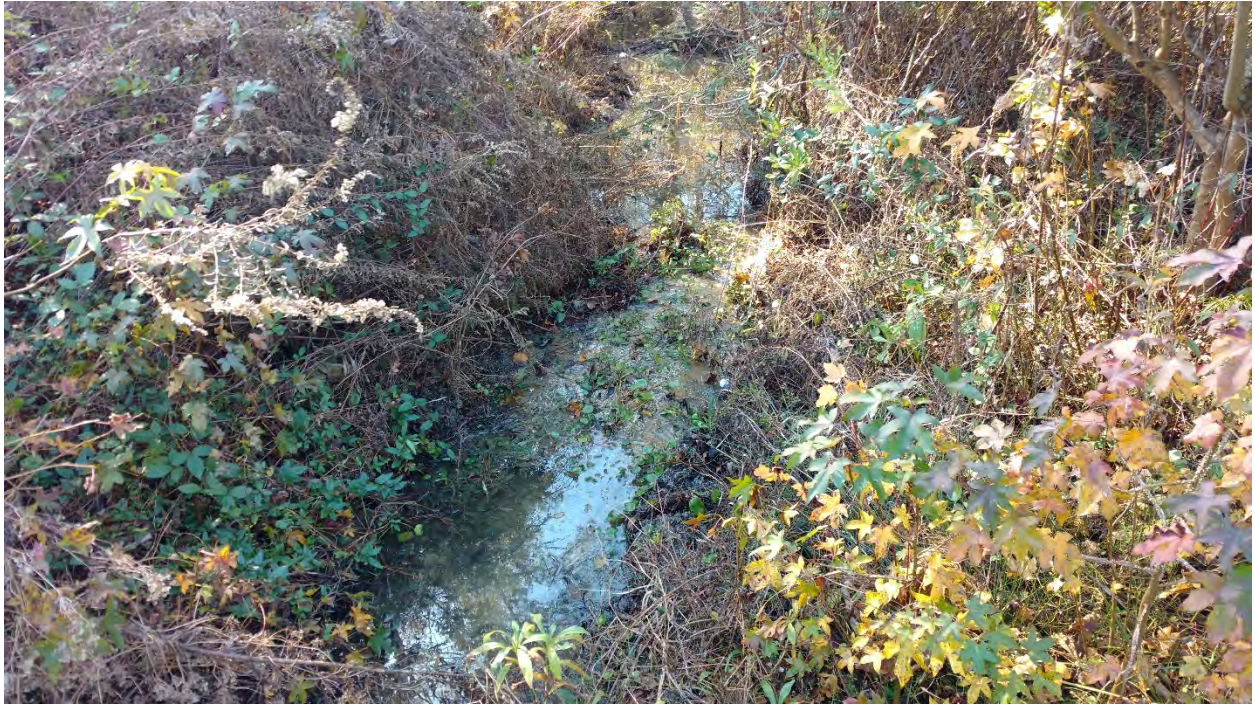
**Reach B: Stream Problem Area 55 – Scour**

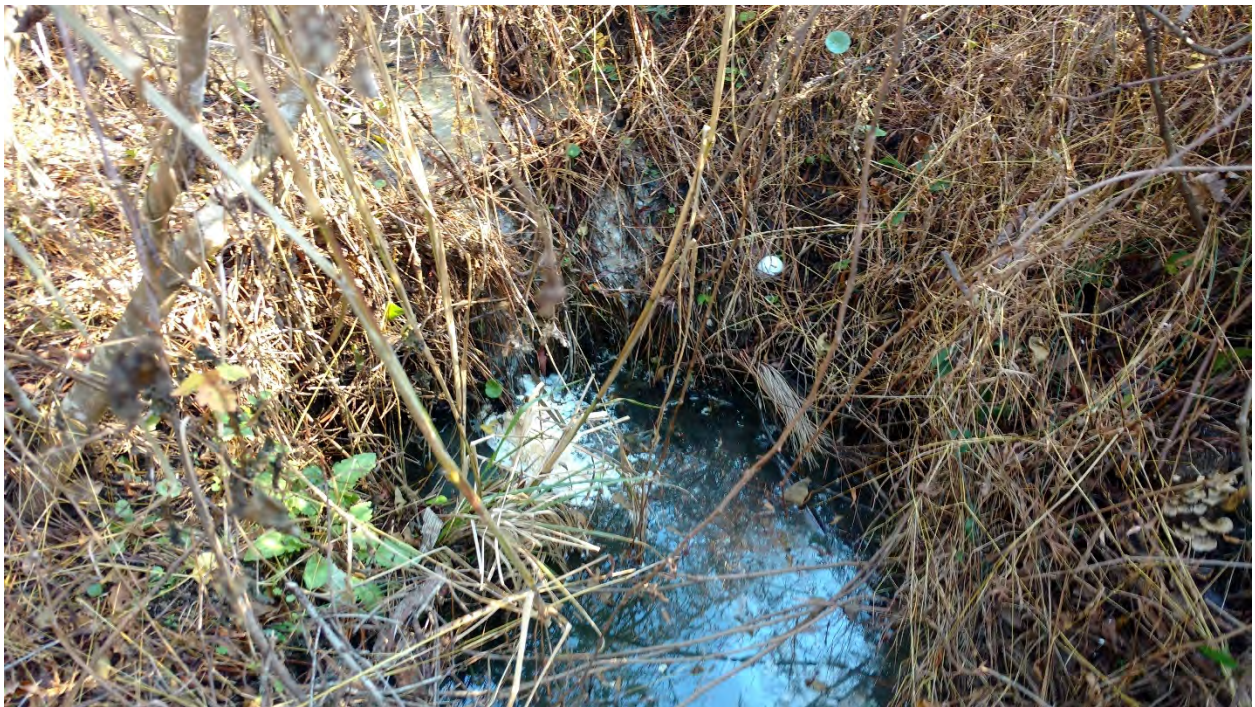
Enhancement Reach: Stream Problem Area 56a – Aggradation

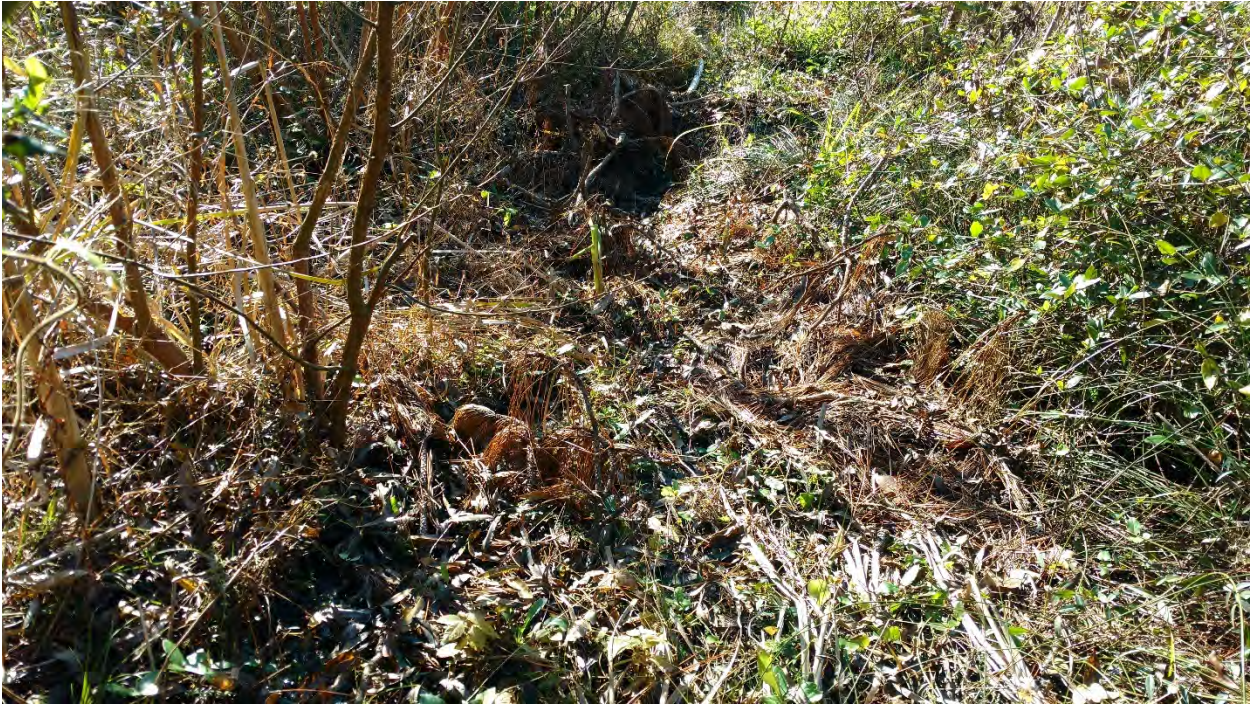
Enhancement Reach: Stream Problem Area 57b – Aggradation

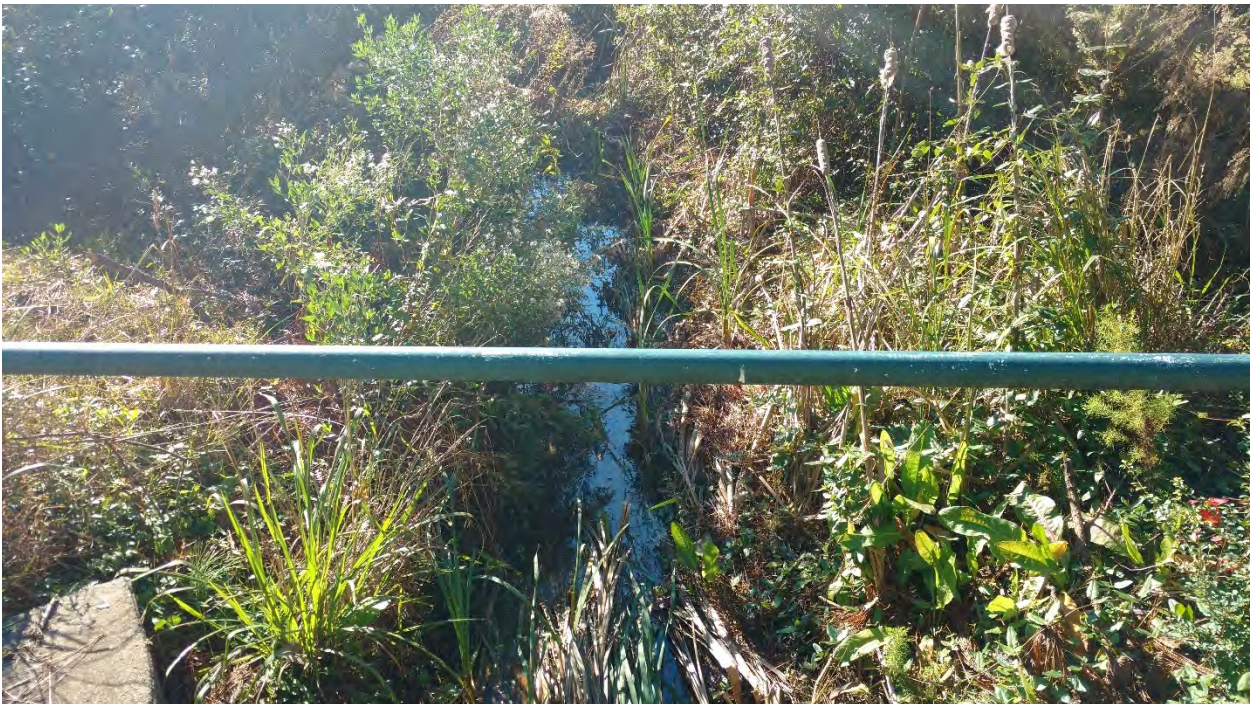
Enhancement Reach: Stream Problem Area 57d – Aggradation
