**Jacob's Ladder**  
**Stream Restoration Monitoring Report**  
**DMS Project # 95023**  
**DMS Contract # 003983**  
**Monitoring Year 04**

**Construction Completed: January 2014**

**Data Collection: 2017**

**Submitted: January 2018**

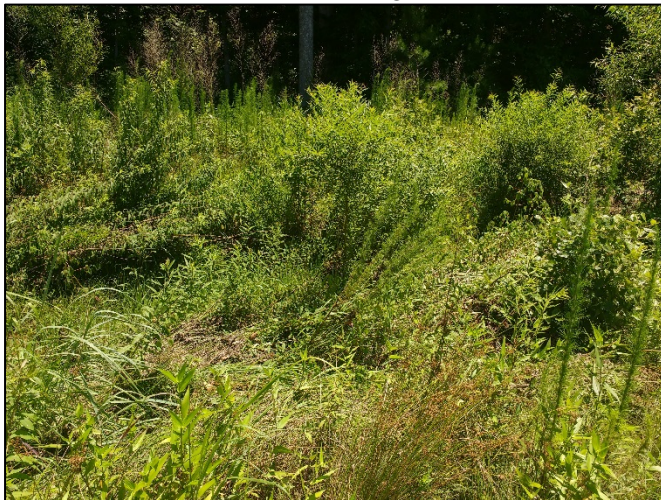
Photo 3. Bankfull indicators along T1, 6/28/17
