OVERHILLS STREAM AND WETLAND
RESTORATION MONITORING REPORT (YEAR 5)

Harnett County, North Carolina

EEP Project No. 199

Status of Plan: Final
Submission Date: November 2011

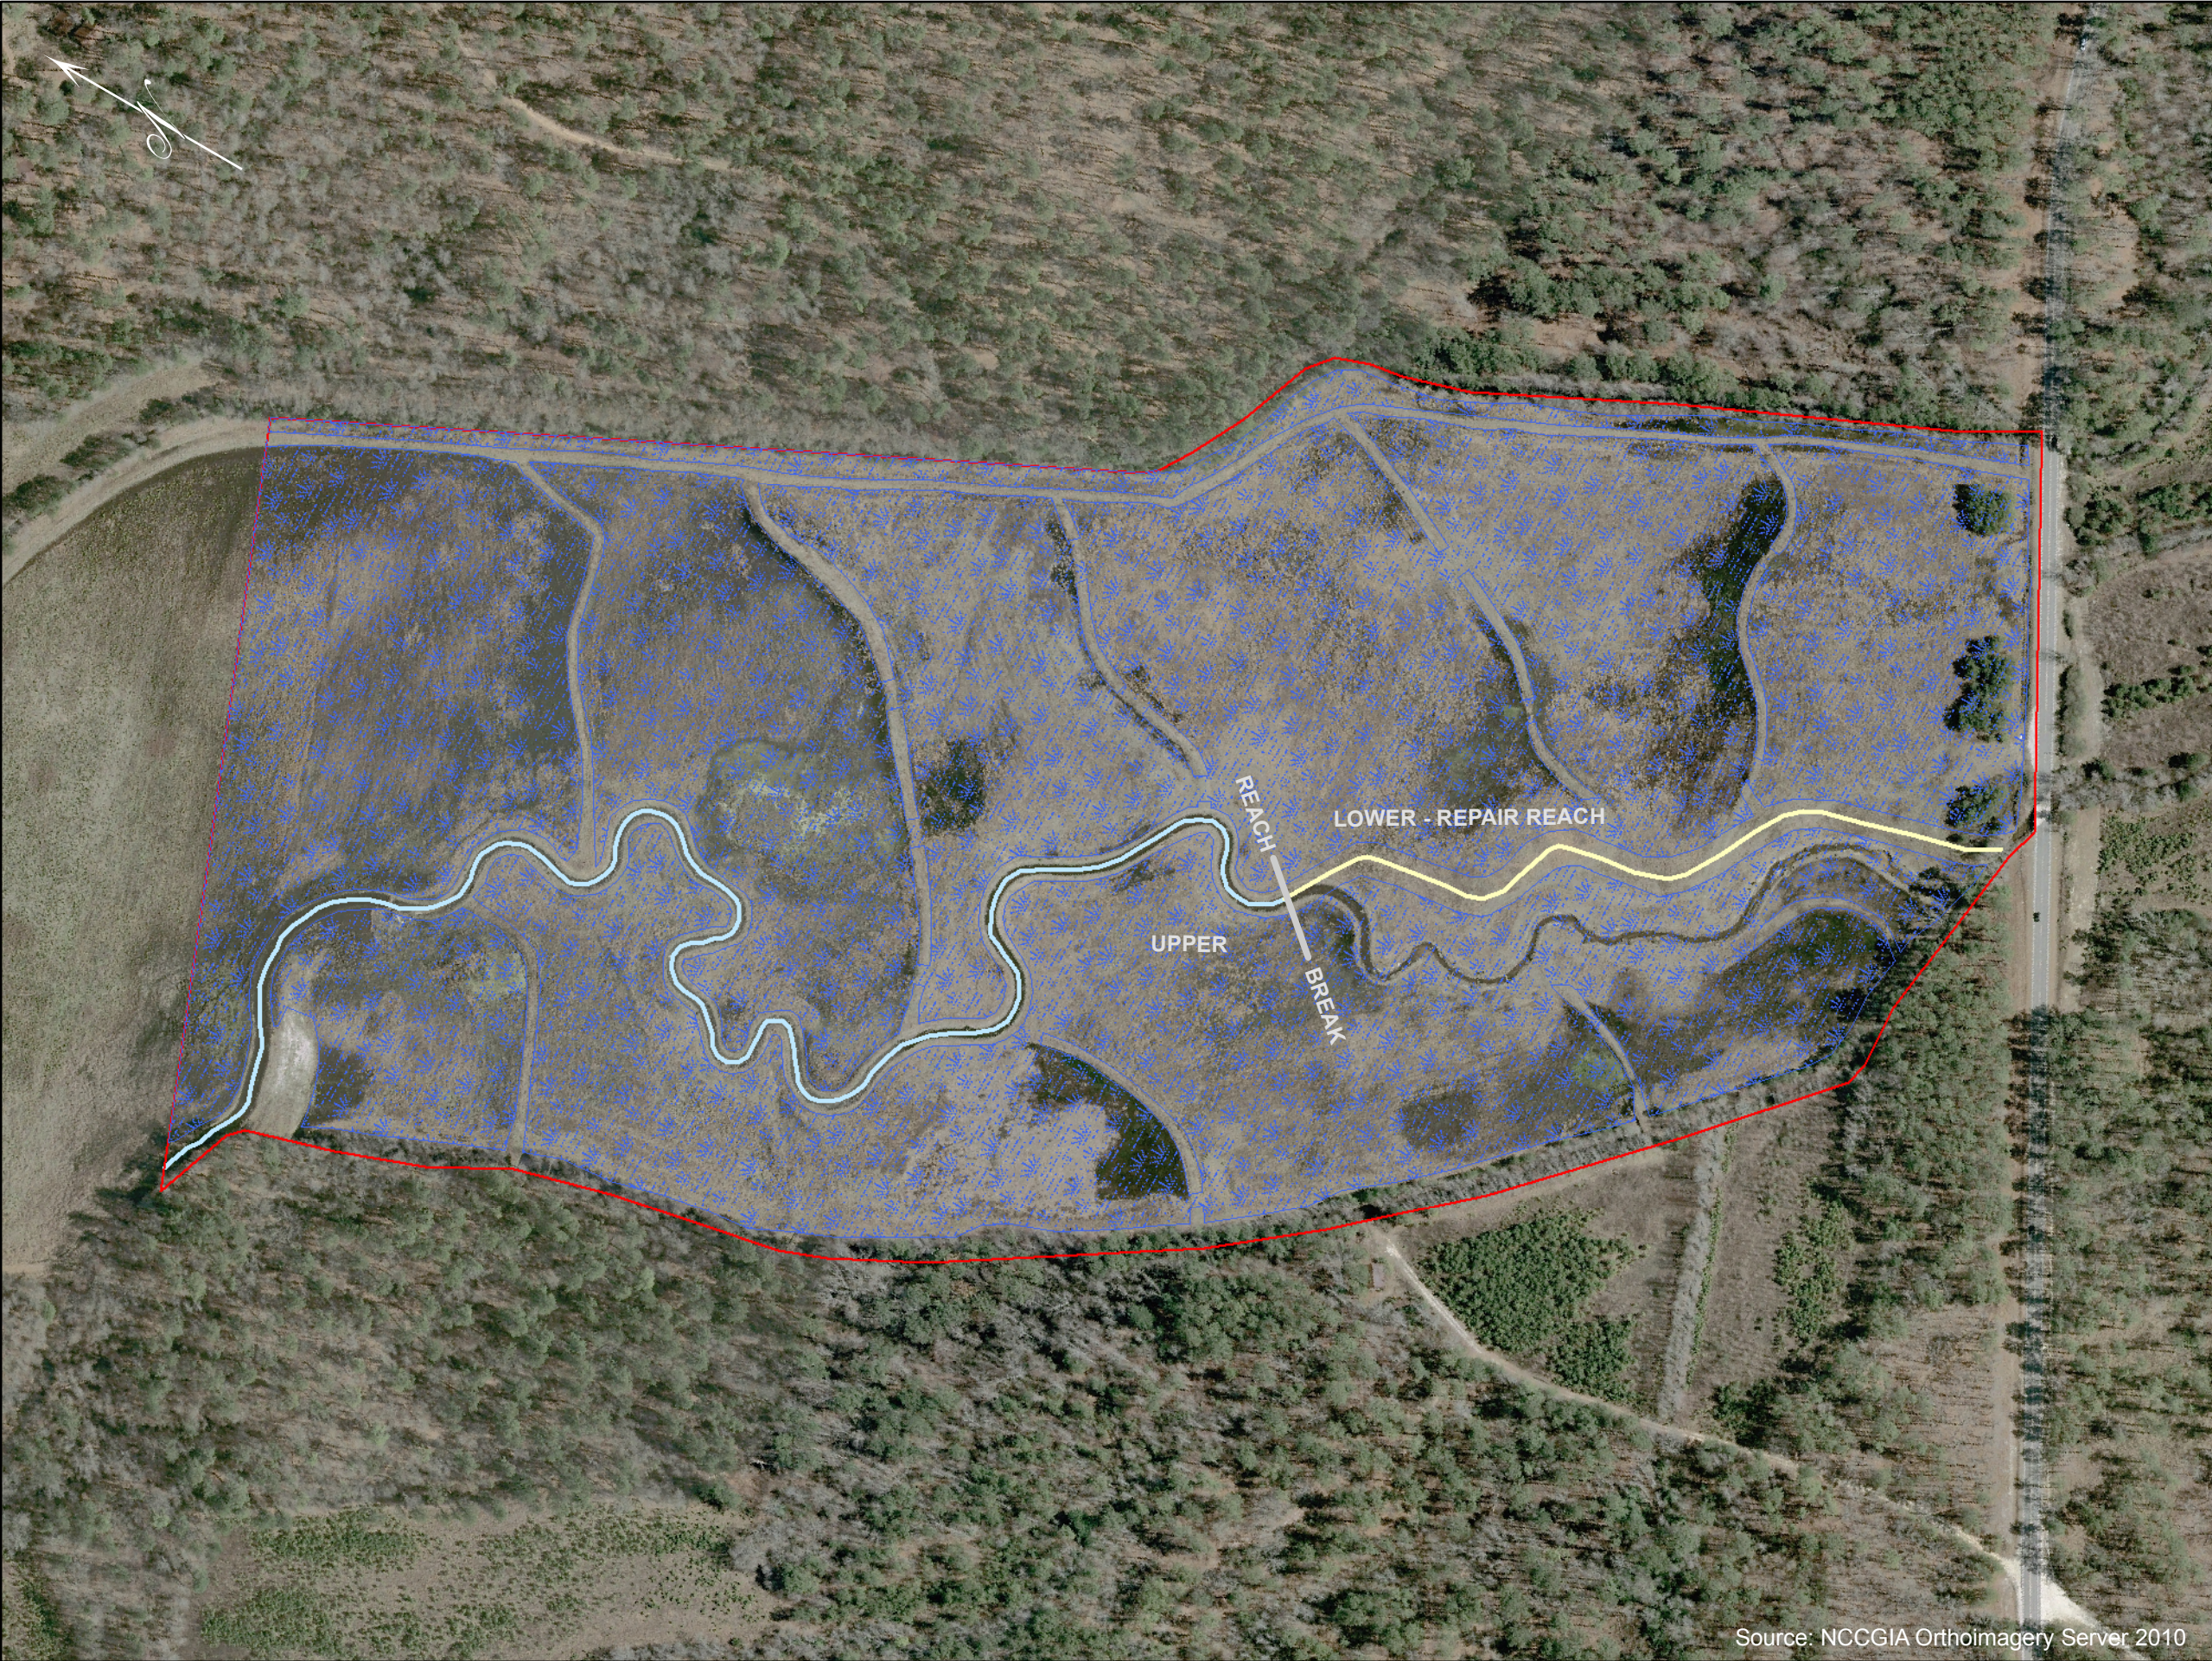
Figure 2 - Asset Map

THIS MAP DEPICTS MY5 CONDITIONS AS OF 10/2011

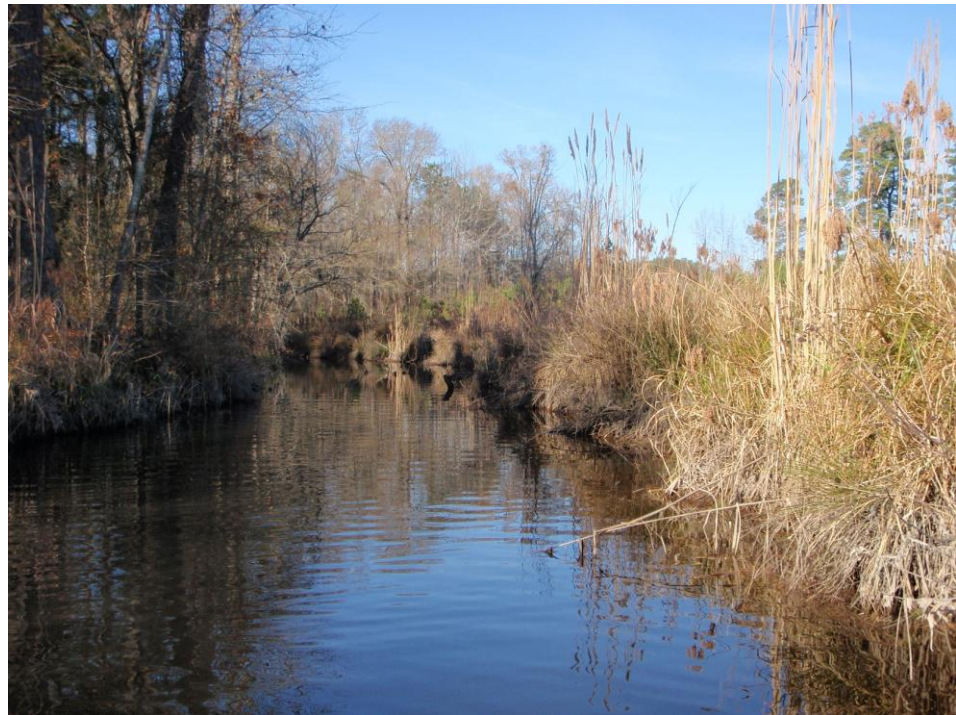
Photo Station 1 – Looking upstream at beginning of project (12/13/11)

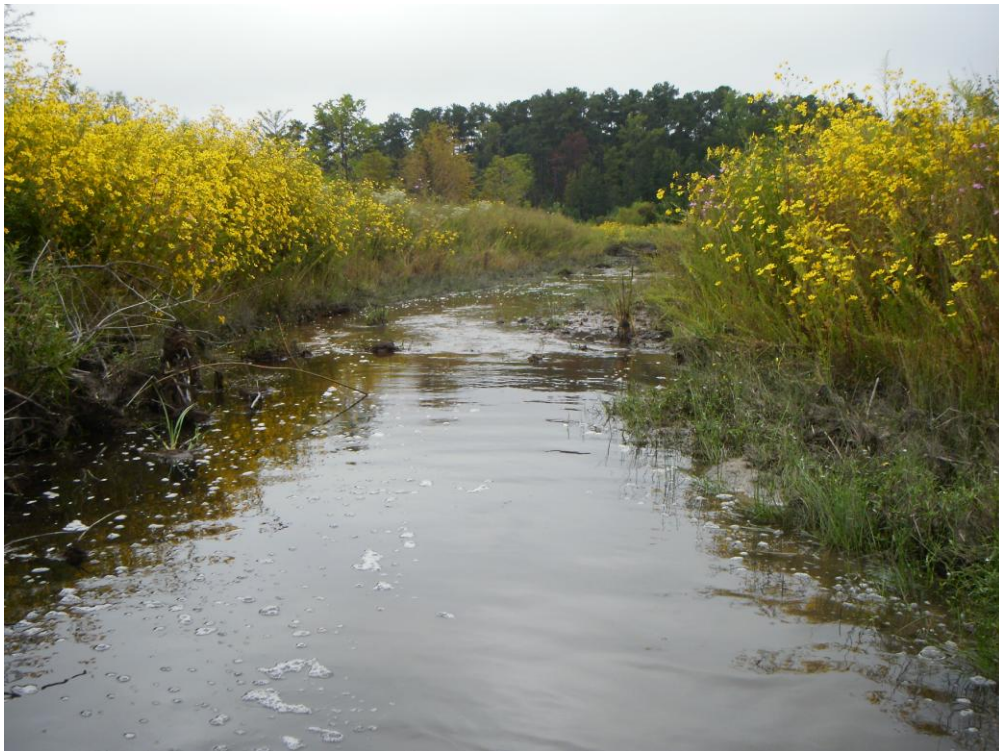
Photo Station 7 – Cross Section R1 – looking downstream (9/21/11)

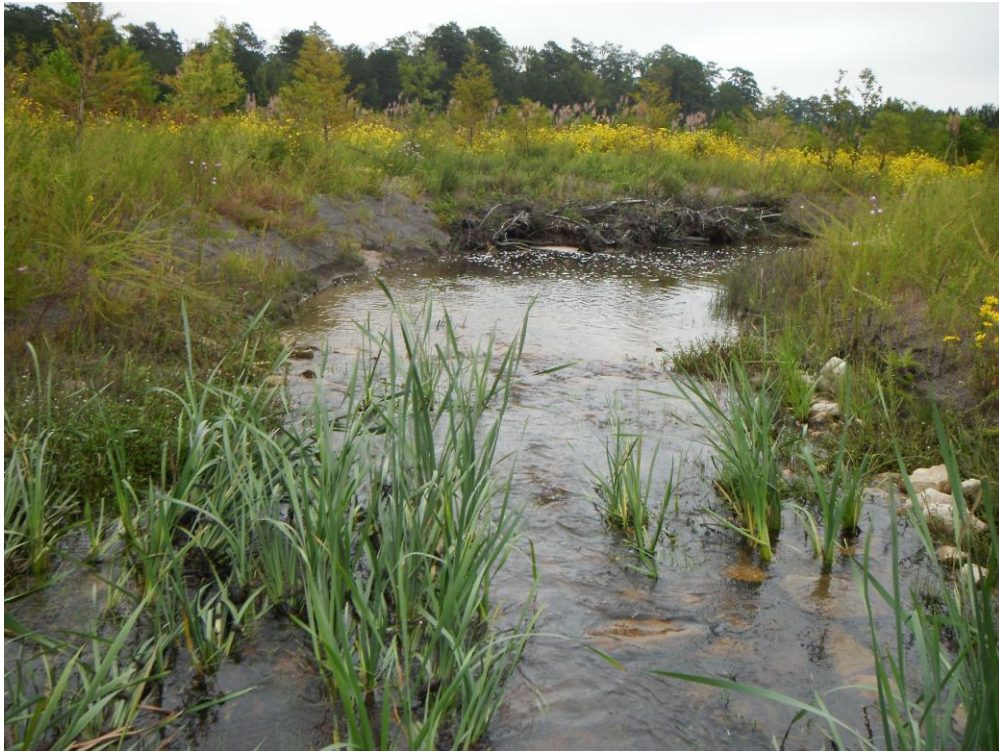
Photo Station 8 – Cross Section R2 – looking downstream (9/21/11)

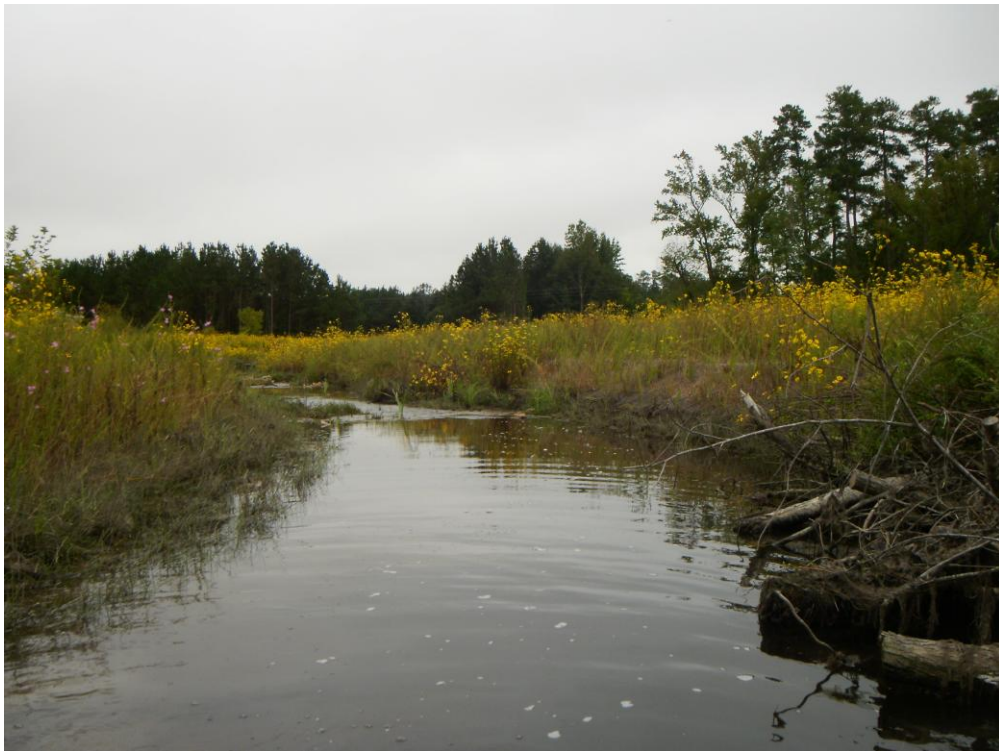
Photo Station 9 – Cross Section R3 – looking downstream (9/21/11)

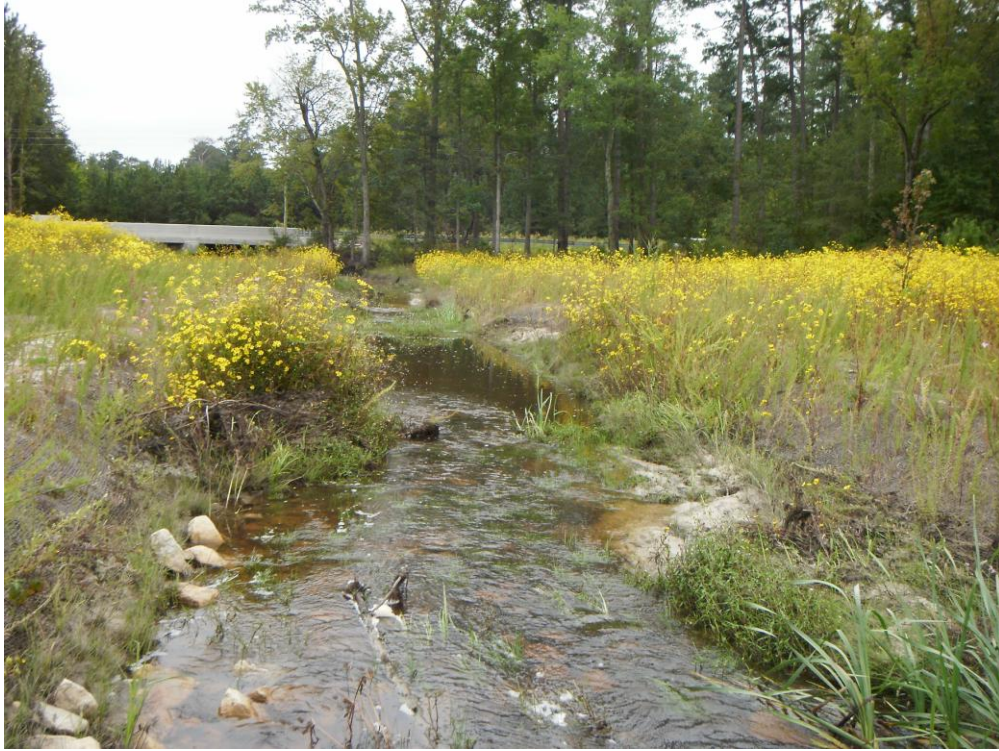
Photo Station 10 – Cross Section R4 – looking downstream (9/21/11)

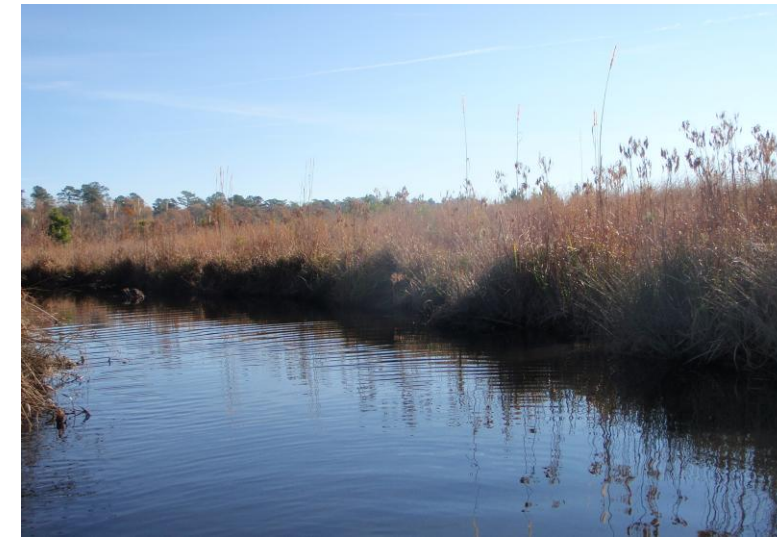
Photo of Cross-Section 1 - Looking Downstream @ STA 1+64

Year 5 - 2011	Year 4 - 2010	Year 3 - 2009	Year 2 - 2008	Year 1 - 2007	Baseline
BKF Area	73.61	75.30	69.97	67.39	67.45	71.89
BKF Width	25.38	24.91	25.19	24.42	24.66	26.87
BKF Mean Depth	2.90	3.02	2.78	2.76	2.74	2.68
BKF Max Depth	5.00	5.00	4.54	4.80	4.49	4.66
W/D	8.75	8.24	9.07	8.85	9.02	10.04

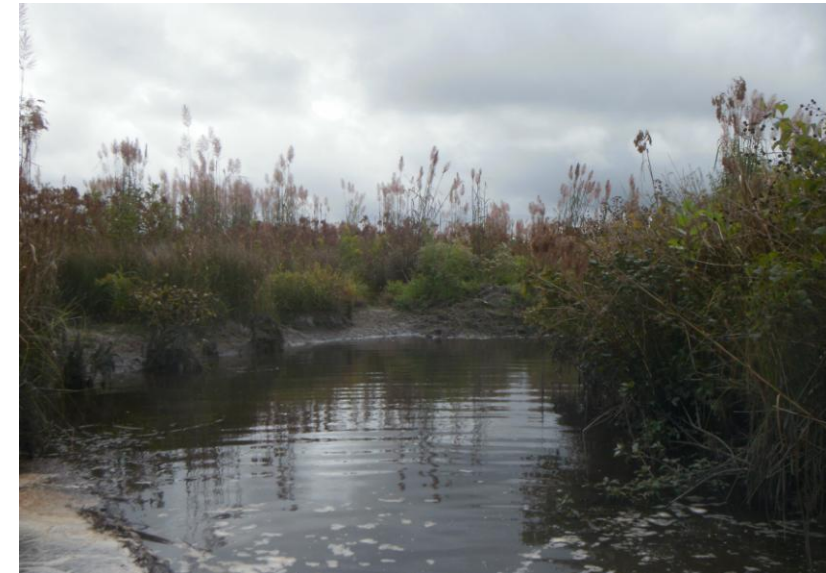
Photo of Cross-Section 2 - Looking Downstream @ STA 8+47

Year 5 - 2011	Year 4 - 2010	Year 3 - 2009	Year 2 - 2008	Year 1 - 2007	Baseline
BKF Area	31.70	38.08	39.54	54.18	51.12	44.82
BKF Width	20.65	28.93	20.86	22.40	22.29	22.27
BKF Mean Depth	1.54	1.32	1.90	2.42	2.29	2.01
BKF Max Depth	2.79	3.40	3.84	4.83	4.90	4.79
W/D	13.45	21.90	11.01	9.26	9.72	11.07

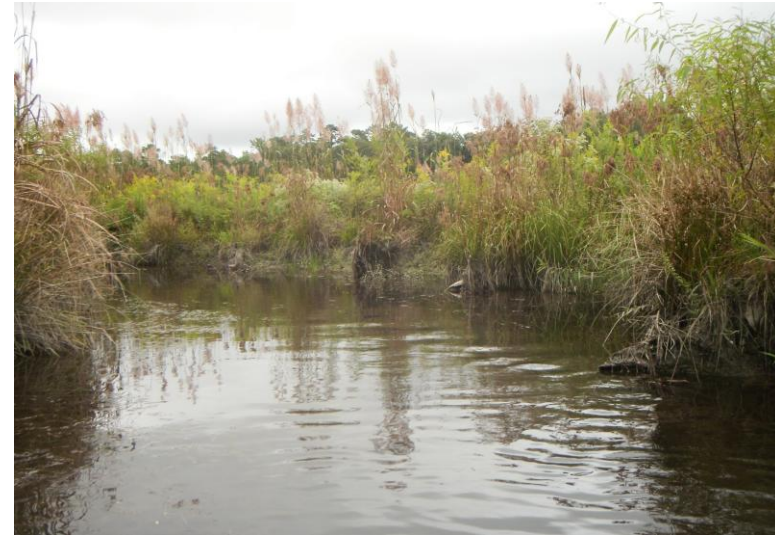
Photo of Cross-Section 3 - Looking Downstream @ STA 13+12

Year 5 - 2011	Year 4 - 2010	Year 3 - 2009	Year 2 - 2008	Year 1 - 2007	Baseline
BKF Area	38.43	33.96	33.96	35.19	31.56	31.03
BKF Width	19.98	19.22	19.22	18.94	18.36	18.15
BKF Mean Depth	1.91	1.77	1.77	1.86	1.72	1.71
BKF Max Depth	3.01	2.73	2.73	2.95	2.60	2.60
W/D	10.46	10.87	10.87	10.19	10.68	10.62

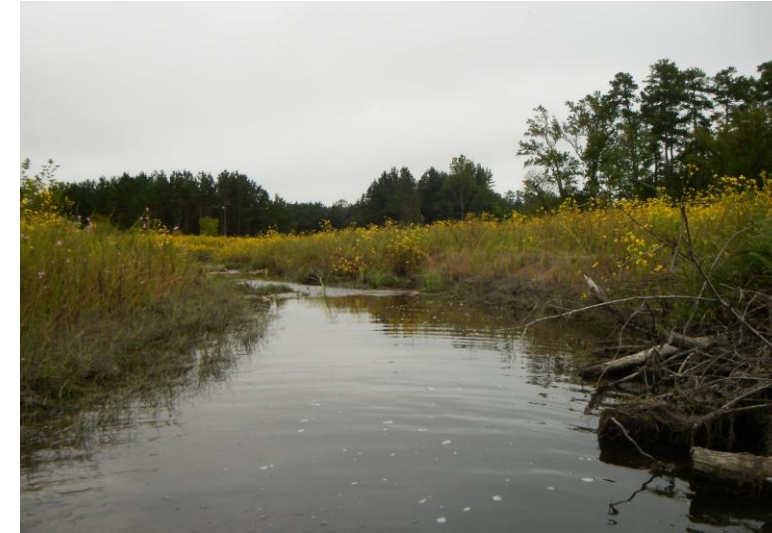
Photo of Cross-Section R3 - Looking Downstream @ STA 37+28

Year 6 - 2012	Year 5 - 2011	Baseline - 2011
BKF Area		66.57	63.05
BKF Width		34.41	31.87
BKF Mean Depth		1.93	1.98
BKF Max Depth		3.95	3.85
W/D		17.83	16.10

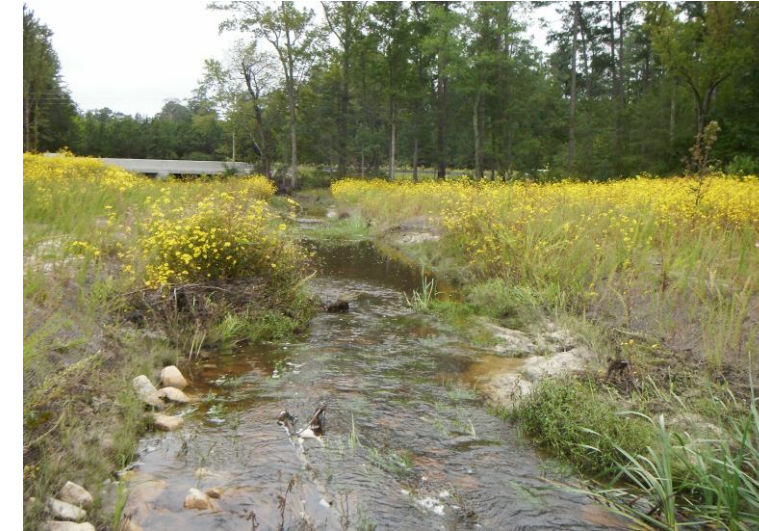
Photo of Cross-Section R4 - Looking Downstream @ STA 39+93						
	Year 6 - 2012	Year 5 - 2011	Baseline - 2011			
BKF Area		29.90	33.29			
BKF Width		18.65	19.24			
BKF Mean Depth		1.60	1.73			
BKF Max Depth		2.48	2.59			
W/D		11.66	11.12
