MONITORING YEAR 1 ANNUAL REPORT FINAL

LAUREL VALLEY MITIGATION SITE

Burke County, NC
Catawba River Basin
HUC 03050101

LAUREL VALLEY MITIGATION SITE
Monitoring Year 1 Annual Report

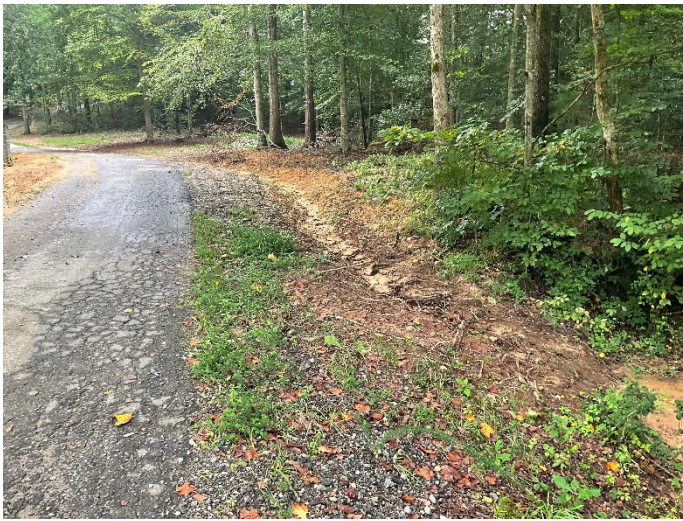
UT1 206+00 – French drain (8/29/2023)

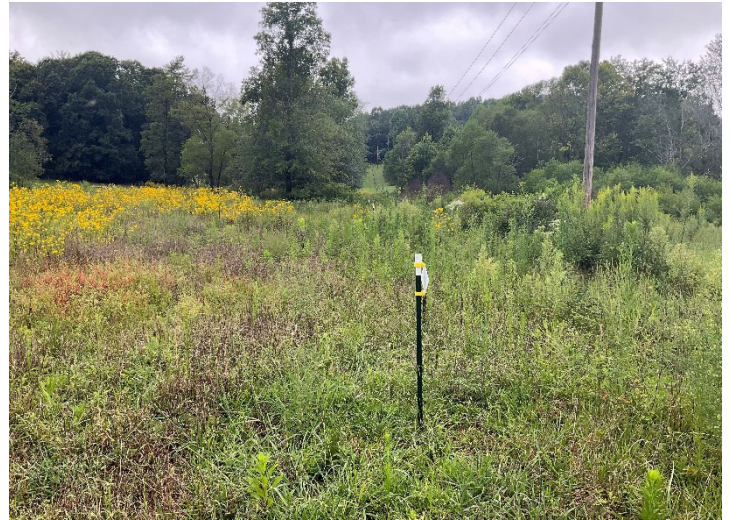
Utility Easement– Conservation Easement signage (9/22/2023)
