# Lick Creek Stream Restoration Site MONITORING REPORT 2009 (Year 4)

Cataloging Unit: 0303004 EEP Contract #: D04013-1

**December 11, 2009**

Wolf Creek Engineering, PLLC  
51 North Knob Lane  
Weaverville, NC 28787

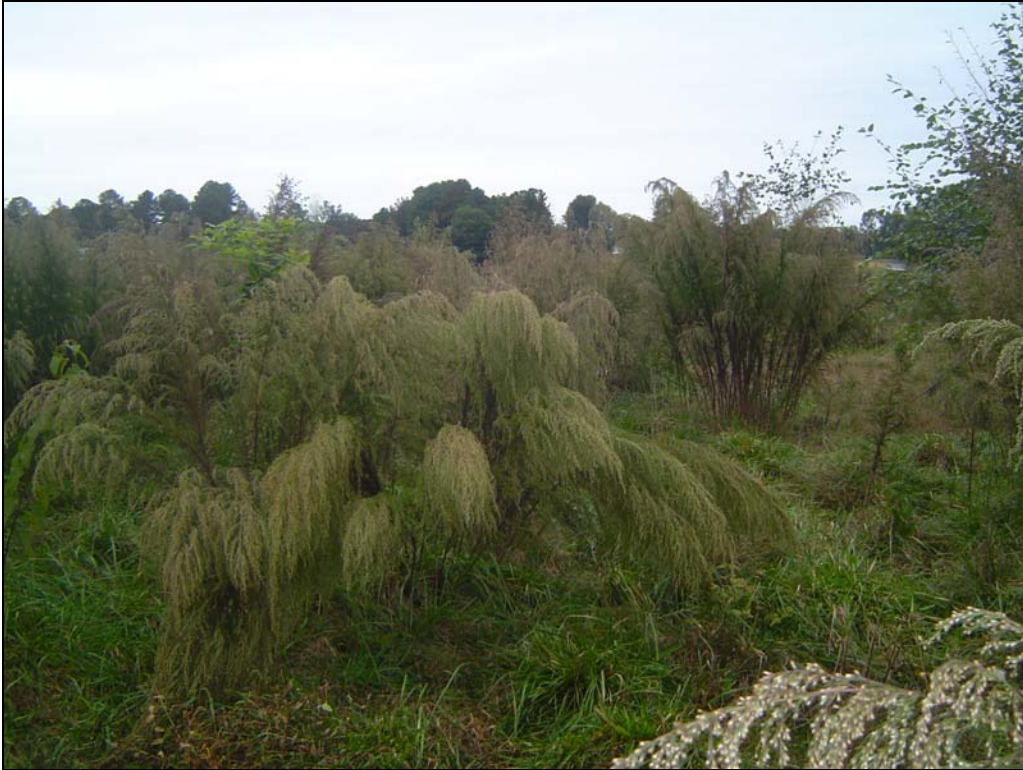
Photo No. 1

Year 3

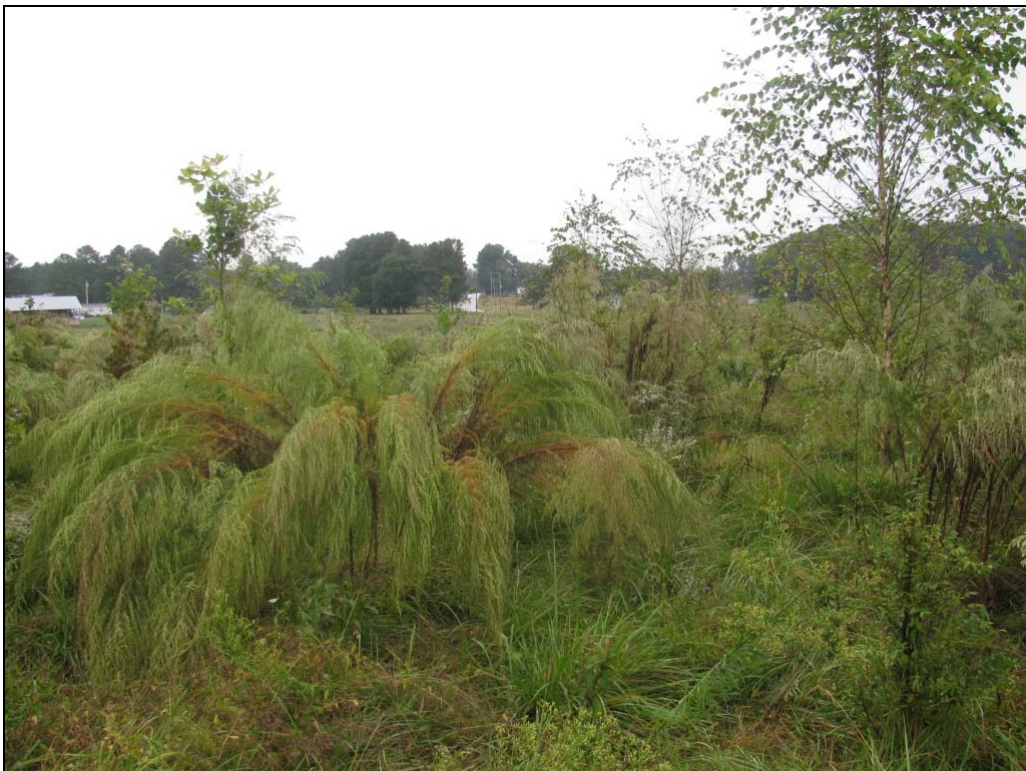
Photo No. 2

Year 4

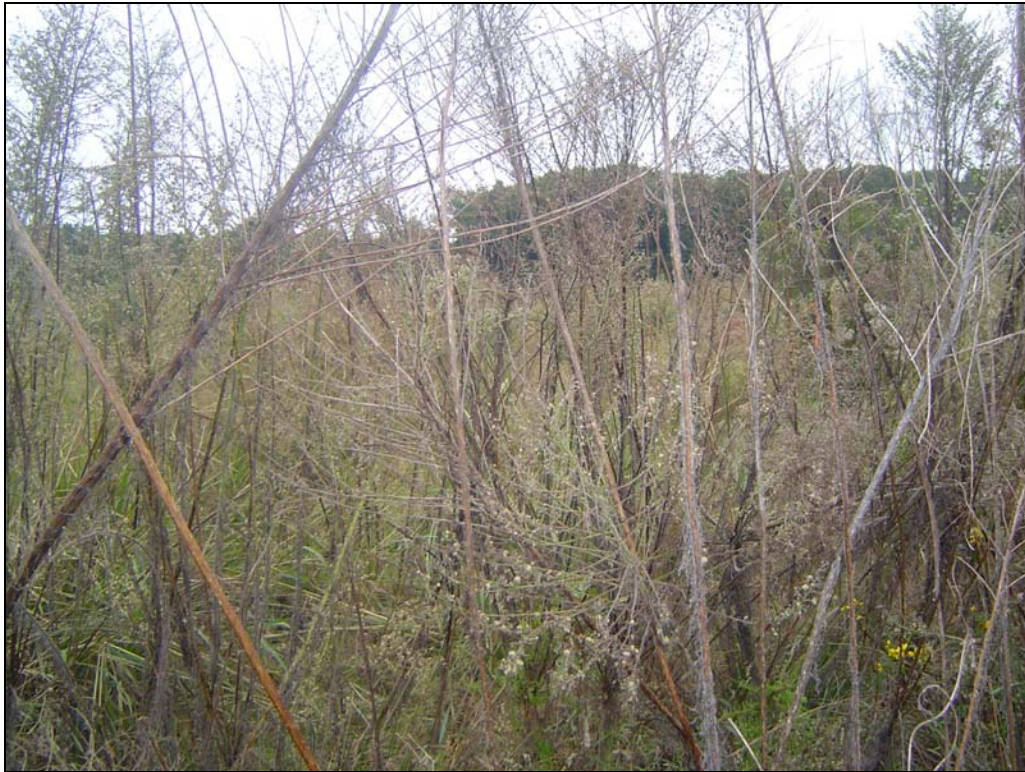
Photo No. 3

Year 3

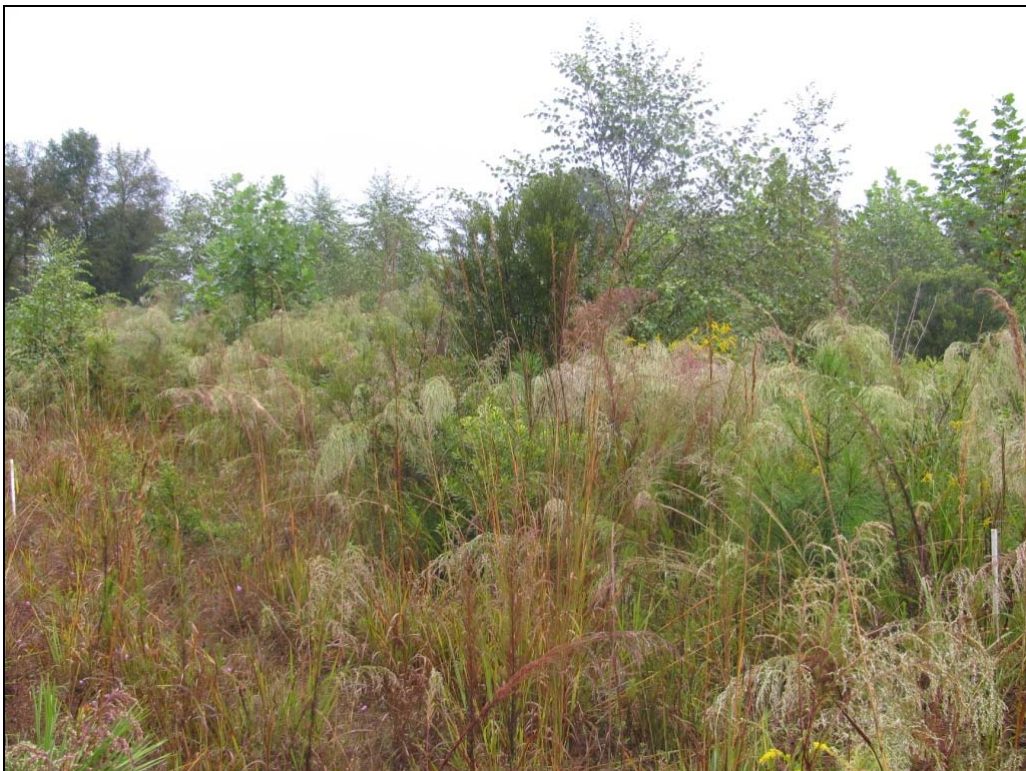
Photo No. 4

Year 4

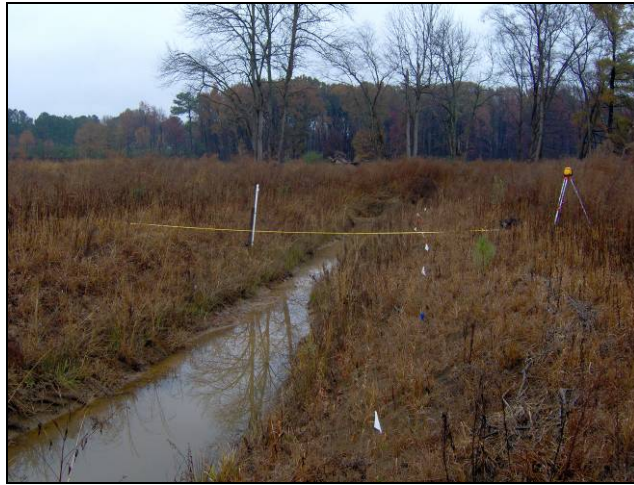
Photo No. 25

Year 2 - 10' offset from PP1

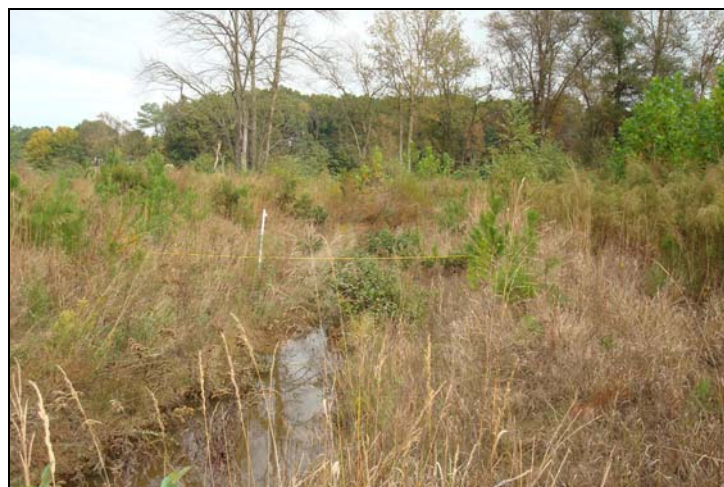
Photo No. 27

Year 4 - 25' offset from PP1

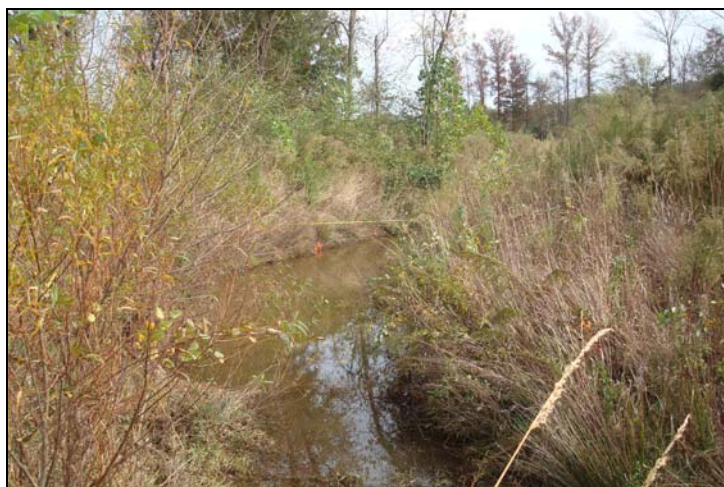
Photo No. 30

Year 4 - 10' offset from PP2

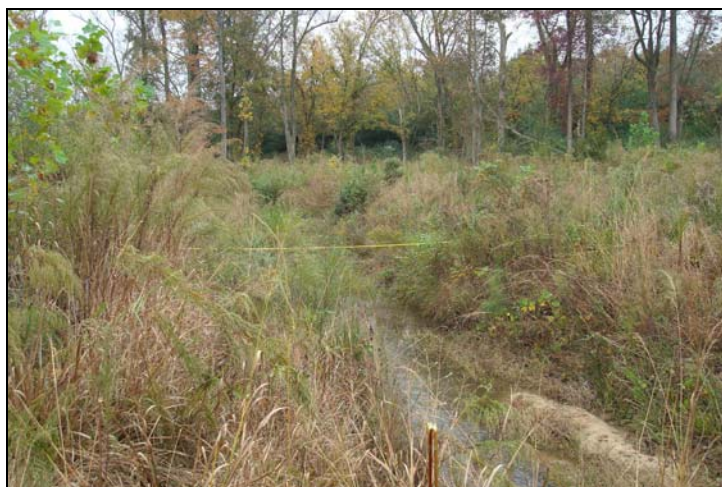
Photo No. 33

Year 4 - 10' offset from PP3

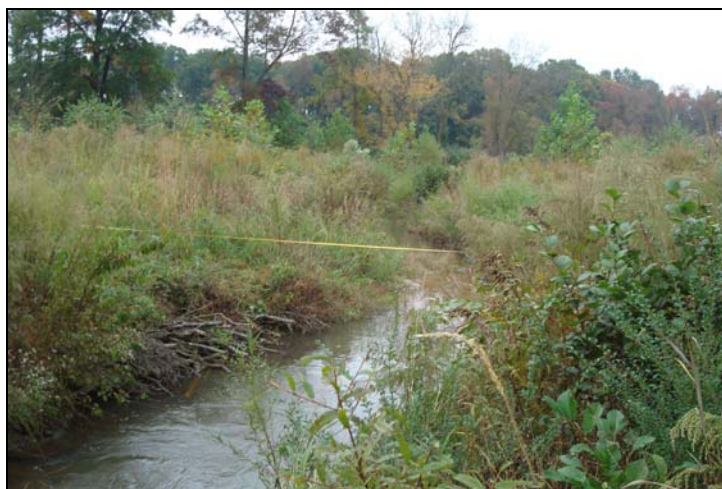
Year 4 - 10' offset from PP4 Photo No. 36
