Annual Monitoring Report
FINAL
Little Pine Creek II
Monitoring Year 4 of 7

New River Basin
HUC 5050001
NCDMS Project No. 856
DWR Project No. 20090048 (v.2)
Contract No. LP082819
USACE Action ID: SAW-2009-00591
Alleghany County, North Carolina
Data Collected: April 2023 – October 2023
Date Submitted: February 2024

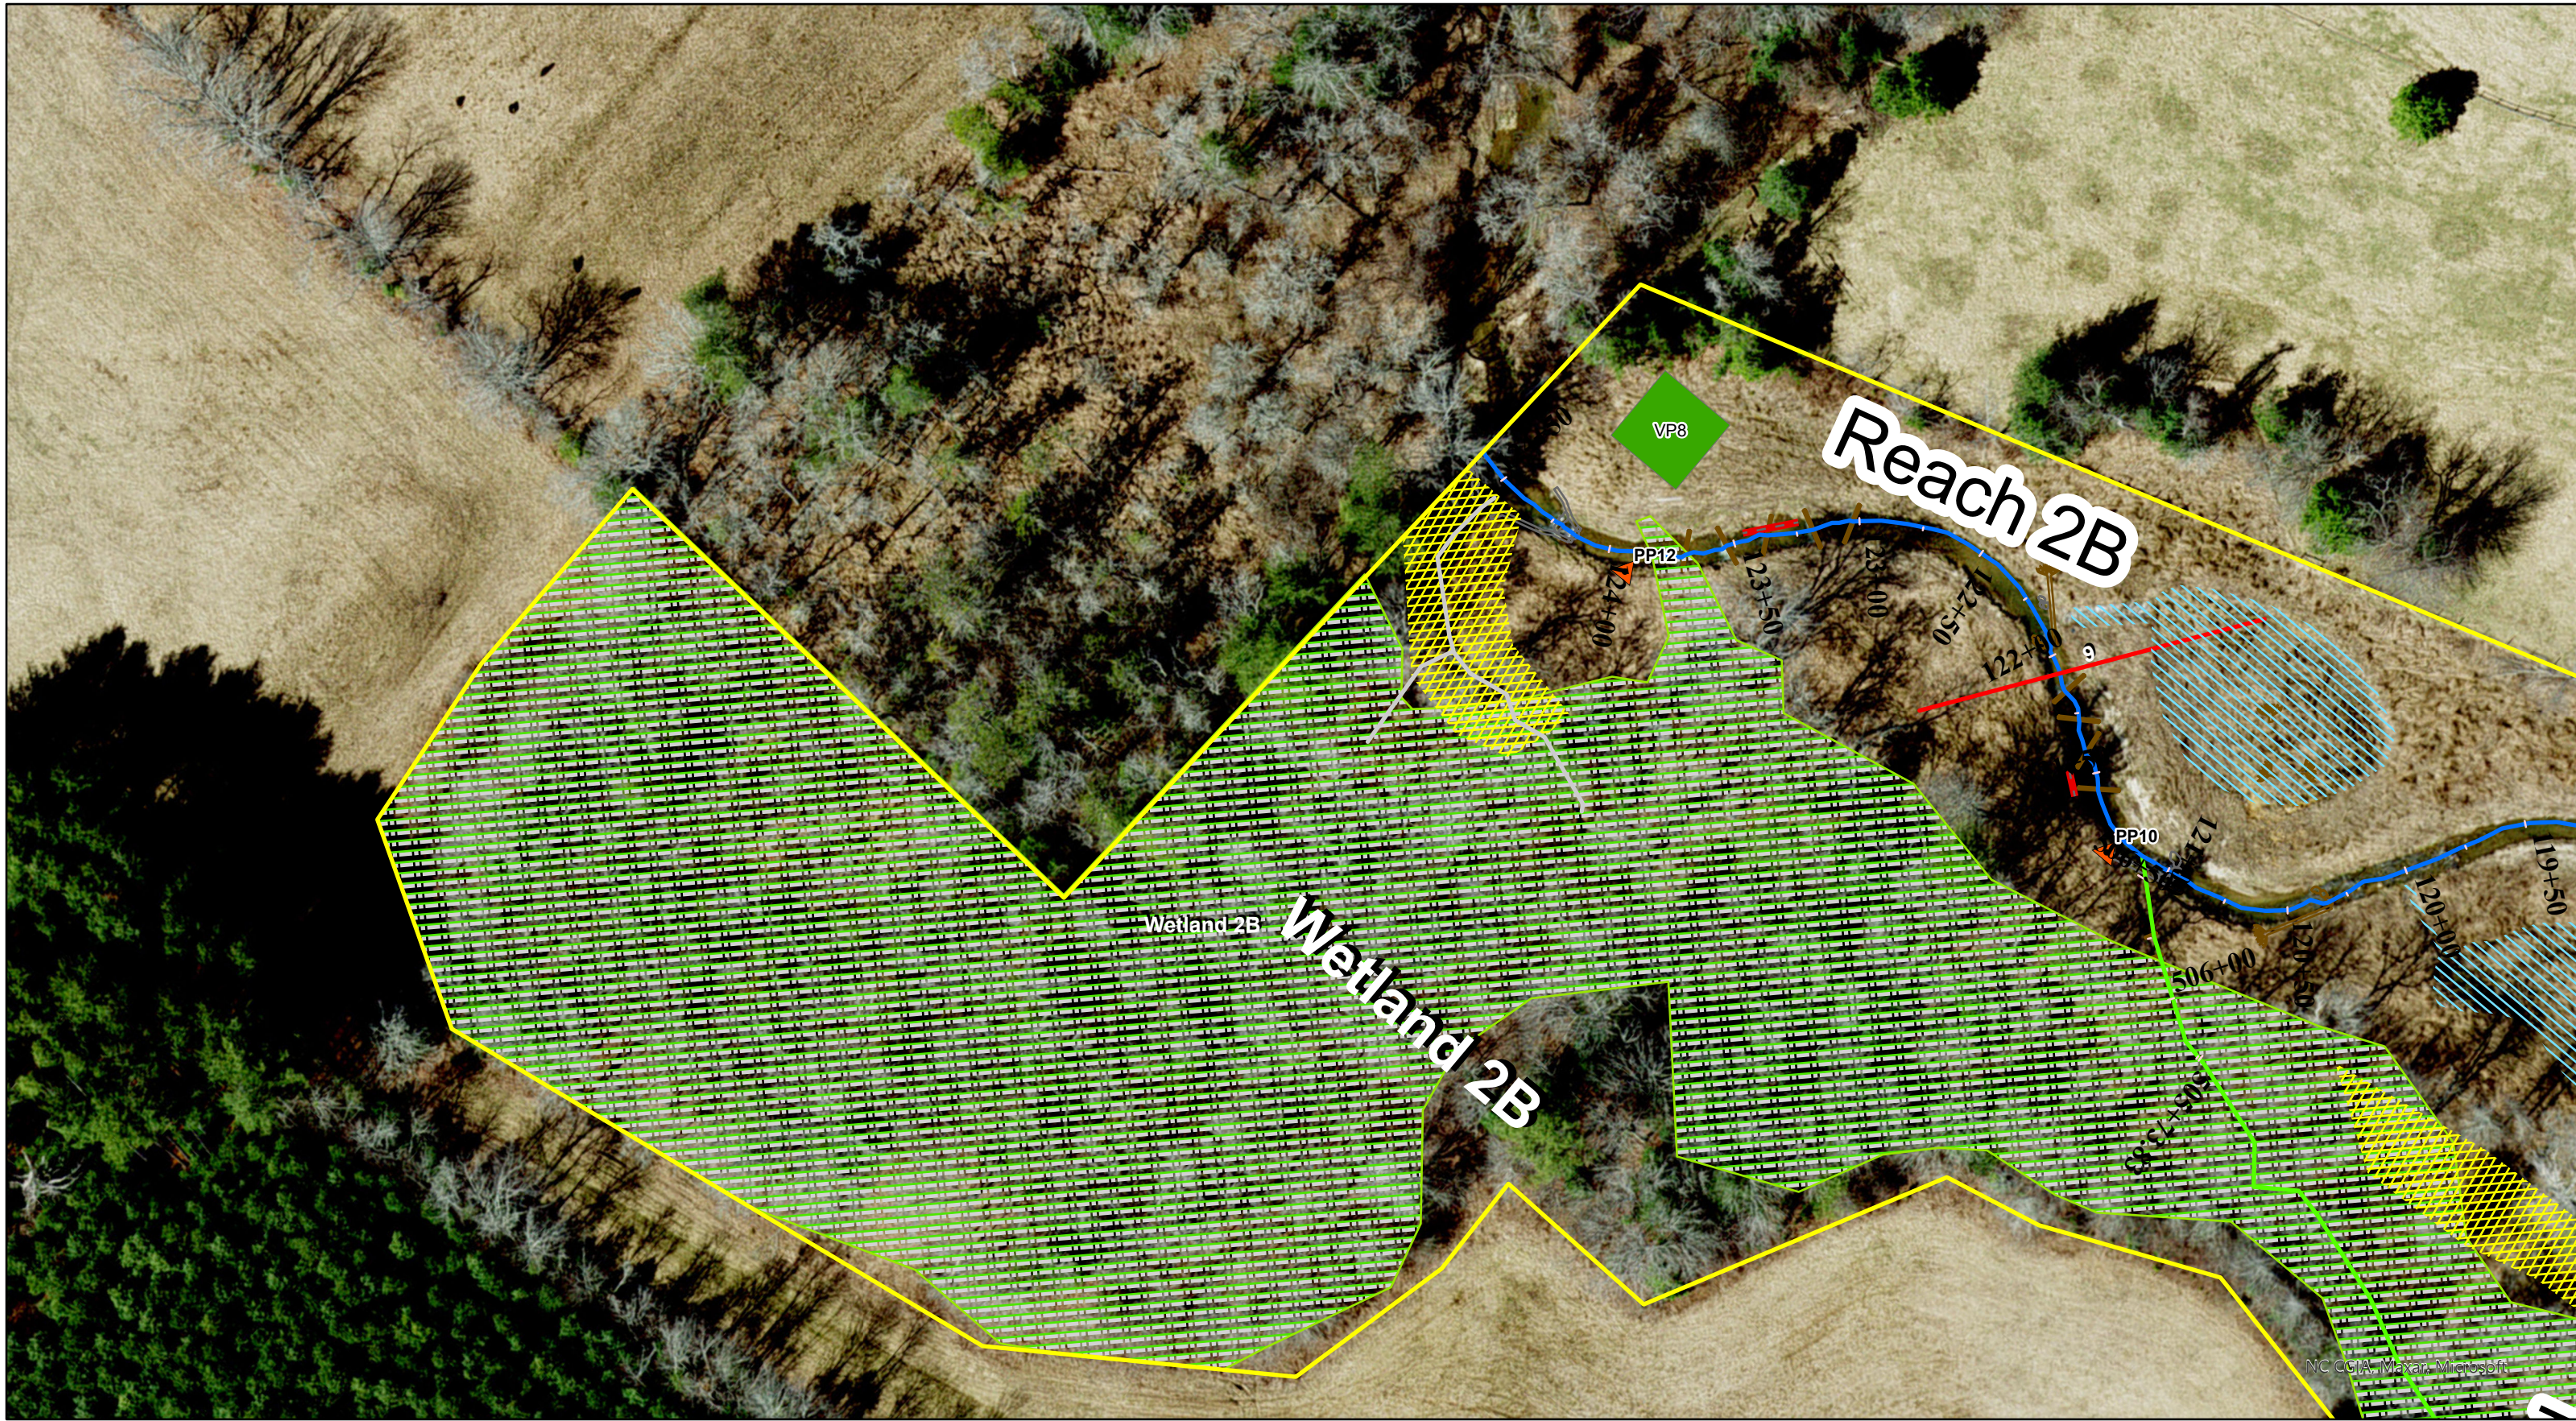
CCPV MY4
Little Pine Creek II
Alleghany County, NC

Visual assessment of vegetation indicates that the herbaceous vegetation is well established throughout the project. Previously noted vegetation problem areas and bare areas are nearly nonexistent in MY4. Seven areas of bank scour were present in MY4, similar to those noted in MY3. Some revegetation of these areas was evident between MY3 and MY4. As part of the planned stream repairs, supplemental planting will be conducted within portions of the site.

Areas of exotic vegetation are depicted within the CCPV (n=2). Multiflora rose (*Rosa multiflora*), Asiatic bittersweet (*Celastrus orbiculatus*) and Japanese honeysuckle (*Lonicera japonica*) were the dominant observed species. Invasive vegetation was identified in two primary pockets in Wetland 2B. The two most contiguous areas of invasives noted within the CCPV occur in Reach 2A and 2B. The largest area of invasives in Reach 2a contains primarily Asiatic bittersweet. The larger patch of invasives in Reach 2B was predominantly multiflora rose along the non-creditable reach and southward into Wetland 2B. Treatments in summer 2023 have significantly reduced the number of invasive areas and their density. The location and density of invasive vegetation will continue to be monitored in future site visits. The site has a contract for invasive vegetation management through MY7 (2026).

One exposed structure (113+30) and seven areas of bank scour or slumping (103+50, 110+20, 112+25, 113+30, 118+20, 121+50, and 123+30,) were identified at the LPC II Project in MY3. At Stations 113+30 - 113+60 the toe logs of an outer bend structure have been exposed and there is an area of bank slump immediately downstream. Bank scour noted at 110+20 was identified in MY3 and had somewhat improved in MY4. At Station 118+20, the outside bend has notable scour and bank slump. The area of instability at Station 121+50 has a similar amount of scour along the outer bend at the beginning of the "rock and roll" log structures. At the final problem areas (123+50), the bank at the of log-drop structures has a significant amount of erosion (CCPV and Table 5, Appendix B). The site will continue to be monitored for signs of instability.

NC Division of Mitigation Services has a contract for repairs. Repair work has been fully permitted and the repairs will begin in January 2024. A description and summary of the repairs will be included in the MY5 monitoring report.

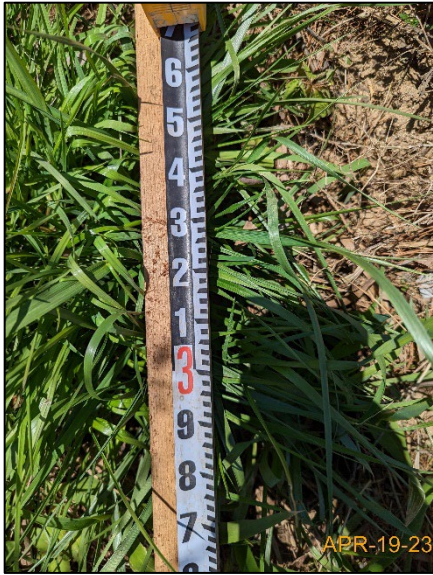
1. CG 1 04/19/2023

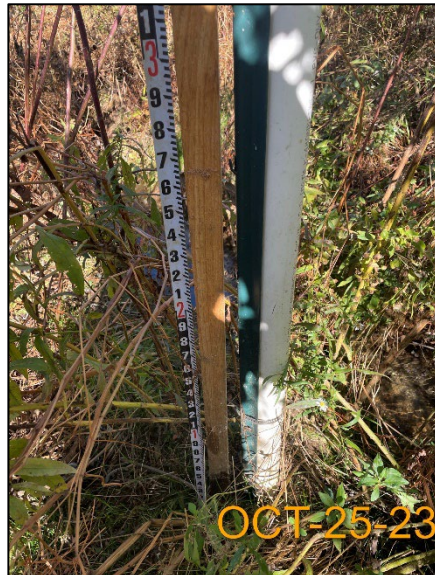
2. CG 1 10/25/2023

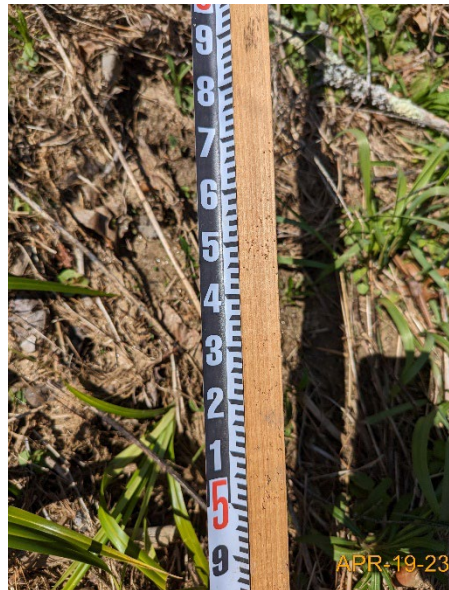
3. CG 2 04/19/2023

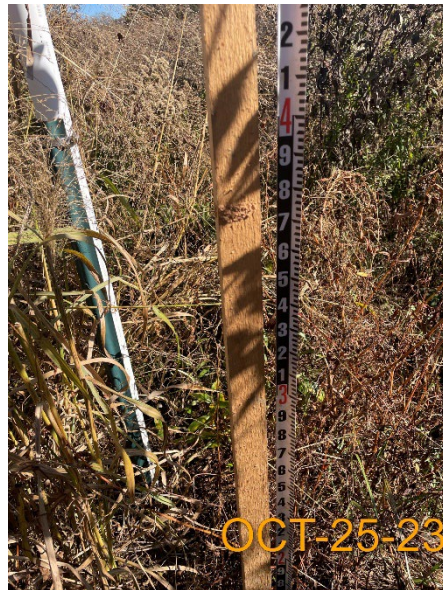
4. CG 2 10/25/2023
