# Little Alamance Creek (Burlington Park) Stream Restoration 2013 Monitoring Report Monitoring Year 2 of 5

Alamance County, NC  
Cape Fear River Basin  
Cataloging Unit: 03030002  
NCEEP Project Number: 92372  
NCEEP Contract Number: 4998

**FINAL** – 2013 Monitoring Report – Year 2 of 5

**Prepared by:**  
**EEE Consulting, Inc.**  
601 Cascade Pointe Lane, Suite 101  
Cary, NC 27513

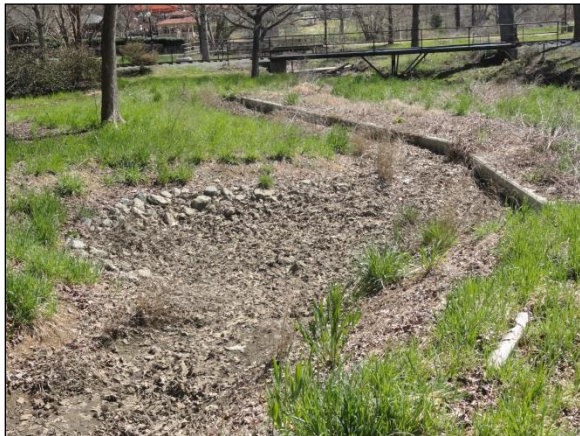
Photo Station 2, level spreader at bollard 410, facing east; April 3, 2013

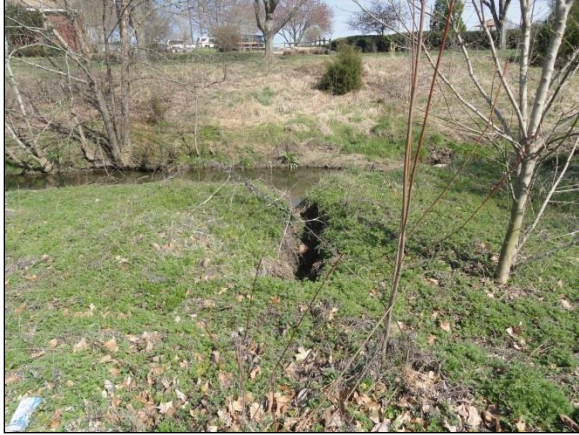
Photo Station 4, discharge at bollard 312, facing west; April 3, 2013

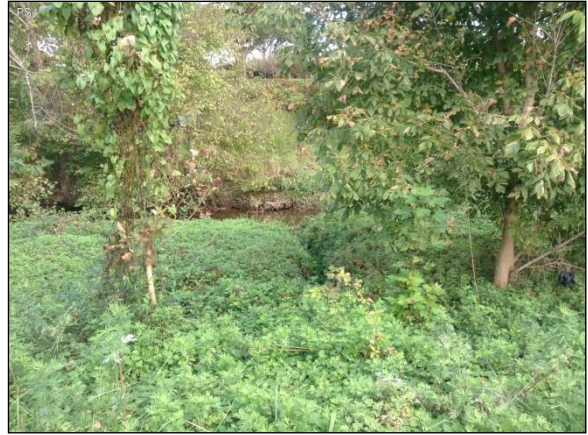
Photo Station 4, discharge at bollard 312, facing west; October 15, 2013

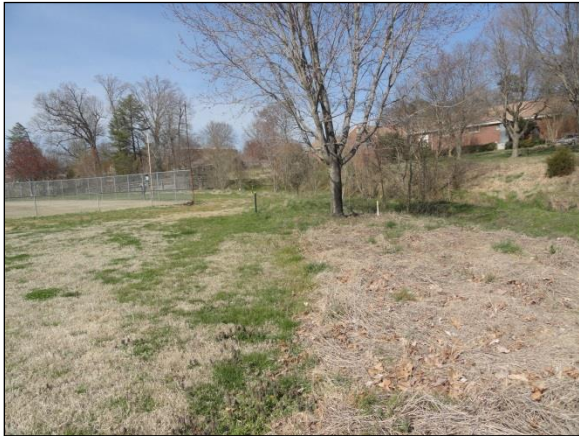
Photo Station 5, view of easement facing northwest; April 3, 2013

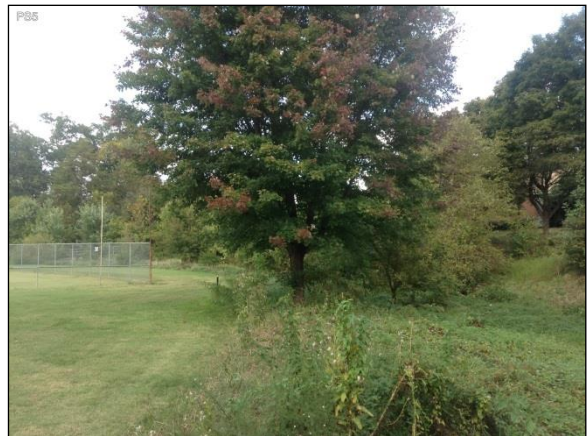
Photo Station 5, view of easement facing northwest; October 15, 2013

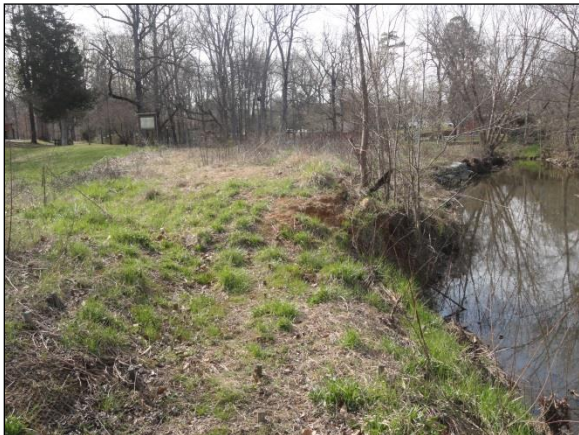
Photo Station 6, VP 7 at bollard 401, facing west; April 3, 2013

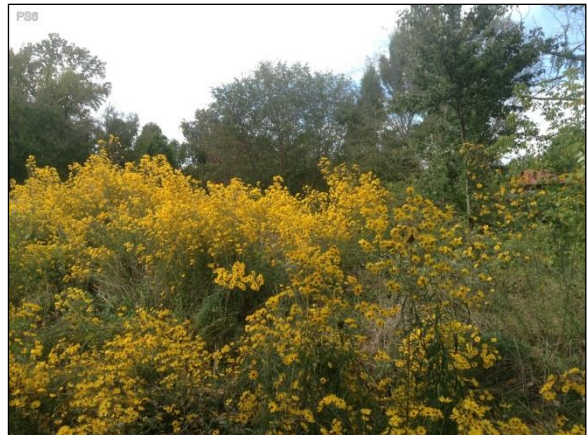
Photo Station 6, VP 7 at bollard 401, facing west; October 15, 2013

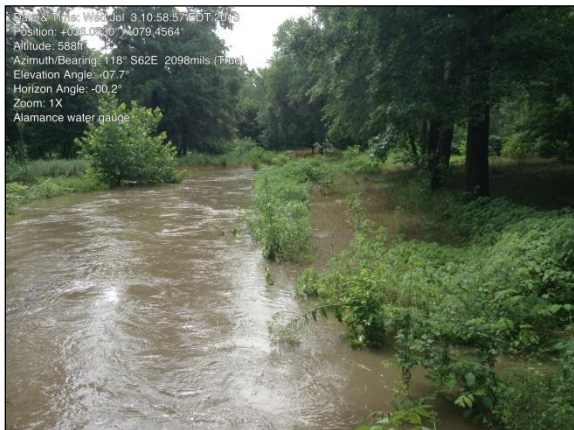
View of water gauge on main tributary  
July 3, 2013

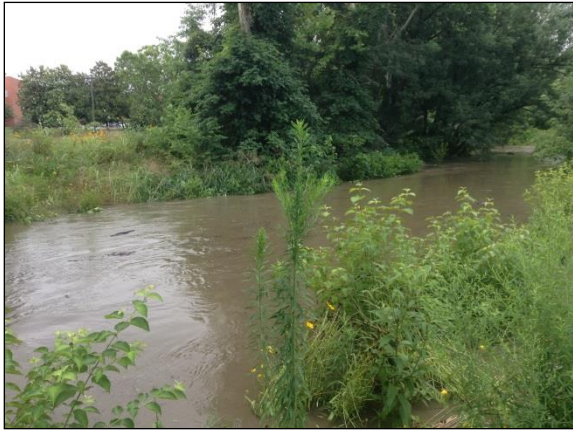
View from XS 7  
July 3, 2013
