**Little Alamance Creek (Burlington Park) Stream Restoration
2015 Monitoring Report
Monitoring Year 4 of 5**

**Alamance County, NC
Cape Fear River Basin
Cataloging Unit: 03030002
NCDMS Project Number: 92372
NCDMS Contract Number: 4998**

Final – 2015 Monitoring Report – Year 4 of 5

Prepared by:
EEE Consulting, Inc.
601 Cascade Pointe Lane, Suite 101
Cary, NC 27513

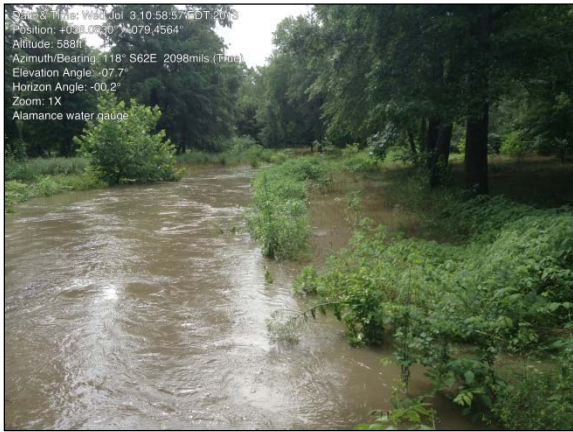
View of water gauge on main tributary
July 3, 2013

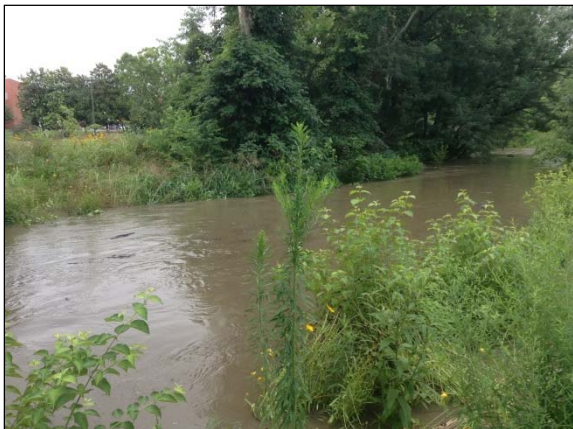
View from XS 7
July 3, 2013

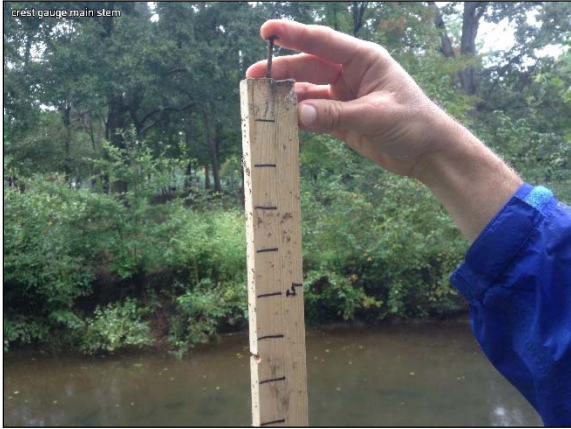
Crest gauge, main stem. Cork overtopped gauge.
September 29, 2014

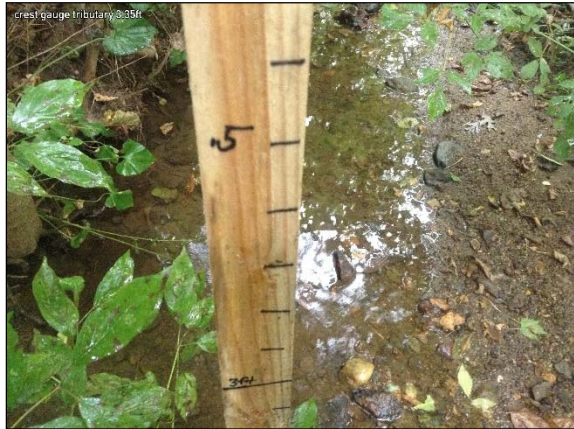
Crest gauge, UT. Cork at 3.35 ft.
September 29, 2014

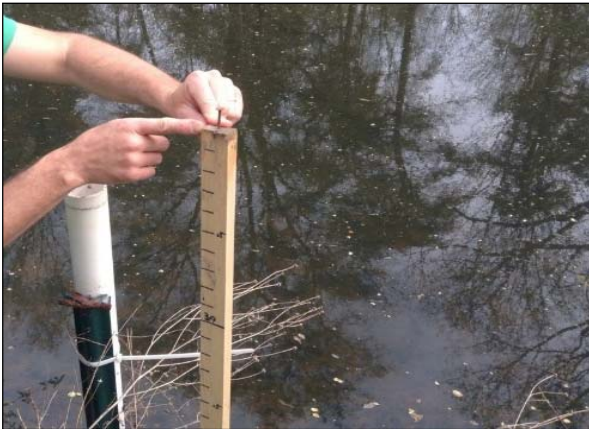
Crest gauge, main stem. Cork overtopped gauge.
April 10, 2015

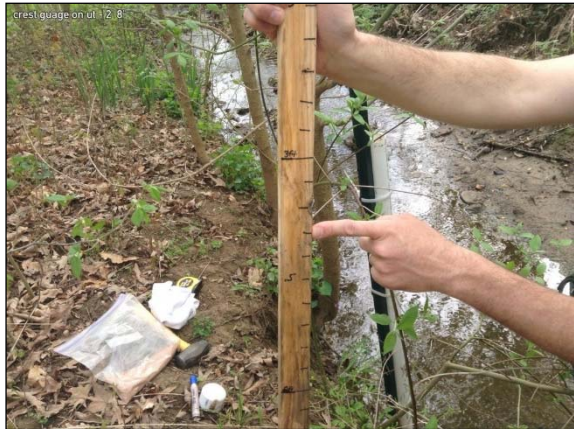
Crest gauge, UT. Cork at 2.8 ft.
April 10, 2015

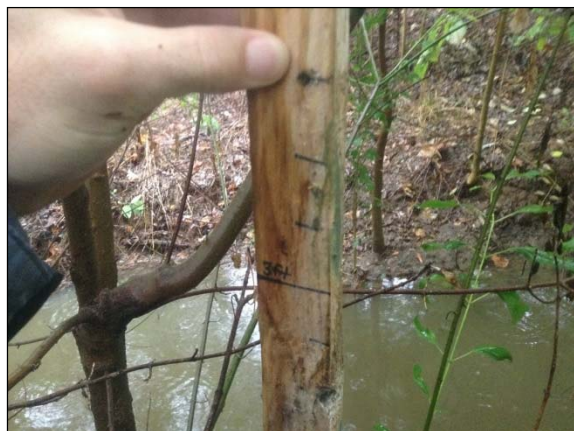
Crest gauge, main stem. Cork at 3.3 ft.
September 25, 2015
