**Little Alamance Creek (Burlington Park) Stream Restoration
2016 Monitoring Report
Monitoring Year 5 of 5**

**Alamance County, NC
Cape Fear River Basin
Cataloging Unit: 03030002
NCDMS Project Number: 92372
NCDMS Contract Number: 4998**

Final – 2016 Monitoring Report – Year 5 of 5

Prepared by:
EEE Consulting, Inc.
601 Cascade Pointe Lane, Suite 101
Cary, NC 27513

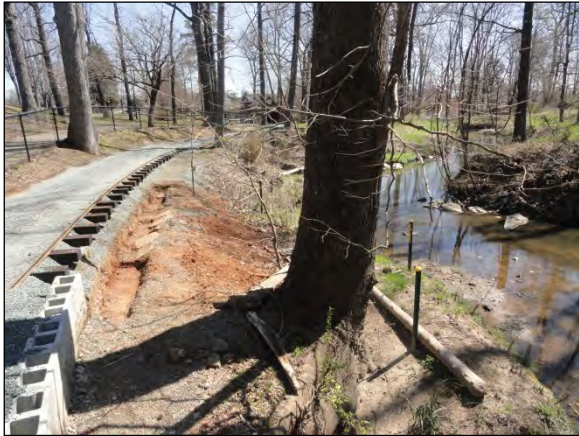
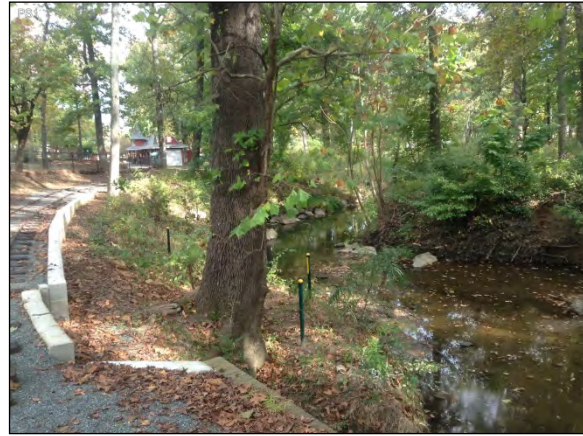
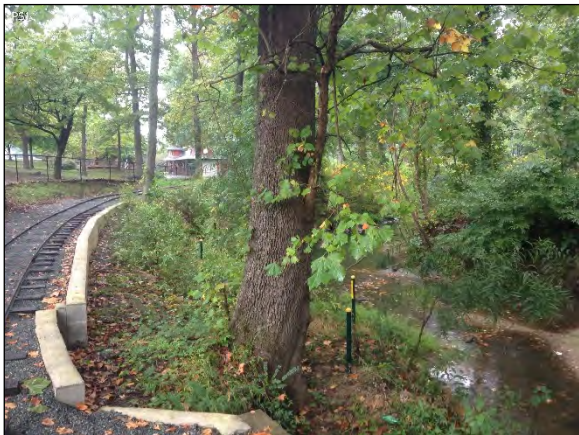
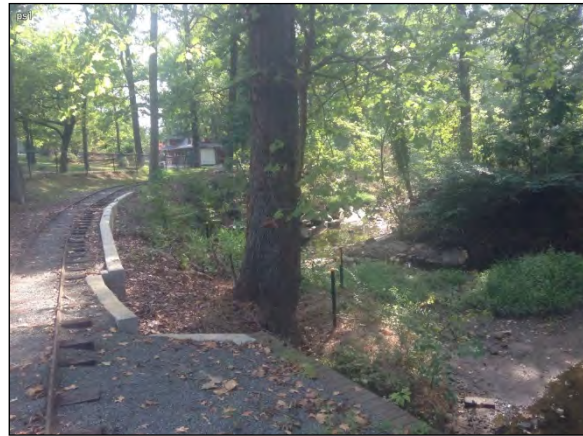
Photo Station 1, rail line at bollard 172, facing east:
April 3, 2013

Photo Station 1, rail line at bollard 172, facing east:
October 15, 2013

Photo Station 1, rail line at bollard 172, facing east:
September 30, 2014

Photo Station 1, rail line at bollard 172, facing east:
September 3, 2015

Photo Station 1, rail line at bollard 172, facing east:
October 5, 2016

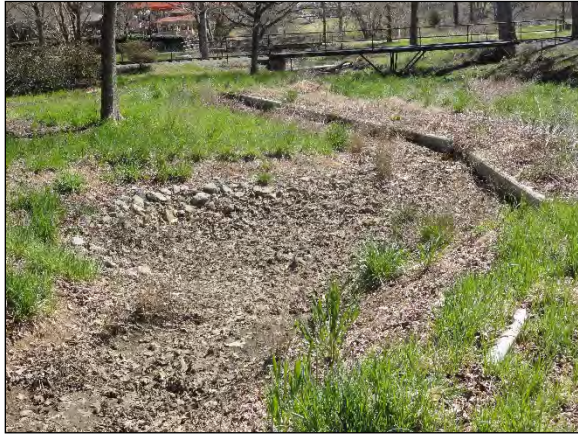
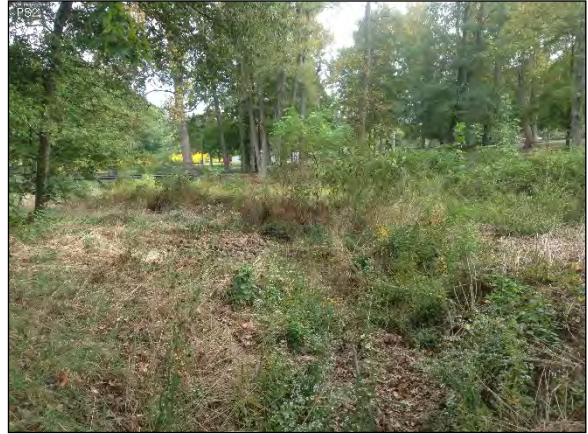
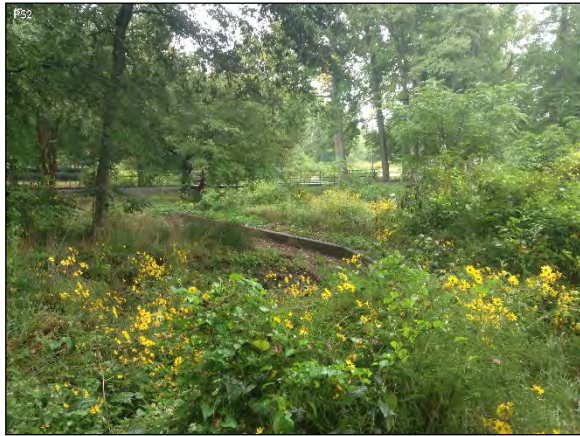
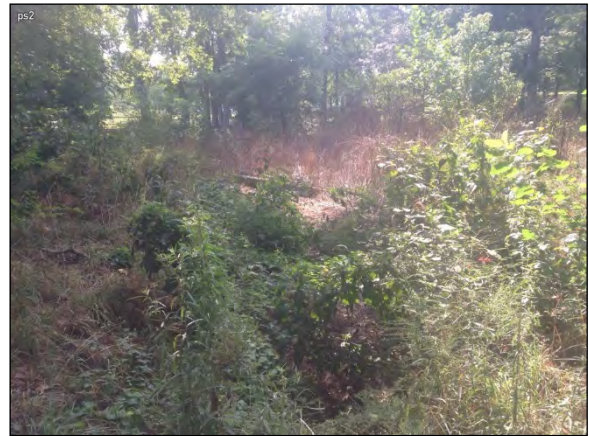
Photo Station 2, level spreader at bollard 410, facing east: April 3, 2013

Photo Station 2, level spreader at bollard 410, facing east: October 15, 2013

Photo Station 2, level spreader at bollard 410, facing east: September 30, 2014

Photo Station 2, level spreader at bollard 410, facing east: September 3, 2015

Photo Station 2, level spreader at bollard 410, facing east: October 5, 2016

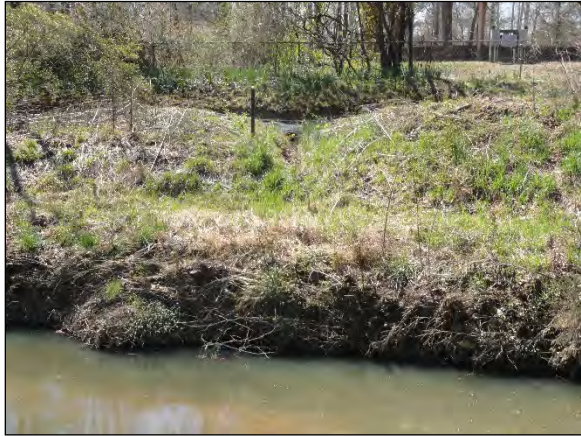
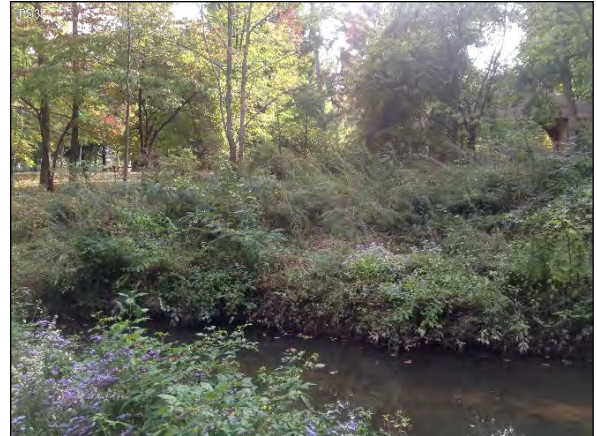
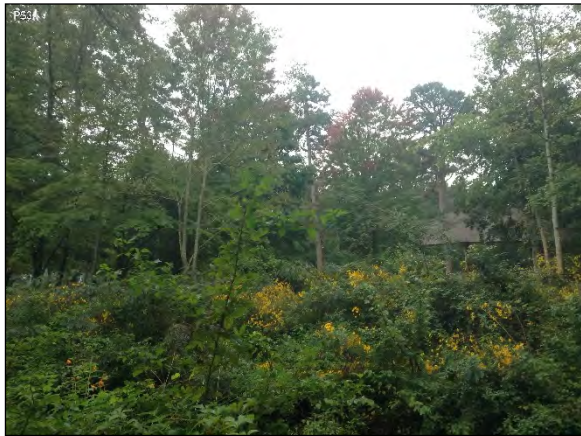
Photo Station 3, rail line discharge, facing south:
April 3, 2013

Photo Station 3, rail line discharge, facing south:
October 15, 2013

Photo Station 3, rail line discharge, facing south:
September 30, 2014

Photo Station 3, rail line discharge, facing south:
September 3, 2015

Photo Station 3, rail line discharge, facing south:
October 5, 2016

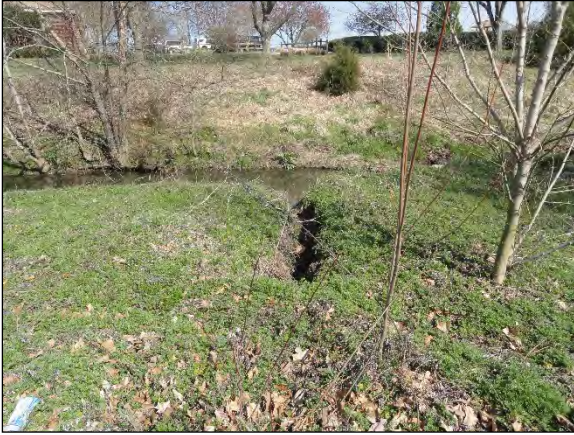
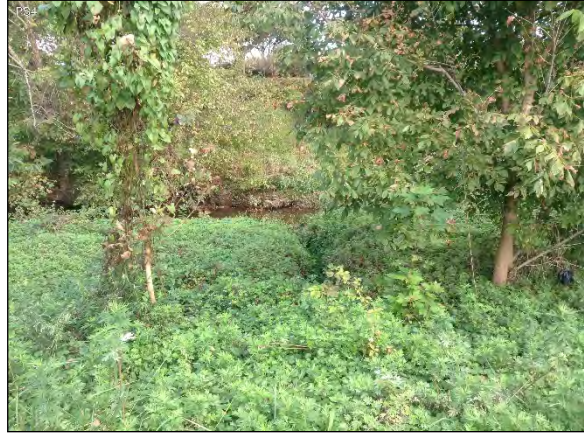
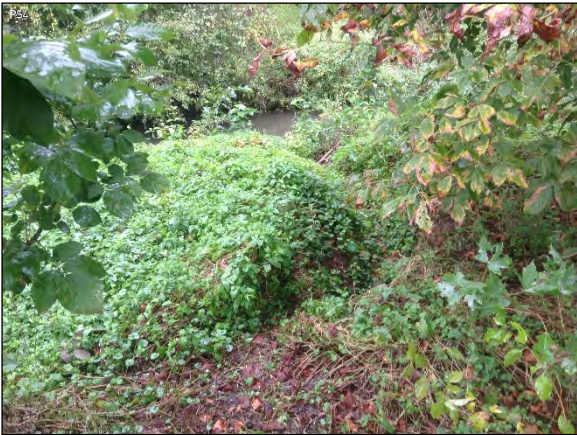
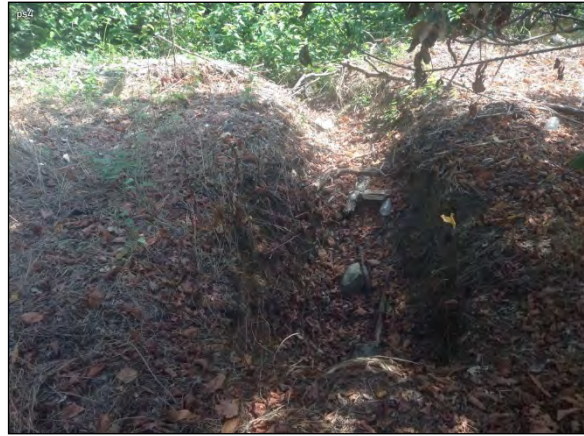
Photo Station 4, discharge at bollard 312, facing west:
April 3, 2013

Photo Station 4, discharge at bollard 312, facing west:
October 15, 2013

Photo Station 4, discharge at bollard 312, facing west:
September 30, 2014

Photo Station 4, discharge at bollard 312, facing west:
September 3, 2015

Photo Station 4, discharge at bollard 312, facing west:
October 5, 2016

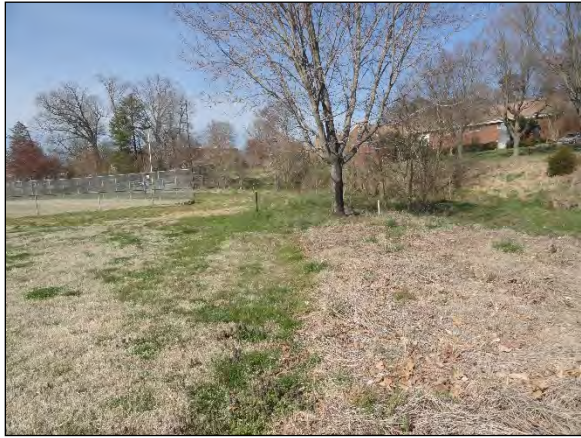
Photo Station 5, view of easement facing northwest:
April 3, 2013

Photo Station 5, view of easement facing northwest:
October 15, 2013

Photo Station 5, facing northwest:
September 30, 2014

Photo Station 5, facing northwest:
September 3, 2015

Photo Station 5, view of easement facing northwest:
October 5, 2016

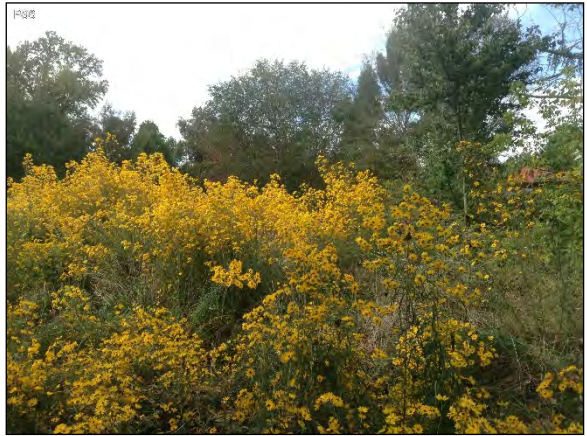
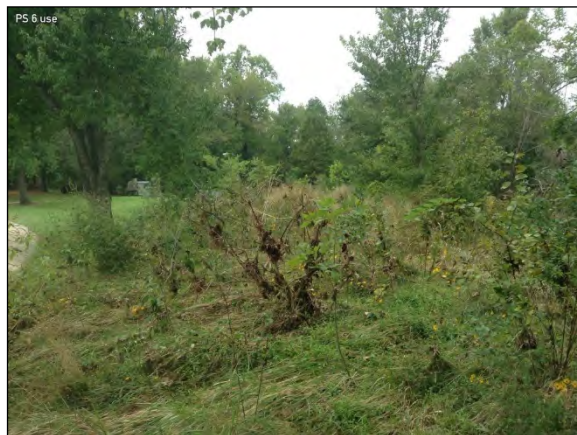
Photo Station 6, VP 7 at bollard 401:
April 3, 2013

Photo Station 6, VP 7 at bollard 401:
October 15, 2013

Photo Station 6, VP 7 at bollard 401:
September 30, 2014

Photo Station 6, VP 7 at bollard 401:
September 3, 2015

Photo Station 6, VP 7 at bollard 401:
October 5, 2016

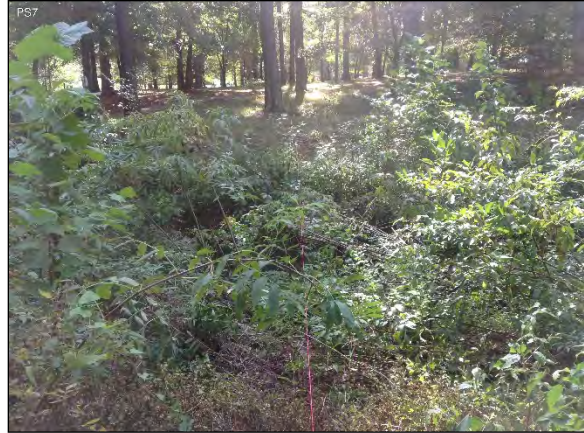
Photo Station 7, XS 1, facing right bank:
April 3, 2013

Photo Station 7, XS 1, facing right bank:
October 15, 2013

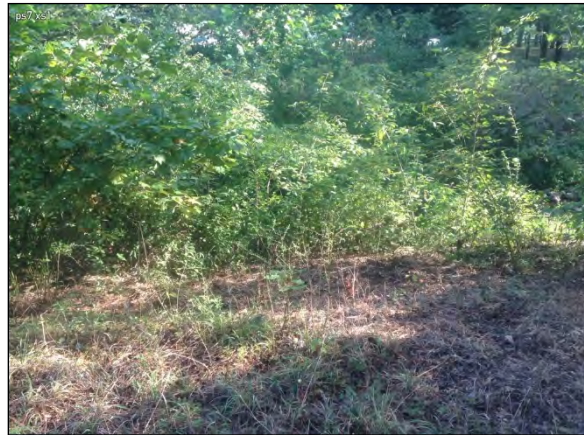
Photo Station 7, XS 1, facing right bank:
September 30, 2014

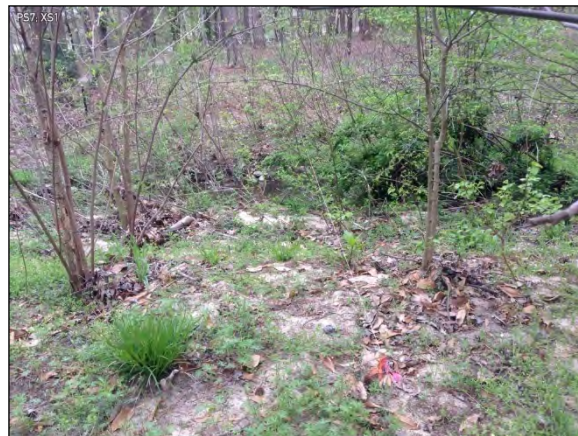
Photo Station 7, XS 1, facing right bank:
September 3, 2015

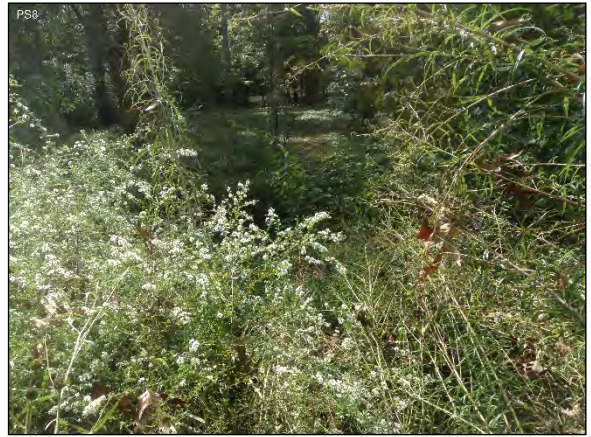
Photo Station 8, XS 2, facing right bank:
April 3, 2013

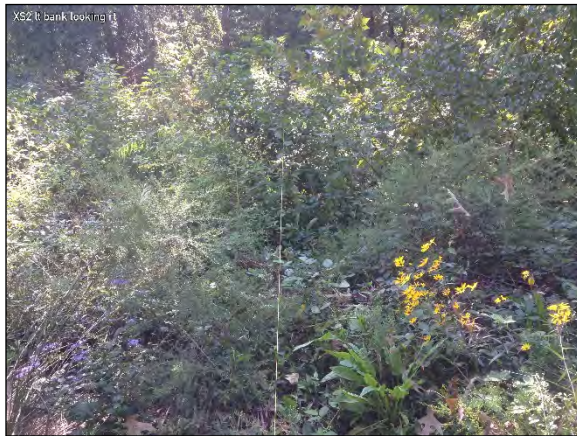
Photo Station 8, XS 2, facing right bank:
October 15, 2013

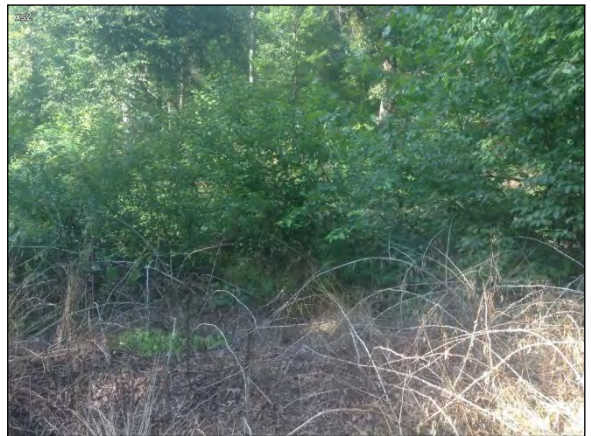
Photo Station 8, XS 2, facing right bank:
September 30, 2014

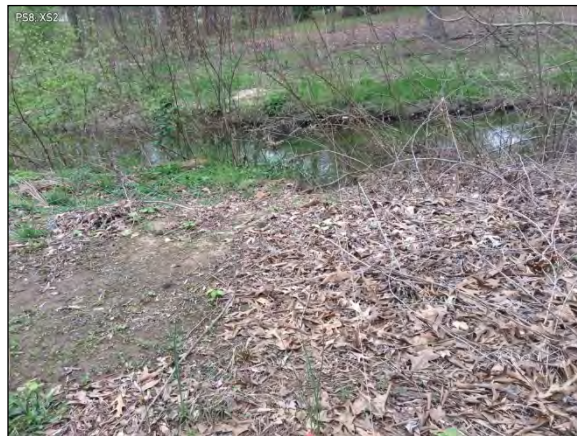
Photo Station 8, XS 2, facing right bank:
September 3, 2015

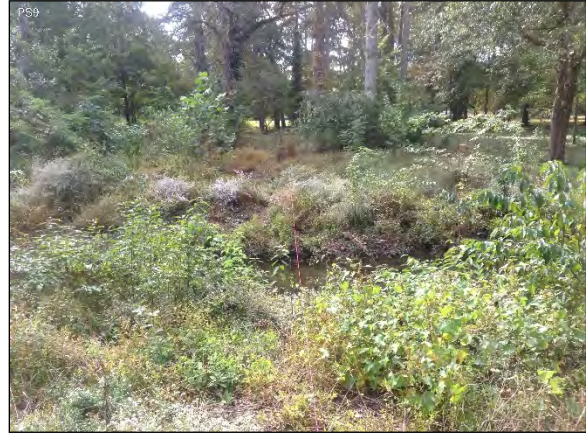
Photo Station 9, XS 3, facing right bank:
April 3, 2013

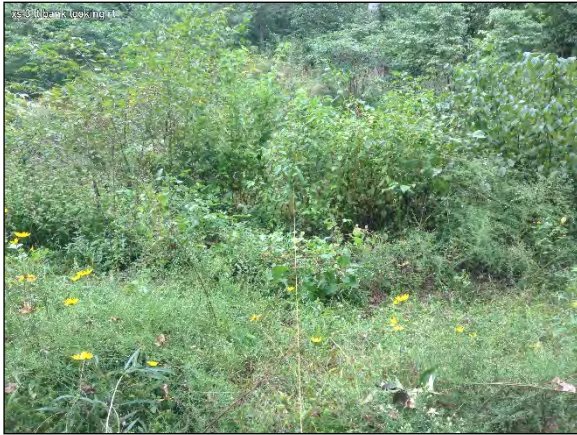
Photo Station 9, XS 3, facing right bank:
October 15, 2013

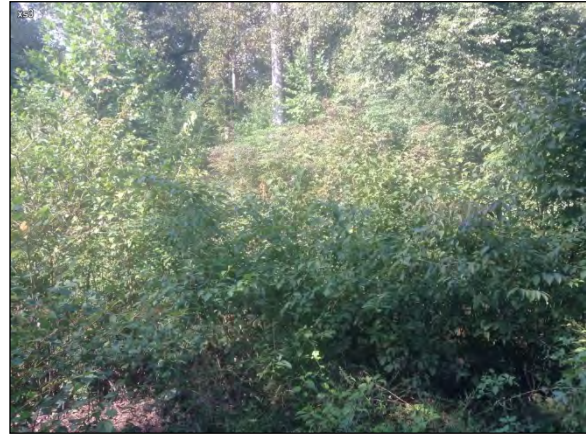
Photo Station 9, XS 3, facing right bank:
September 30, 2014

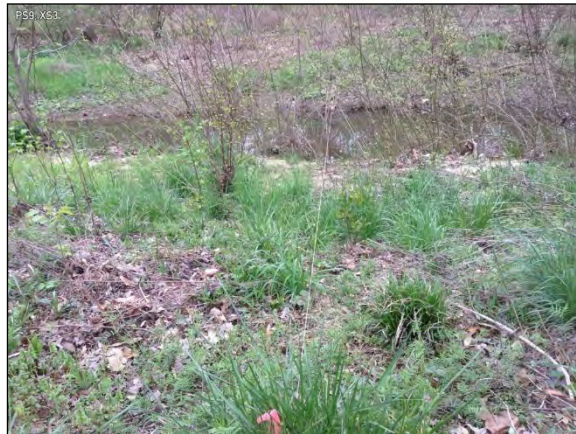
Photo Station 9, XS 3, facing right bank:
September 3, 2015

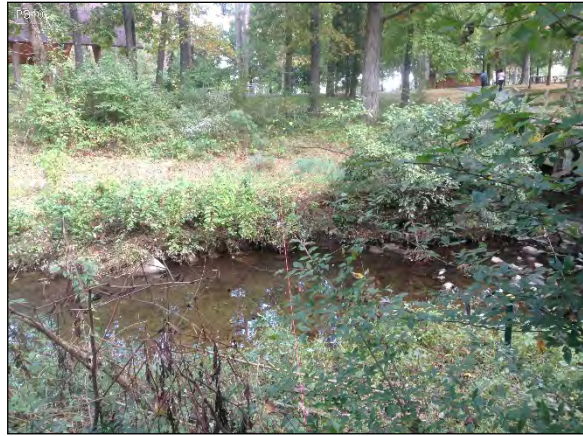
Photo Station 10, XS 4, facing right bank:
April 3, 2013

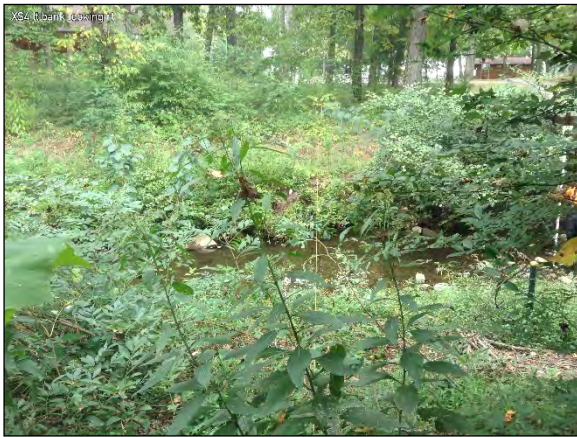
Photo Station 10, XS 4, facing right bank:
October 15, 2013

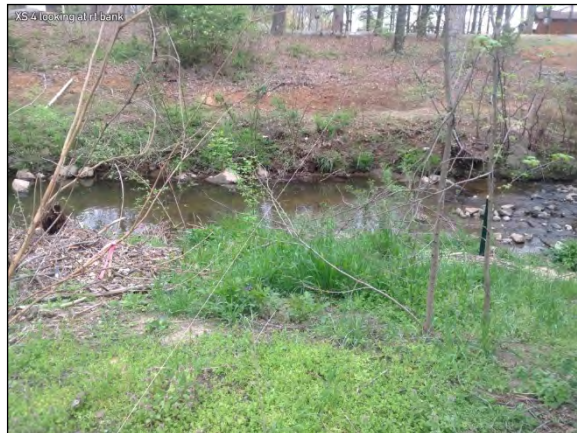
Photo Station 10, XS 4, facing right bank:
September 3, 2015

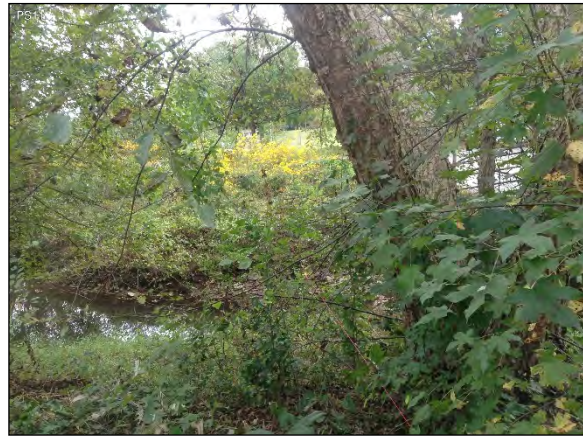
Photo Station 11, XS 5, facing right bank:
April 3, 2013

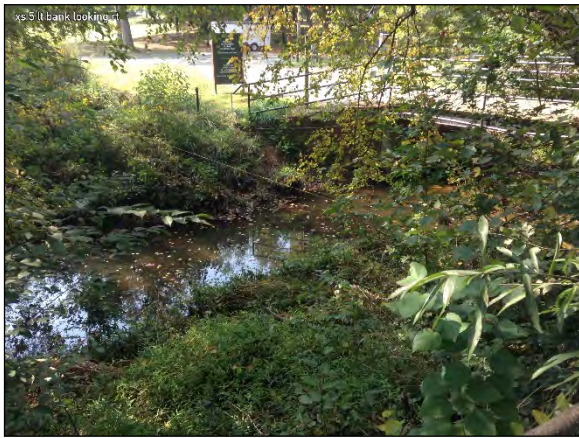
Photo Station 11, XS 5, facing right bank:
October 15, 2013

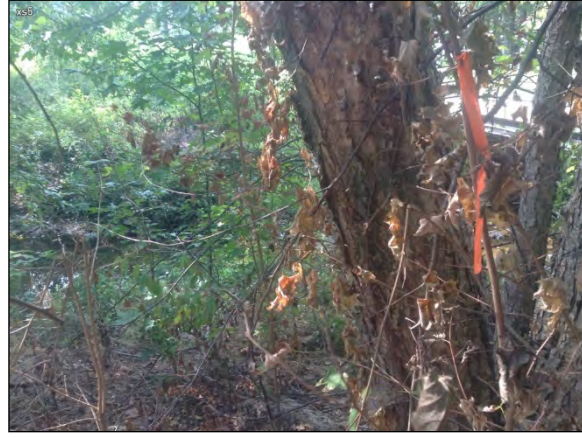
Photo Station 11, XS 5, facing right bank:
September 30, 2014

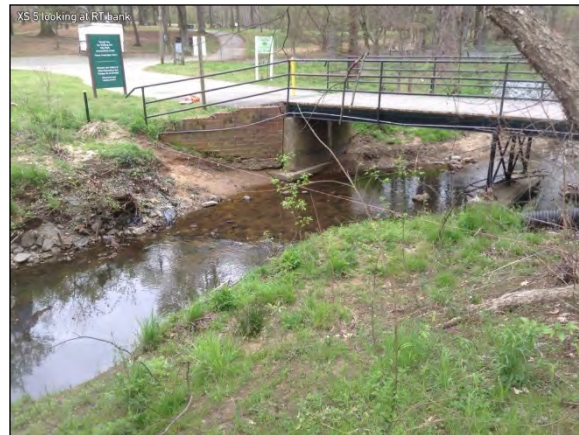
Photo Station 11, XS 5, facing right bank:
September 3, 2015

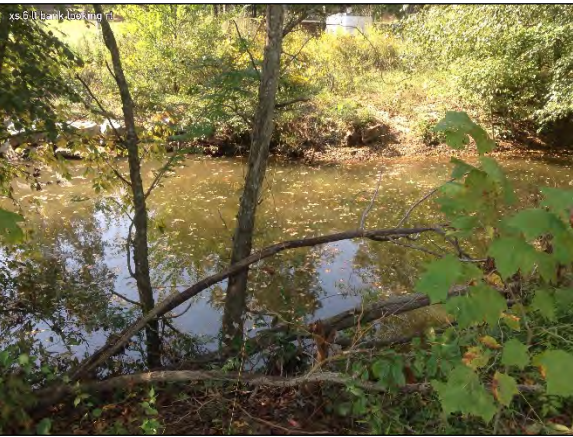
Photo Station 12, XS 6, facing right bank:
October 15, 2013

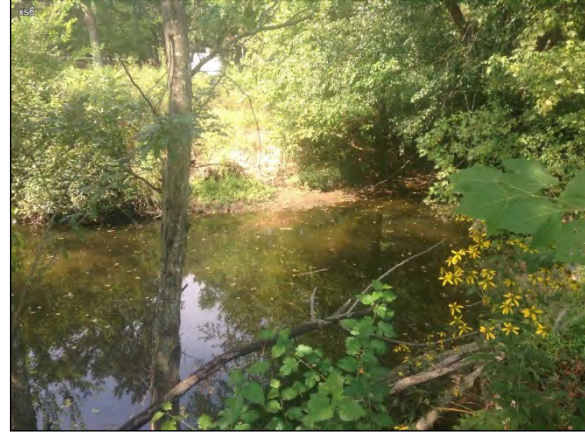
Photo Station 12, XS 6, facing right bank:
September 30, 2014

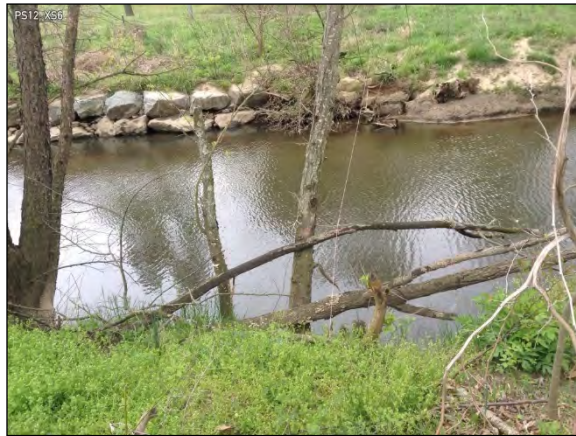
Photo Station 12, XS 6, facing right bank:
September 3, 2015

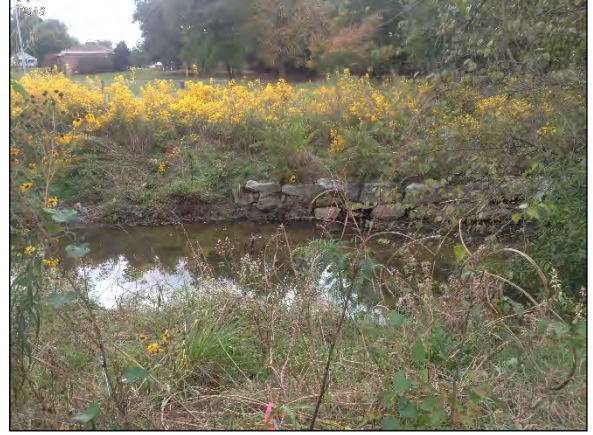
Photo Station 13, XS 7, facing right bank:
April 3, 2013

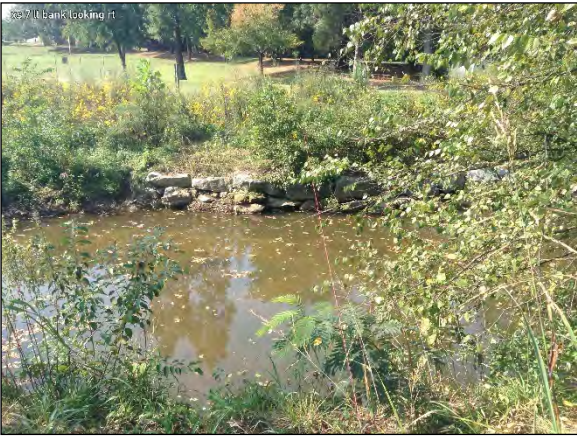
Photo Station 13, XS 7, facing right bank:
October 15, 2013

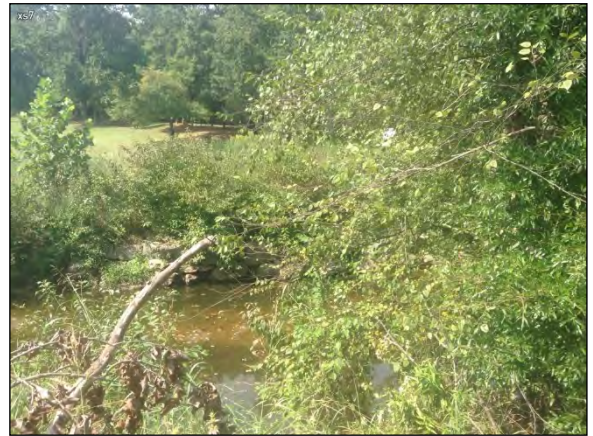
Photo Station 13, XS 7, facing right bank:
September 30, 2014

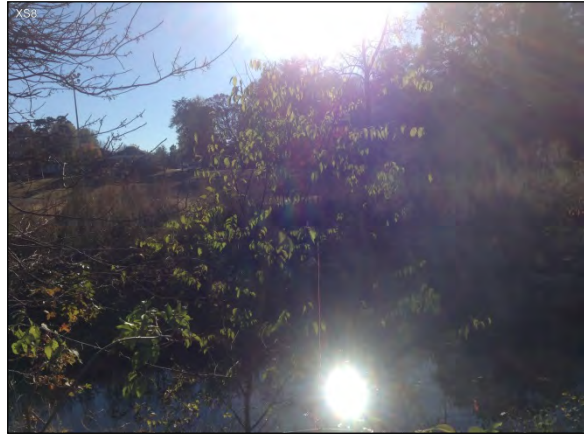
Photo Station 14, XS 8, facing right bank:
April 3, 2013

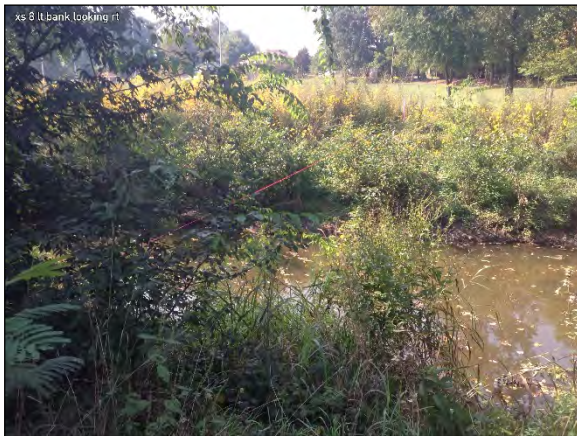
Photo Station 14, XS 8, facing right bank:
October 15, 2013

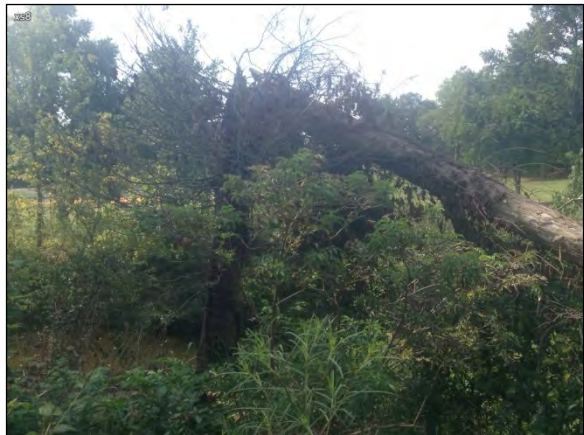
Photo Station 14, XS 8, facing right bank:
September 30, 2014

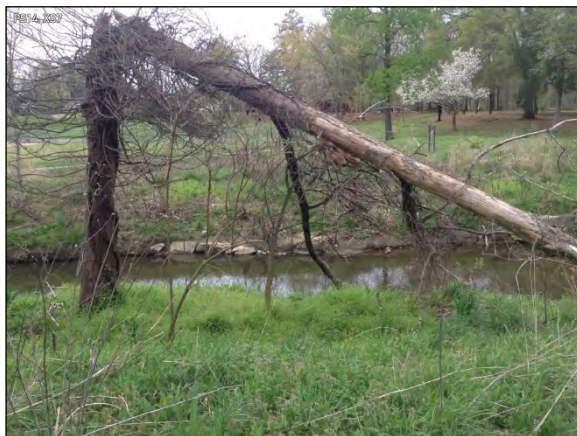
Photo Station 14, XS 8, facing right bank:
September 3, 2015

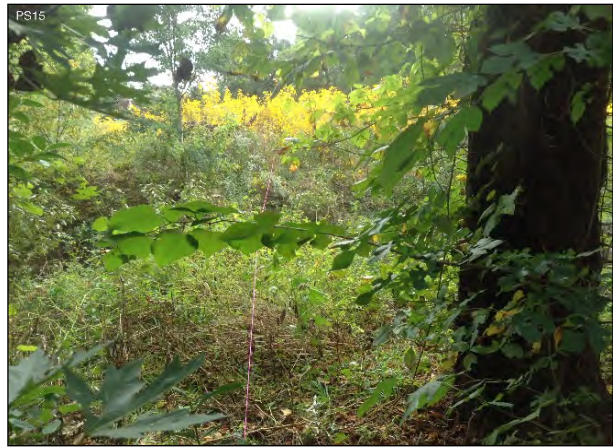
Photo Station 15, XS 9, facing right bank:
April 3, 2013

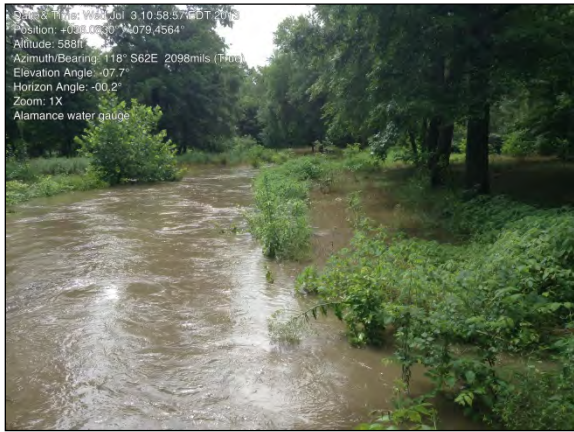
View of water gauge on main tributary
July 3, 2013

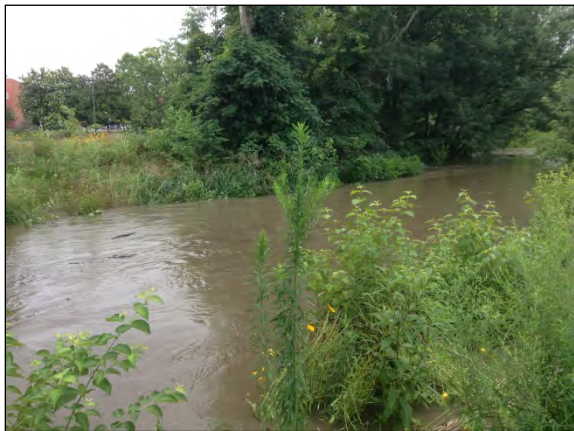
View from XS 7
July 3, 2013

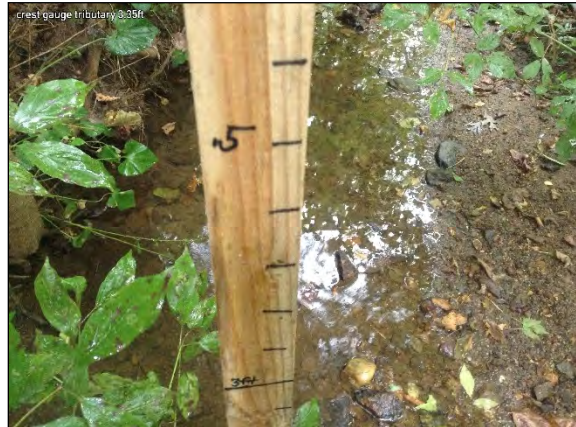
Crest gauge, UT. Cork at 3.35 ft.
September 29, 2014

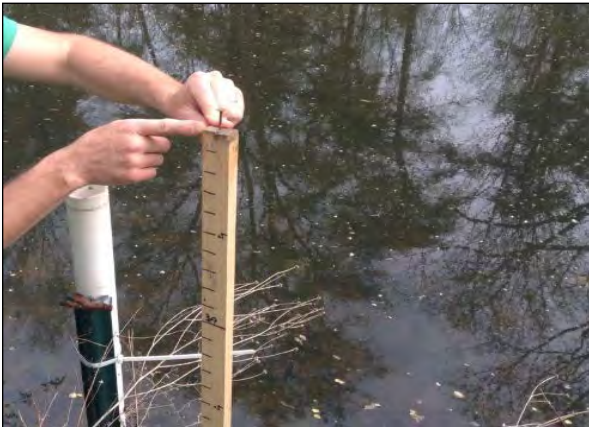
Crest gauge, main stem. Cork overtopped gauge.
April 10, 2015

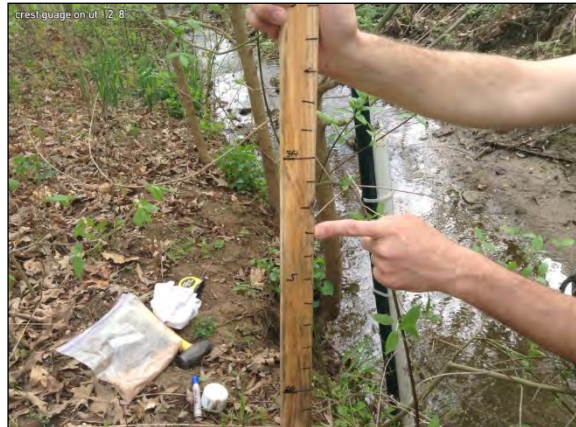
Crest gauge, UT. Cork at 2.8 ft.
April 10, 2015

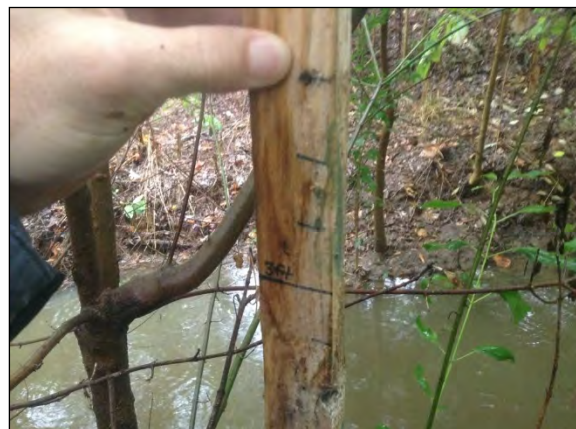
Crest gauge, main stem. Cork at 3.3 ft.
September 25, 2015
